Year 3 Monitoring Report

LITTLE SEBASTIAN SITE

NCDMS Project # 100027 (Contract # 7187) | RFP 16-006993 (Issued 9/16/2016)
USACE Action ID: SAW-2017-01507 | DWR Project # 2017-1041

Surry County, North Carolina
Yadkin River Basin
HUC 03040101

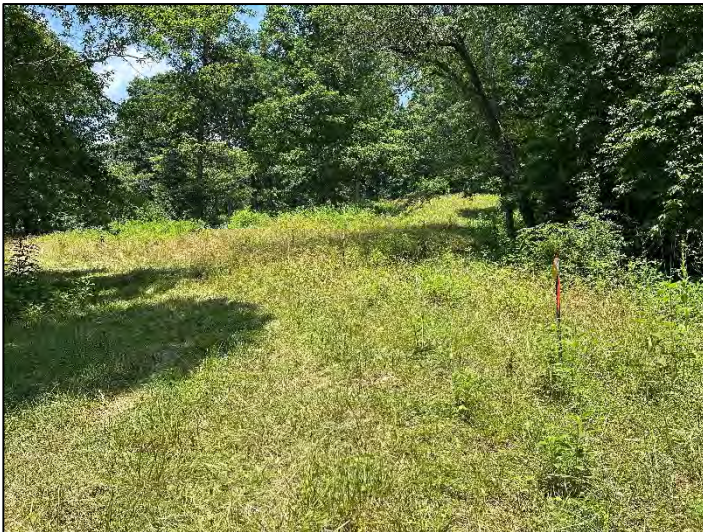
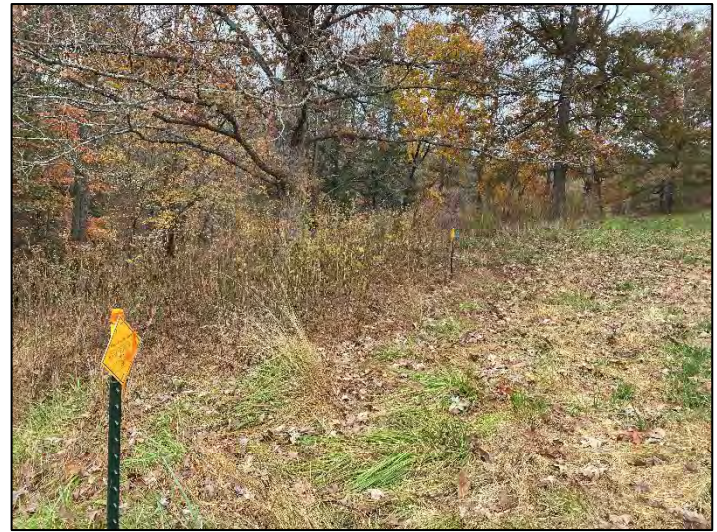
There was a recent DMS boundary inspection conducted on November 7th, 2023. Based on the boundary inspection there are several action items that are going to be addressed including one area of old fencing found along MC1-C which will be removed in early 2024. There was one area of fencing adjacent to reach MC3-D that needs to be relocated which will be done in early 2024. Along the easement near JN2-B there are a few trees that fell down on the fence which will be removed, and the fence will be fixed in 2024. Along JN3-B and MC1-C the top strand of fencing is loose and will be fixed in 2024. Additional easement signage was put along the easement boundary since the boundary inspection along reach MC1-B, JN2-A, JN2-B, and JN2-C. Additional easement signage is still needed near reach MC3-A, KN3-A, and JN2-A and will be completed in 2024. The cable tie fastening on easement boundary signs will be upgraded in 2024. There is also

an old tubular bull gate within the easement, and it will be removed in 2024. Approximate locations of conservation easement boundary issues or completed maintenance can be found in **Figure 2, Appendix B.**

Ascension Land Surveying is working on rectifying plat corner number duplications and installing any missing corner monuments. As well as replacing #4 rebar length will be with #5 rebar 30" in length. These issues will be completed in 2024 and will be discussed within the MY4 report.

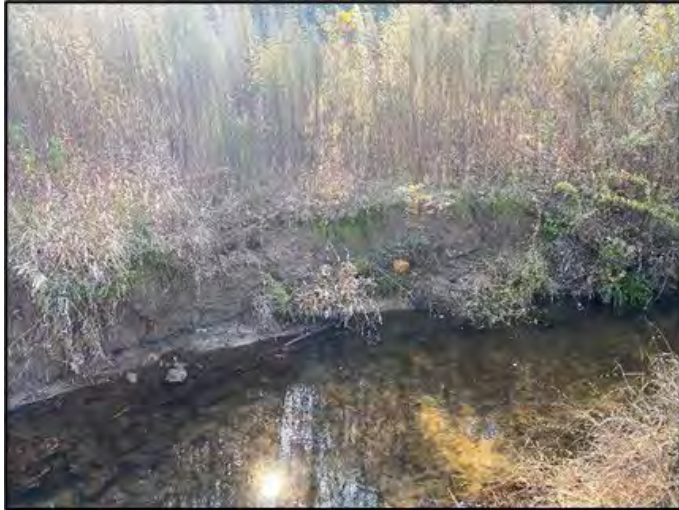
10. Section 1.7 Monitoring Performance (MY3) _Stream Geomorphology: An area of erosion is noted at Right Bank Erosion MC1-C and mapped on the CCPV, and “caused by a brush toe failing during a major storm event”; however, a photo of this area was not included. Is this an area RES also intends to address with matting and live staking, and is RES confident that this approach will stabilize the area? Does RES have an idea which storm event caused this? Please add additional information in the report text to detail the project issue and proposed resolution. The photo of the brush toe failure was previously mislabeled with the wrong reach and has been updated. The CCPV and report now also refer to the stream problem areas by station numbers. RES can not confirm what storm event caused the brush tow to fail but feels confident that the matting, packing with coir logs, and live staking will stabilize the area.

Visual assessment of the stream channel was performed to document signs of instability, such as eroding banks, structural instability, or excessive sedimentation (**Table 5, Appendix B**). There is one erosion area on the right bank along MC1-C (stream problem area #1) and two areas on BS1-C (stream problem area #2 & #3). The erosion on MC1-C was caused by a brush toe failing during a major storm event. The area erosion on BS1-C was caused by a failed log sill causing the stream flow to erode away at the right bank. These are localized areas of erosion and not a sign of systematic failure, RES plans to stabilize stream problem area #1 with matting, coir logs, and livestock stakes in 2024. For stream problem area #2 RES will rebuild the right bank with a stone toe. For stream problem area #3 RES plans to rebuild the piping log sill and add riffle material upstream of that log sill to convert the step-pool feature into more of a cascade feature and rebuild the left bank above that sill with a soil lift. Also, to notch the log sill above the piping log sill to give the low flow a preferential path that isn't under the left bank. Cross sections three (stream problem

Right Bank Erosion & Brush Toe Failure
on MC1-C / Stream Problem Area #1 (10/31/2023)

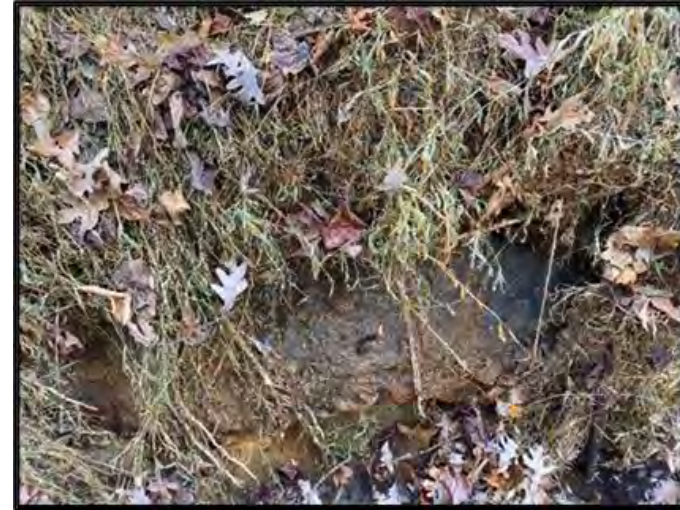
9. Section 1.7 Monitoring Performance (MY3) _Stream Geomorphology: An area of erosion is noted at Right Bank Erosion BS1-C and mapped on the CCPV, and “caused by a failed log sill causing the stream flow to erode away at the right bank”. It is noted that matting and live staking will be completed to stabilize this area in early 2024; however, the photo shows a vertical, eroding bank. Is RES confident that matting and staking can rectify and stabilize the apparently actively eroding bank? Please review and discuss in the report text.

Right Bank Erosion BS1-C / Stream Problem
Area #2 (11/7/2023)

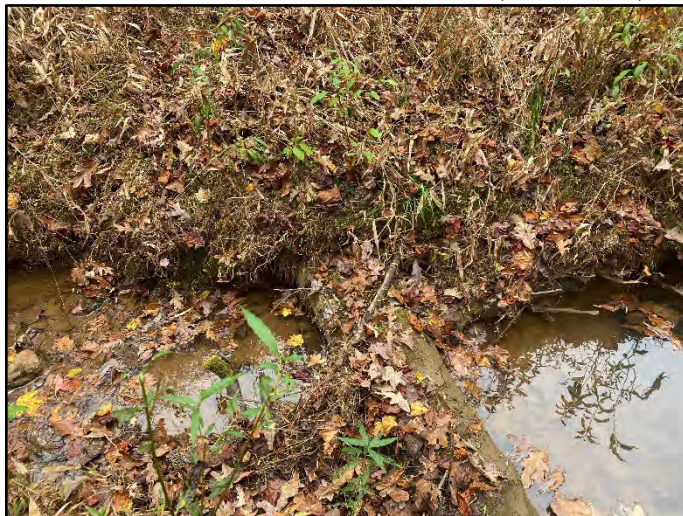
Failing Log Sill BS1-C / Stream Problem
Area #3 (10/31/2023)

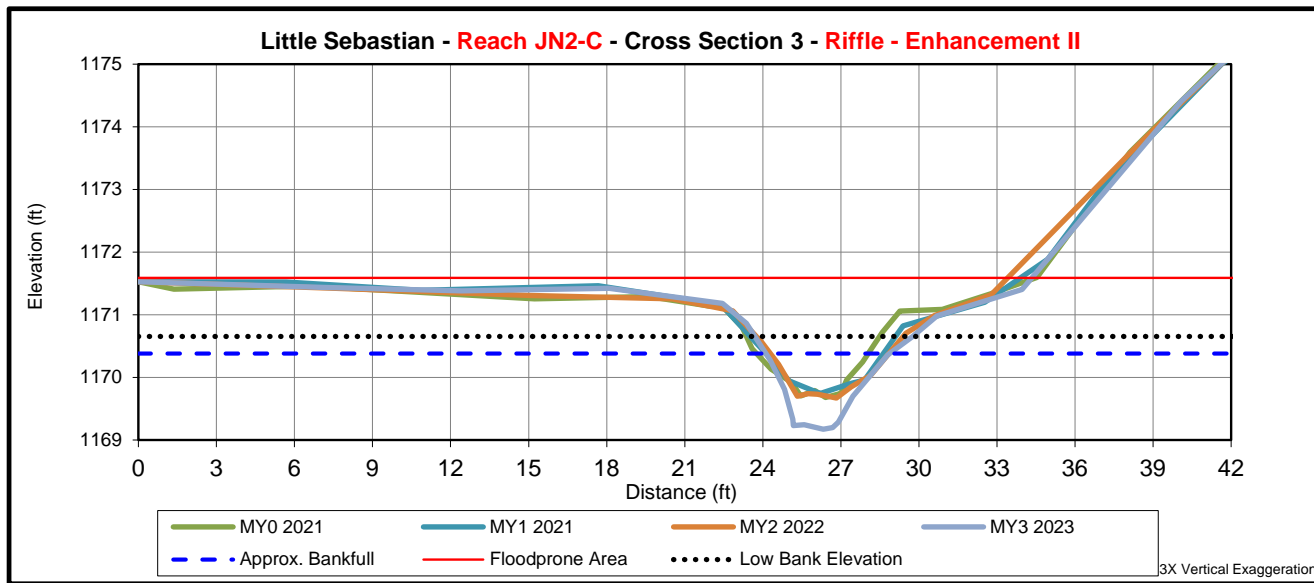
area #4) and four (stream problem area #5) are experiencing some unusual downcutting for a riffle, it appears that the downcutting seen is the riffle material moving downstream. RES will add material to lift the channel bed back to the proposed depth, the new material will be sized to be less mobile. This maintenance work will be scheduled to happen in 2024. Pictures of these areas can be found in **Appendix B** and locations can be found on **Figure 2**. The channel is transporting sediment as designed and will continue to be monitored for aggradation and degradation.

Cross Section 3 (Riffle)						
	Base	MY1	MY2	MY3	MY5	MY7	MY+
Bankfull Elevation (ft) - Based on AB-XSA¹	1170.7	1170.7	1170.7	1170.4			
Bankfull Width (ft) ¹	5.3	5.8	5.6	4.8			
Floodprone Width (ft) ¹	>34.8	>34.1	>33.5	34.3			
Bankfull Max Depth (ft) ²	1.0	1.1	1.0	1.5			
Low Bank Elevation (ft)	1170.7	1170.8	1170.7	1170.7			
Bankfull Cross Sectional Area (ft ²) ²	3.5	4.3	3.8	4.9			
Bankfull Entrenchment Ratio ¹	>6.6	>5.9	>5.9	7.2			
Bankfull Bank Height Ratio ¹	1.0	1.1	1.1	1.2

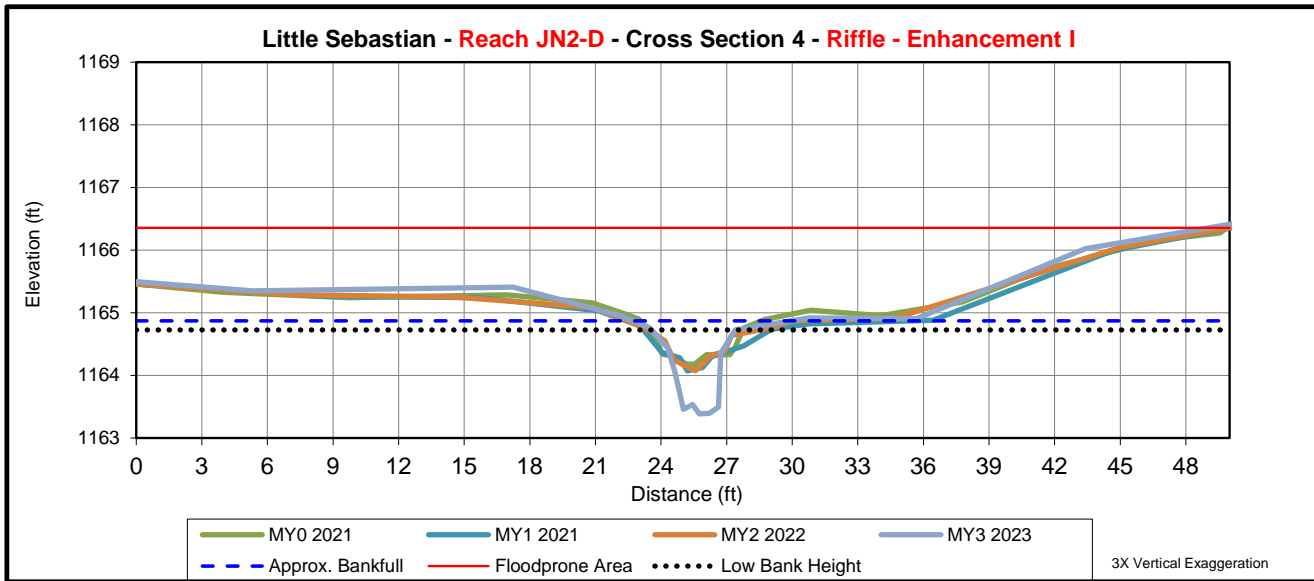
Cross Section 4 (Riffle)						
	Base	MY1	MY2	MY3	MY5	MY7	MY+
Bankfull Elevation (ft) - Based on AB-XSA¹	1165.0	1164.9	1165.0	1164.9			
Bankfull Width (ft) ¹	9.0	8.8	8.5	4.7			
Floodprone Width (ft) ¹	>43.9	>43.2	>43.9	>49			
Bankfull Max Depth (ft) ²	0.9	0.8	0.8	1.3			
Low Bank Elevation (ft)	1165.0	1164.8	1164.9	1164.7			
Bankfull Cross Sectional Area (ft ²) ²	3.5	2.6	2.4	2.9			
Bankfull Entrenchment Ratio ¹	>4.9	>4.9	>5.2	>10.5			
Bankfull Bank Height Ratio ¹	1.0	0.9	0.9	0.9
