Little Alamance Creek (Burlington Park) Stream Restoration 2013 Monitoring Report Monitoring Year 1 of 5

Alamance County, NC
Cape Fear River Basin
Cataloging Unit: 03030002
NCEEP Project Number: 92372
NCEEP Contract Number: 4998

FINAL – 2013 Monitoring Report – Year 1 of 5

Prepared by:
EEE Consulting, Inc.
601 Cascade Pointe Lane, Suite 101
Cary, NC 27513

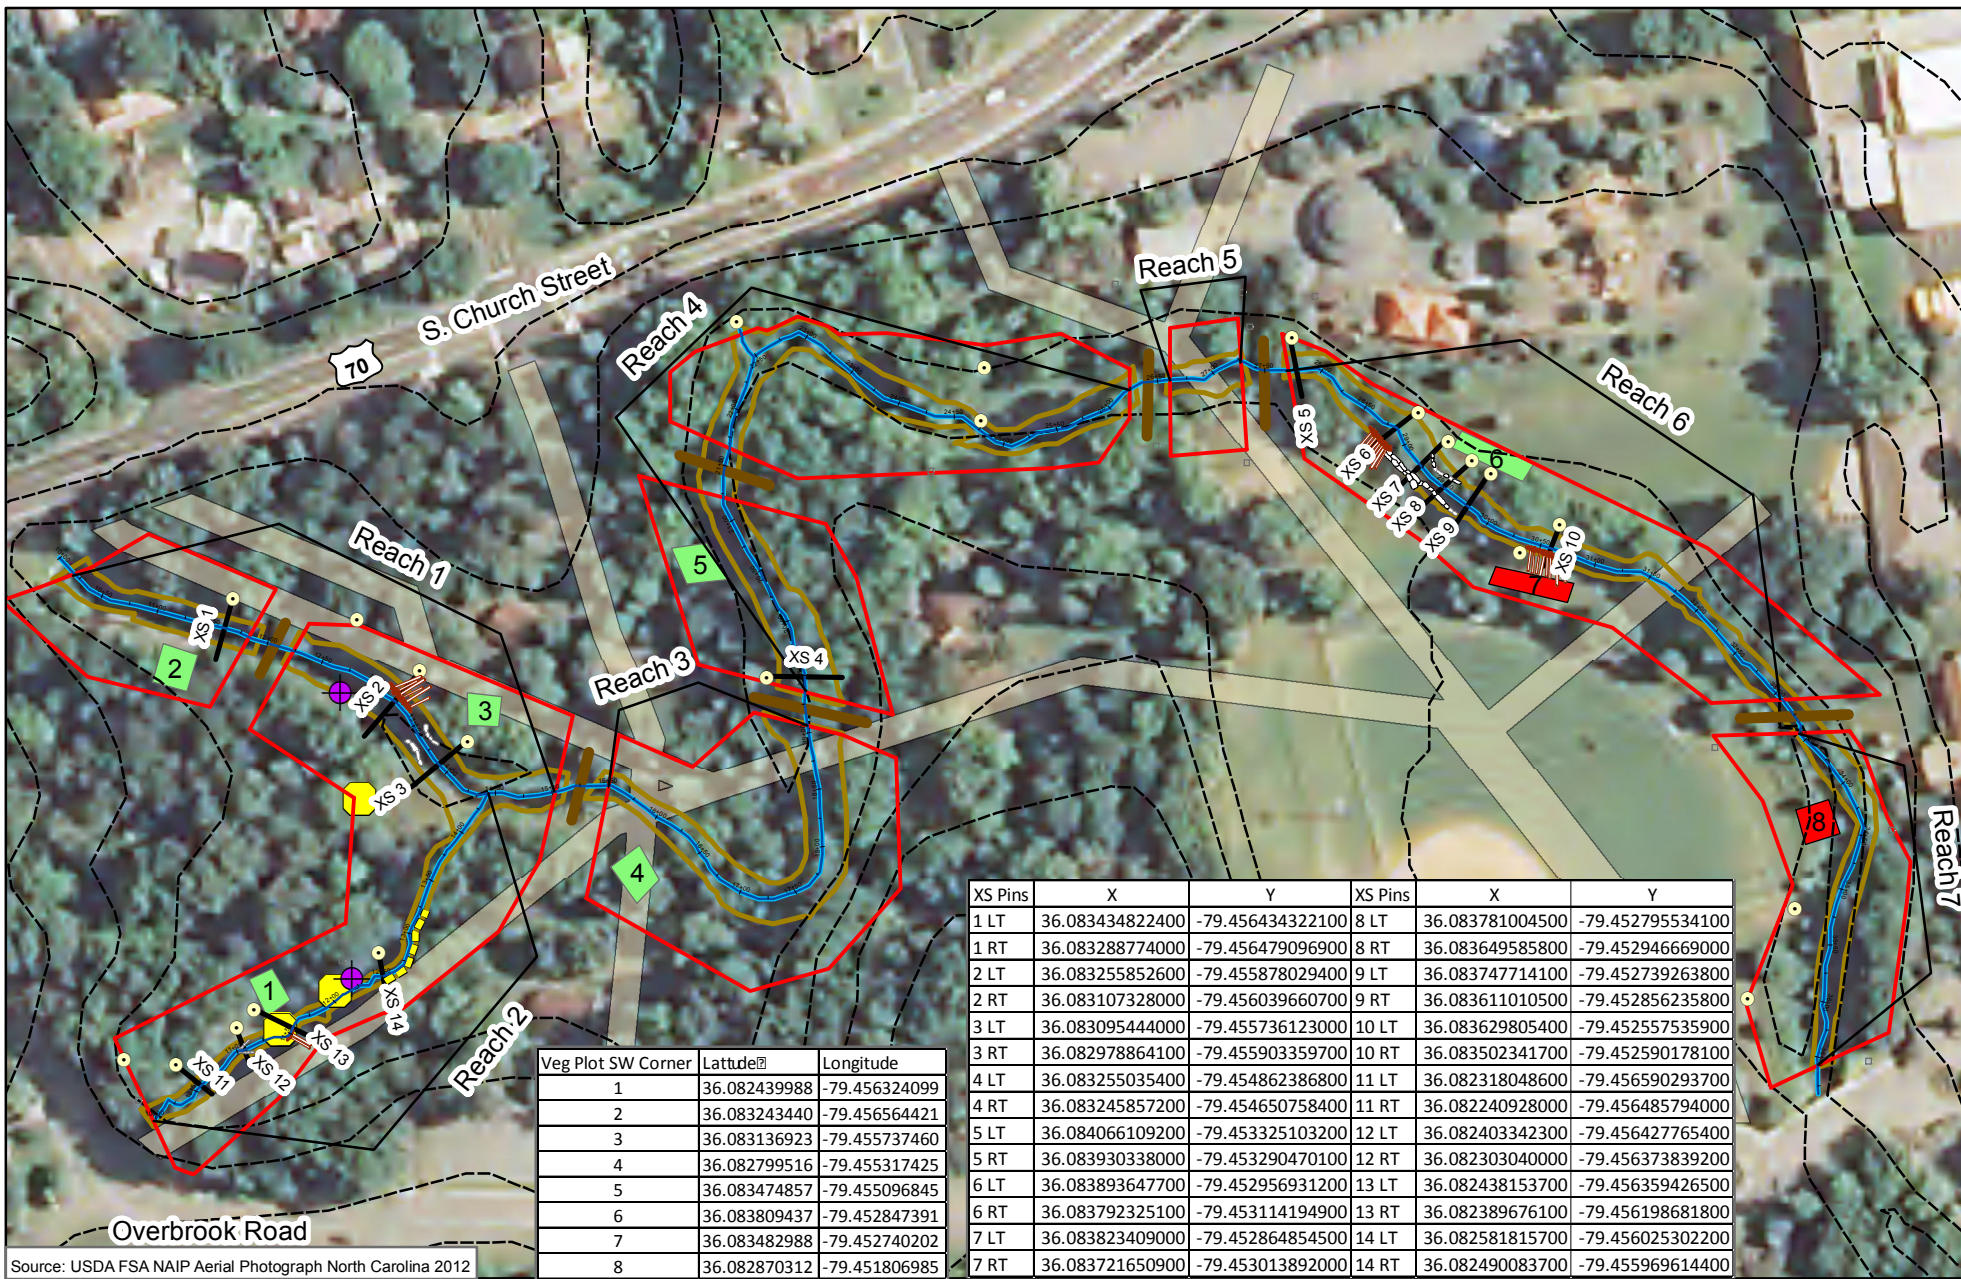
Figure 2: Current Condition Plan View
 Little Alamance Creek (Burlington Park) Stream Restoration
 Alamance County
 NCEP Project Number: 92372

requirement; however, vegetation plots 7 and 8 did not (Table 1). Volunteer species are establishing on site as expected and thus increasing the overall stems per acre. The Total Mean Density of the site is 809 stems per acre. Three areas were identified with invasive species in the conservations easement (Figure 2). Along the upper reaches of the unnamed tributary, multiflora rose (*Rosa multiflora*) was observed. These areas are negligible in size and are represented as point features. Along the upper reach of the mainstem, Chinese privet (*Ligustrum sinense*) was observed. This area was also negligible in size and is represented as a point feature. Individual stems of multiflora rose and Chinese privet were observed throughout the site, but at very low density. Both multiflora rose and Chinese privet are listed as high concern in the NCEEP Monitoring Report Template, Version 1.5. However, the presence of invasive species is minor, covering approximately 5 percent of the planted easement. These areas will continue to be monitored in the upcoming monitoring years. No other problems areas were observed.

Overall, the Little Alamance Creek Stream Restoration Site is in very good condition. All structures are intact and performing as intended. The Monitoring Year 1 thalweg has not deviated from the design thalweg. There is a notable lack of bank erosion, attributable to low bank angles and well established streamside vegetation. One small area along the unnamed tributary downstream of cross section 14 that has minor bank erosion (Figure 2). This area will continue to be monitored in the upcoming monitoring years. No other problems areas were observed. Two crest gauges were installed during Monitoring Year 1; one gauge along the mainstem of Little Alamance Creek and one gauge along the unnamed tributary. These gauges will be checked starting in Monitoring Year 2 to record the max height of the yearly storm event.

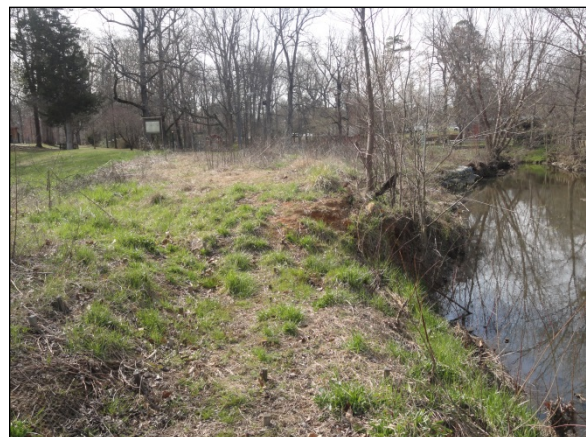
Photo Station 6, VP 7 at bollard 401,
facing west; April 3, 2013

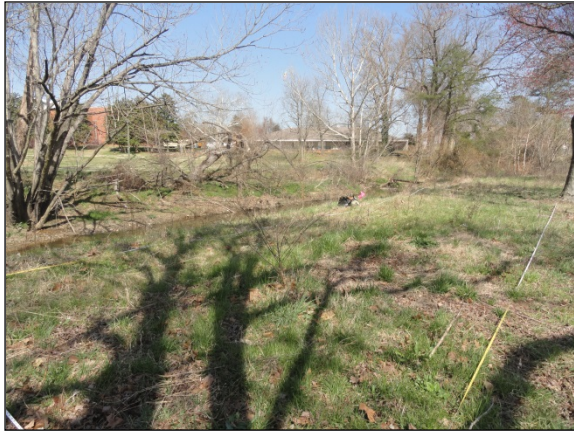
Veg Plot 7, view from southwest corner
April 3, 2013

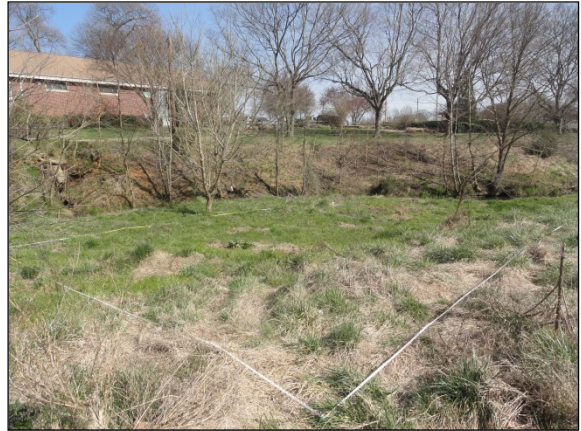
Veg Plot 8, view from southwest corner
April 3, 2013
