# Little Alamance Creek (Burlington Park) Stream Restoration 2013 Monitoring Report Monitoring Year 2 of 5

Alamance County, NC  
Cape Fear River Basin  
Cataloging Unit: 03030002  
NCEEP Project Number: 92372  
NCEEP Contract Number: 4998

**FINAL** – 2013 Monitoring Report – Year 2 of 5

**Prepared by:**  
**EEE Consulting, Inc.**  
601 Cascade Pointe Lane, Suite 101  
Cary, NC 27513

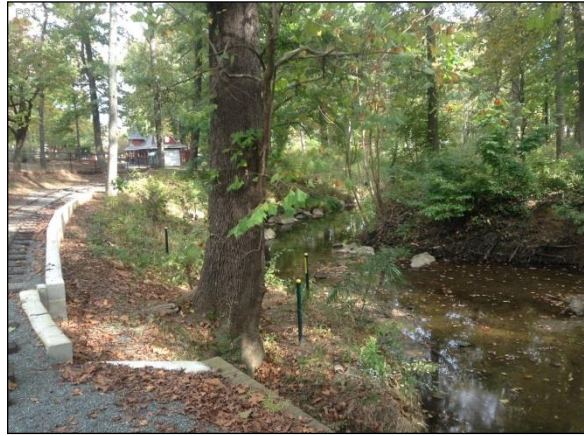
Photo Station 1, rail line at bollard 172, facing east; October 15, 2013

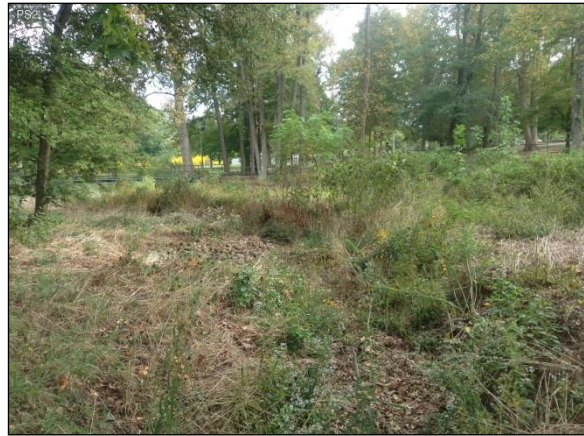
Photo Station 2, level spreader at bollard 410, facing east; October 15, 2013

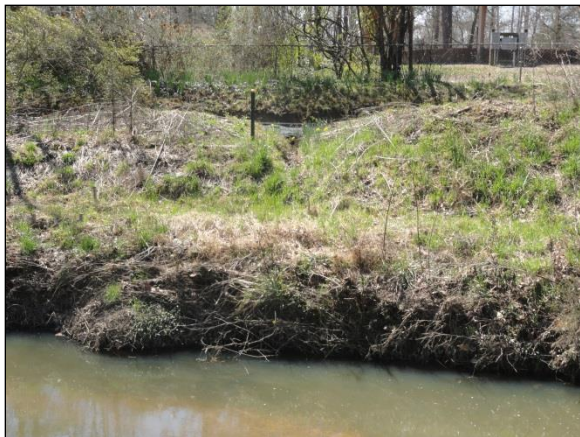
Photo Station 3, rail line discharge, facing south; April 3, 2013

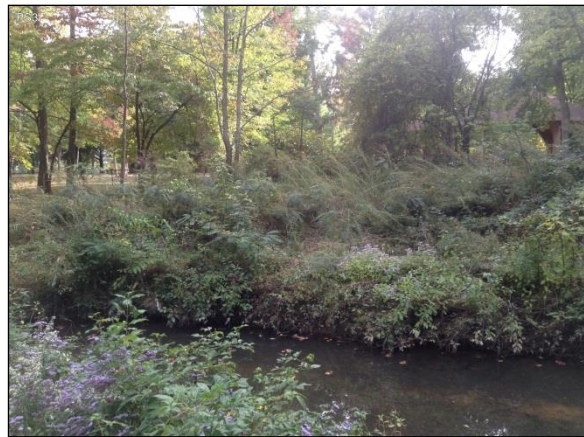
Photo Station 3, rail line discharge, facing south; October 15, 2013

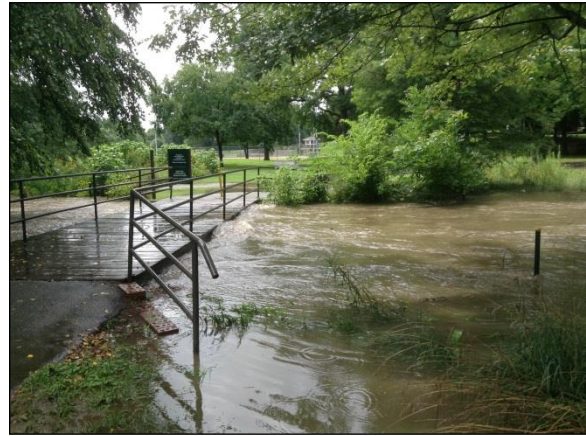
View of Rail Road at PS1  
July 3, 2013
