**Little Alamance Creek (Burlington Park) Stream Restoration
2015 Monitoring Report
Monitoring Year 4 of 5**

**Alamance County, NC
Cape Fear River Basin
Cataloging Unit: 03030002
NCDMS Project Number: 92372
NCDMS Contract Number: 4998**

Final – 2015 Monitoring Report – Year 4 of 5

Prepared by:
EEE Consulting, Inc.
601 Cascade Pointe Lane, Suite 101
Cary, NC 27513

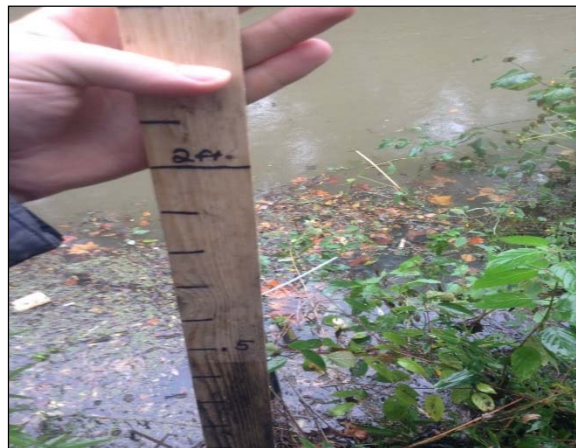
Crest gauge, UT. Cork at 2.8 ft.
April 10, 2015
