**Little Alamance Creek (Burlington Park) Stream Restoration
2016 Monitoring Report
Monitoring Year 5 of 5**

**Alamance County, NC
Cape Fear River Basin
Cataloging Unit: 03030002
NCDMS Project Number: 92372
NCDMS Contract Number: 4998**

Final – 2016 Monitoring Report – Year 5 of 5

Prepared by:
EEE Consulting, Inc.
601 Cascade Pointe Lane, Suite 101
Cary, NC 27513

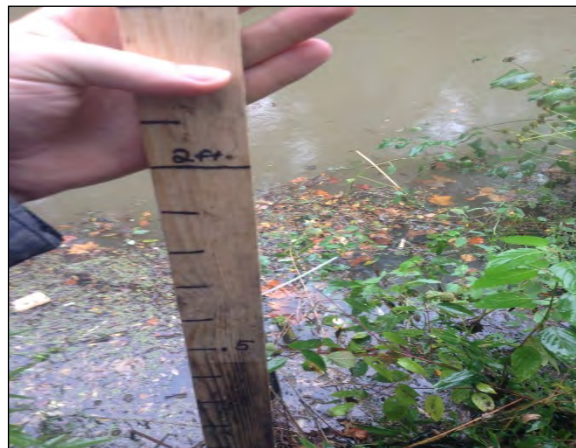
Crest gauge, UT. Cork at 2.8 ft.
April 10, 2015
