**Little Beaver Creek
Stream Restoration
Wake County, North Carolina
Mitigation Report**

SCO ID # 01-05299-01A
NCEEP Project Number 221
EEP Project Manager: Julia Hunt

January 2007

**LITTLE BEAVER CREEK STREAM RESTORATION
MITIGATION REPORT**

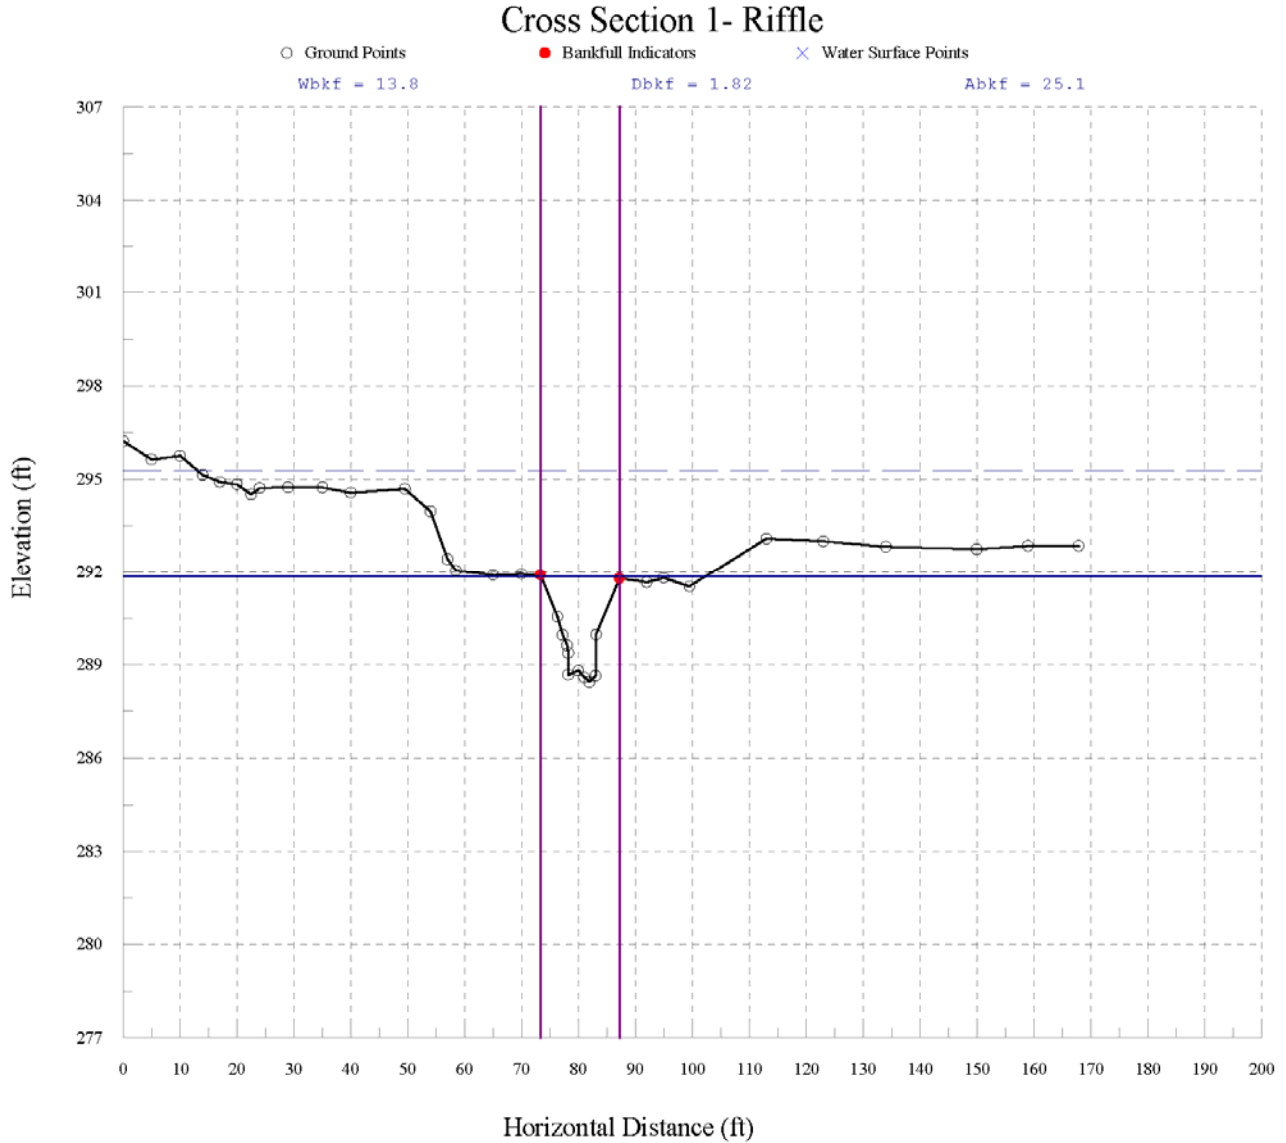
Cross Section 1 Year 1 (black)*

*The location of Cross Section 1 was reset in Year 1 monitoring to give a more accurate representation of the stream. This cross-section data is the Year 1 data.
