**Little Beaver Creek
Stream Restoration
Wake County, North Carolina
Year 1 Monitoring Report**

Monitoring Year: 2007
Measurement Year 1
As-Built Date 2005
NCEEP Project Number 221

February 2008

**LITTLE BEAVER CREEK STREAM RESTORATION
YEAR 1 MONITORING REPORT**

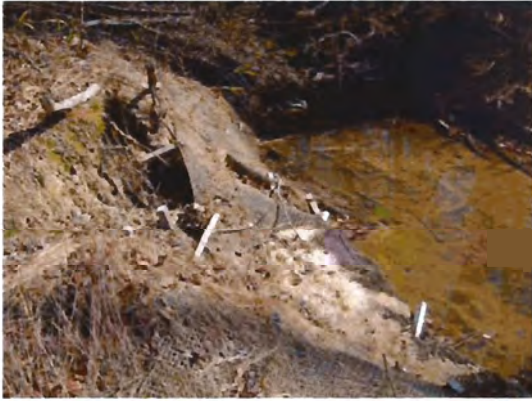
Feature/Issue	Station#/Range	Probable Cause	Photo#
Bare Bank	10+00	Unvegetated coir matting, both banks	VPA 1
	10+50	Eroded banks	VPA 2
	12+00	Bare coir matting, both banks	
	14+50	Bare coir matting/ eroded bank, left bank	VPA 6
	15+80	Bare coir matting, both banks	
	16+10	Bare coir matting/ eroded banks, both banks	
	17+40	Bare coir matting, both banks	
	18+80	Eroded bank, right bank	
	21+80	Bare coir matting/eroded bank, right bank	VPA 11
	24+00	Bare coir matting/ eroded bank, both banks	VPA 12
	26+00	Bare coir matting/ eroded bank, both banks SEVERE	VPA 13
	27+00	Eroded bank, left bank	
	28+50	Bare coir matting, eroded bank, both banks	
	30+00	Bare coir matting/ eroded bank, both banks	
	31+00	Bare coir matting/ eroded bank, both banks	
	32+30	Bare coir matting/ eroded bank, both banks	
	33+10	Bare coir matting, both banks	
	34+60	Bare coir matting/ eroded bank, both banks	VPA 20
	35+50	Bare coir matting/ eroded bank, both banks

VPA 1. Unvegetated coir matting on both banks.

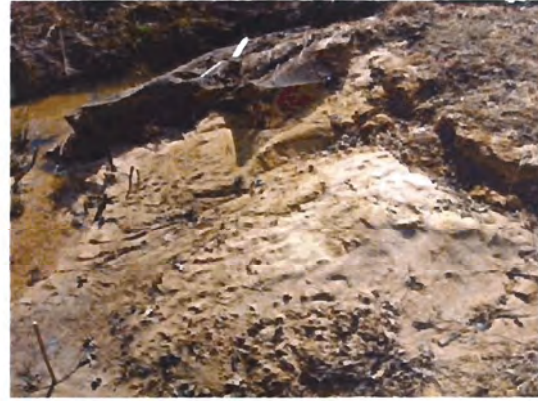
VPA 2. Eroded banks from lack of vegetation.

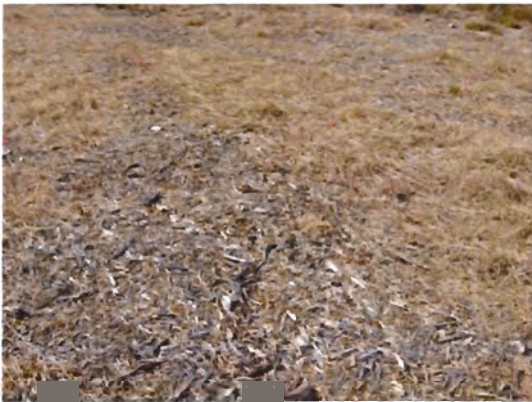
VPA 3. Exceedingly thick area of mulch preventing vegetation growth.

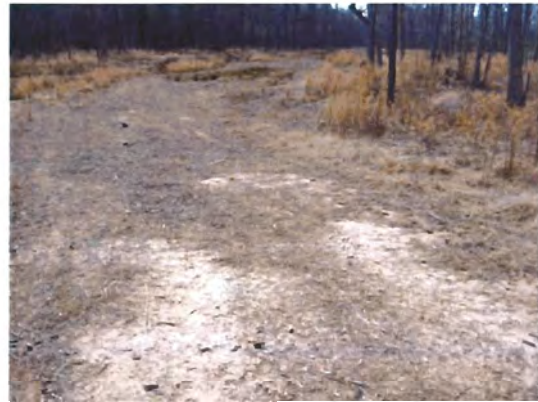
VPA 5. Dirt road through overly mulched area.

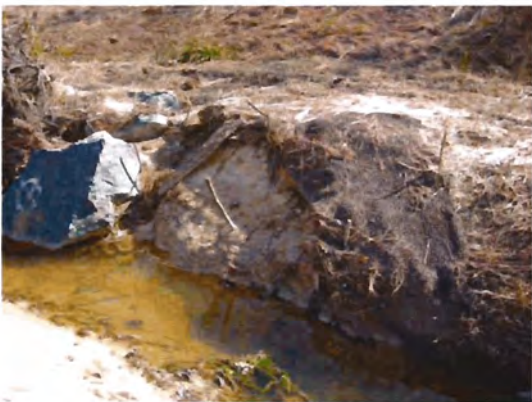
VPA 6. Live stakes not establishing allowing for eroded bank on left bank.

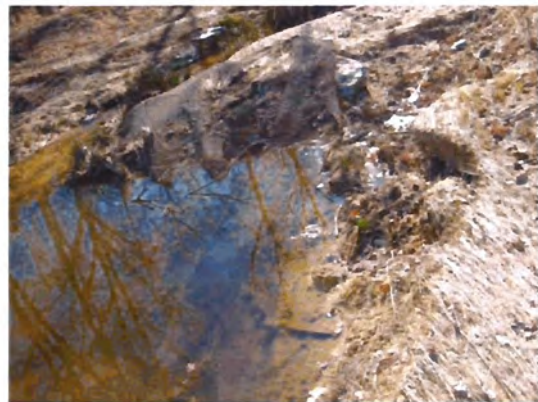
VPA 12. Vegetation not establishing through coir matting.

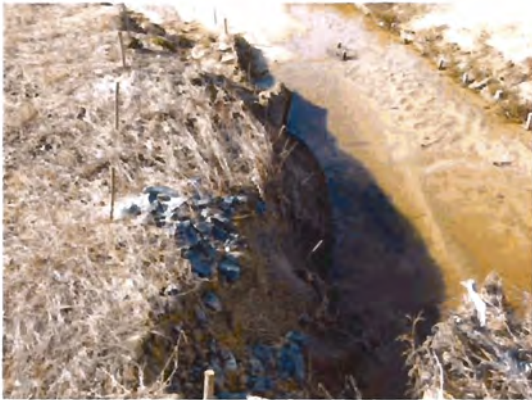
VPA 20. Vegetation not establishing through coir matting on both banks.

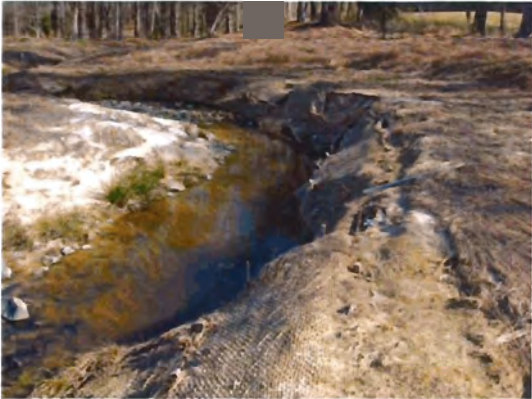
VPA 23. Vegetation not establishing through coir matting.

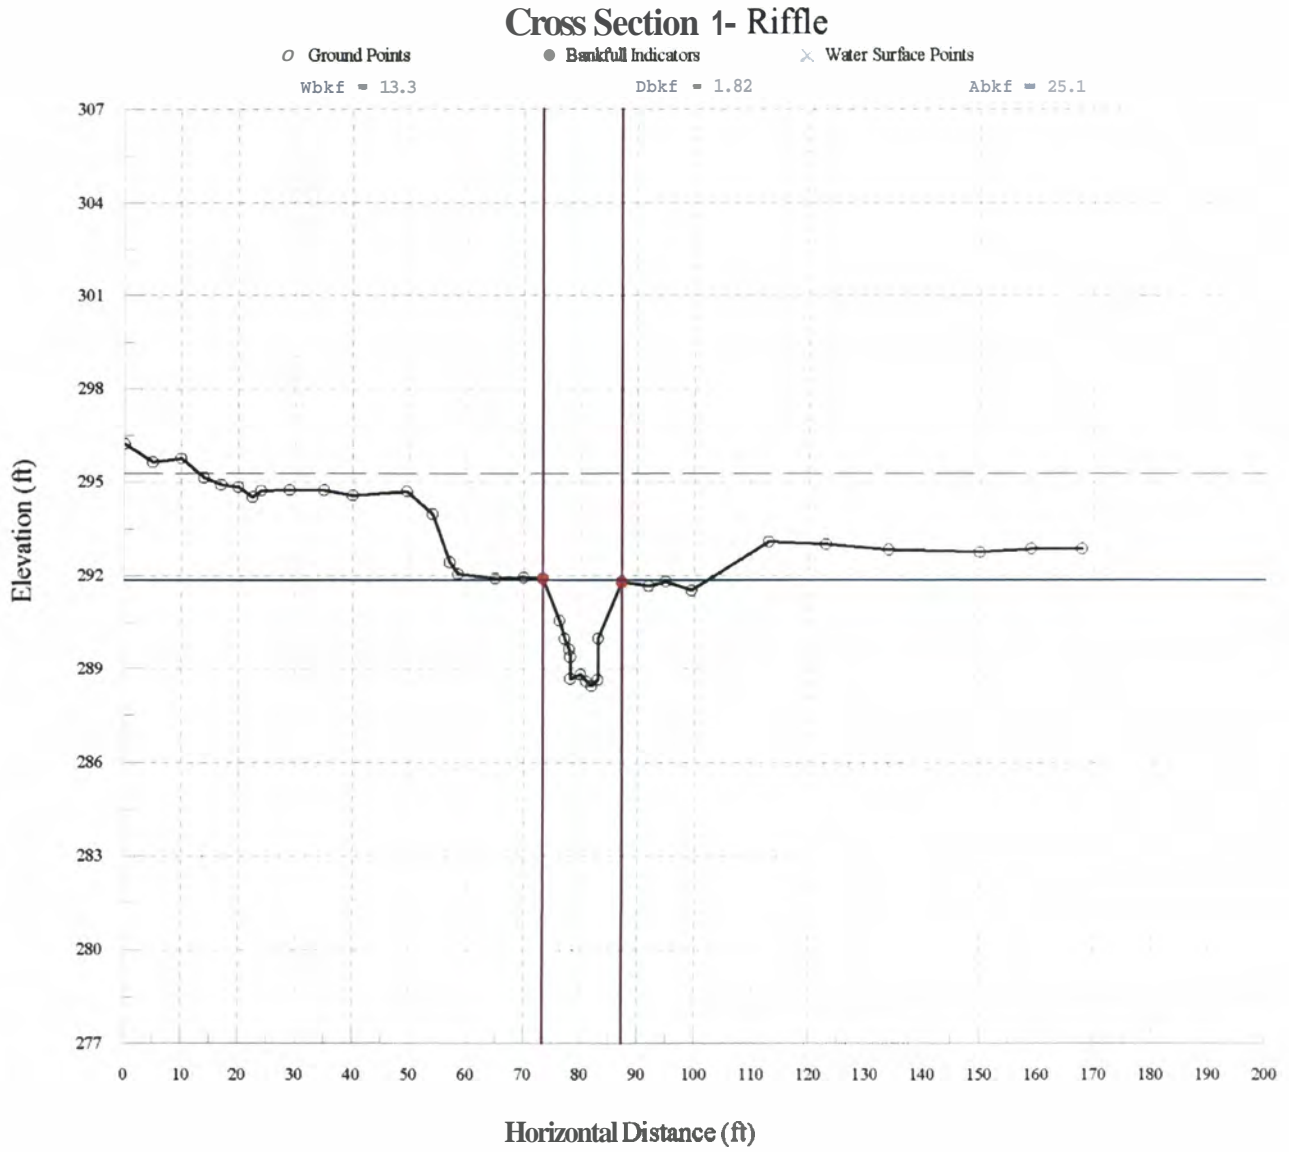
Cross Section 1 Year 1 (black)*

*The location of Cross Section 1 was reset in Year 1 monitoring to give a more accurate representation of the stream, therefore no comparison with Year 0 is provided.
