Little Beaver Creek Stream and Wetland Restoration Site

2008 Annual Monitoring Report- (Year 2)

Wake County
EEP Project No. 221
Design Firm: Earth Tech

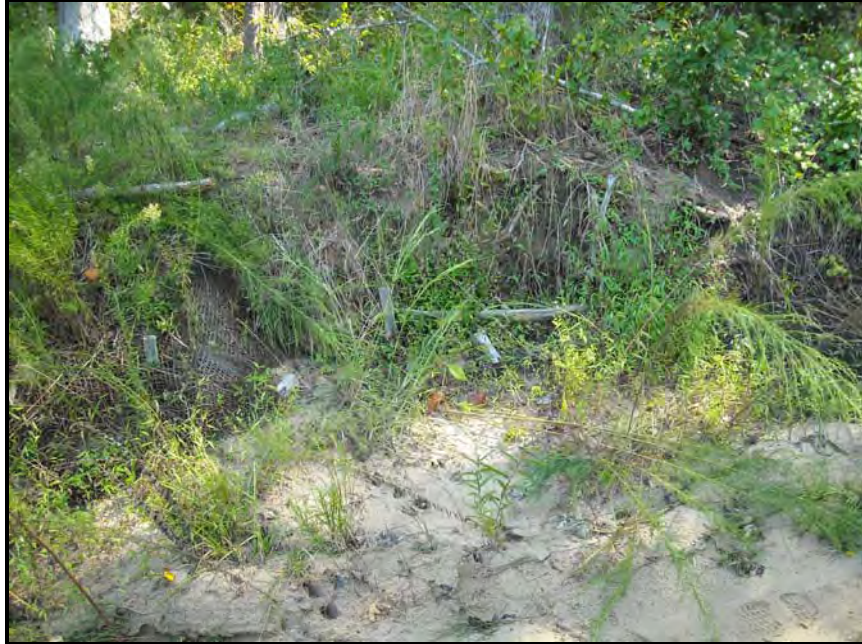
VPA 1. Left and Right descending banks have eroded bank.

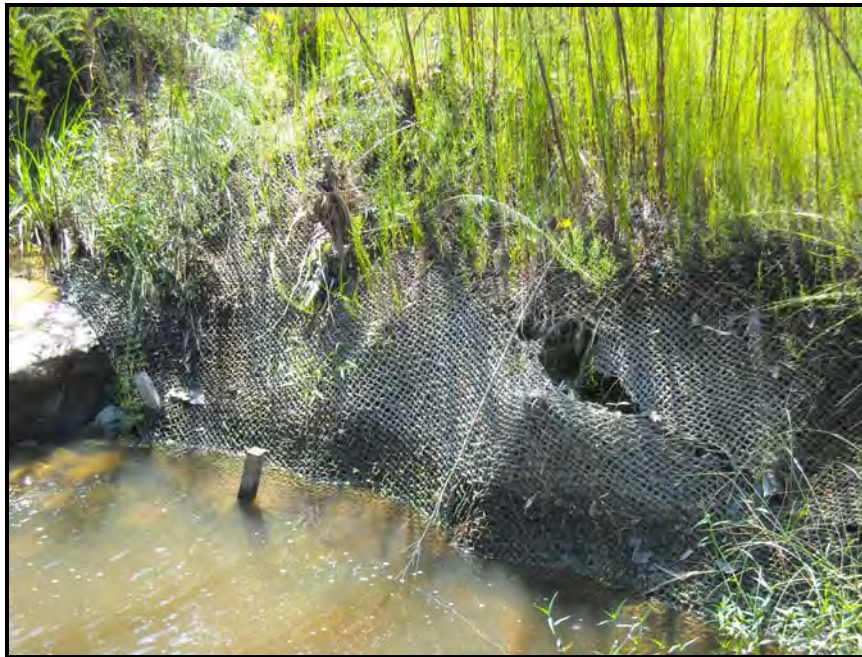
VPA 5. Left and rifght descending banks have eroding banks.

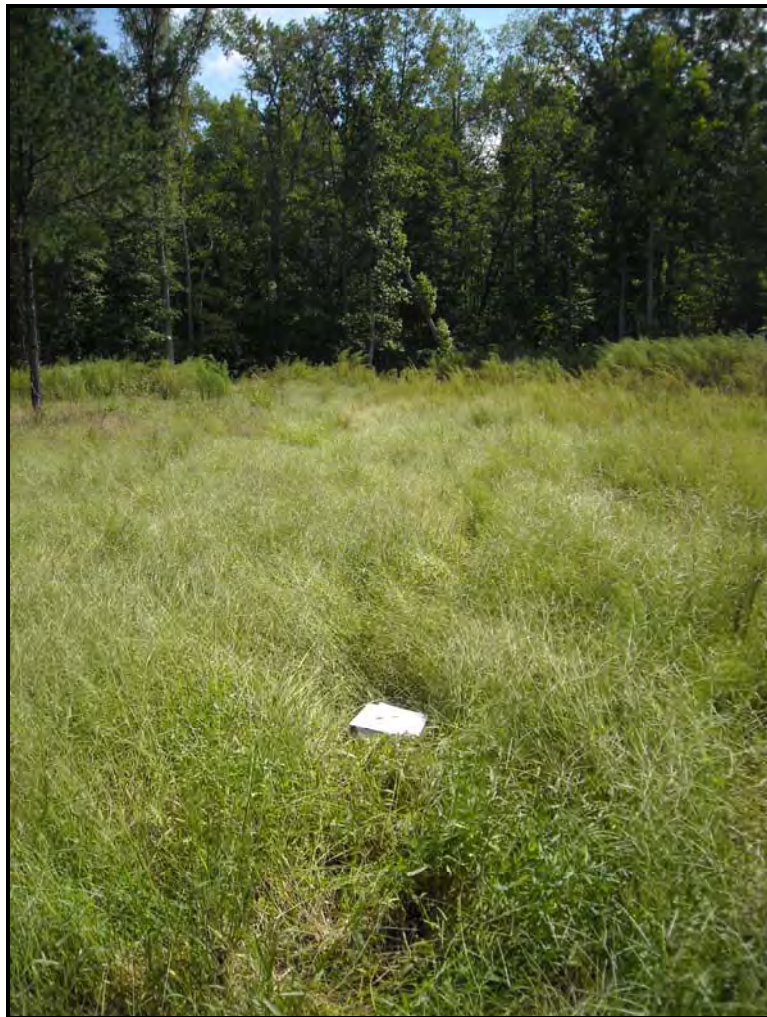
VPA 7. Grassy area within buffer with no evidence of planted tree species.

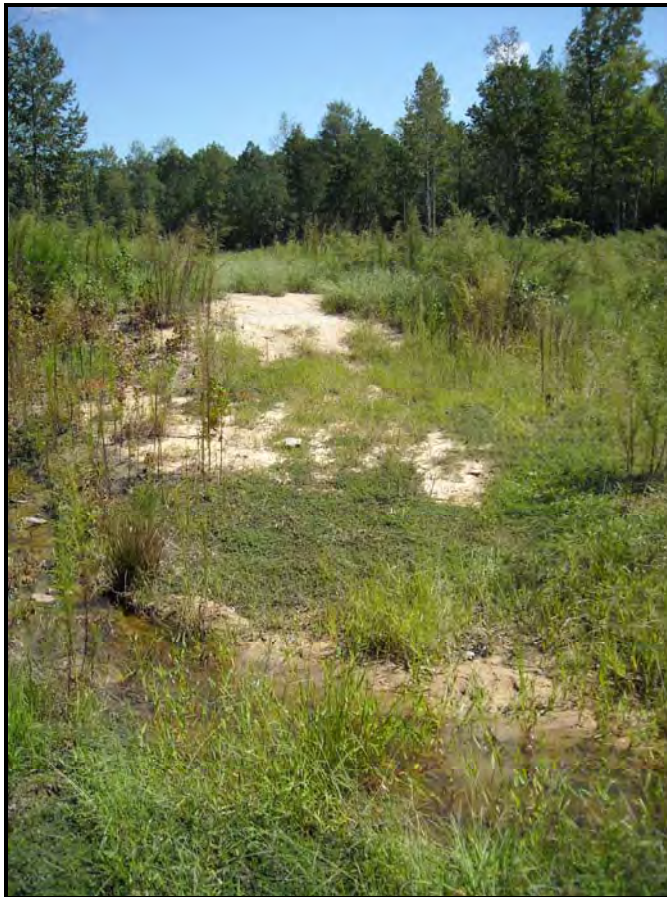
VPA 15. Bare area within buffer.

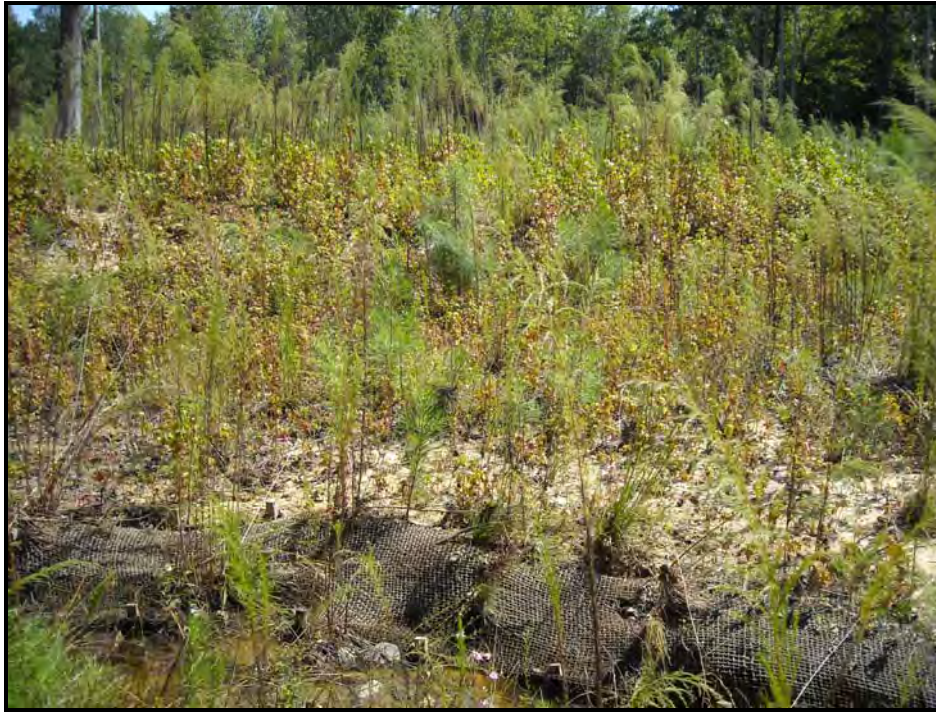
VPA 16. Bare coir matting with ubiquitous sweetgum saplings (*Liquidambar styraciflua*).

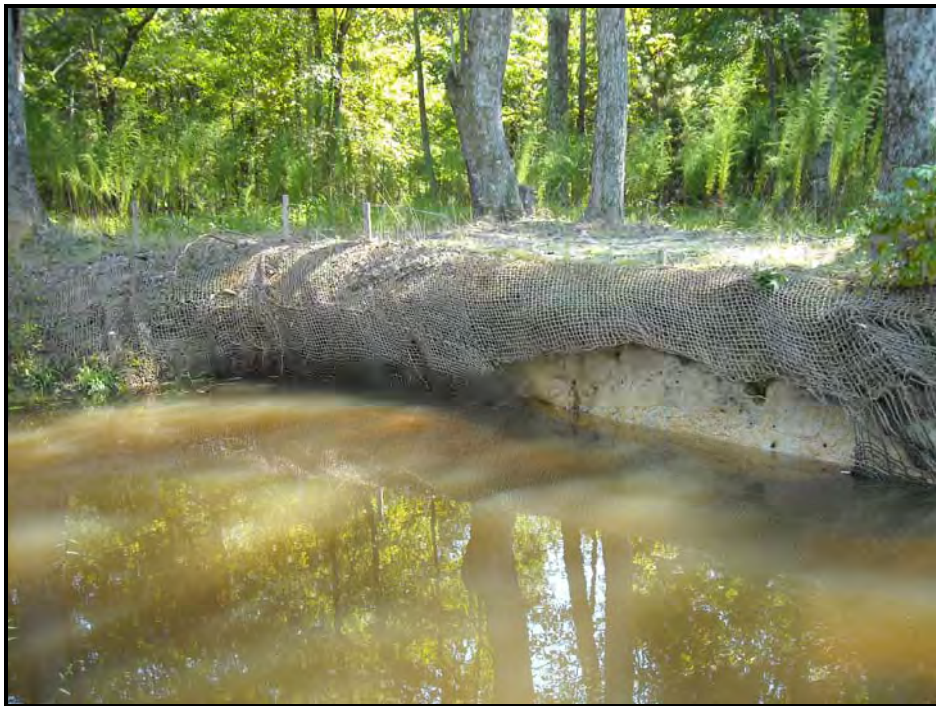
VPA 21. Left descending bank is eroding and is has bare coir matting.

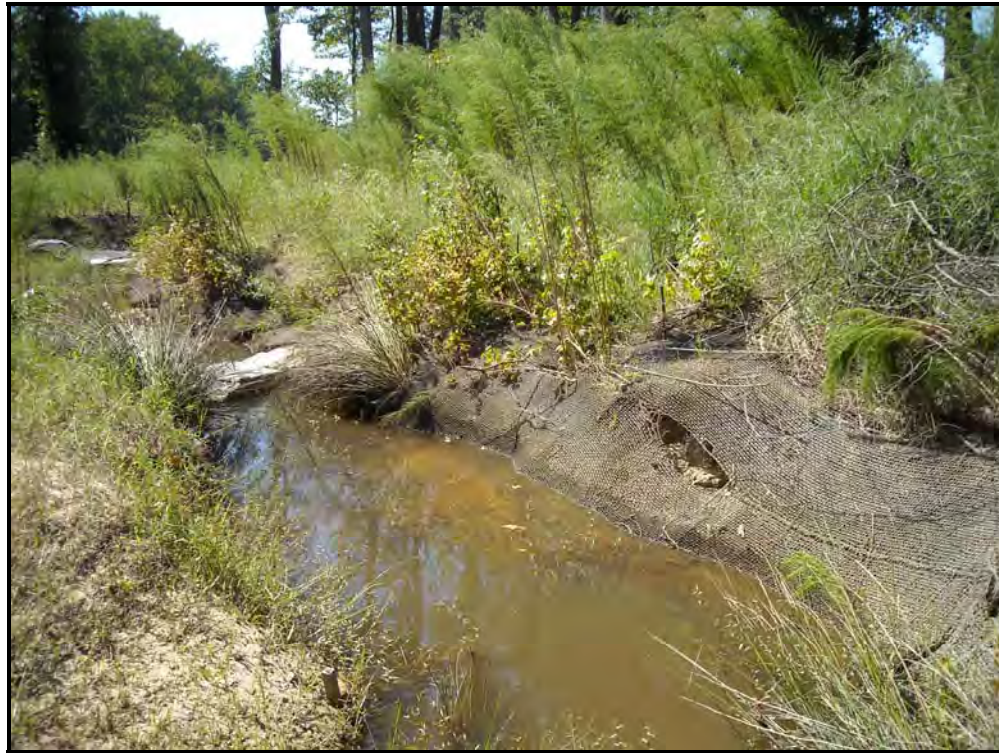
VPA 24. Left descending bank has bare coir matting and eroding banks.

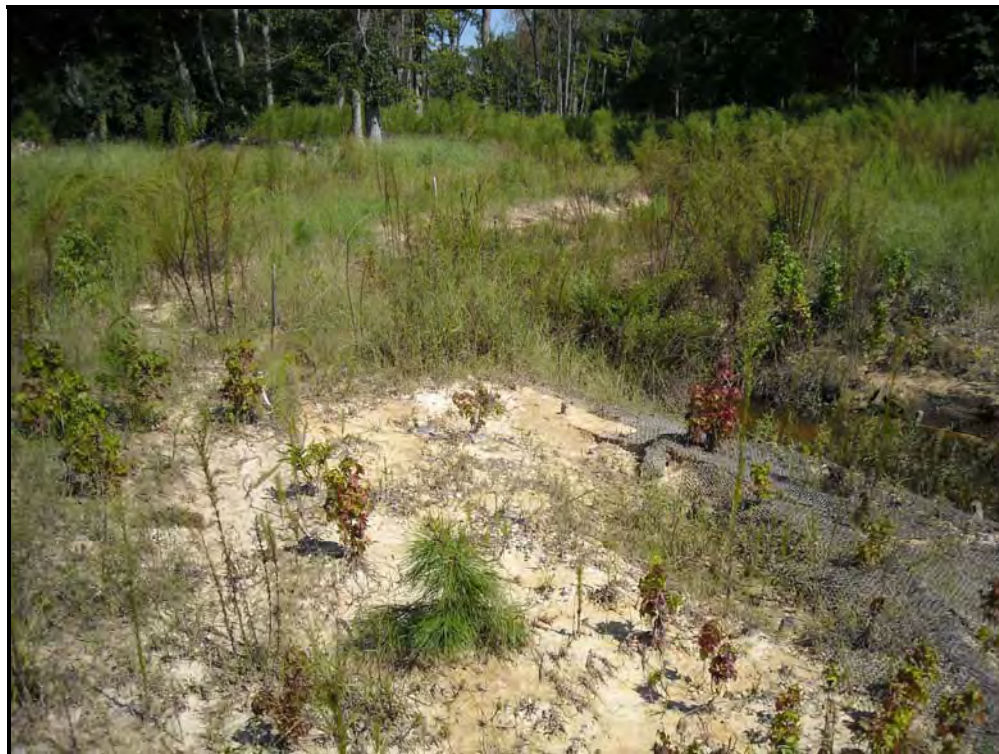
VPA 26. Left and right descending banks are bare of vegetation.

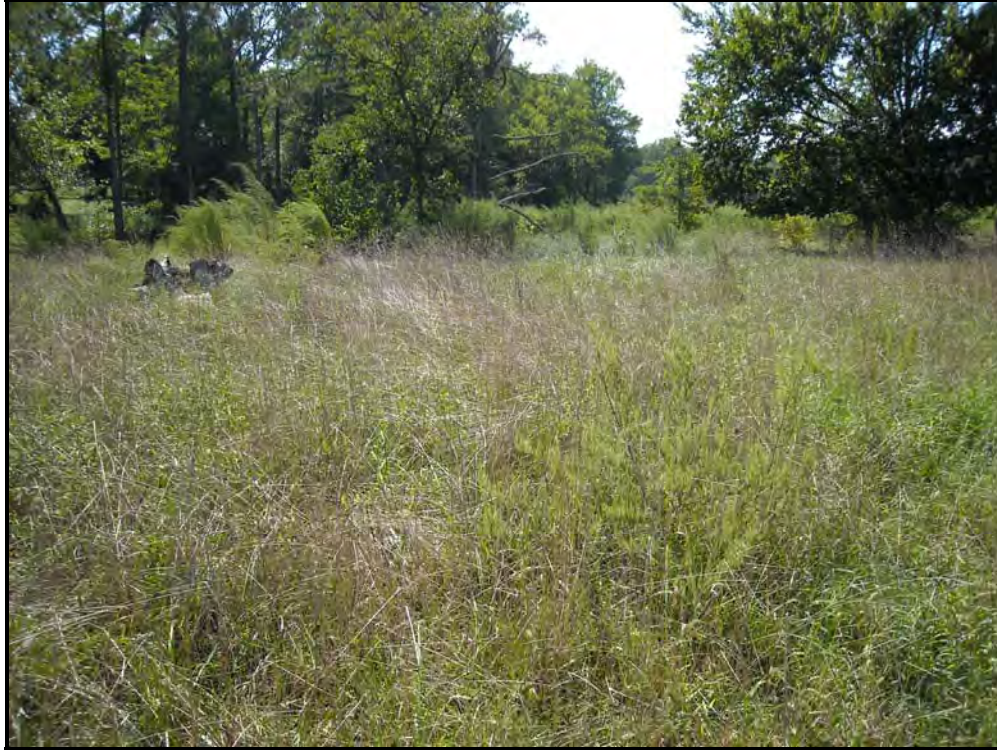
VPA 30. Tall Fescue (*Lolium arundinaceum*) is encroaching into the buffer on the right descending side of the stream.

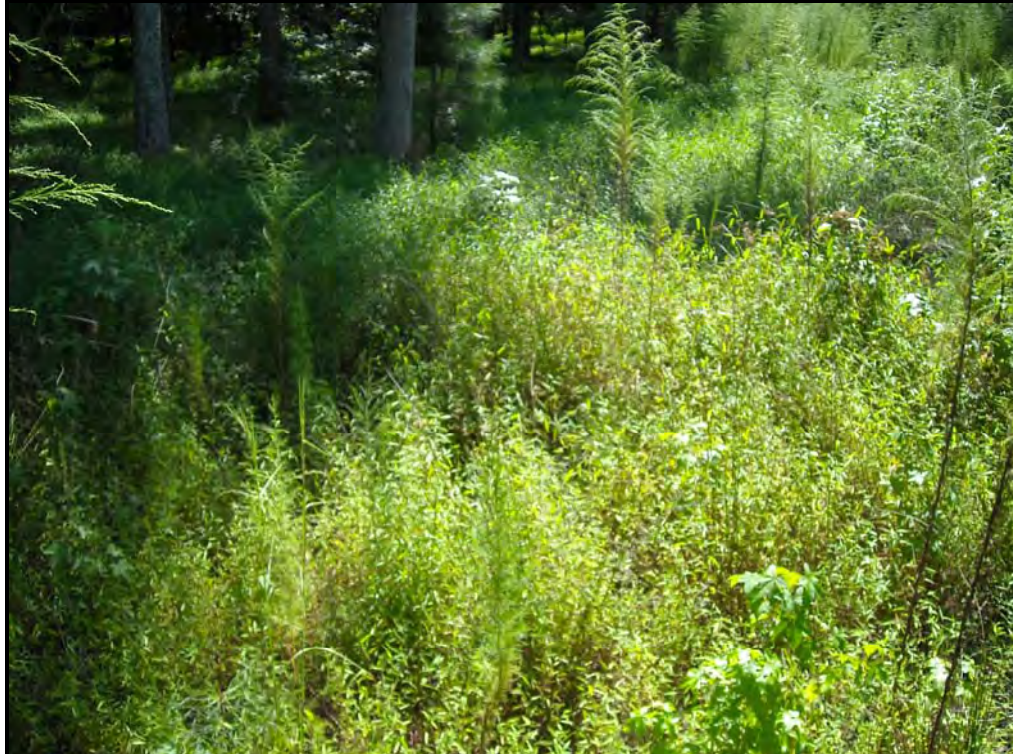
VPA 31. The invasive exotic Japanese Stiltgrass (*Microstegium vimineum*) encroaching into the buffer.

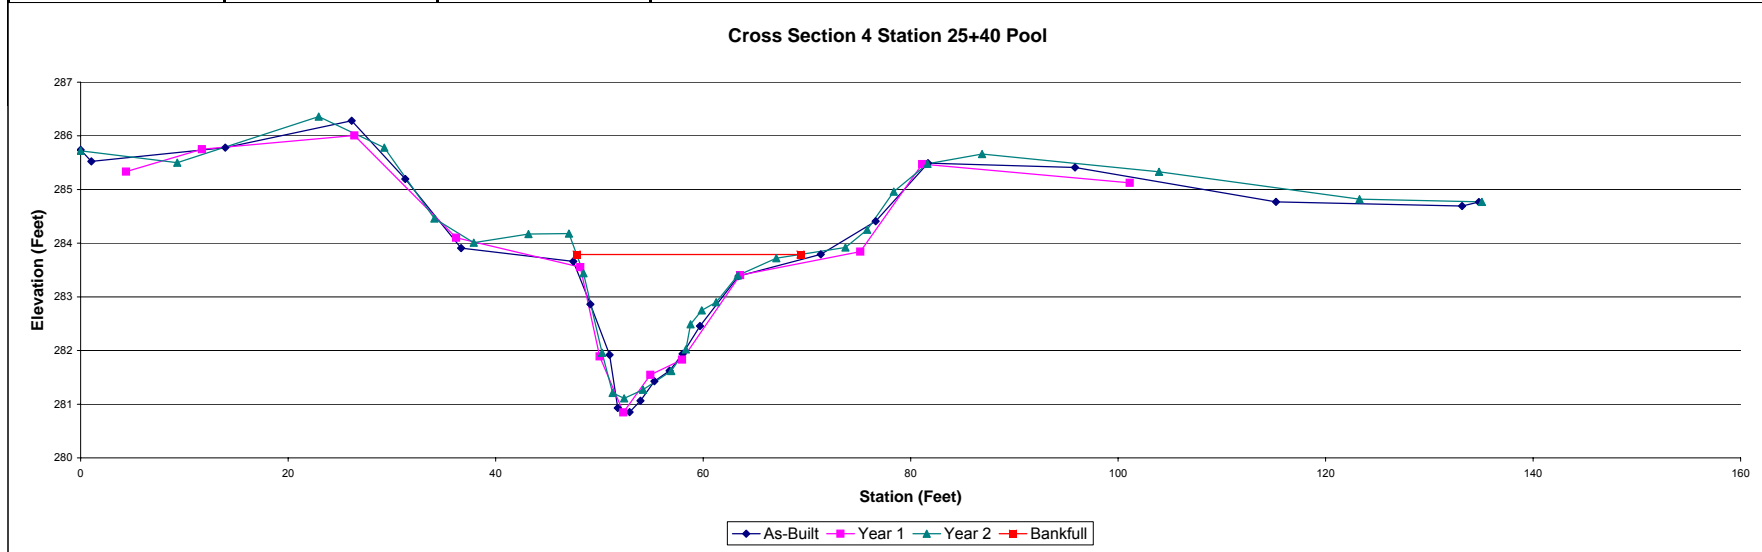
Photo of XS-4, Sta 25+40 looking in the downstream direction

Reach 2 extends from the confluence with Tributary 1 to station 33+00, 1,309 linear feet, and contains two riffles and one pool cross section. Of the two riffle sections, little change was found in section 3 from MY-01. Riffle section 5, however, had insufficient points in MY-01 to make a good comparison. The pool section shows an 11% increase in width and area, however no significant changes were noted in the section and therefore this may be attributed to the bankfull location between years. The longitudinal profile, station 20+00 through 26+50, is dominated by riffles and pools that have shifted into inappropriate places within the plan form of the stream or segments in which structures have caused submerged riffles and long pools. The profile station 27+00 through 32+00 is dominated by a series of structures. These structures placed at riffle locations are forming scour pools at the downstream face. The pools typically extend to the next structure. The sill structures have influenced the stream profile by creating a sill step followed by a scour pool formation that is not compatible with the stream type or plan form. The section of this reach from station 29+50 to 30+50 has riffles migrating into pools due to structure placement.

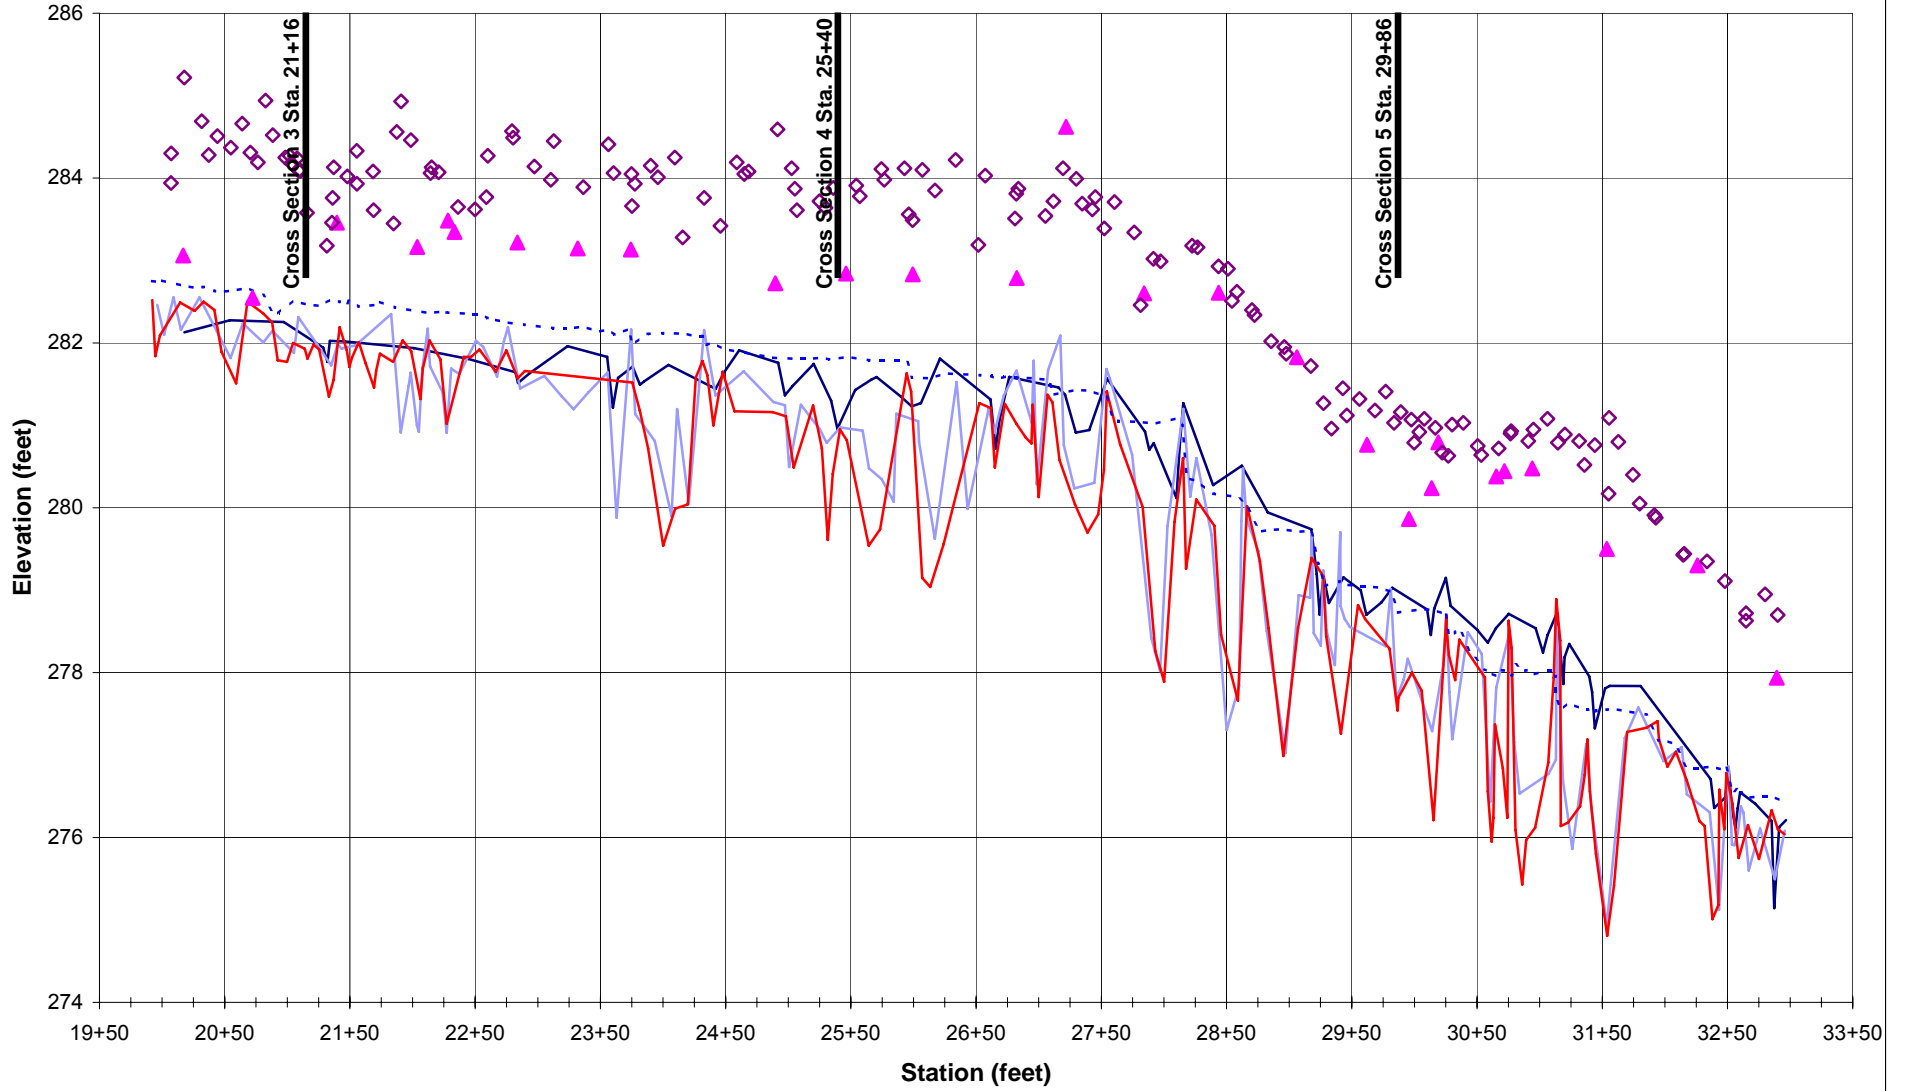
Little Beaver Creek
Longitudinal Profile
Reach 2: Station 19+91-33+00

Reach 2 extends from the confluence with Tributary 1 to station 33+00, 1,309 linear feet. The longitudinal profile in the upper reach is primarily dominated by riffles and pools that have shifted into inappropriate places within the plan form of the stream, or segments in which structures have caused submerged riffles and long pools. The lower portion of the reach is dominated by a series of structures. These sill structures have influenced the stream profile by creating a sill step followed by a scour pool formation that is not compatible with the stream type or plan form.
