**Little Beaver Creek (EEP #221)
Stream and Wetland Restoration Site
2013 Annual Monitoring Report (MY4)**

**Wake County
EEP Project No. 221
Design Firm: Earthtech
Construction Completed February 2007
Construction Repairs Completed May 2013**

September 2014

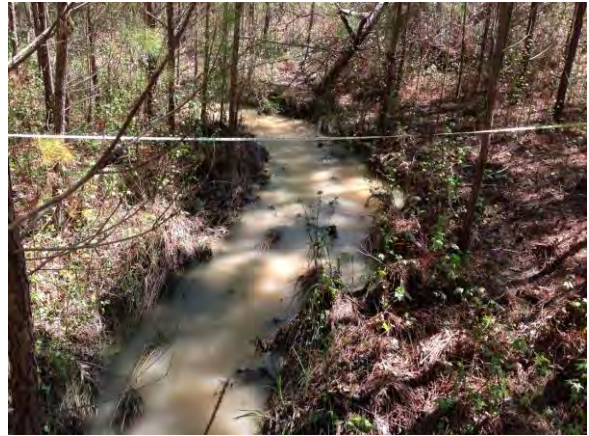
Photo 10. Tributary 1 - CS-T2 Looking Upstream

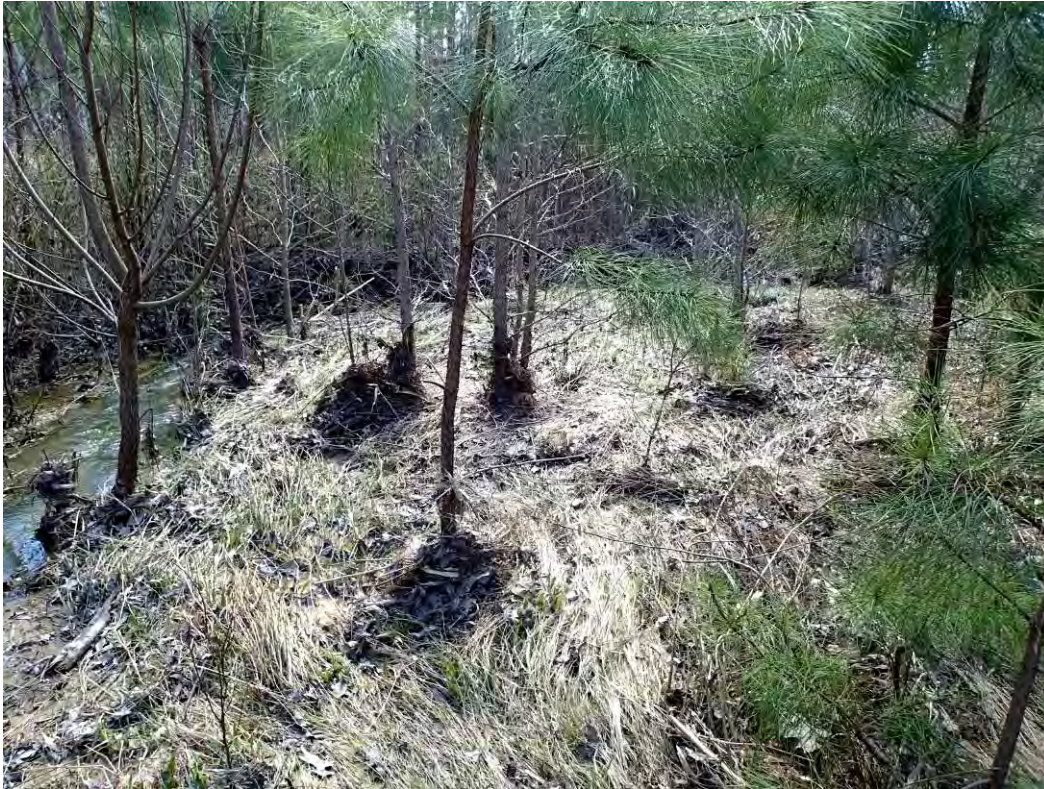
View of floodplain at the confluence of Little Beaver Creek and the tributary.
