**Monitoring Report
Year 1
FINAL
Little Buffalo Creek Stream Mitigation Project**

NCDENR-DMS Project Number: 94147

Data collection: September 2015

Submitted: March 2016

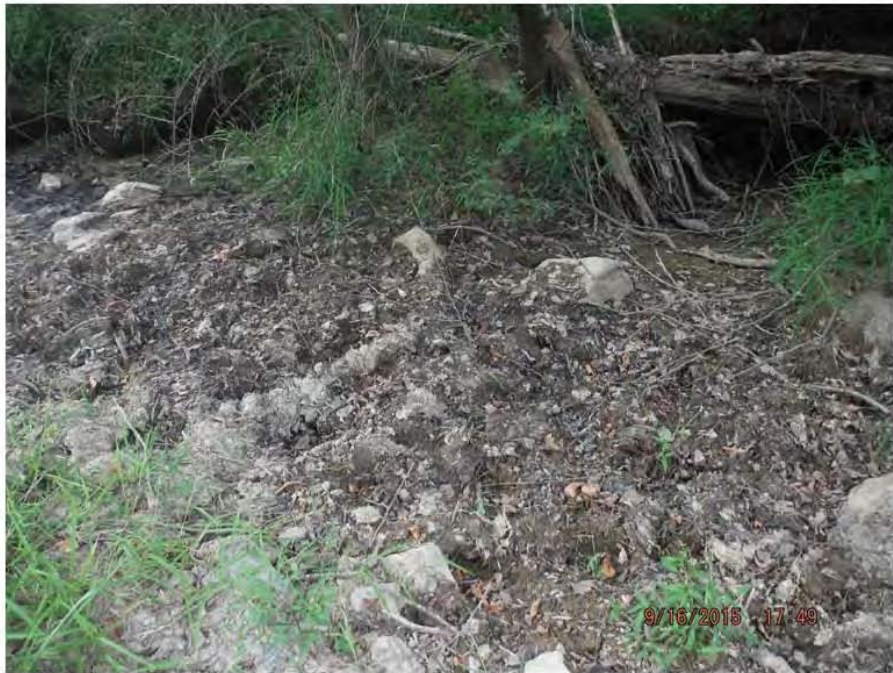
Reach 4 - Head cut in UT3 upstream of gage 7

Routine channel maintenance and repair activities will include examination of current pool conditions and, if warranted, excavation of deposited bed load material within the step-pool structures of UT 7 to reestablish pool depths and habitat functionality. Future channel maintenance may include chinking of in-stream structures to prevent piping, securing of loose coir matting, and supplemental installations of live stakes and other target vegetation along the channel bank. Areas where storm water and floodplain flows intercept the channel may also require maintenance to prevent bank failures and head-cutting.

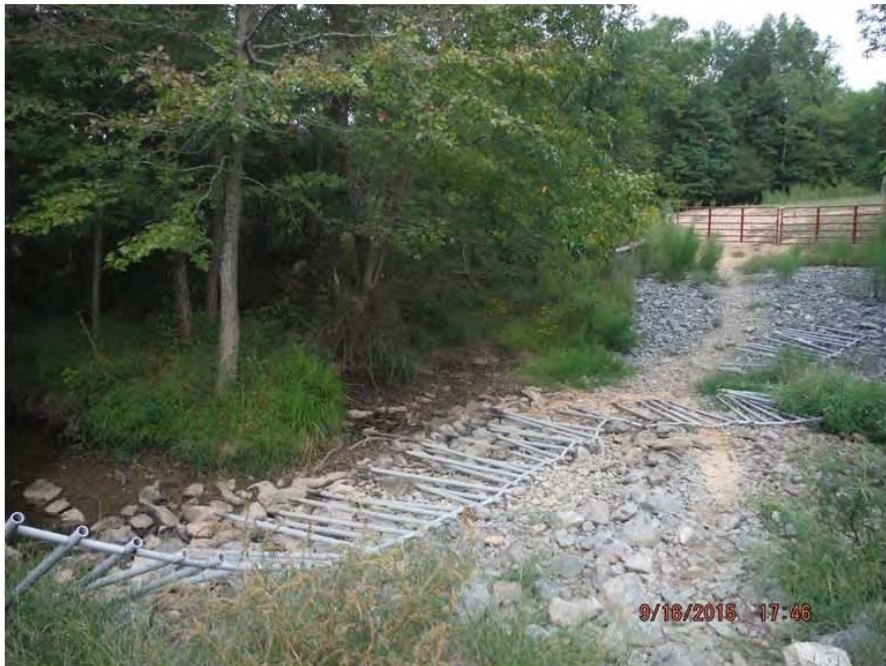
Reach 5 - Cattle crossing fence broken and cows trampling bank

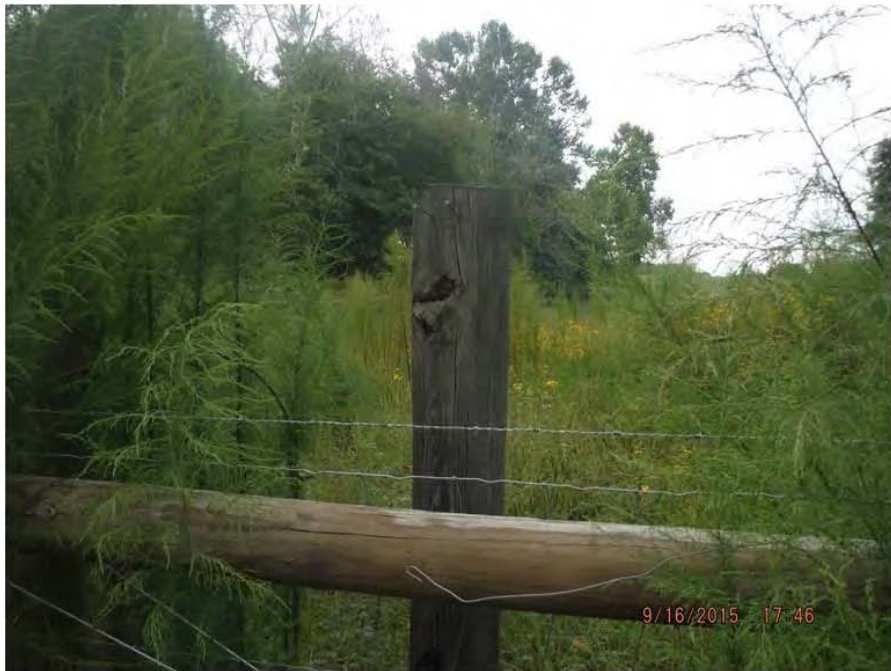
Reach 5 – Cattle fence down

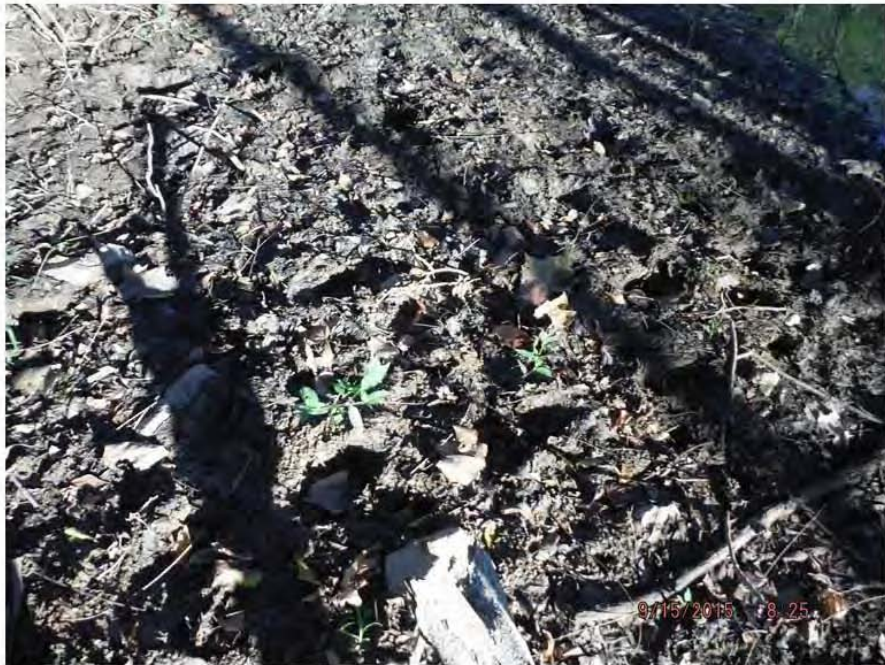
Site boundaries have been well maintained with the exception of one corner of fence where UT 3 joins the mainstem which has been cut and reassembled, presumably by the land owner to remove escaped cattle. Additionally, the upstream electrical fence associated with the cattle crossing in Reach 5 was observed to be down and ineffective. Observations of this area during the Year 1 monitoring suggested that some cattle may have accessed this area, but the cattle are currently excluded by the gates placed on both sides of the stream. The fence through this area has subsequently been repaired by the landowner and the fence electrified through an additional source. The exclusion fence along UT3, while still effective, will be repaired in 2016. Discussions with the landowners regarding maintenance of the crossing, fencing and encroachments into the easement is ongoing. Additional fencing will be installed along the mainstem at Old Mine Road in 2016 to prevent access to the easement at these locations. The installation of conservation easement boundary signs will be completed in 2016.

Reach 5 – Solar cell powering cattle fence missing
