**Monitoring Report  
Year 3  
FINAL  
Little Buffalo Creek Stream Mitigation Project**

*NCDEQ-DMS Project Number: 94147  
Contract Number: 2029  
USACE Permit Action ID: 2014-00386  
DWR Permit: 14-0129  
Cabarrus County*

**Data collection: September/November 2017  
Draft Submitted: December 2017  
Final Submitted: February 2018**

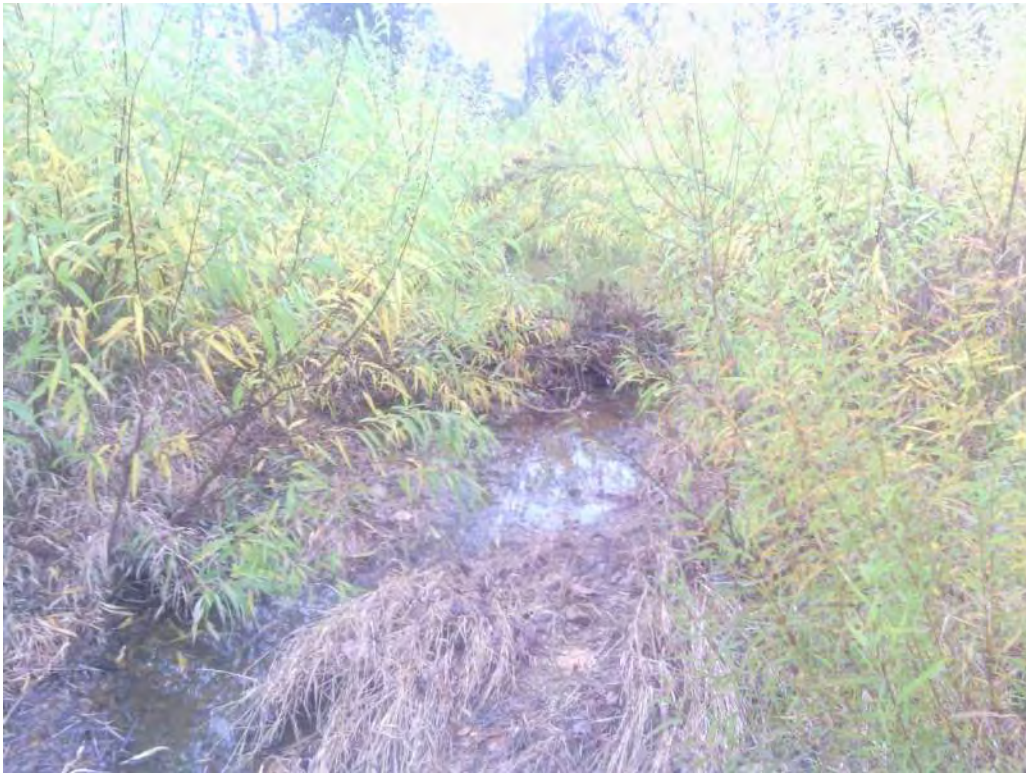
Downstream portions of channel below beaver dam in restoration area of reach 1

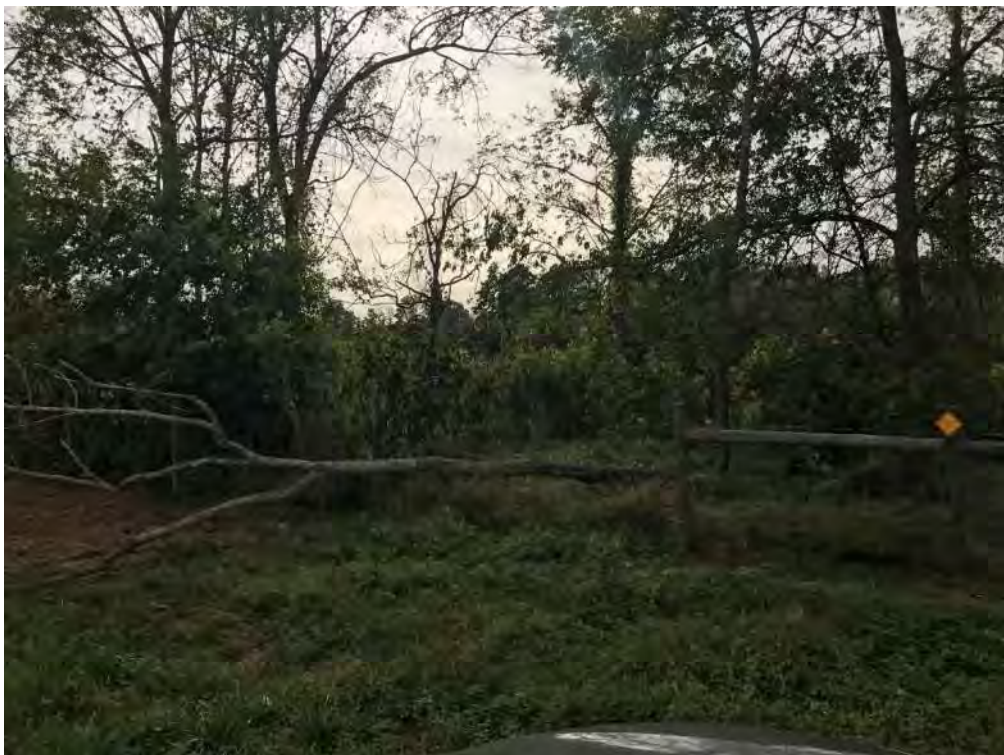
Tree fallen on easement fence at UT7. Minor damage will need repair.

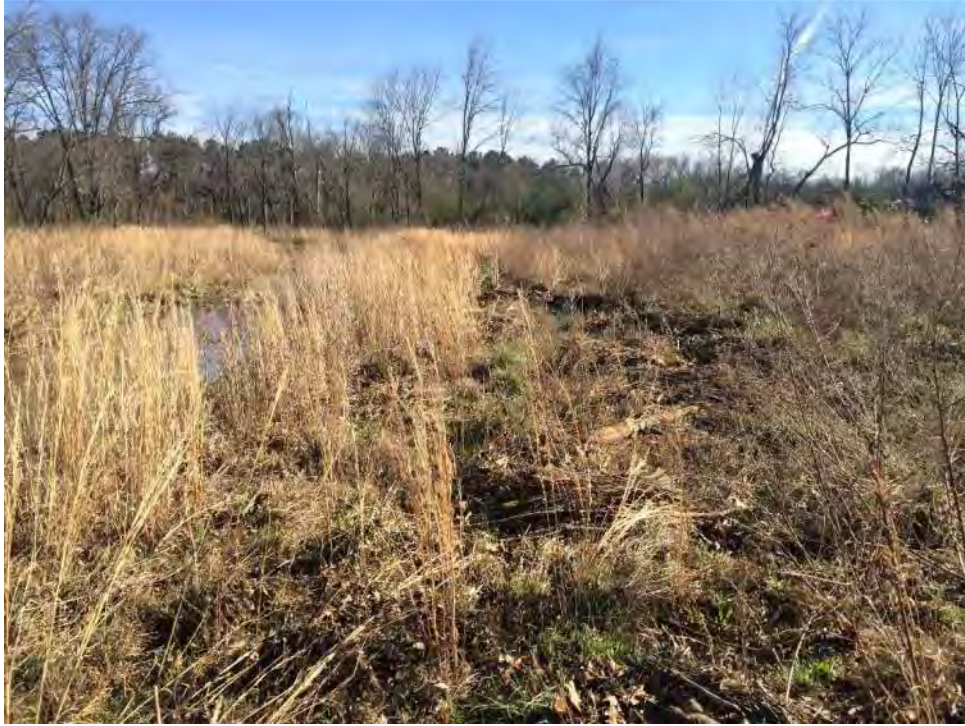
Debris dropped and vegetation bent in direction of flow at UT7, March 2017.
