**Monitoring Report
Year 4
FINAL**

Little Buffalo Creek Stream Mitigation Project

*NCDEQ-DMS Project Number: 94147
Contract Number: 2029
USACE Permit Action ID: 2014-00386
DWR Permit: 14-0129
Cabarrus County*

**Data collection: September/October/November 2018
Draft Submitted: January 2019
Final Submitted: March 2019**

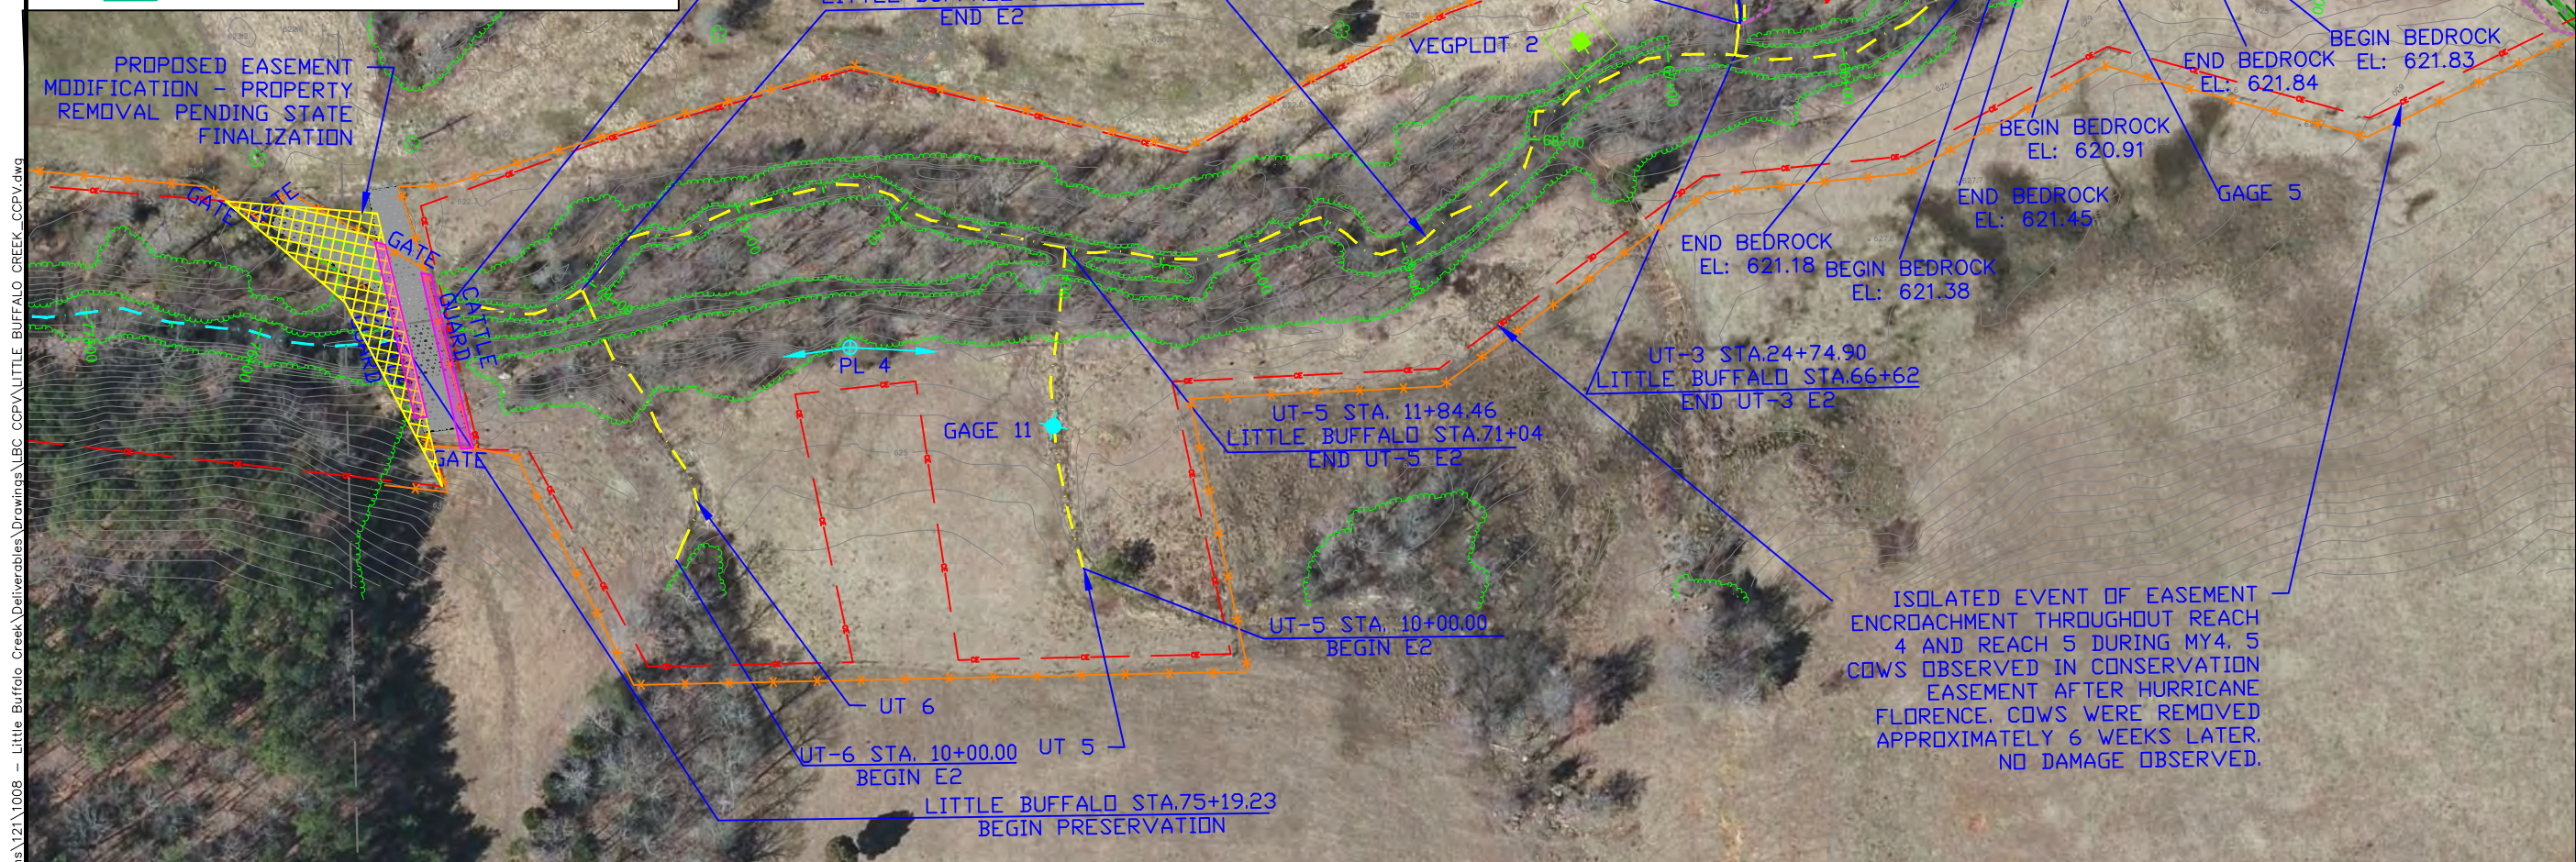
ISOLATED EVENT OF EASEMENT ENCROACHMENT THROUGHOUT UT3 DURING MY4. 5 COWS OBSERVED IN CONSERVATION EASEMENT AFTER HURRICANE FLORENCE. COWS WERE REMOVED APPROXIMATELY 6 WEEKS LATER. NO DAMAGE OBSERVED.

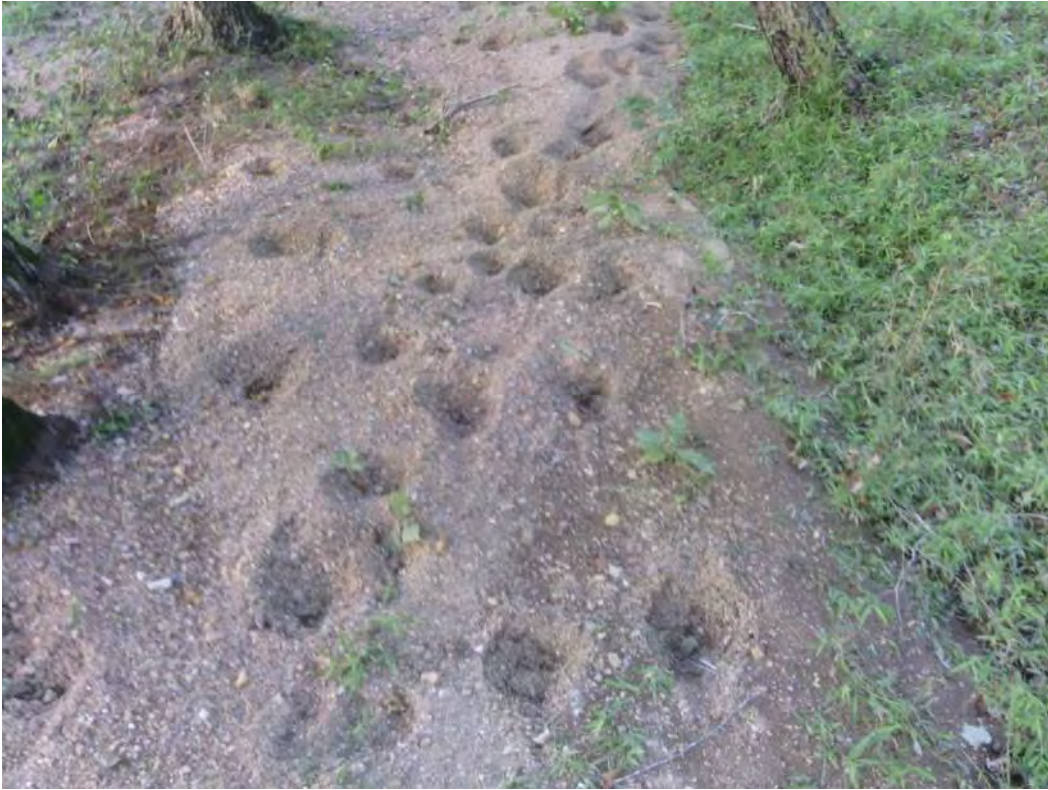
Cattle trail in Reach 5

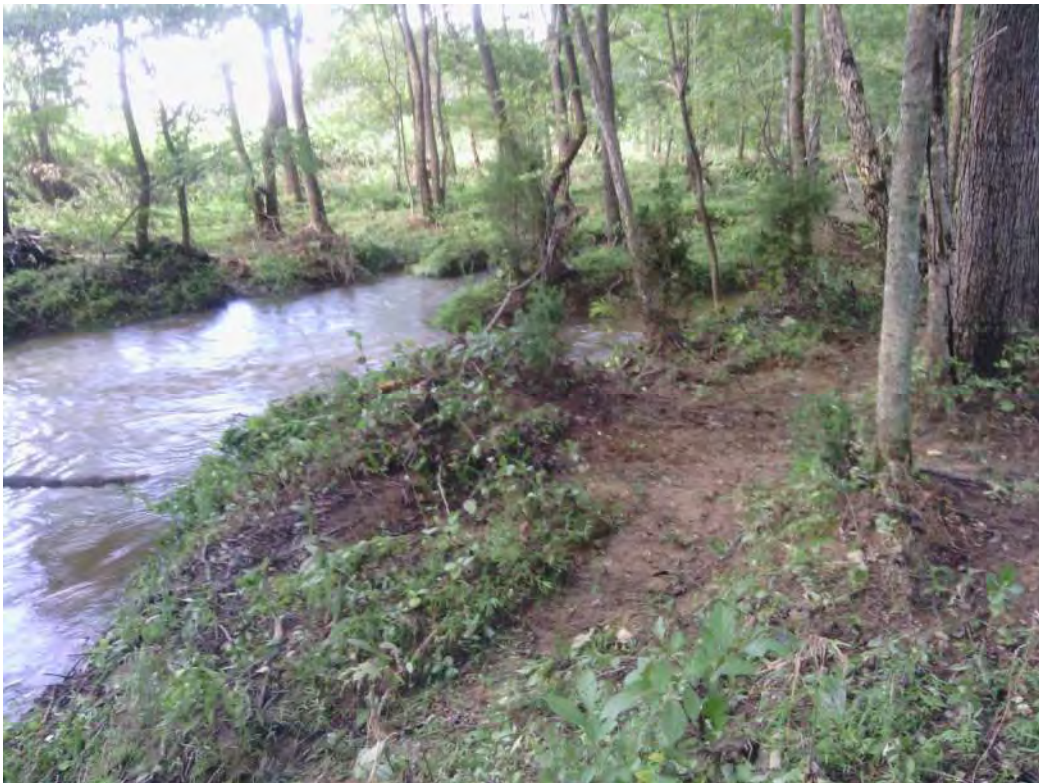
Cow tracks in Reach 5

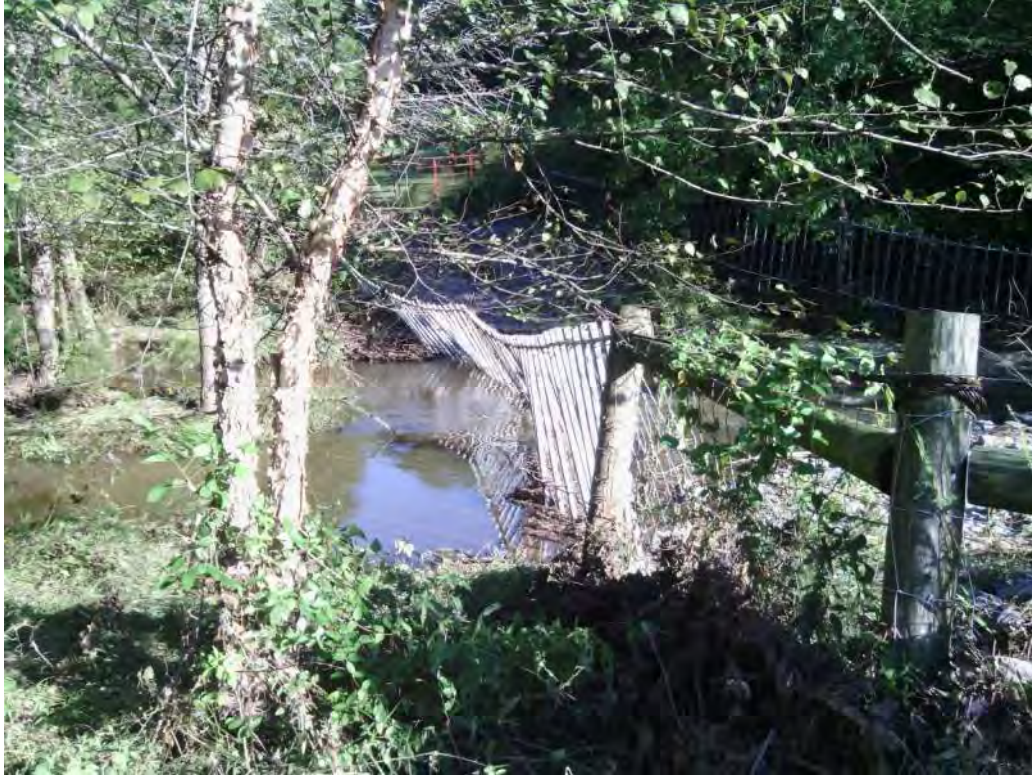
Cow tracks in Reach 5

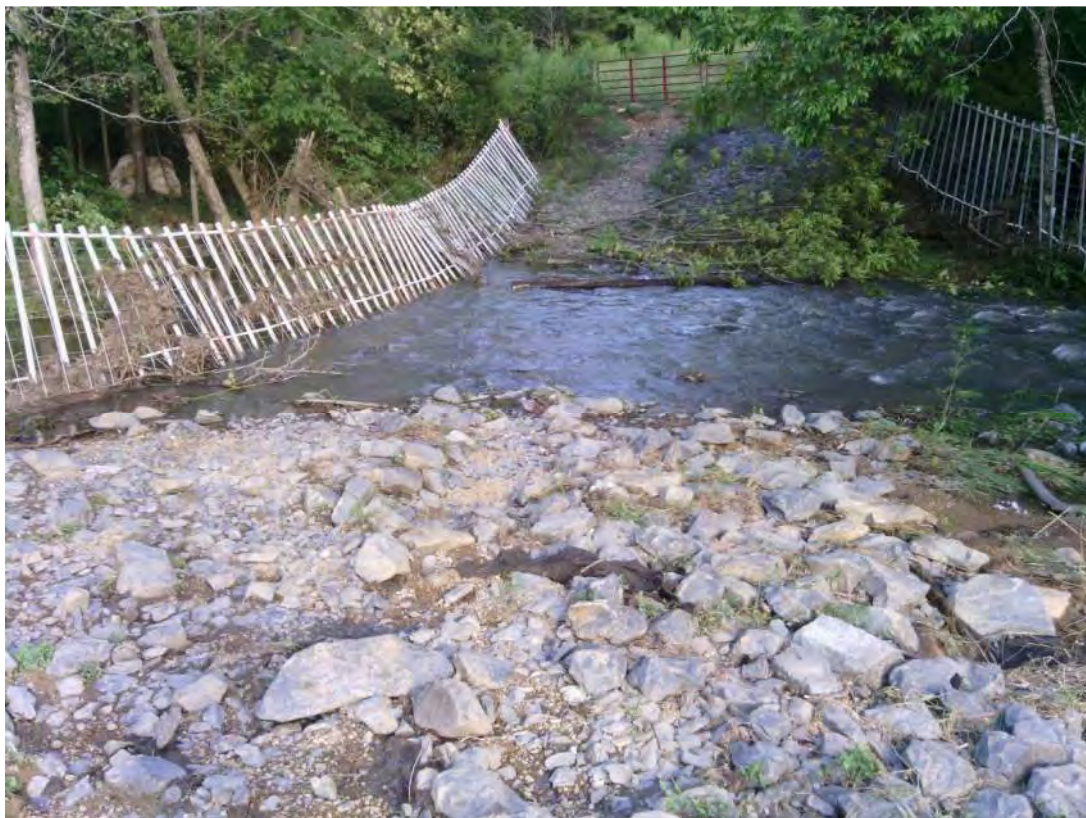
Blown out cattle crossing (Reach 5)

- *Louis Berger is coordinating the repair of the cattle crossing with the repair of the fence in the coming months. Louis Berger is looking to include through the removal in order for the landowners to maintain the crossing more easily after project transfer to the DEQ stewardship.*

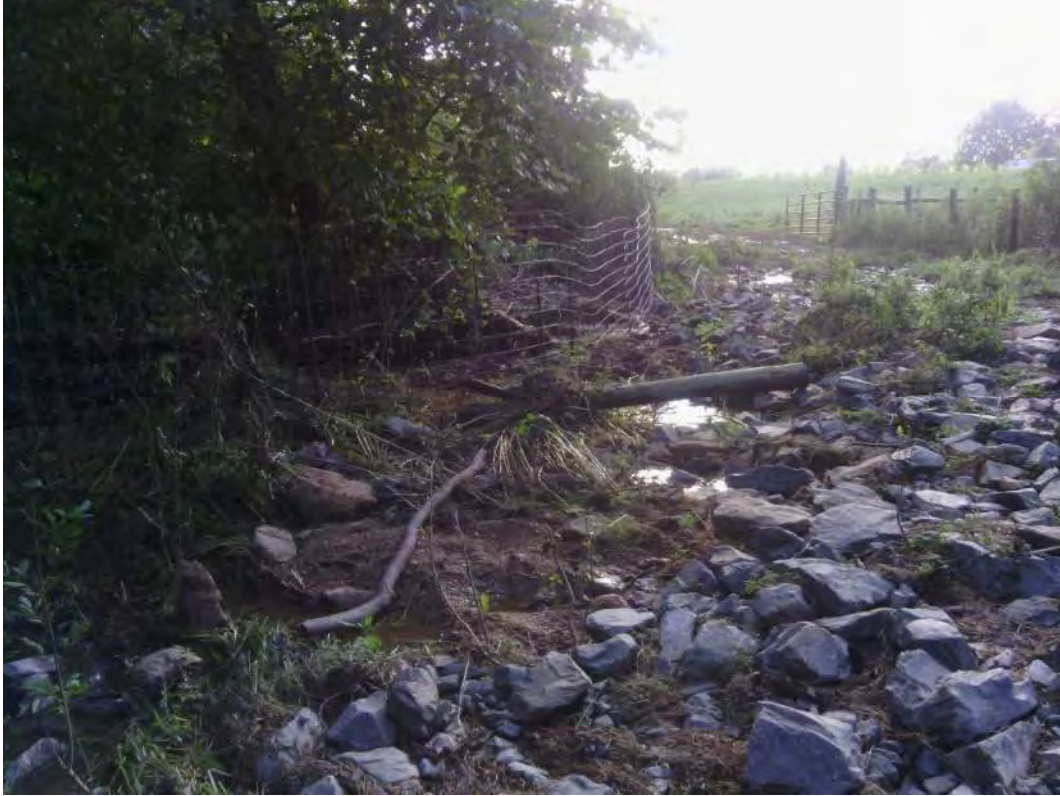
Blown out cattle crossing (Reach 5)

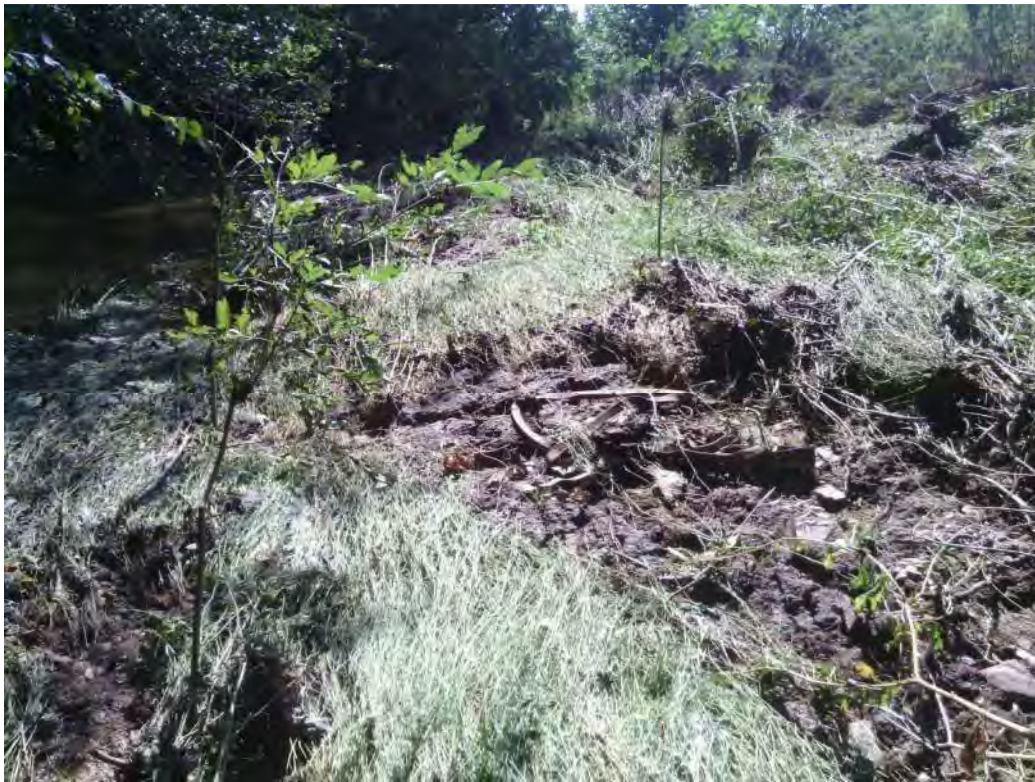
Wrack line indicating high water levels
Photo take in September 2018

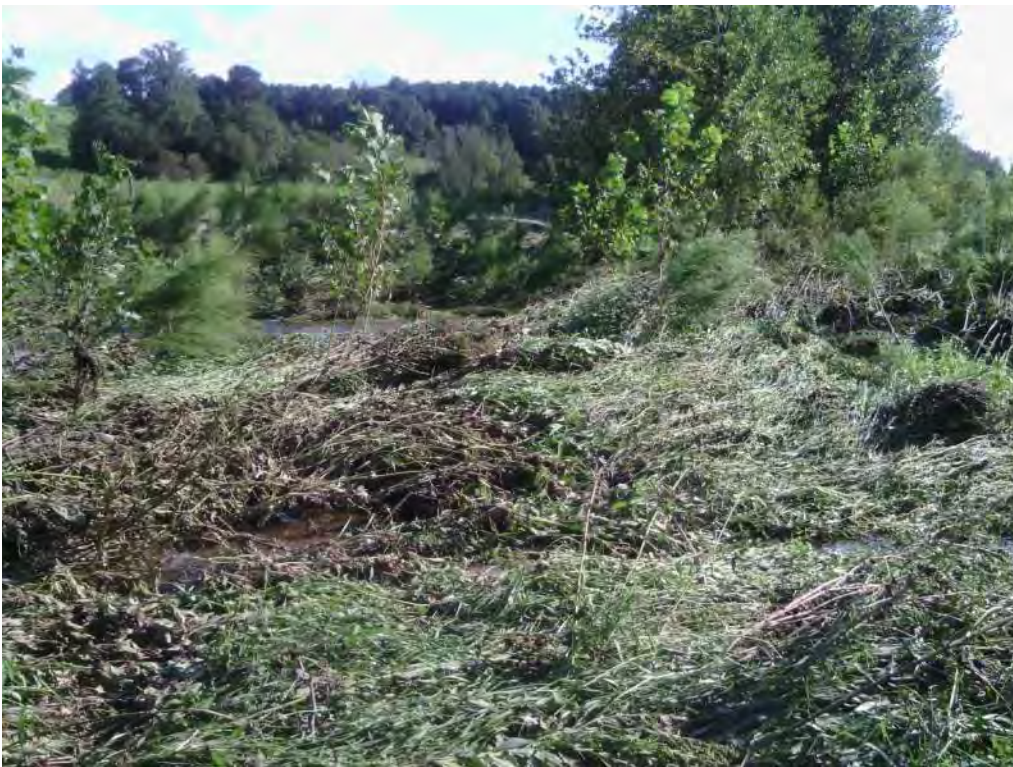
Significant flow evidence in Reach 4

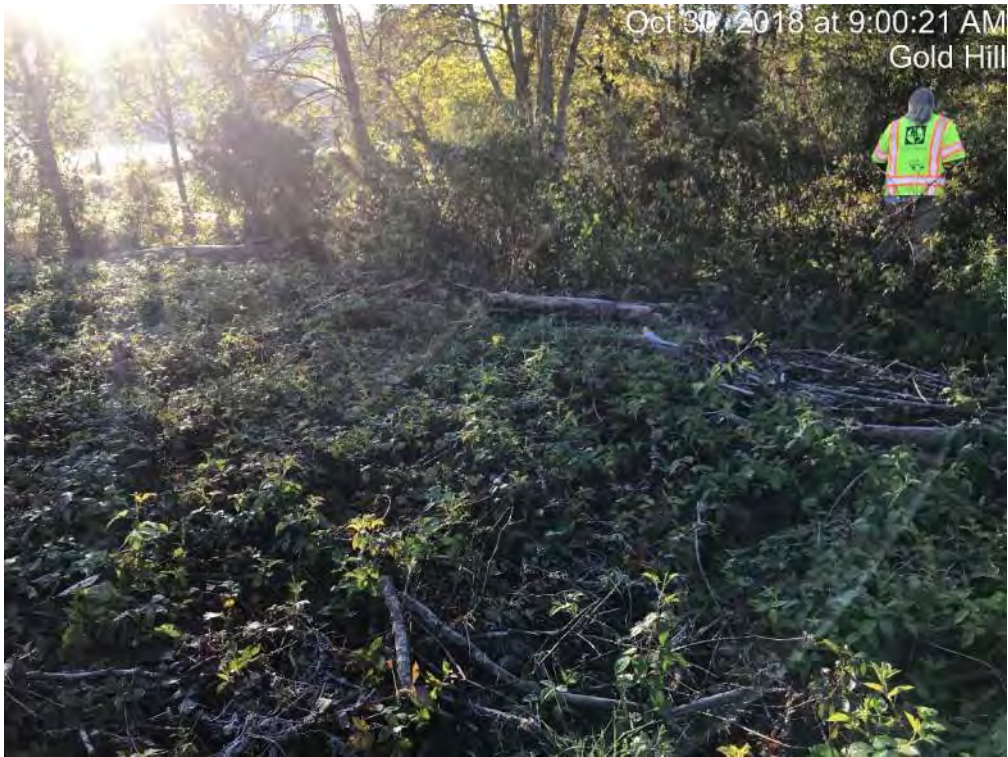
Hurricane flow damage in Reach 4
