**Monitoring Report
Year 5
FINAL**

Little Buffalo Creek Stream Mitigation Project

*NCDEQ-DMS Project Number: 94147
Contract Number: 2029
USACE Permit Action ID: 2014-00386
DWR Permit: 14-0129
Cabarrus County*

**Data collection: October 2019-January 2020
Draft Submitted: February 2020
Final Submitted: March 2020**

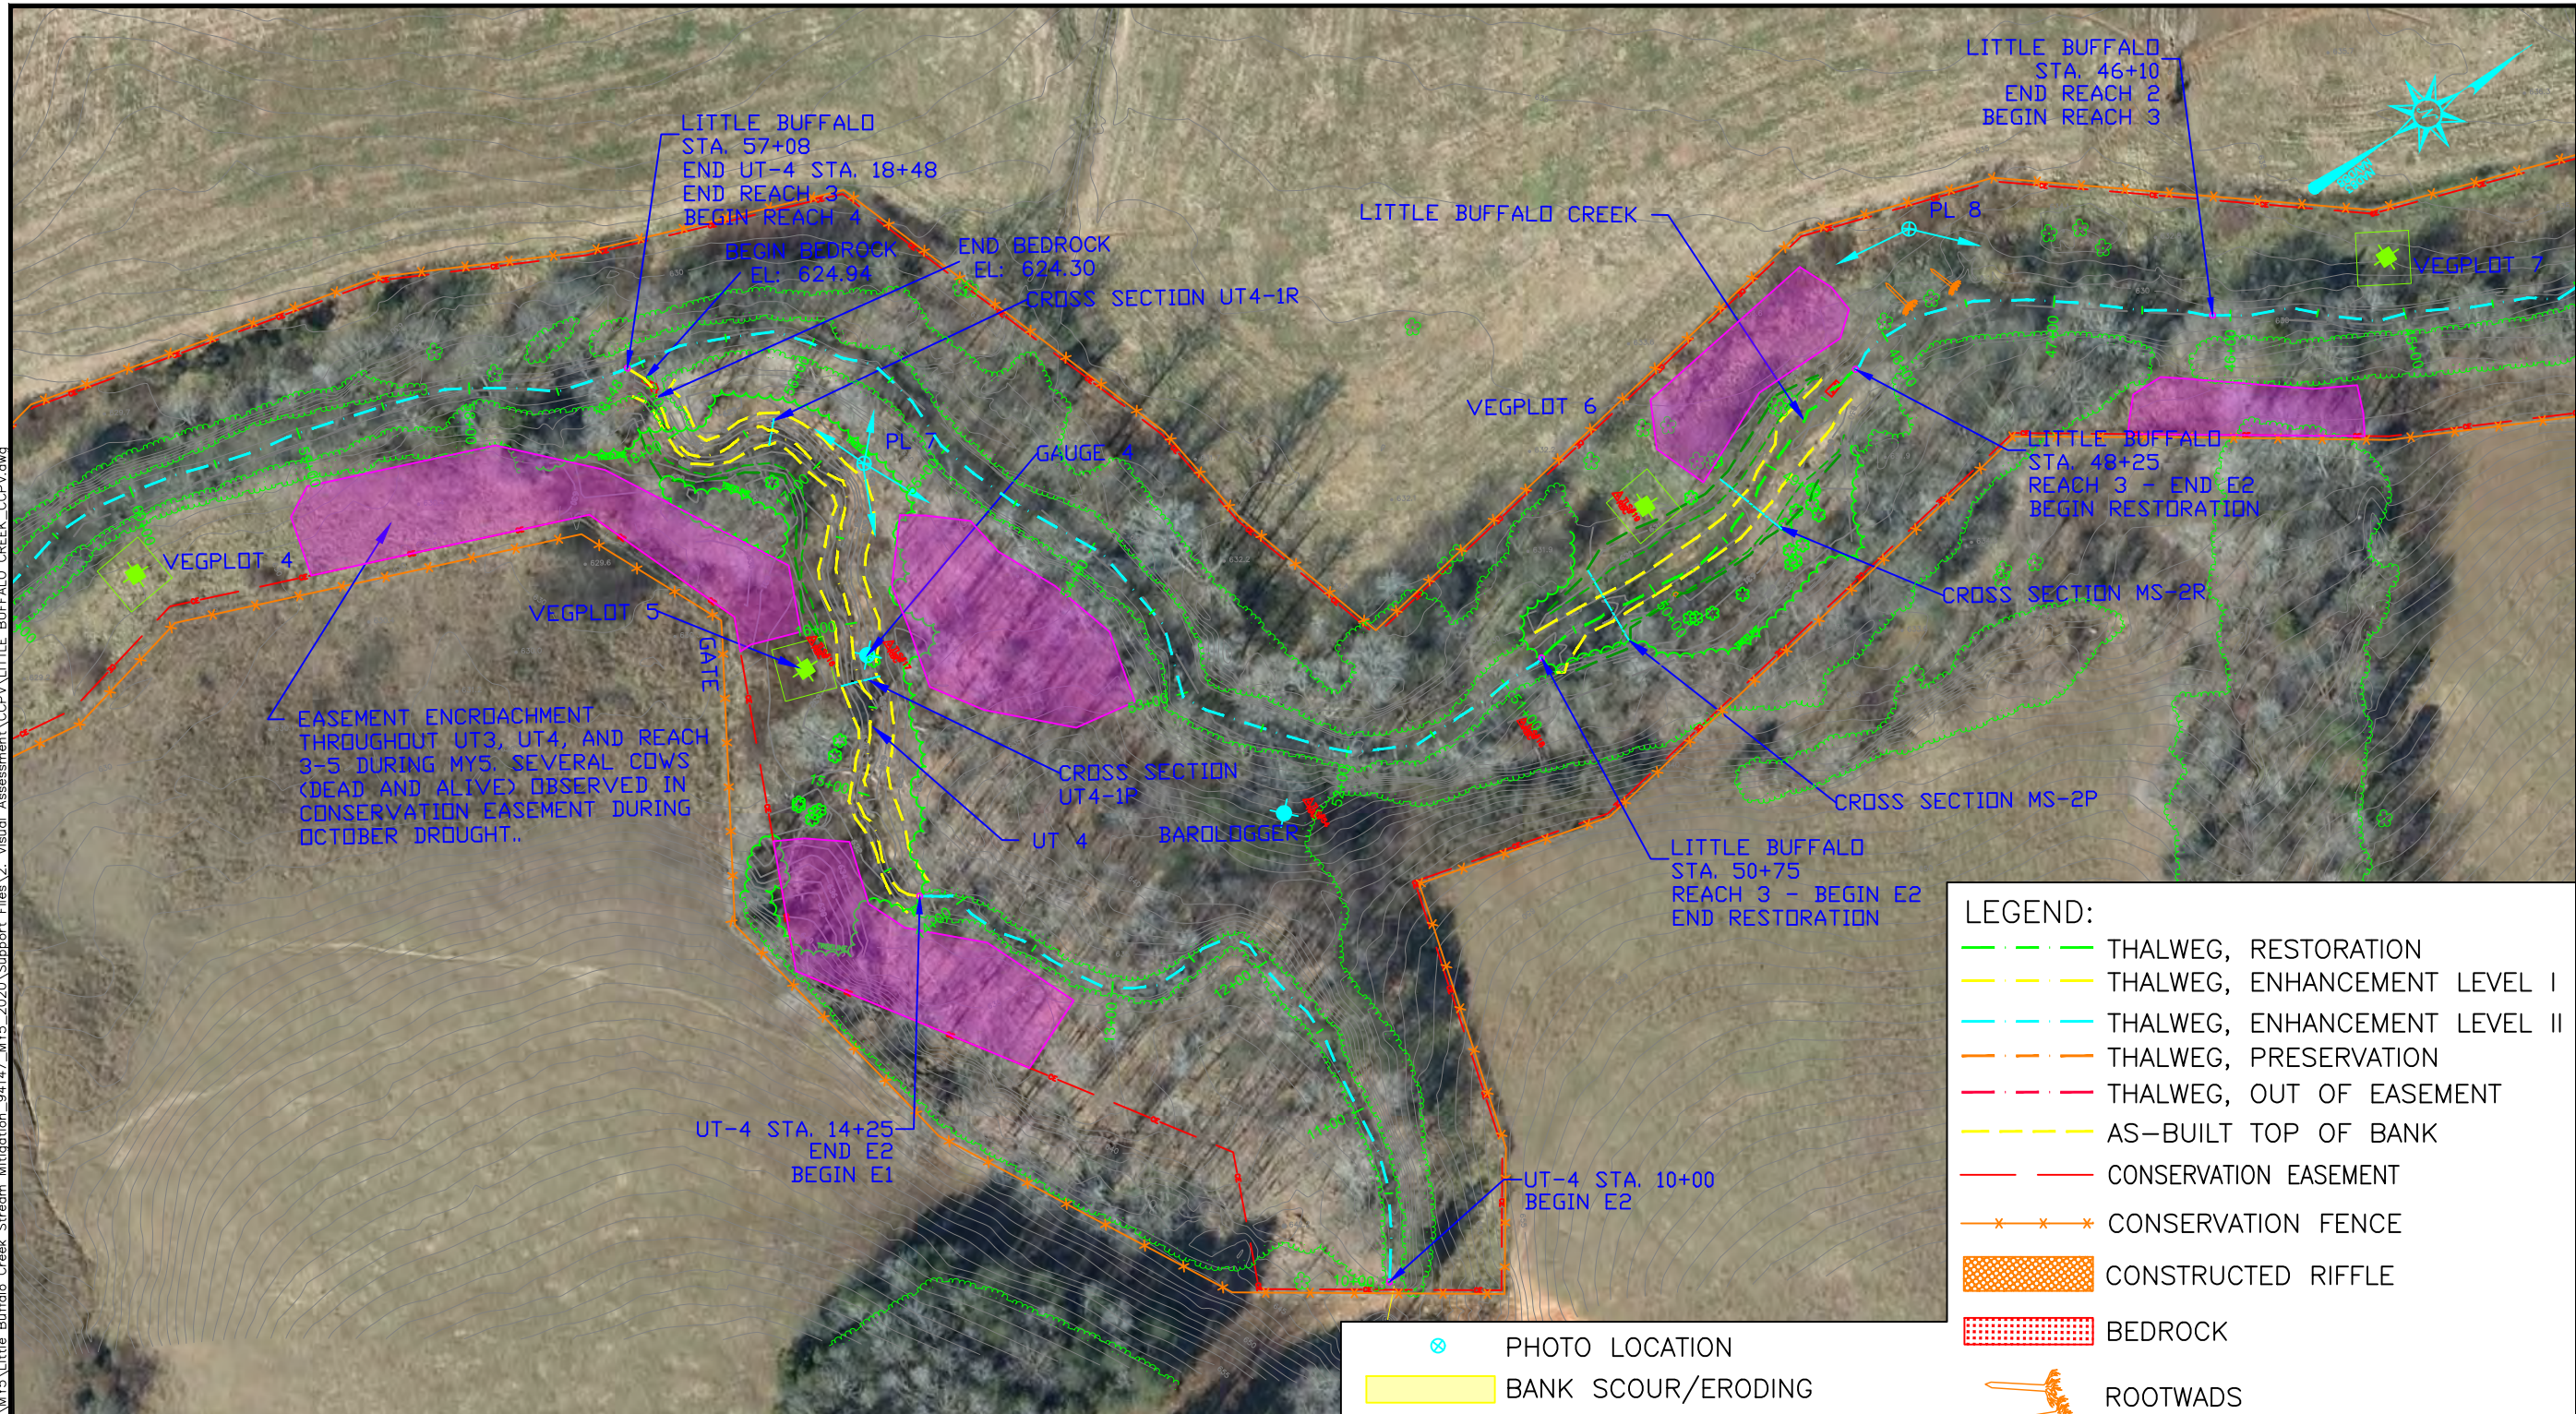
EASEMENT ENCROACHMENT THROUGHOUT UT3, UT4, AND REACH 3-5 DURING MY5. SEVERAL COWS (DEAD AND ALIVE) OBSERVED IN CONSERVATION EASEMENT DURING OCTOBER DROUGHT..

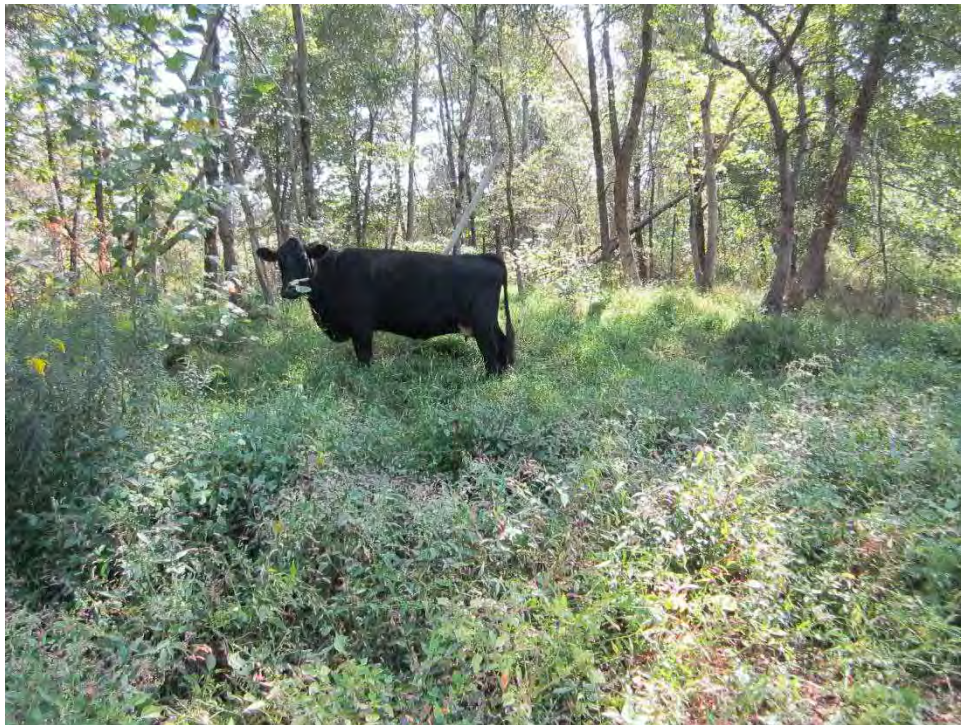
Cow observed near vegetation monitoring plot 7 in UT4 in October 2019

- Recent cattle encroachment was observed during the site visit. Please continue to work with the project landowners to eliminate all cattle encroachment within the conservation easement.

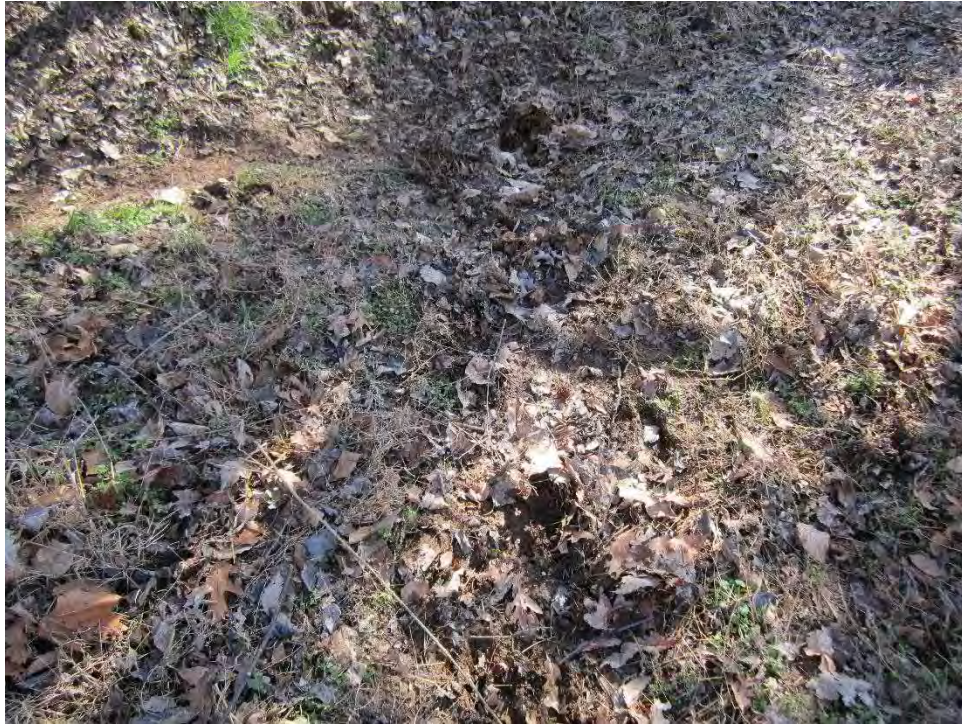
Cow tracks near confluence of Reach 3 and UT4 in January 2020

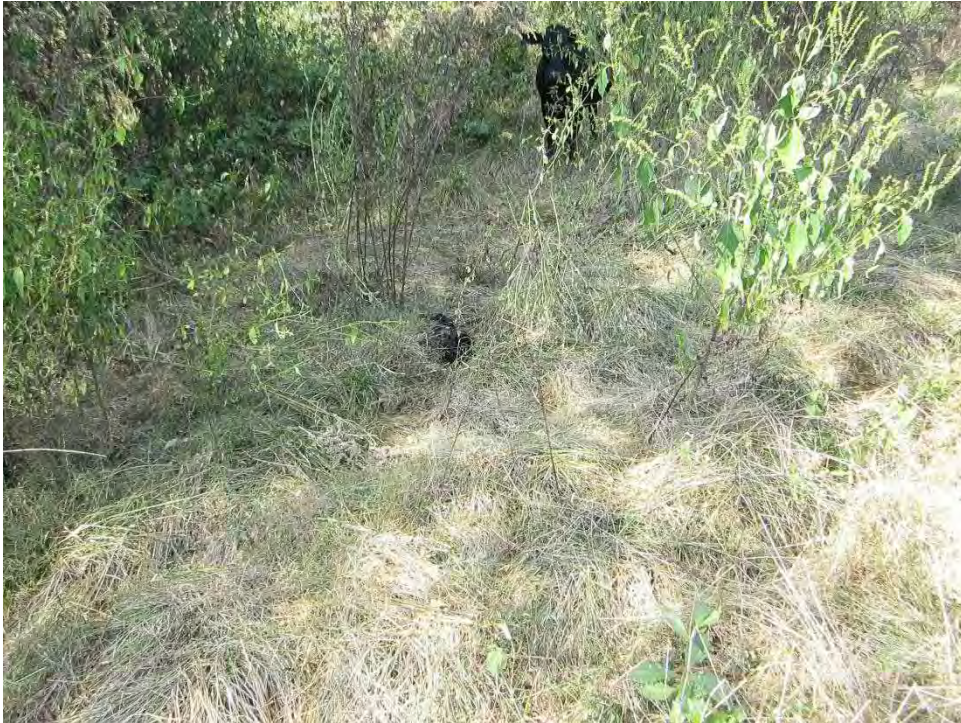
Cow observed near vegetation monitoring plot 4 in October 2019

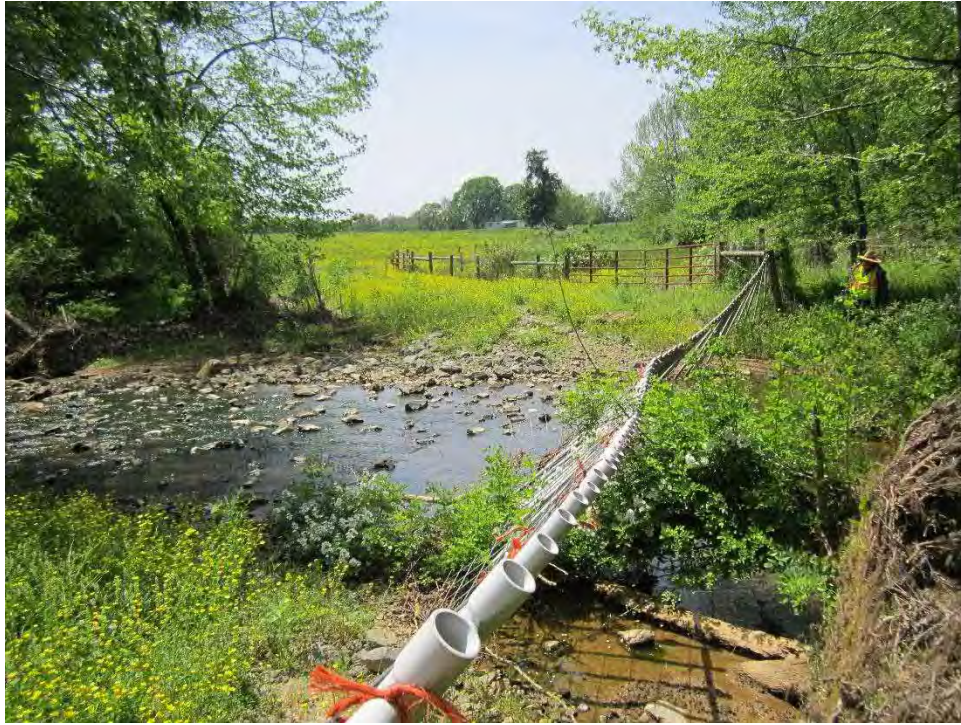
Blown out cattle crossing (Reach 5)

- *WSP has been in contact with contractors for repair work. The current target completion date is the end of April.*
- Please continue to remove beaver and beaver dam/s from all project reaches through project closeout.

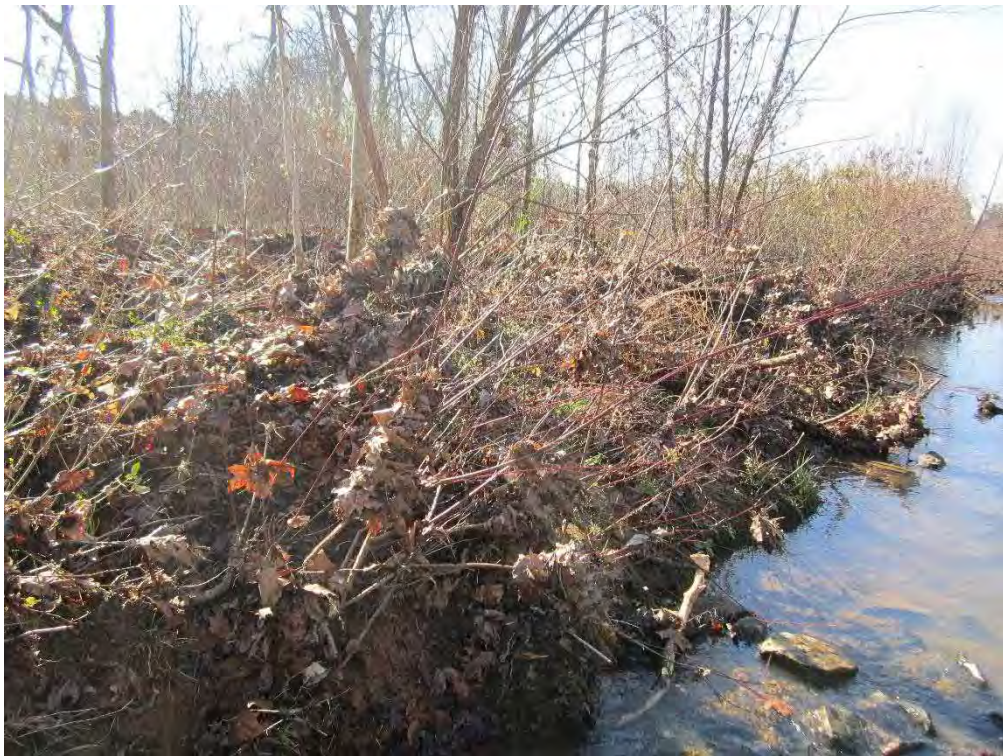
Drift lines along the bank of UT7 upstream of beaver dam that was removed

- *WSP will conduct site visits twice a month until project closeout. If beaver dams are found, a beaver trapper will be contacted and beaver dams will be removed.*

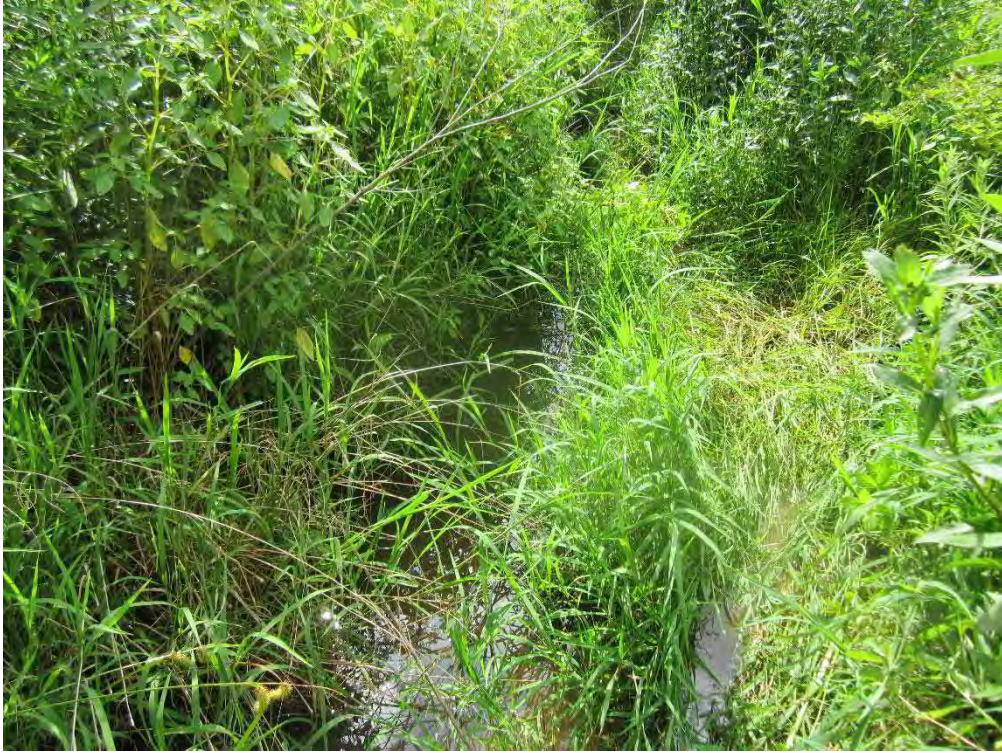
Flowing water in UT2 during July 2019

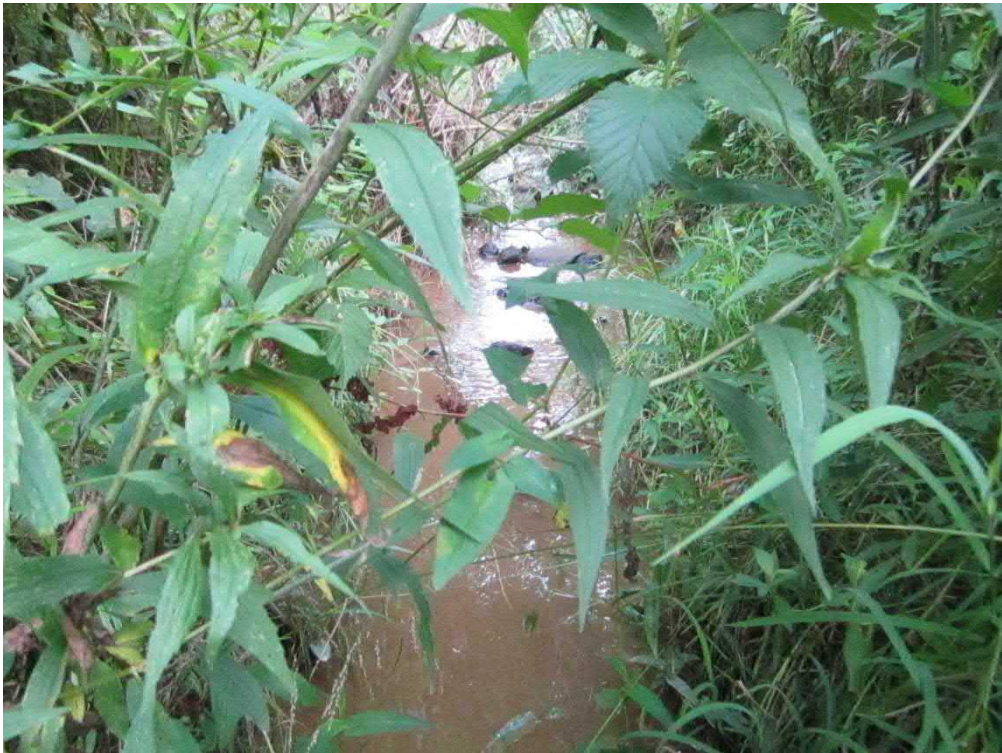
Flowing water in UT2 during July 2019

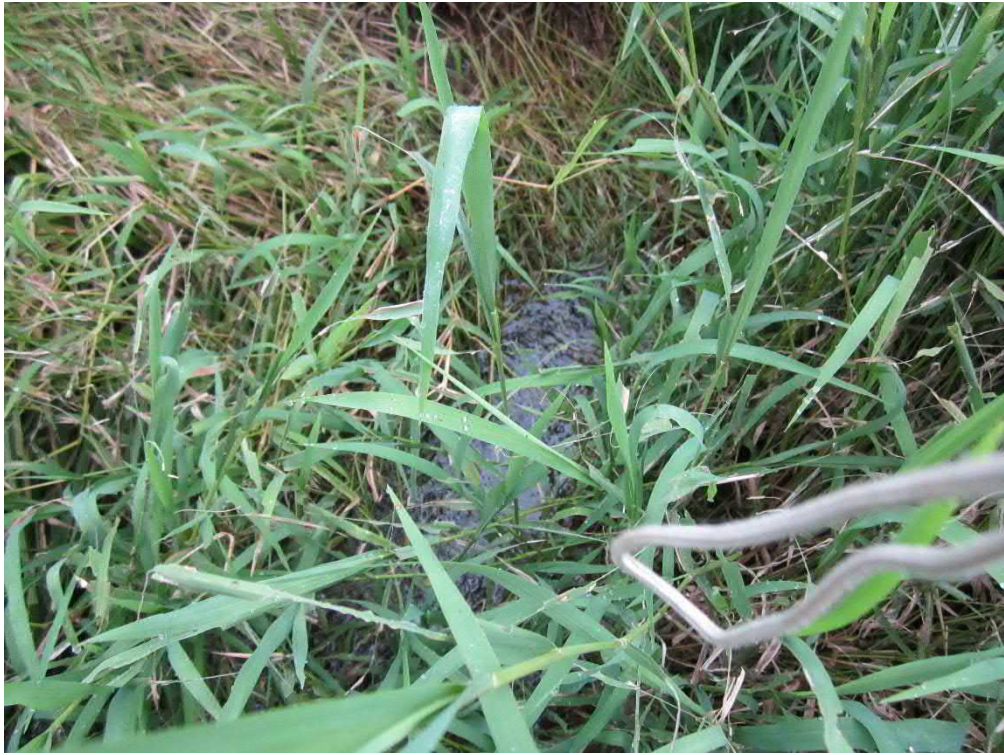
Flowing water in UT2 during July 2019

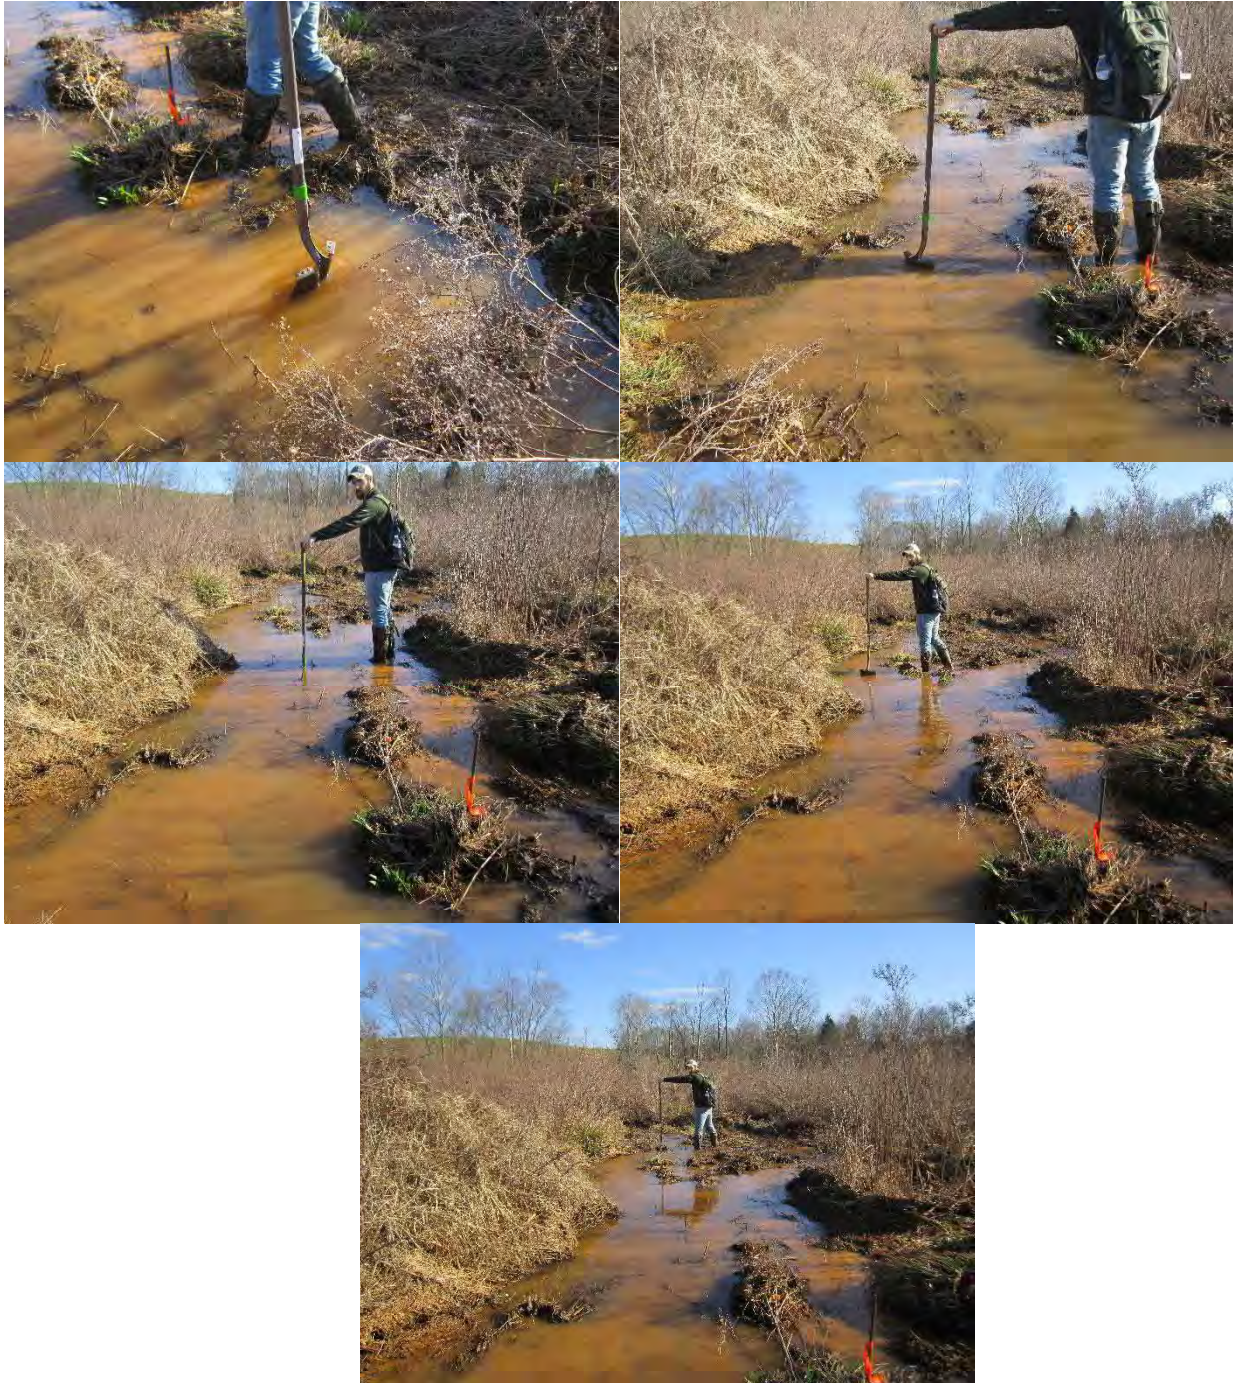
- *The previously identified area of aggradation (linear wetland) in UT 2 near stream station 17+00 is not considered a project issue at this time because continuous flow has been documented for multiple years and evidence of channel development has been observed in this section through Year 4 and Year 5. During the June 19, 2018 IRT site visit, the attendees agreed that as trees mature in the area, additional water observed may begin to be taken up by evapotranspiration and the tree roots will help maintain a defined channel. In July 2019, a sparsely vegetated to unvegetated channel of flowing water surrounded by thick vegetation was noted in this area. More evidence of channel development was observed in January and March 2020, with areas of bank and bed formation. The active channel is difficult to observe due to the presence of water, sediment deposition, and thick herbaceous vegetation. WSP will continue to note evidence of channel development and take photographs in this section of UT 2.*

UT2 near Station 16+85 in January 2020, view downstream. The flagged rebar in the photos is the old location of gauge 3. WSP employee is indicating the thalweg and showing the depth of flowing water.

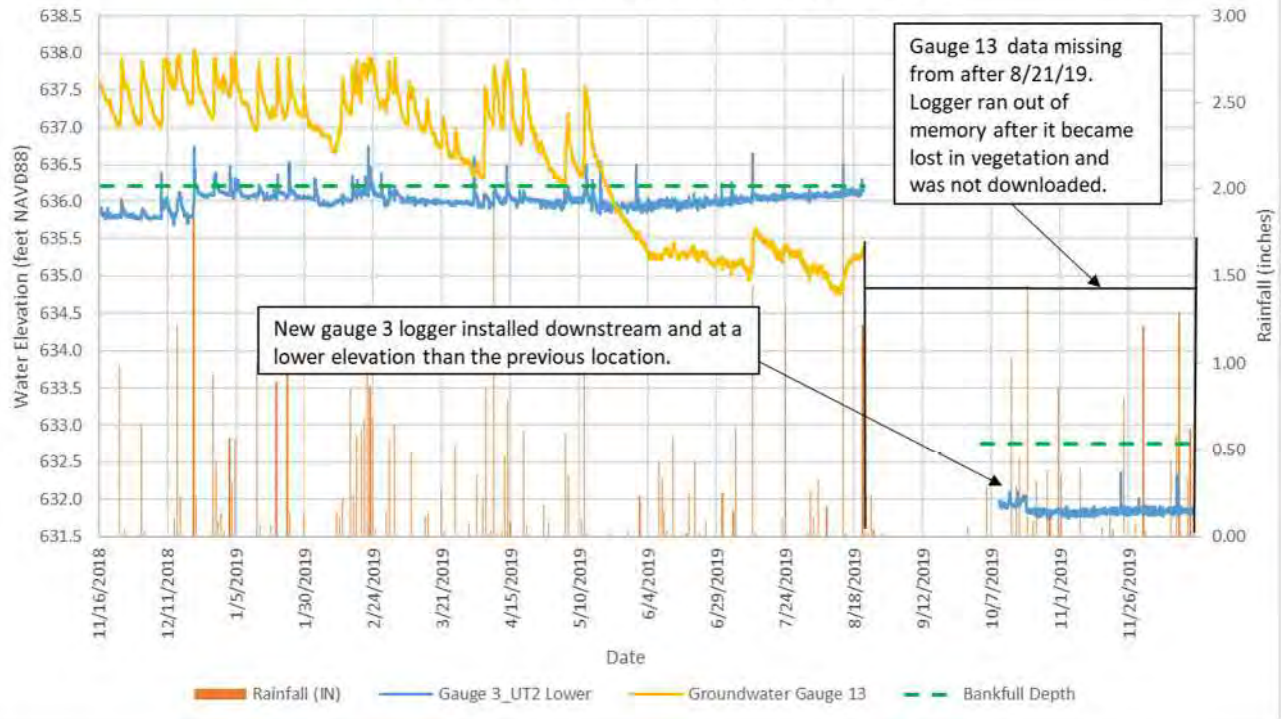
Little Buffalo Creek Hydrology Monitoring - MY5
Groundwater to Surface Water Comparison, UT 2 Lower

Appendix E - Figure 6c - Water Level and Rainfall Plots - Little Buffalo Creek Hydrology Monitoring Graph UT 2 Lower: Leader pointing to the missing data needs to be shifted to the correct interval of missing data.

- *The leaders shown in UT 2 Lower graph were pointing to the period of time when it was believed the instrument was buried in sediment and when a new instrument was installed. The text box for the period of missing data was intended to explain where the data were missing and did not show a leader or limits for the data gap because the data gap was bounded by notes and limits on either side. WSP recognizes this may have been confusing and has adjusted Figure 6c.*
