**LITTLE GRASSY CREEK PROJECT**  
**ANNUAL MONITORING REPORT FOR 2008 (YEAR 1)**

**EEP Project #224**

**February 2009**

**Michael Baker Engineering, Inc.**  
6500 Regency Parkway  
Suite 200  
Cary, North Carolina 27516  
Phone: 919.463.5498  
Fax: 919.463.5490

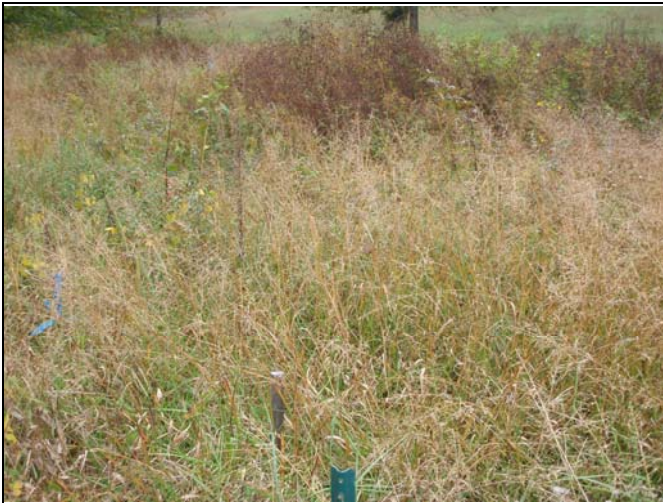
Vegetation Plot 6 – 10/10/2008

However, blackberry (*rubus spp.*) was noted as a risk to stem survivability in plot 6. Plot 7 did not exhibit a significant risk from *rubus spp.* during the site visit. Based on the individual plot results, it is unlikely that plot 6 will meet the success criteria of 320 stems per acre at the end of Year 5 without supplemental plantings. Plot 7 should be observed closely in the coming year to determine if future supplemental planting of the area will be required.

<b>Little Grassy Creek Restoration Site: EEP No. 224</b>			
<b>Feature/Issue</b>	<b>Station # / Range</b>	<b>Probable Cause</b>	<b>Photo</b>
Low denisty - 202 stems/acre	See Plan Sheets	Heavy <i>Rubus spp.</i> within plot boundaries	VP6 10/10/2008

Tables A.1. through A.5. in Appendix A present vegetation metadata, vegetation vigor, vegetation damage and stem count data of the monitoring stations at the end of the Year 1 monitoring period. Data from the Year 1 monitoring event of the seven vegetation plots showed a range of 202 to 728 stems per acre. Data for Year 1 showed that the Site exhibited an average of 497 stems per acre. Based on these results, plots 1, 2, 3, 4, 5, and 7 are on track to meet the interim success criteria of 320 stems per acre at the end of monitoring Year 5. The density for plot 6 was 202 stems per acre, and the plot will need to be replanted in winter/spring 2009.

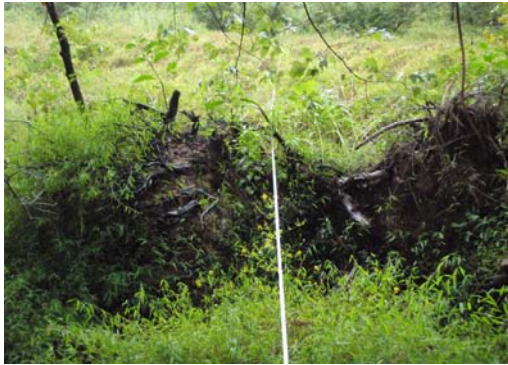
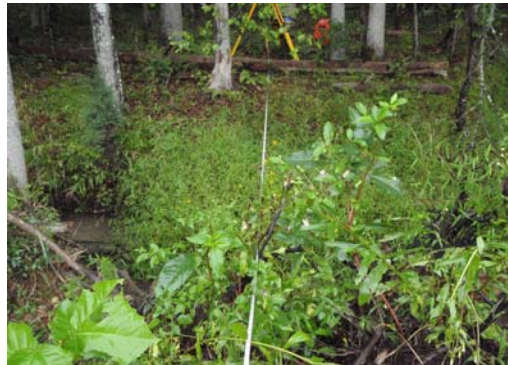
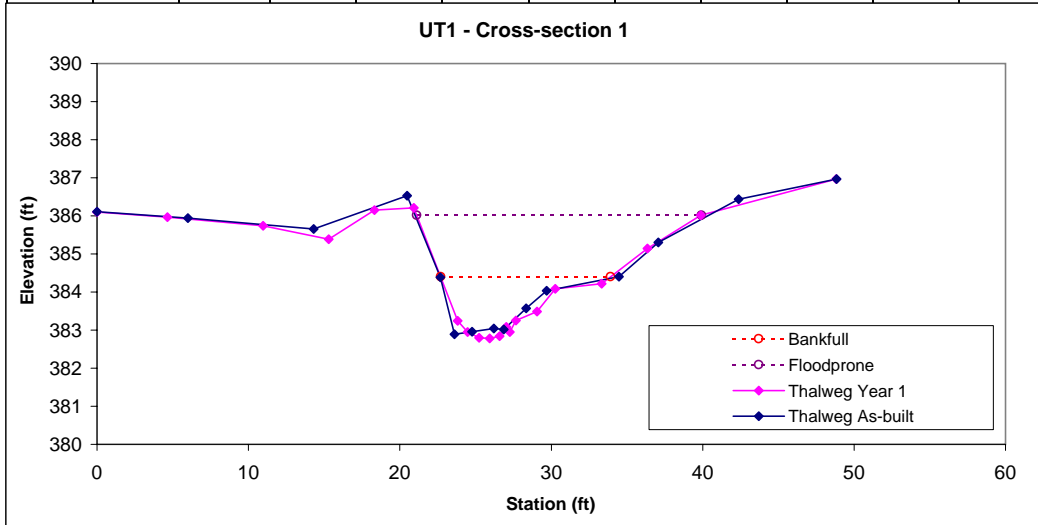
**Permanent Cross-section 1, Station 10+15**  
(Year 1 - Data Collected September 2008)

Cross-sections 1 and 3 are located on UT1 at stations 33+25 and 35+75, respectively. The cross-sections are located across pools found at the apex of meander bends. Based on the cross-section data, the pool on cross-section 1 has deepened slightly since as-built conditions. The pool on cross-section 3 has deepened significantly and has also shown an increase in bankfull area. The pool cross-sections are showing slow development of point bar features on the inside bank of the meander bends.

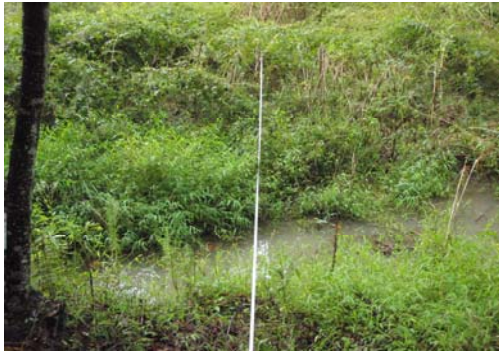
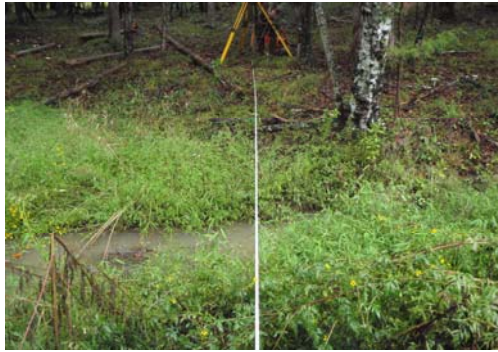
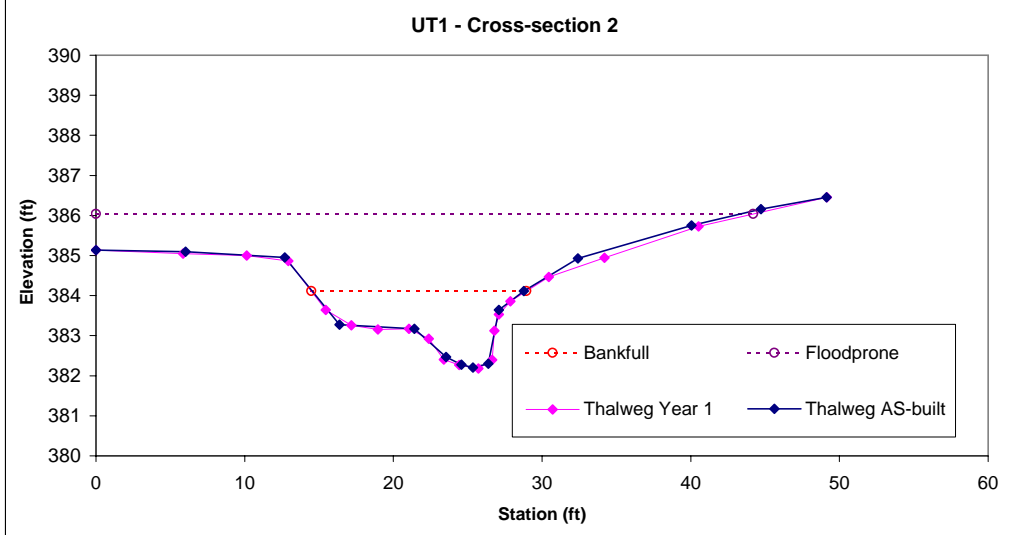
### Permanent Cross-section 2, Station 10+93

Cross-section 2 is located on UT1 at station is 34+00. It is located across a riffle, which is normally found between meander bends. Cross-section 2 remained stable during Year 1 monitoring and exhibited relatively no change since as-built conditions.

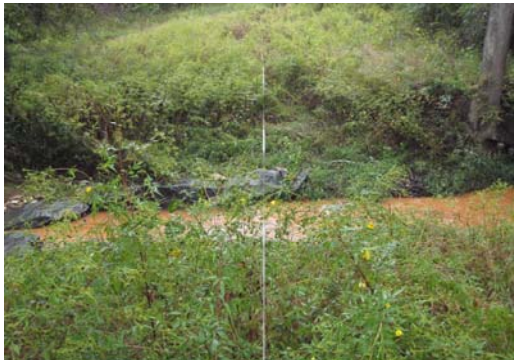
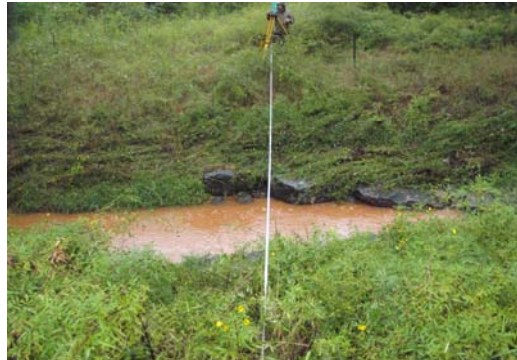
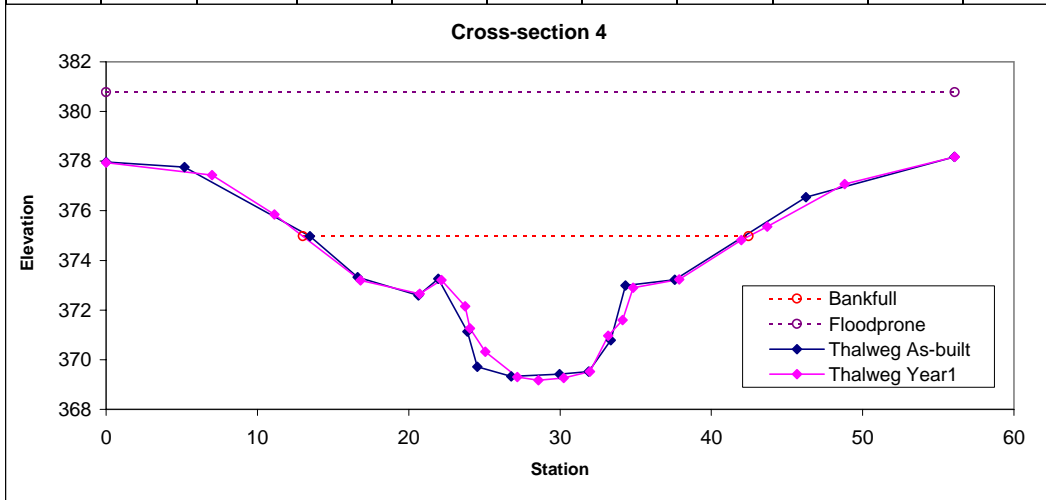
**Permanent Cross-section 4, Station 10+62**  
(Year 1 - Data Collected September 2008)

Cross-section 4 is located across the cross vane on Little Grassy Creek at station 126+50.m The data show that cross-section 4 has deepened slightly and the bankfull area has remained stable since as-built conditions. During Year 1 monitoring, the Site did not experience any stream enhancement-related problems. However, a beaver dam was observed in October of 2008 on Little Grassy Creek. The dam is located upstream of the ford crossing above the historic mill.

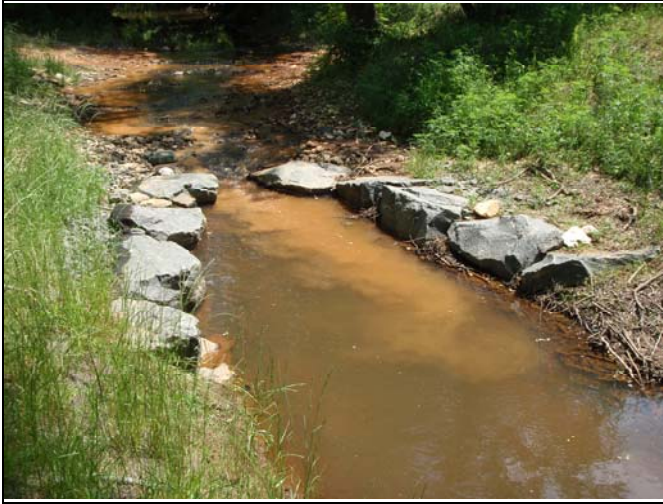
Little Grassy Creek Cross Vane –  
June 5, 2008

According to the cross-section survey, stream dimension remained stable during the Year 1 monitoring. The in-stream cross-vane structure also remained stable during Year 1.

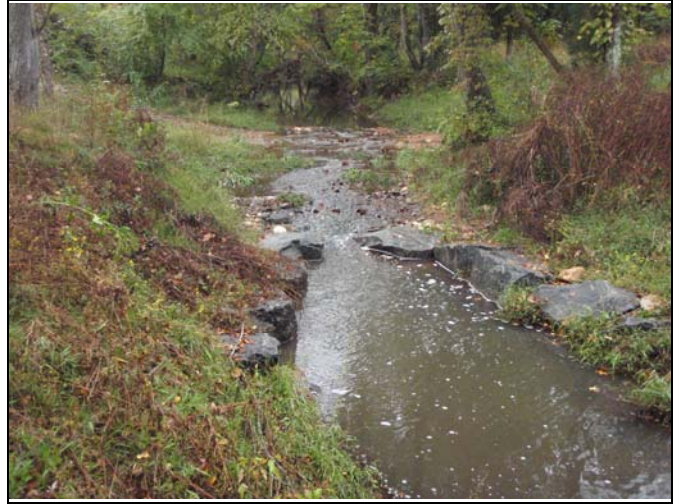
Little Grassy Creek Cross Vane –  
October 10, 2008

The last cross vane photograph was taken in October 2008, at the end of the monitoring season, to document the evolution of the structure since as-built conditions. The cross-section photographs were taken in September 2008.
