# **Annual Monitoring Report**

## **Little Pine Creek II**

### **Monitoring Year 1 of 7**

NCDMS Project No. 856

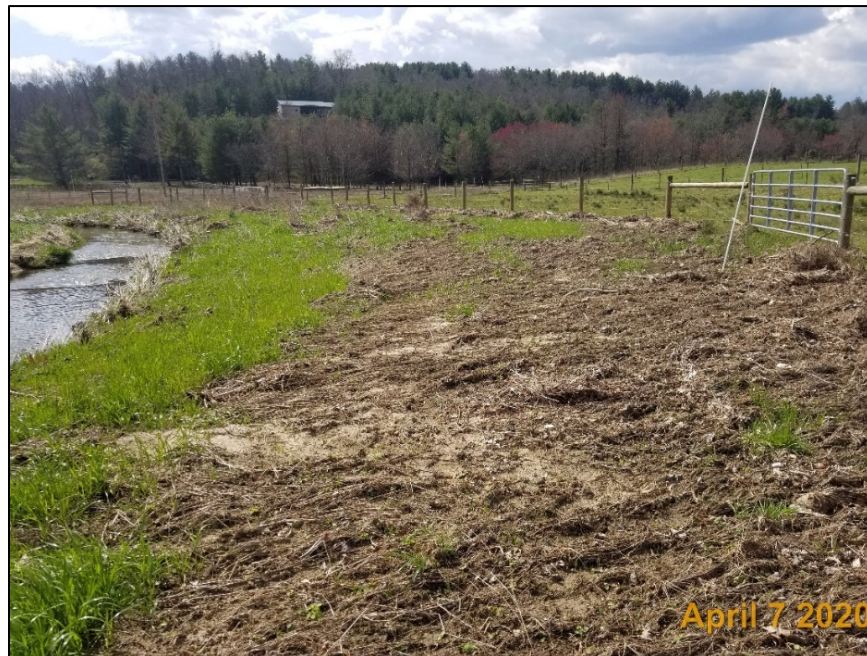
1. Wrack lines and sediment deposits, LPCII Reach 2a.

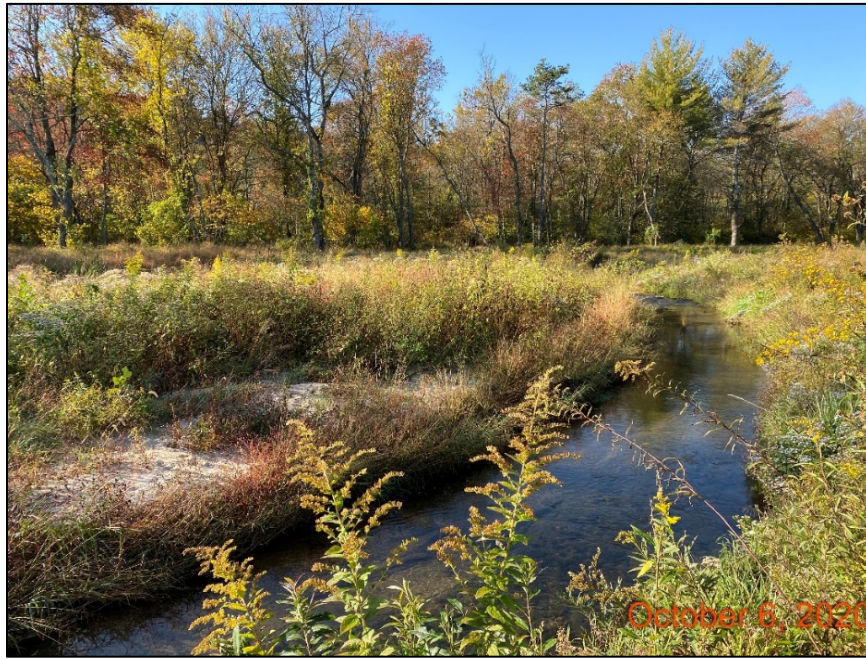
2. Residual wrack lines and sediment deposits, LPCII Reach 2a

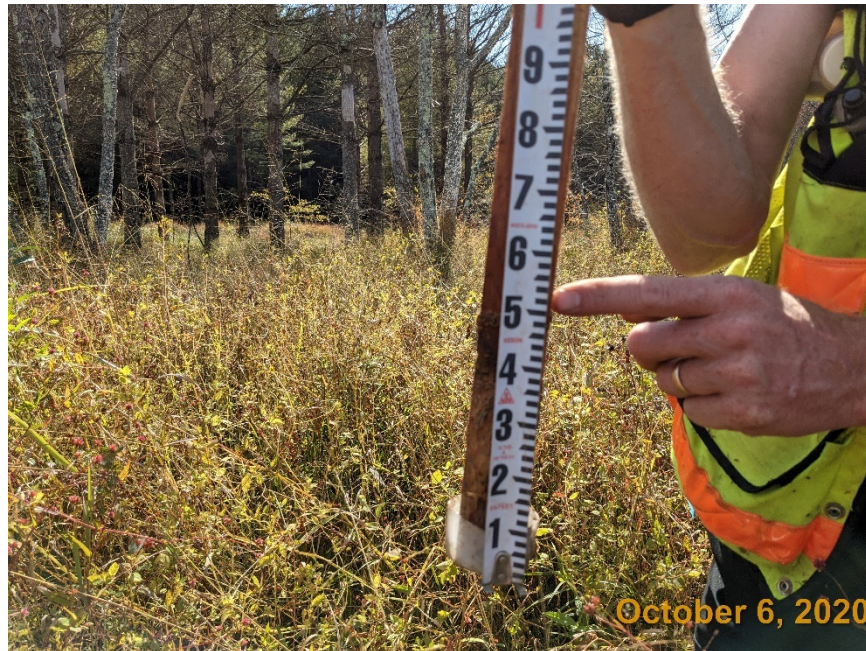
3. Crest gage corklines, LPCII Trib B.
