MONITORING YEAR 7 ANNUAL/CLOSEOUT REPORT

LITTLE PINE III STREAM AND WETLAND RESTORATION PROJECT

Alleghany County, NC
NCDEQ Contract 6844
DMS Project Number 94903
DWR # 14-0041
USACE Action ID 2012-01299

Data Collection Period: August - December 2022
Draft Submission Date: January 26, 2023
Final Submission Date: February 23, 2023

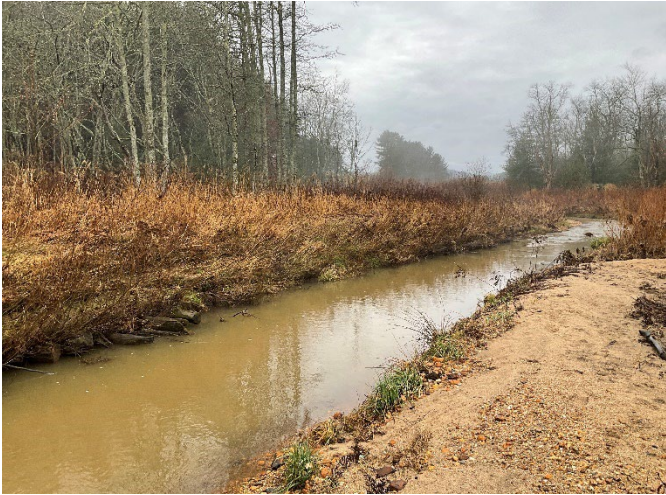
LPC Reach 1 STA 100+50 – Phase II left bank repaired with geolift and toe wood added, looking downstream (12/7/2022)

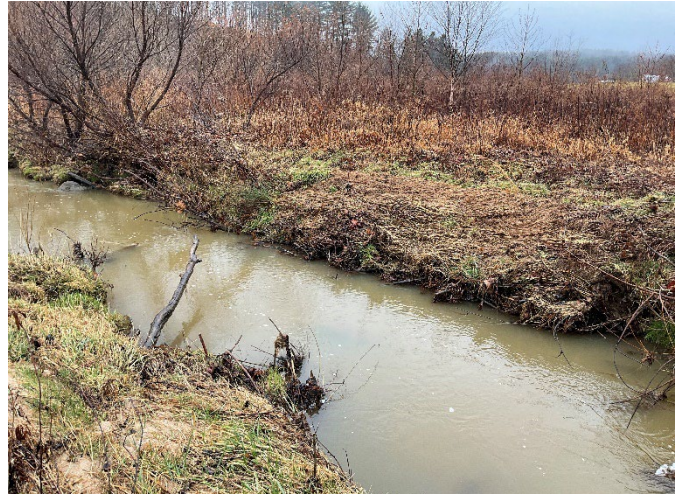
LPC Reach 2a STA 118+00 – Phase III right bank repaired with geolift and toe wood, looking downstream (12/7/2022)

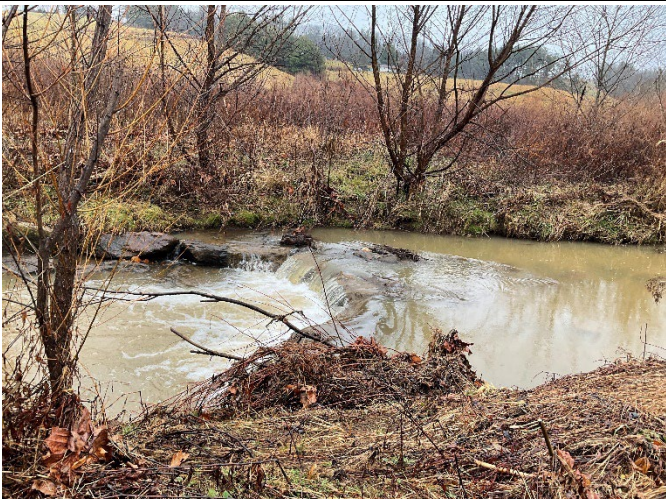
LPC Reach 2a STA 120+25 – Phase III J-hook repaired, looking upstream (12/7/2022)

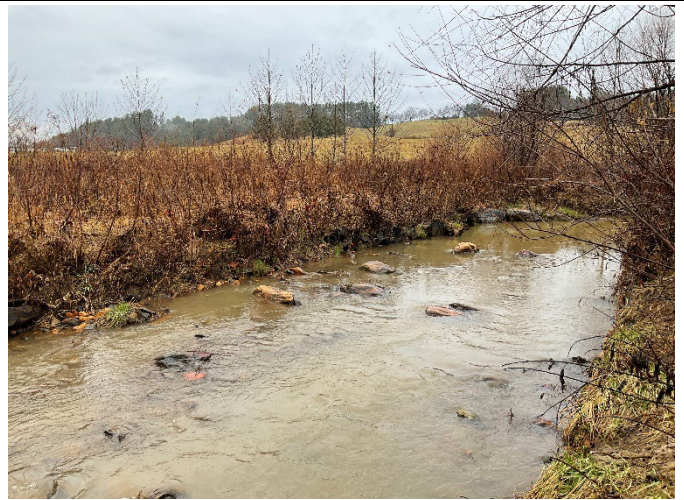
LPC Reach 2a STA 121+50 – Phase II constructed riffle and right bank repaired, looking upstream (12/7/2022)

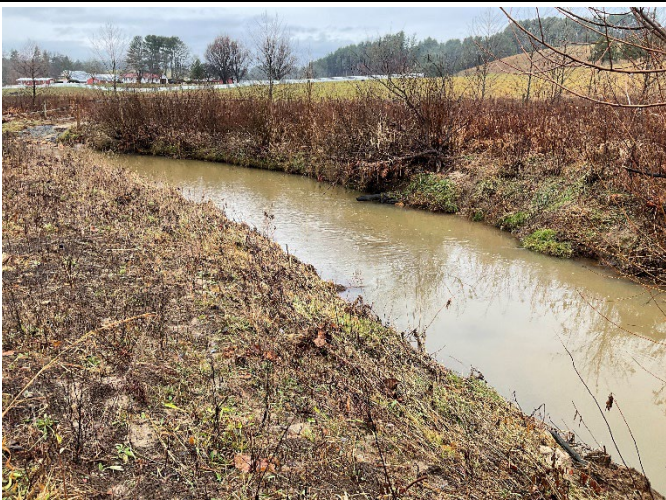
LPC Reach 2a STA 123+00 – Phase III lunker log removed, and left bank repaired, looking downstream (12/7/2022)

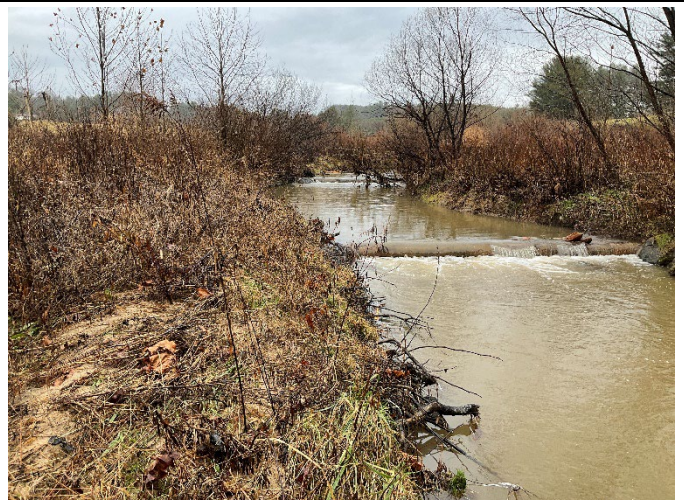
LPC Reach 2b STA 124+50 – Phase III roller log repaired and right bank geolift with toe wood, looking upstream (12/7/2022)

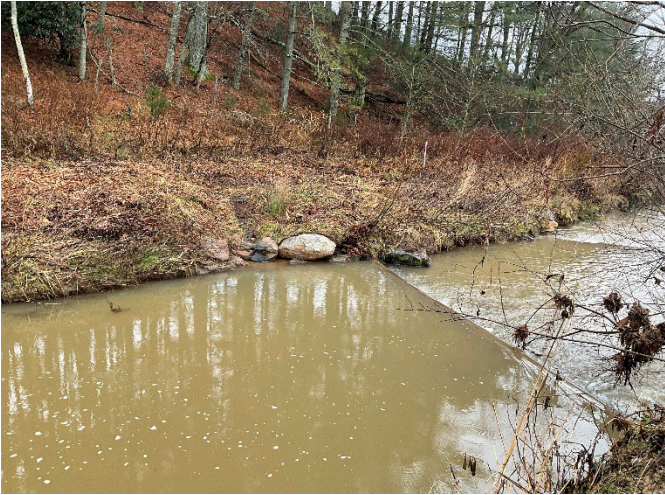
LPC Reach 2b STA 125+50 – Phase III wetland GG outlet repaired with step pool outlets, looking downstream (12/7/2022)

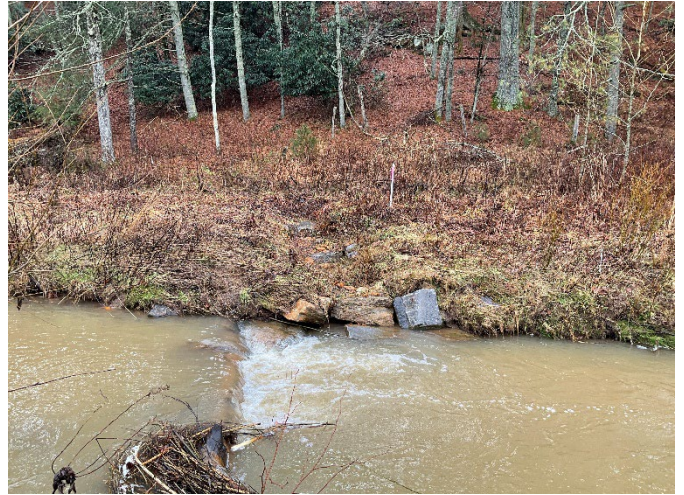
LPC Reach 2b STA 125+75 – Phase III wetland GG outlet repaired with step pool outlets, looking at left bank (12/7/2022)

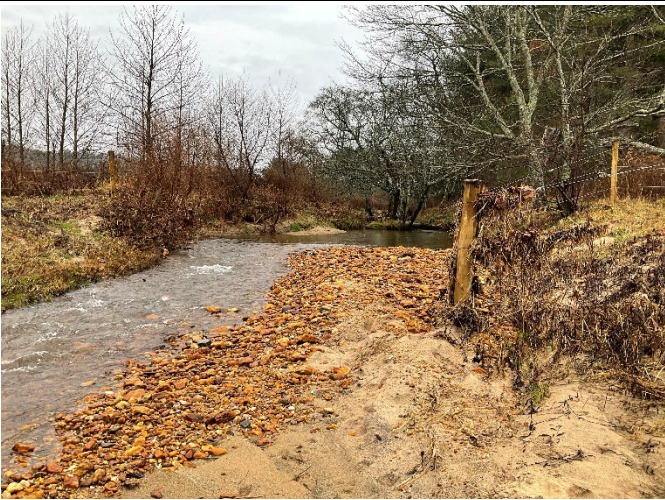
LPC Reach 2b STA 132+00 – Phase III ford crossing bar removal (still present), looking upstream (12/7/2022)

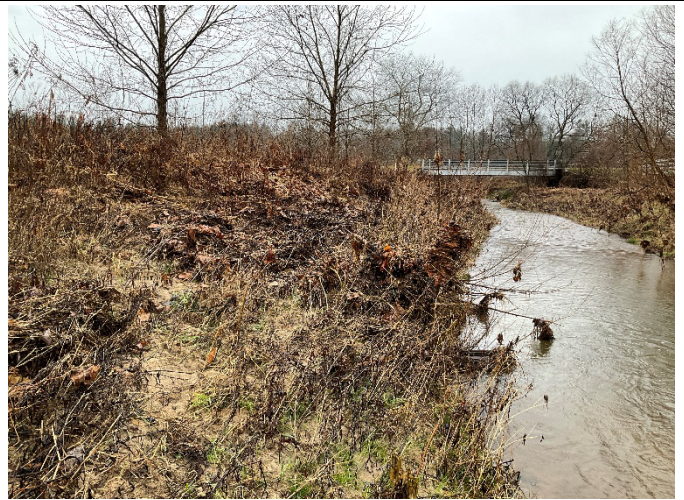
LPC Reach 2b STA 133+00 – Phase III left bank repaired, looking downstream (12/7/2022)

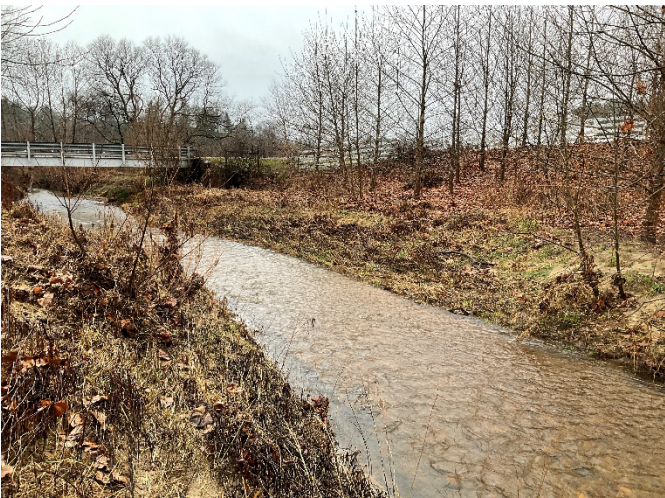
LPC Reach 2b STA 133+50 – Phase III right bank repaired, looking downstream (12/7/2022)

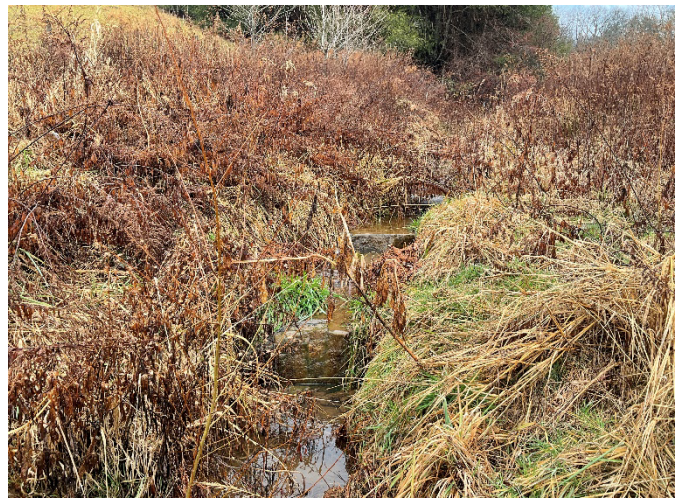
UT1 STA 198+00 – 198+30 – Phase III headcut repaired by installing rock step pools, looking upstream (12/7/2022)

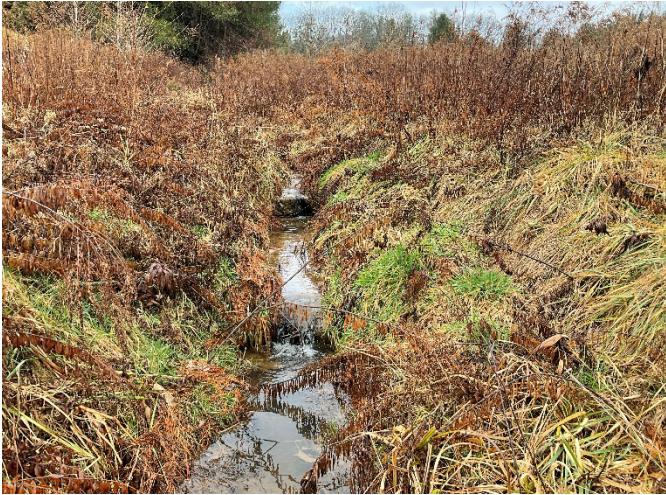
UT1 STA 198+30 – 199+00 – Phase III filter fabric added to repair piping, looking upstream (12/7/2022)

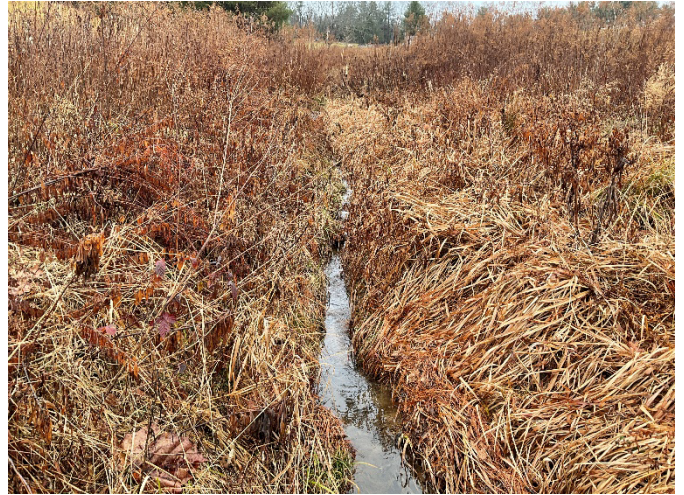
UT1 STA 199+50 – Phase III channel thalweg recentered, looking upstream (12/7/2022)

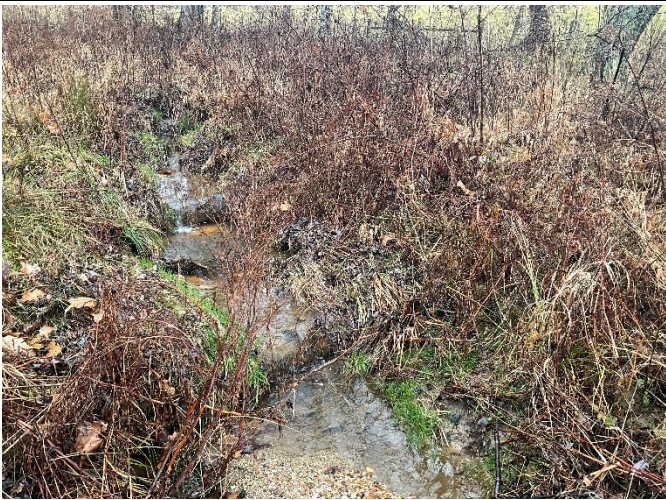
UT2 Reach 1 (Upper) STA 303+16 – Phase III filter fabric installed to repair piping log roller, looking upstream (12/7/2022)

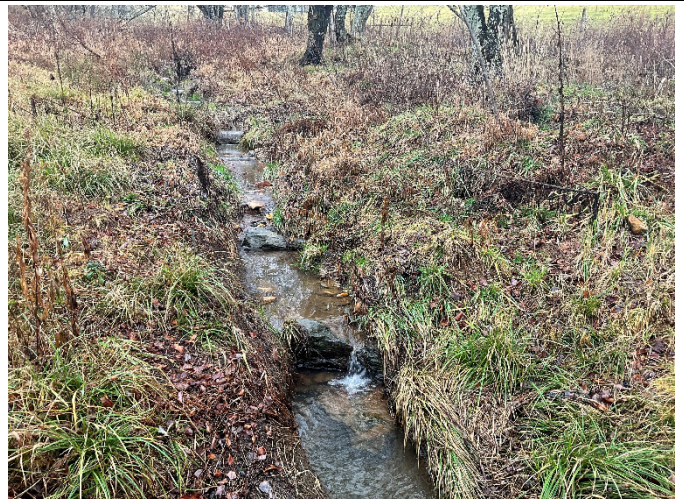
UT2 Reach 1 (Upper) STA 303+80 – 304+20 – Phase III rock cross vanes installed and right bank repaired, looking upstream (12/7/2022)

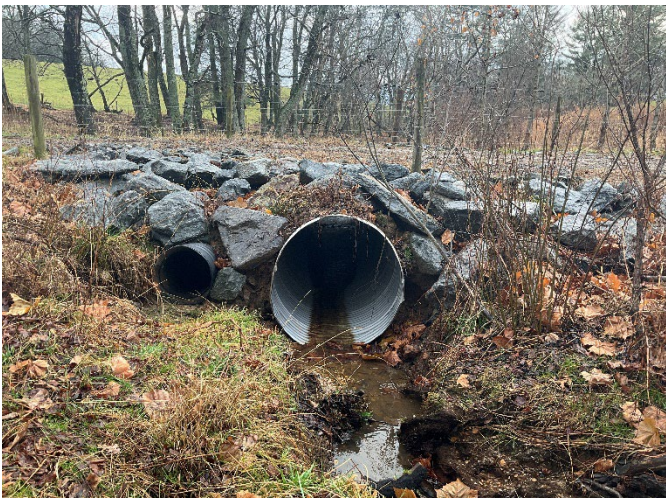
UT2 Reach 1 (Upper) STA 308+50 – Phase III repaired crossing inlet by replacing with 48" culvert, looking downstream (12/7/2022)

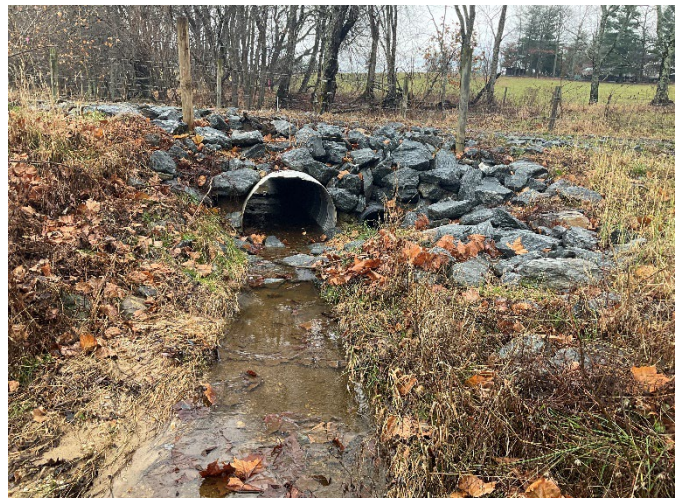
UT2 Reach 1 (Upper) STA 308+75 – Phase III repaired culvert outlet, stone added to plunge pool, looking upstream (12/7/2022)

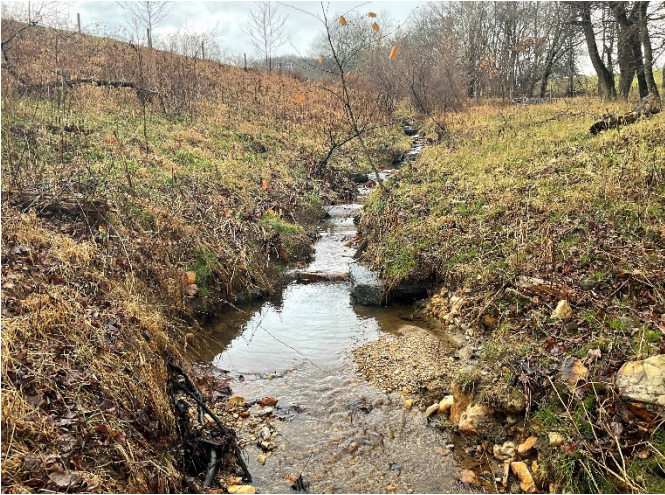
UT2 Reach 1 (Upper) STA 309+50 – 310+50 – Phase III rock cross vanes added, structures and left bank repaired, looking upstream (12/7/2022)

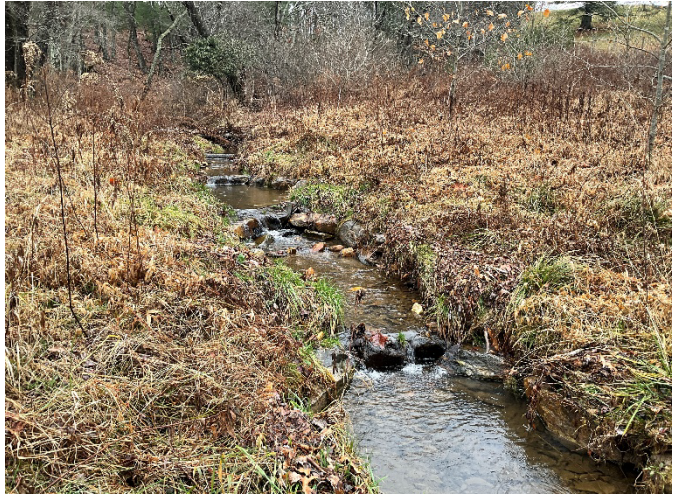
UT2 Reach 1 (Lower) STA 325+50 – 326+00 – Phase III buried channel rebuilt, rock cross vanes and riffles added, looking upstream (12/7/2022)

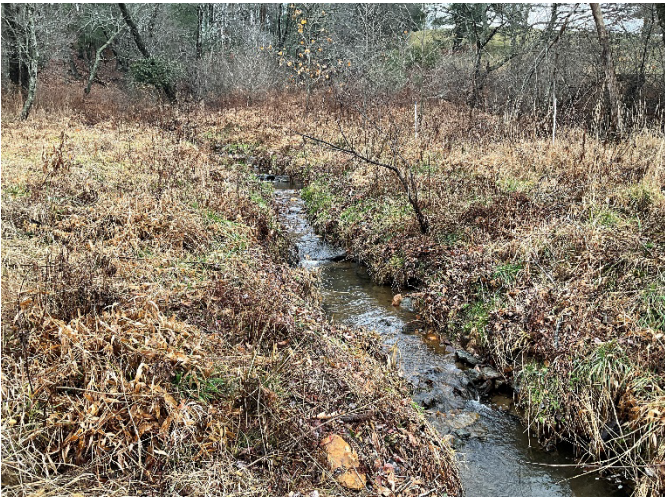
UT2 Reach 1 (Lower) STA 326+00 – 326+50 – Phase III buried channel rebuilt, rock cross vanes and riffles added, looking upstream (12/7/2022)

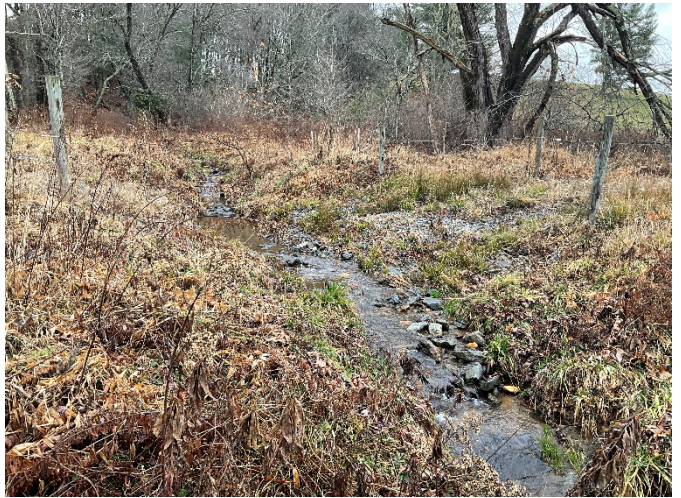
UT2 Reach 1 (Lower) STA 326+75 – Phase III culvert crossing replaced with ford crossing, fencing repaired, looking upstream (12/7/2022)

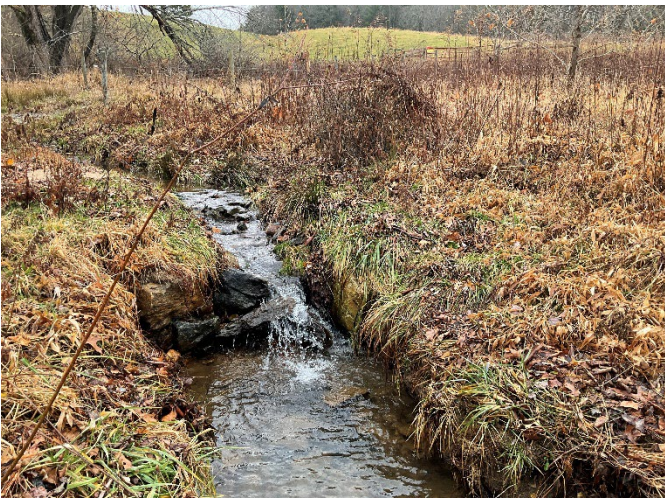
UT2 Reach 1 (Lower) STA 327+00 – Phase III rock cross vane added, looking upstream (12/7/2022)

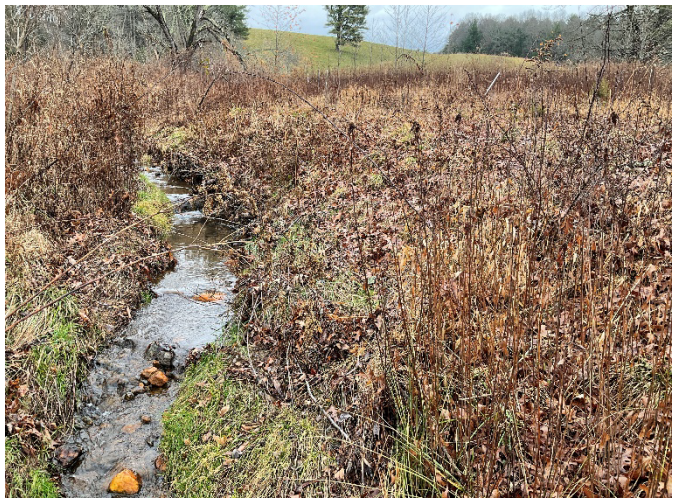
UT2 Reach 1 (Lower) STA 328+25 – Phase III left bank repaired, looking upstream (12/7/2022)

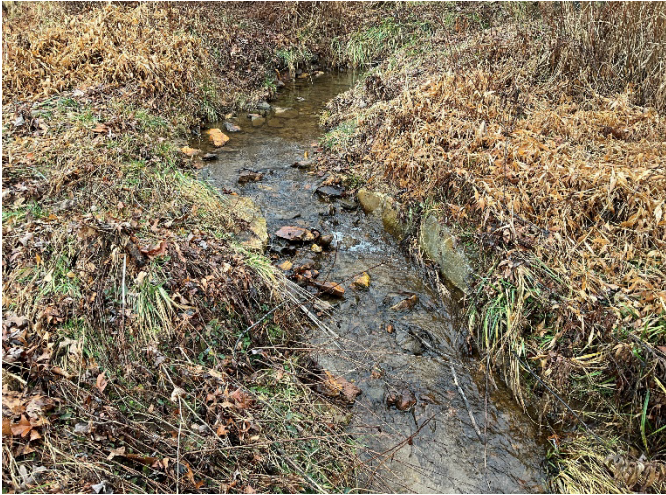
UT2 Reach 2 STA 330+00 – Phase III rock cross vane added, looking upstream (12/7/2022)

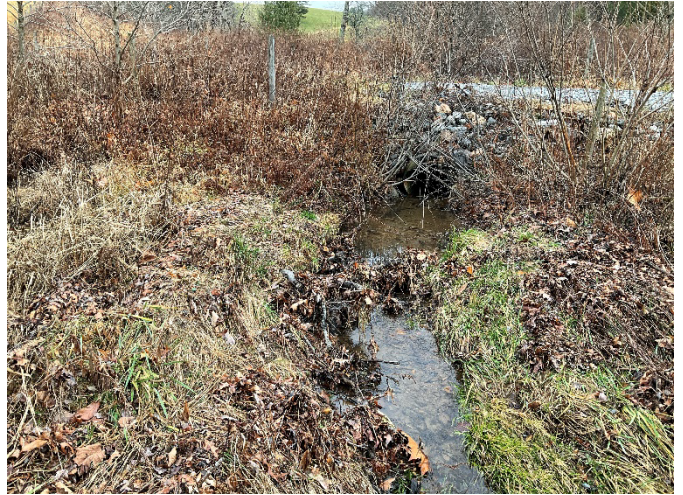
UT2 Reach 2 STA 331+60 – Phase III right bank repaired, looking upstream (12/7/2022)

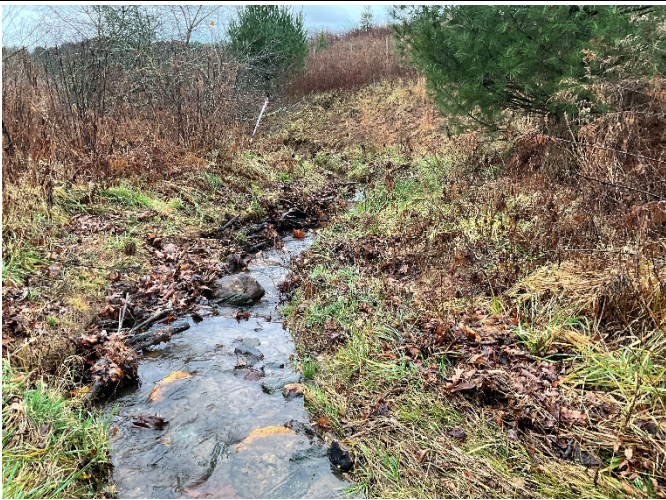
UT2A STA 426+50 – Phase III right and left banks repaired, looking downstream (12/7/2022)

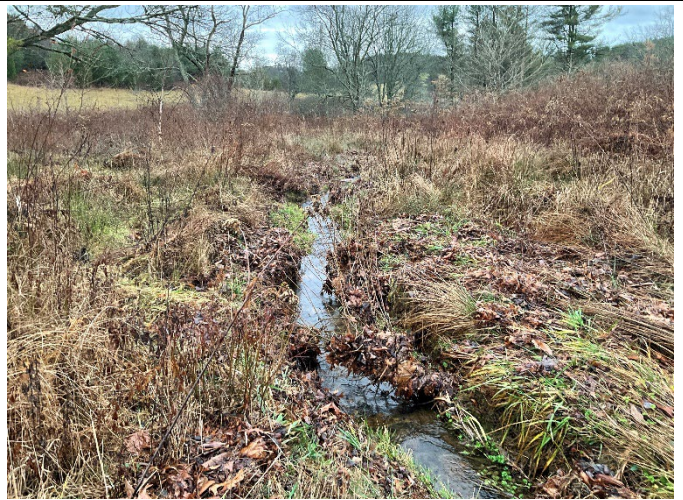
UT2A STA 430+50 – Phase I repair area stone and log step pool added, looking downstream (12/7/2022)

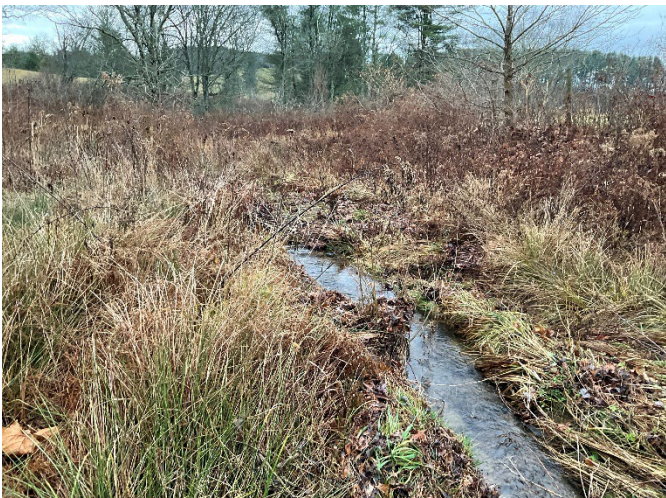
UT2A STA 431+25 – Phase I right bank repair area, looking downstream (12/7/2022)

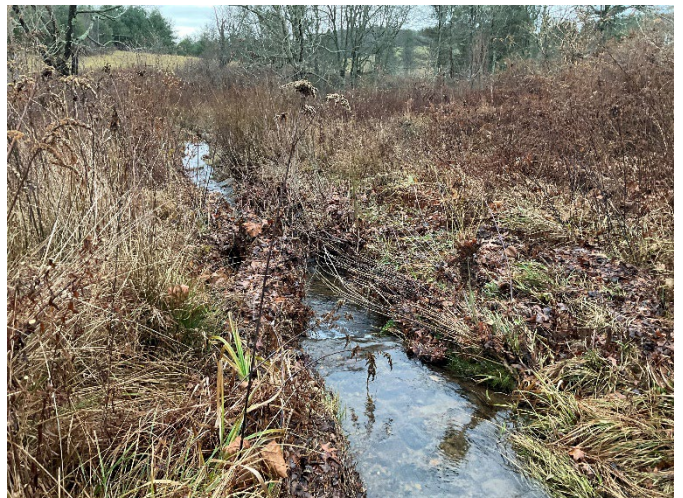
UT2A STA 431+60 – Phase I right bank repair area, looking downstream (12/7/2022)

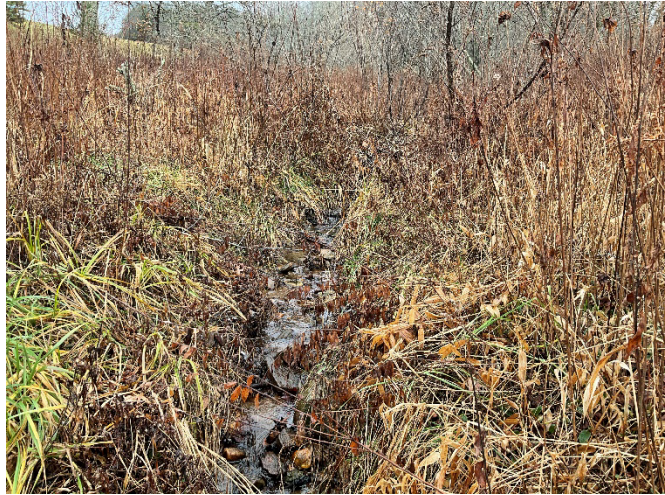
UT2B STA 505+20 – Phase III constructed riffle material added and headcut repaired, looking upstream (12/7/2022)
