MONITORING YEAR 1 REPORT

LITTLE PINE III STREAM AND WETLAND RESTORATION PROJECT

Alleghany County, NC

DMS Project Number 94903

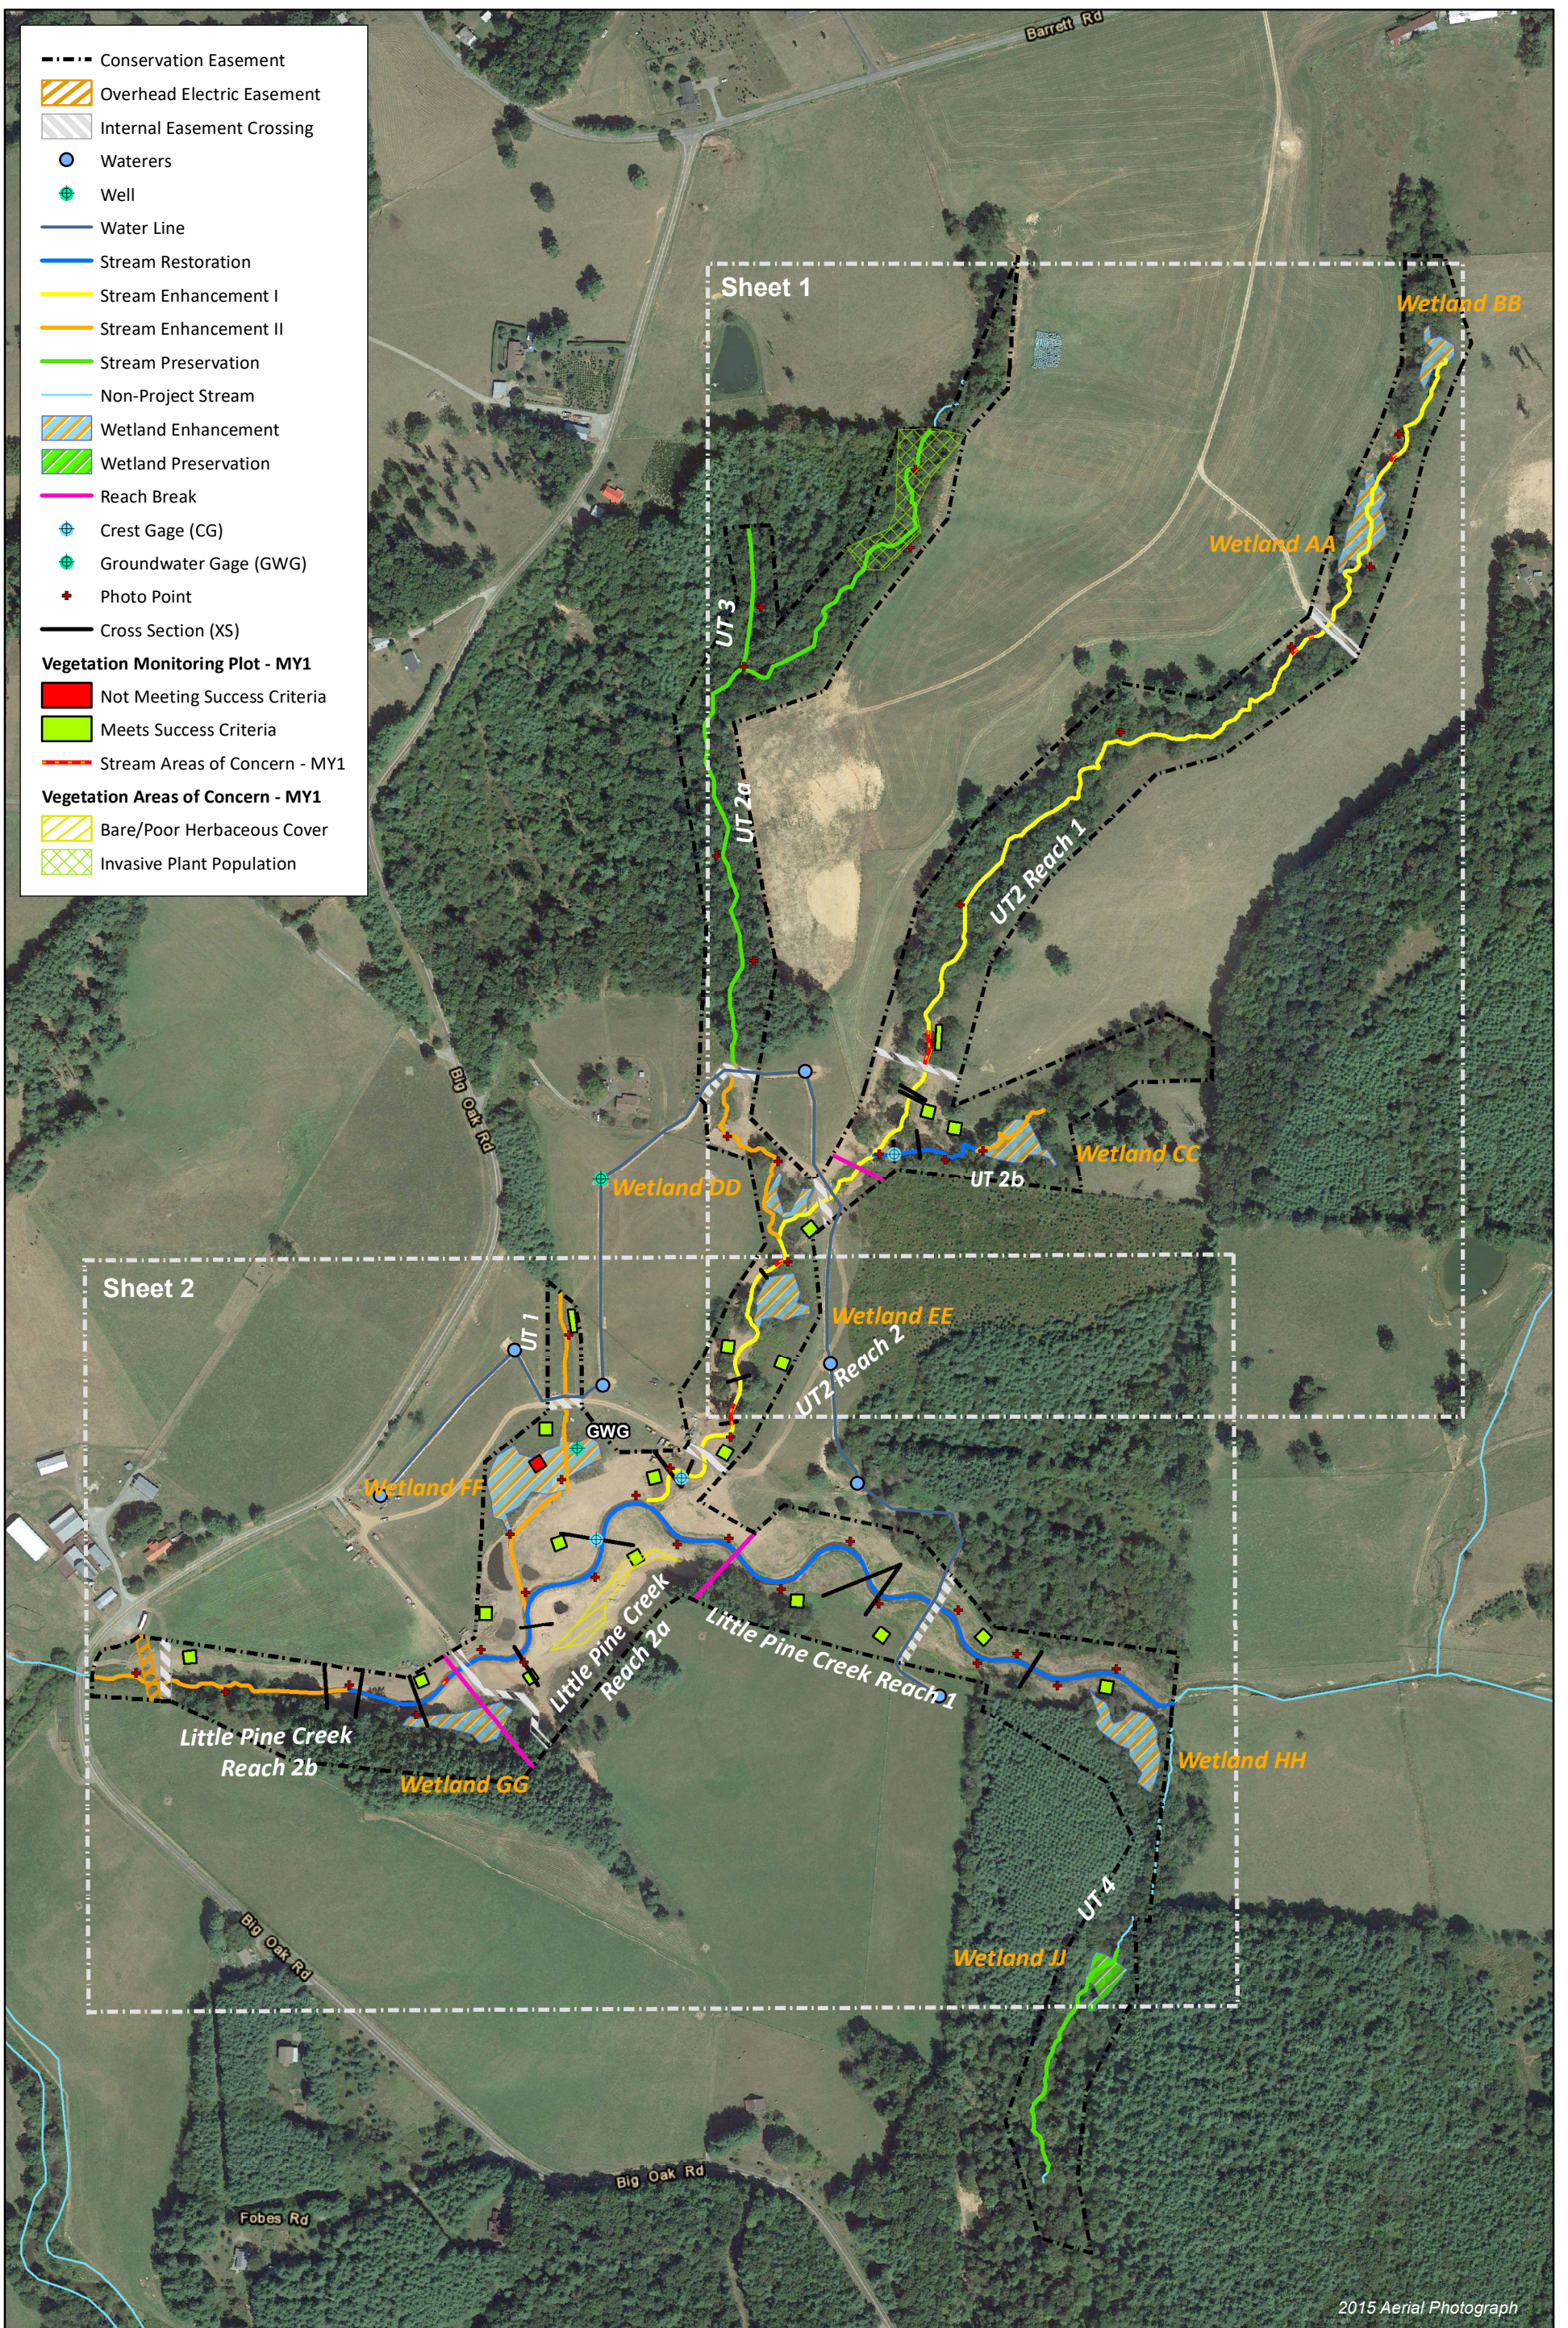
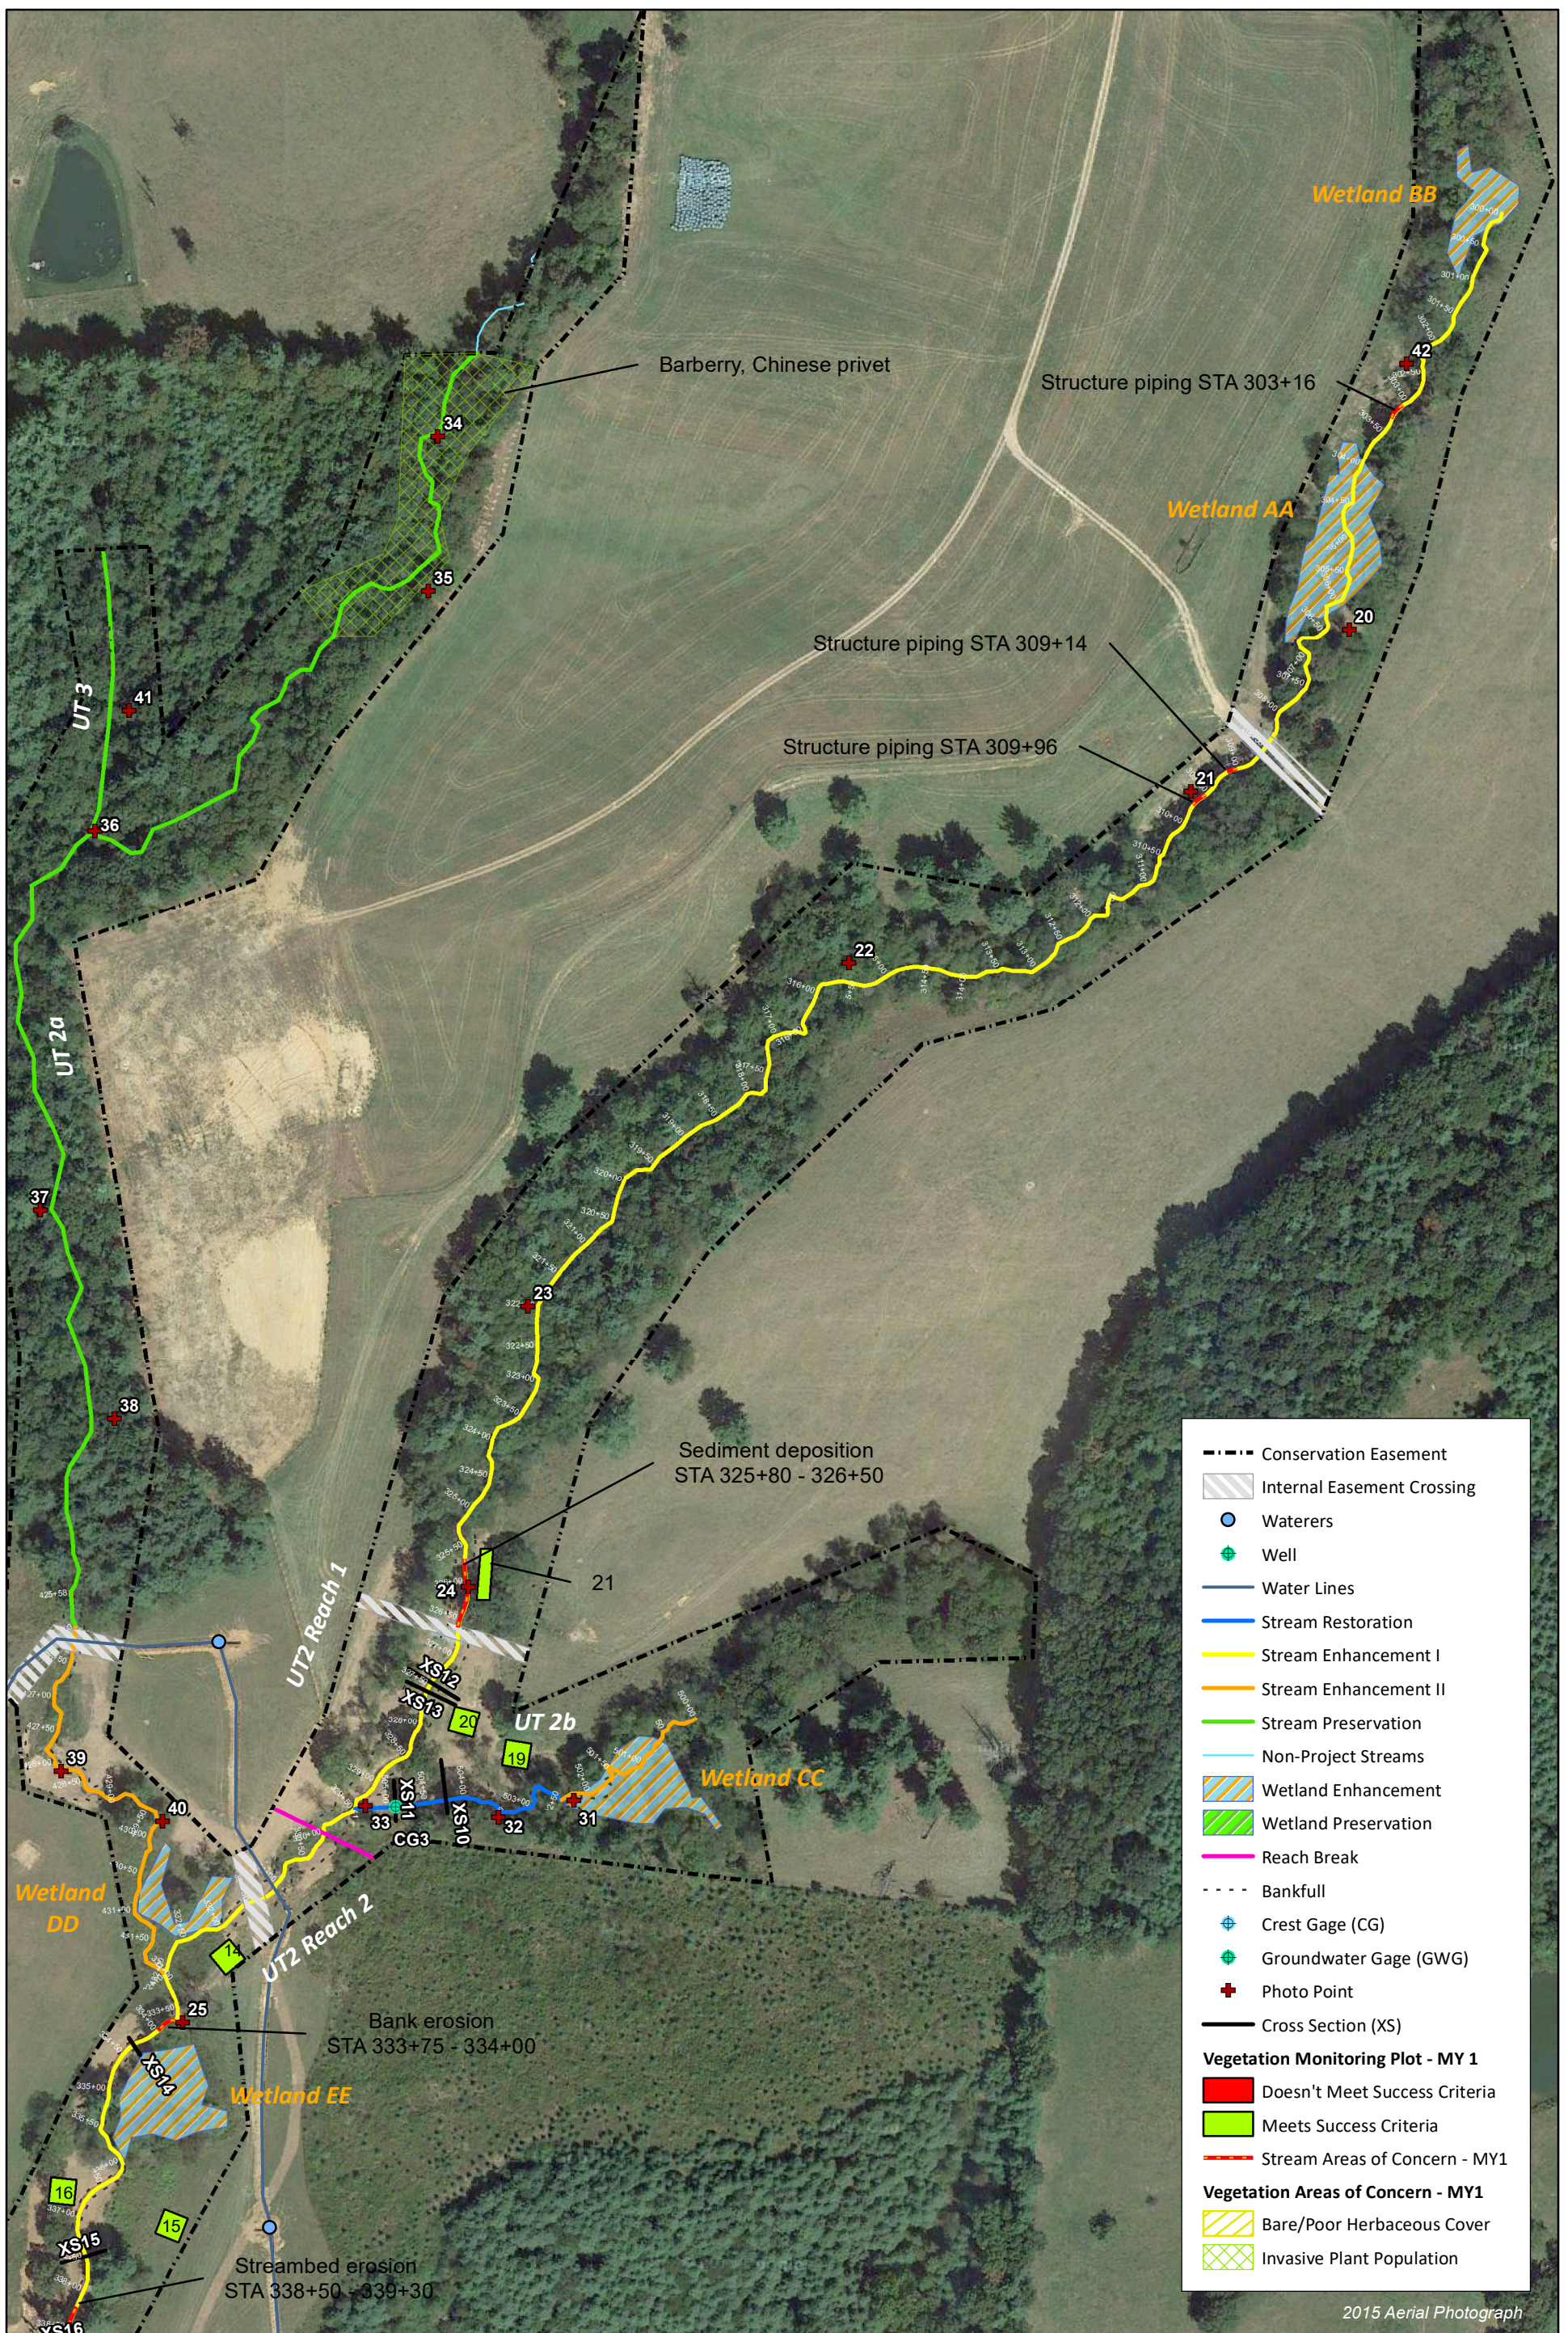
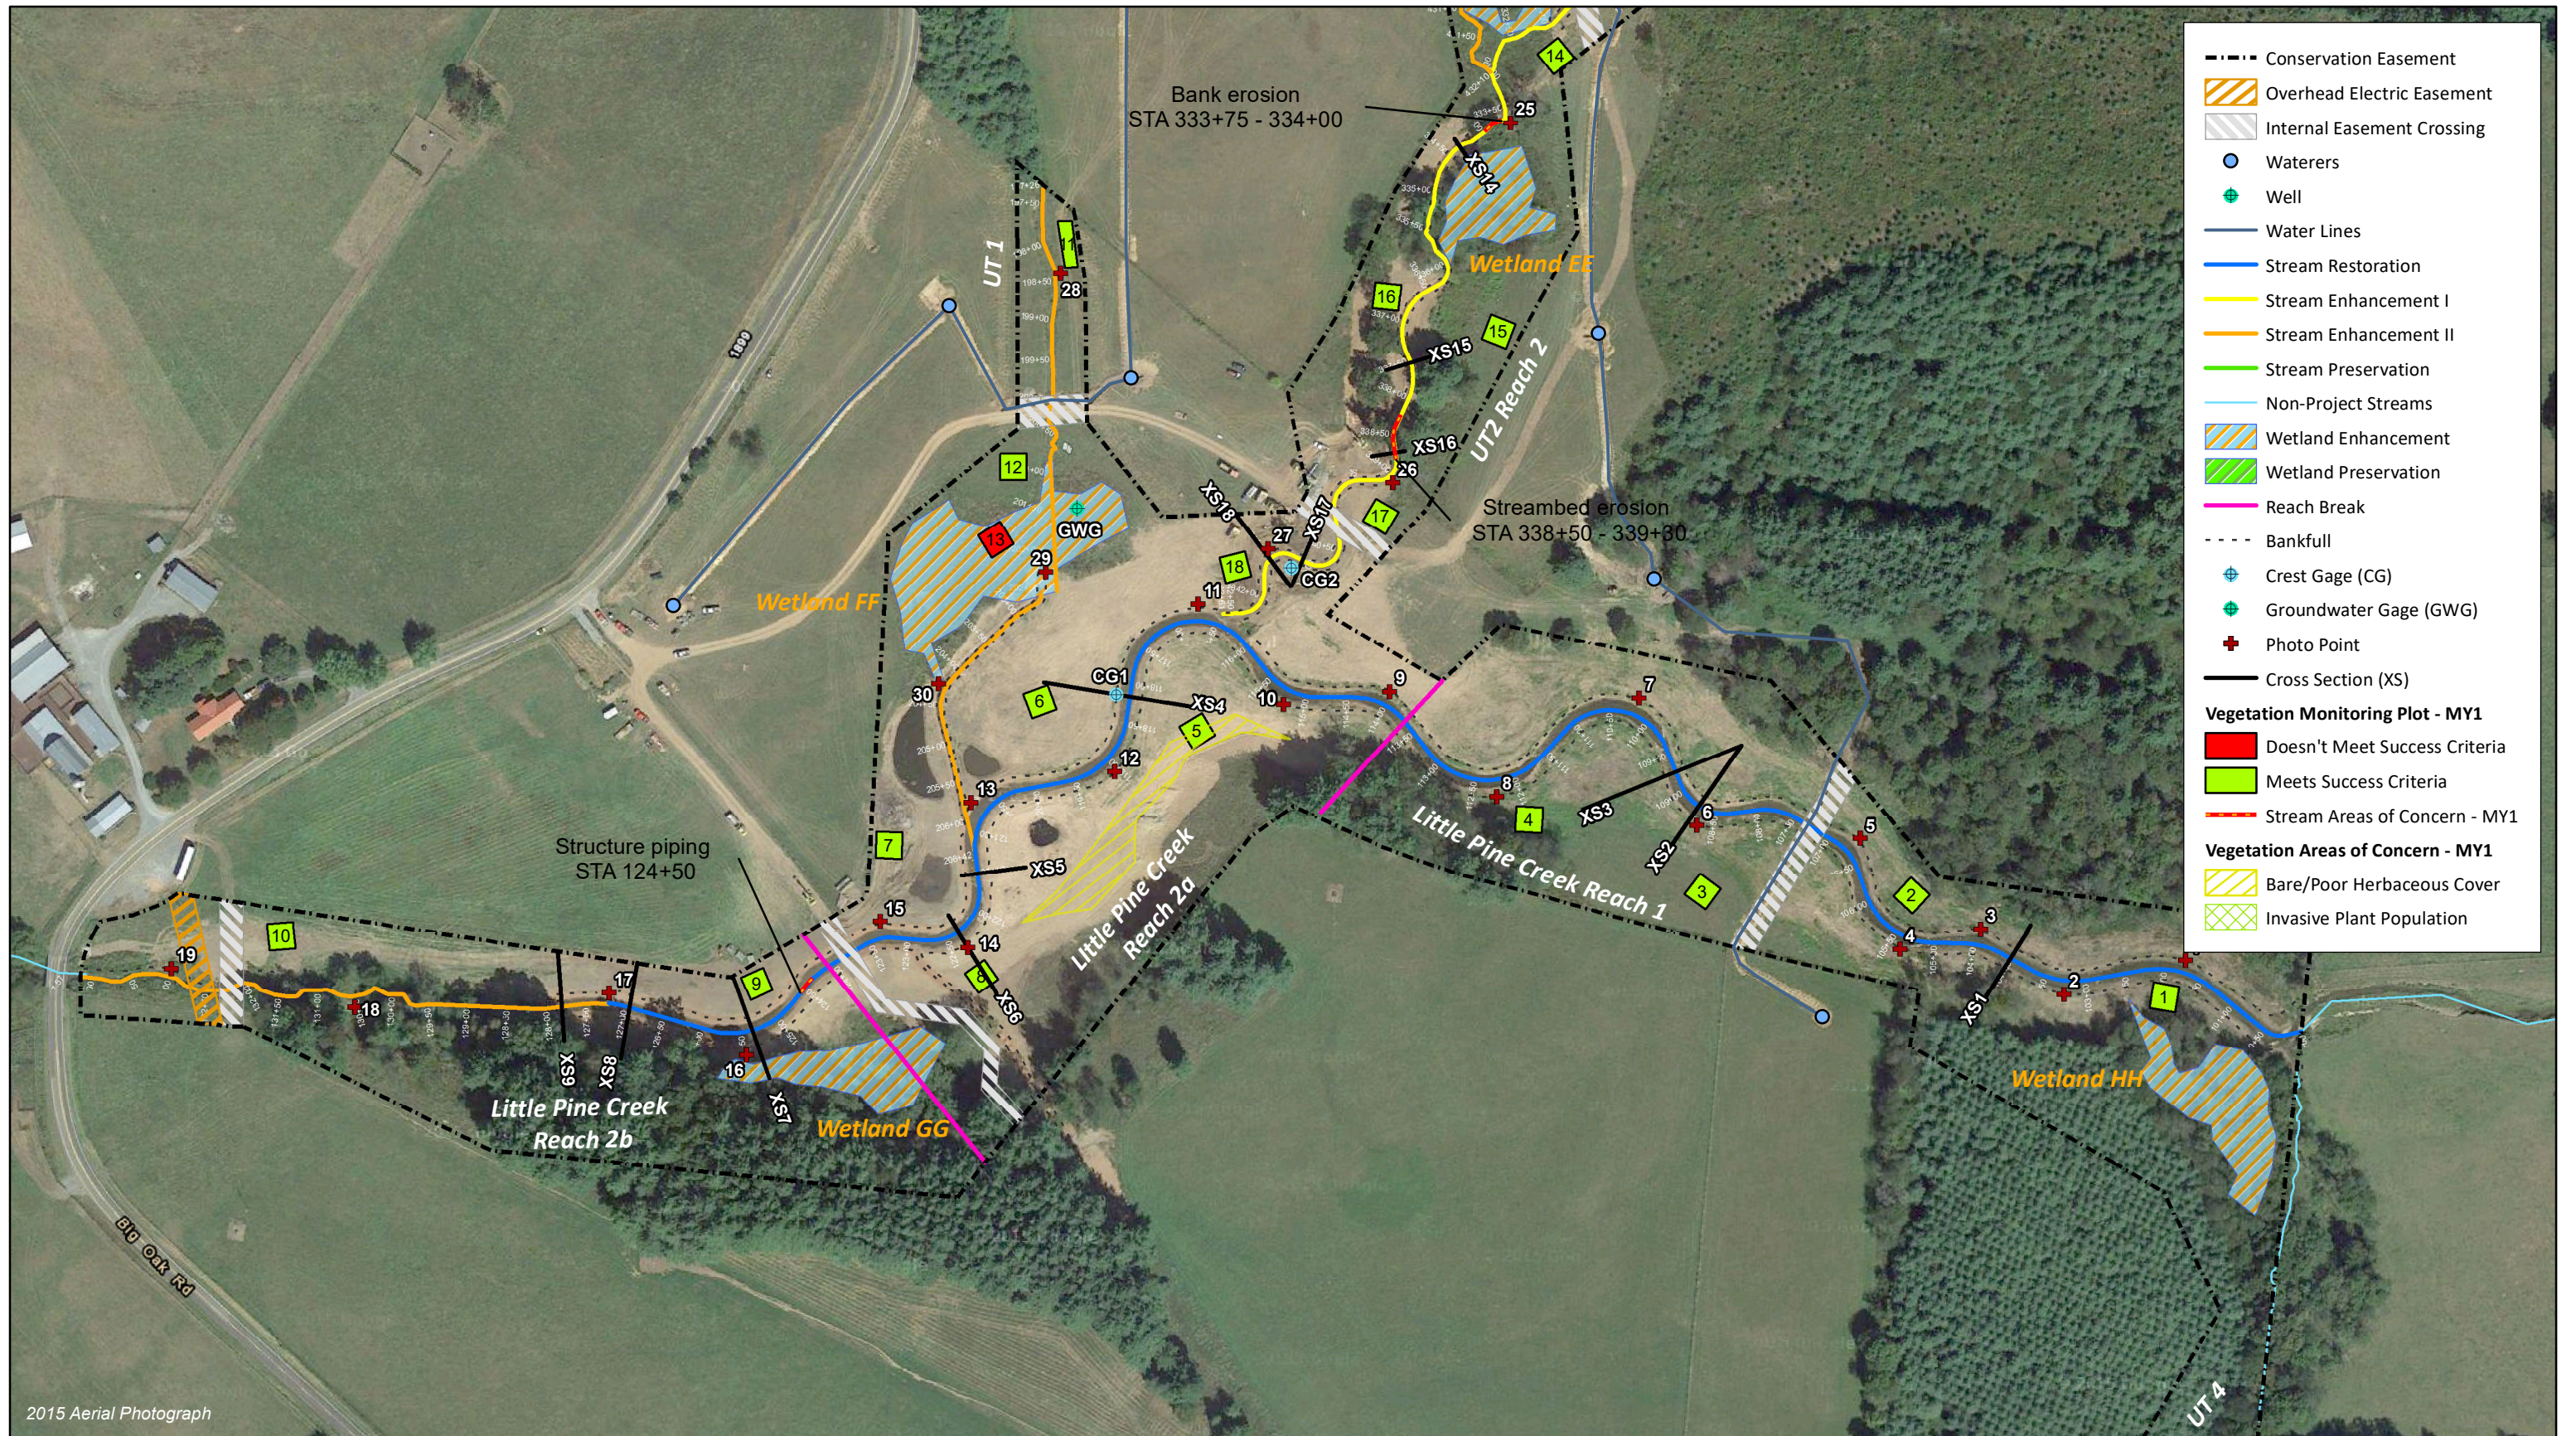
Figure 3.1 Current Condition Plan View Map (Sheet 1 of 2)
 Little Pine Creek III Stream & Wetland Restoration Project
 DMS Project No. 94903
 Monitoring Year 1 - 2016
 Alleghany County, NC

The MY1 vegetation monitoring and visual assessment revealed few vegetation areas of concern. Small patches of bare or poor herbaceous cover in the riparian area of Little Pine Reach 2a were observed. Invasive areas of concern were observed along UT2a, where populations of European barberry (*Berberis vulgaris*) and Chinese privet (*Ligustrum sinense*) are becoming prevalent. These vegetation areas of concern are shown in Figure 3 in Appendix 2.

Stream areas of concern included instances of structure piping, bank scour, sediment deposition, and streambed scour. Little Pine Reach 2b had one instance of structure piping, located at STA 124+50. UT2 Reach 1 Upper had 3 instances of structures piping (STA 303+16, 309+14, and 309+96) resulting in the degradation of one riffle at STA 303+20. UT2 Reach 1 Lower had an area of sediment deposition from STA 325+80-326+50 which buried 4 structures and 3 riffles, and an area of bank erosion from STA 333+75-334+00. The bank erosion from 333+75 to 334+00 was repaired in December 2016. UT2 Reach 2 had one instance of streambed erosion from STA 338+50-339+30 resulting in riffle degradation, shifting

of thalweg position, floodplain scour, and sediment deposition. This area was also repaired in December 2016. These stream areas of concern are indicated in Table 6 and on Figure 3 in Appendix 2.
