MONITORING YEAR 2 REPORT

LITTLE PINE III STREAM AND WETLAND RESTORATION PROJECT

Alleghany County, NC

DMS Project Number 94903

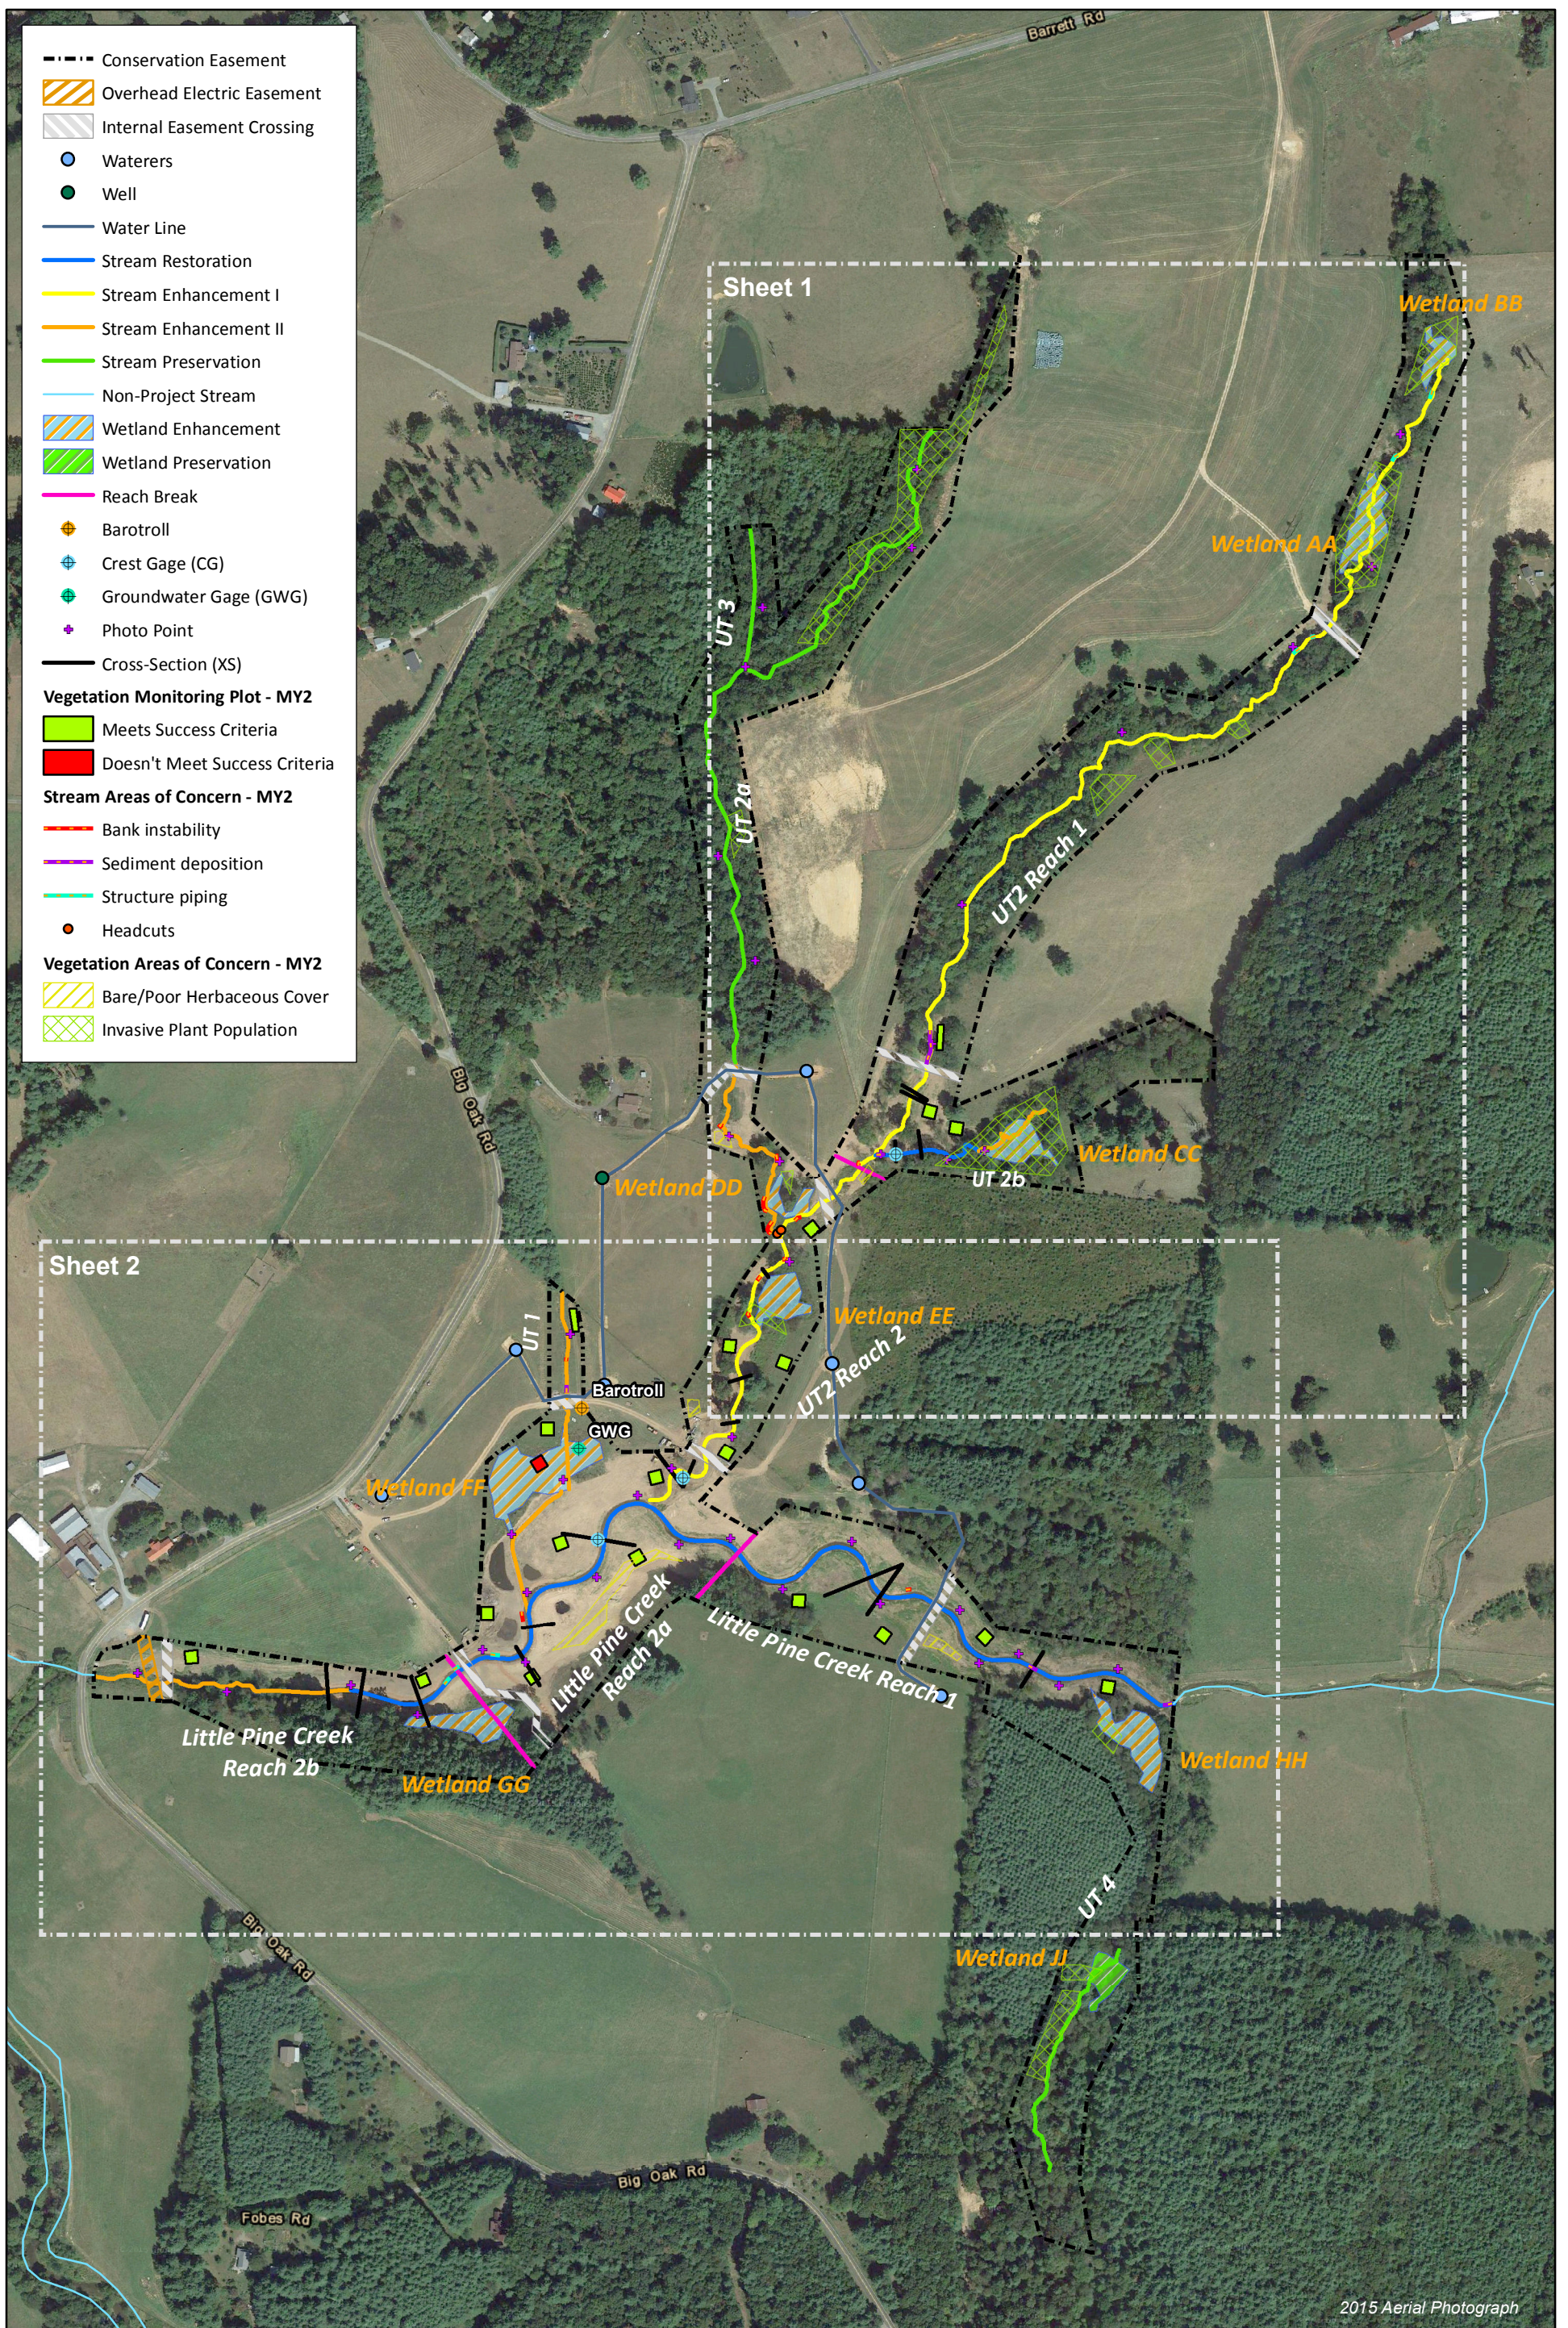
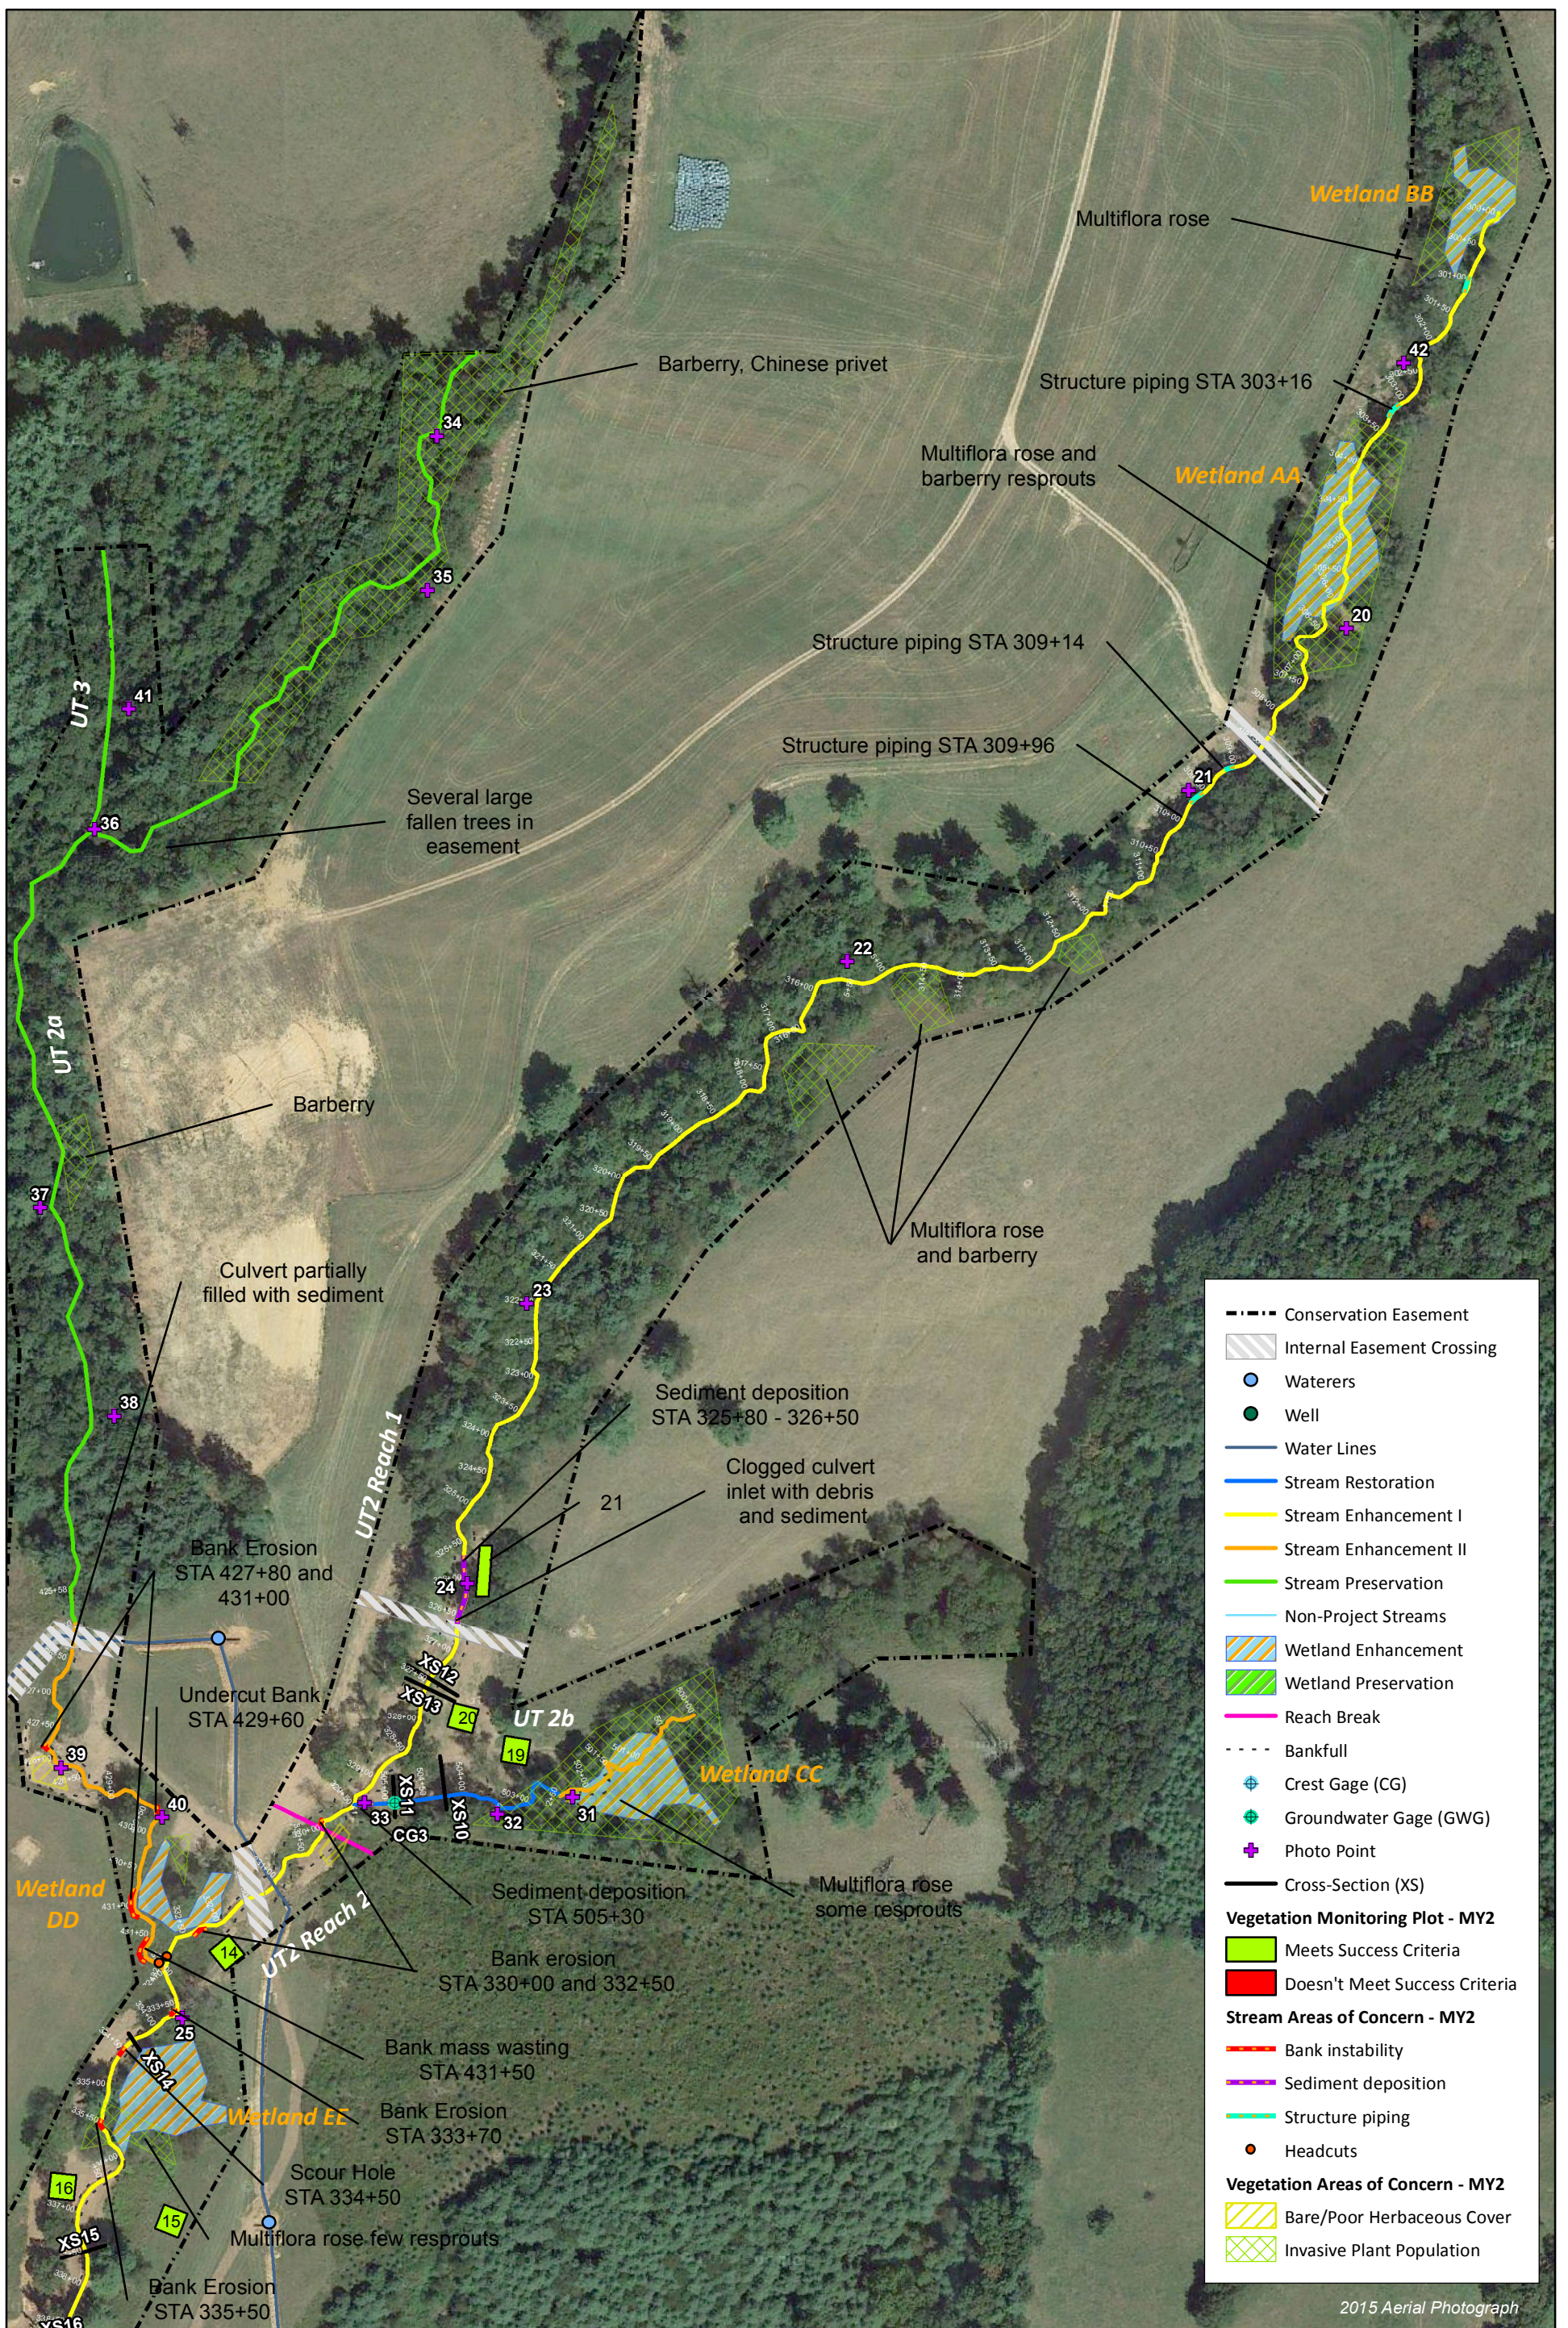
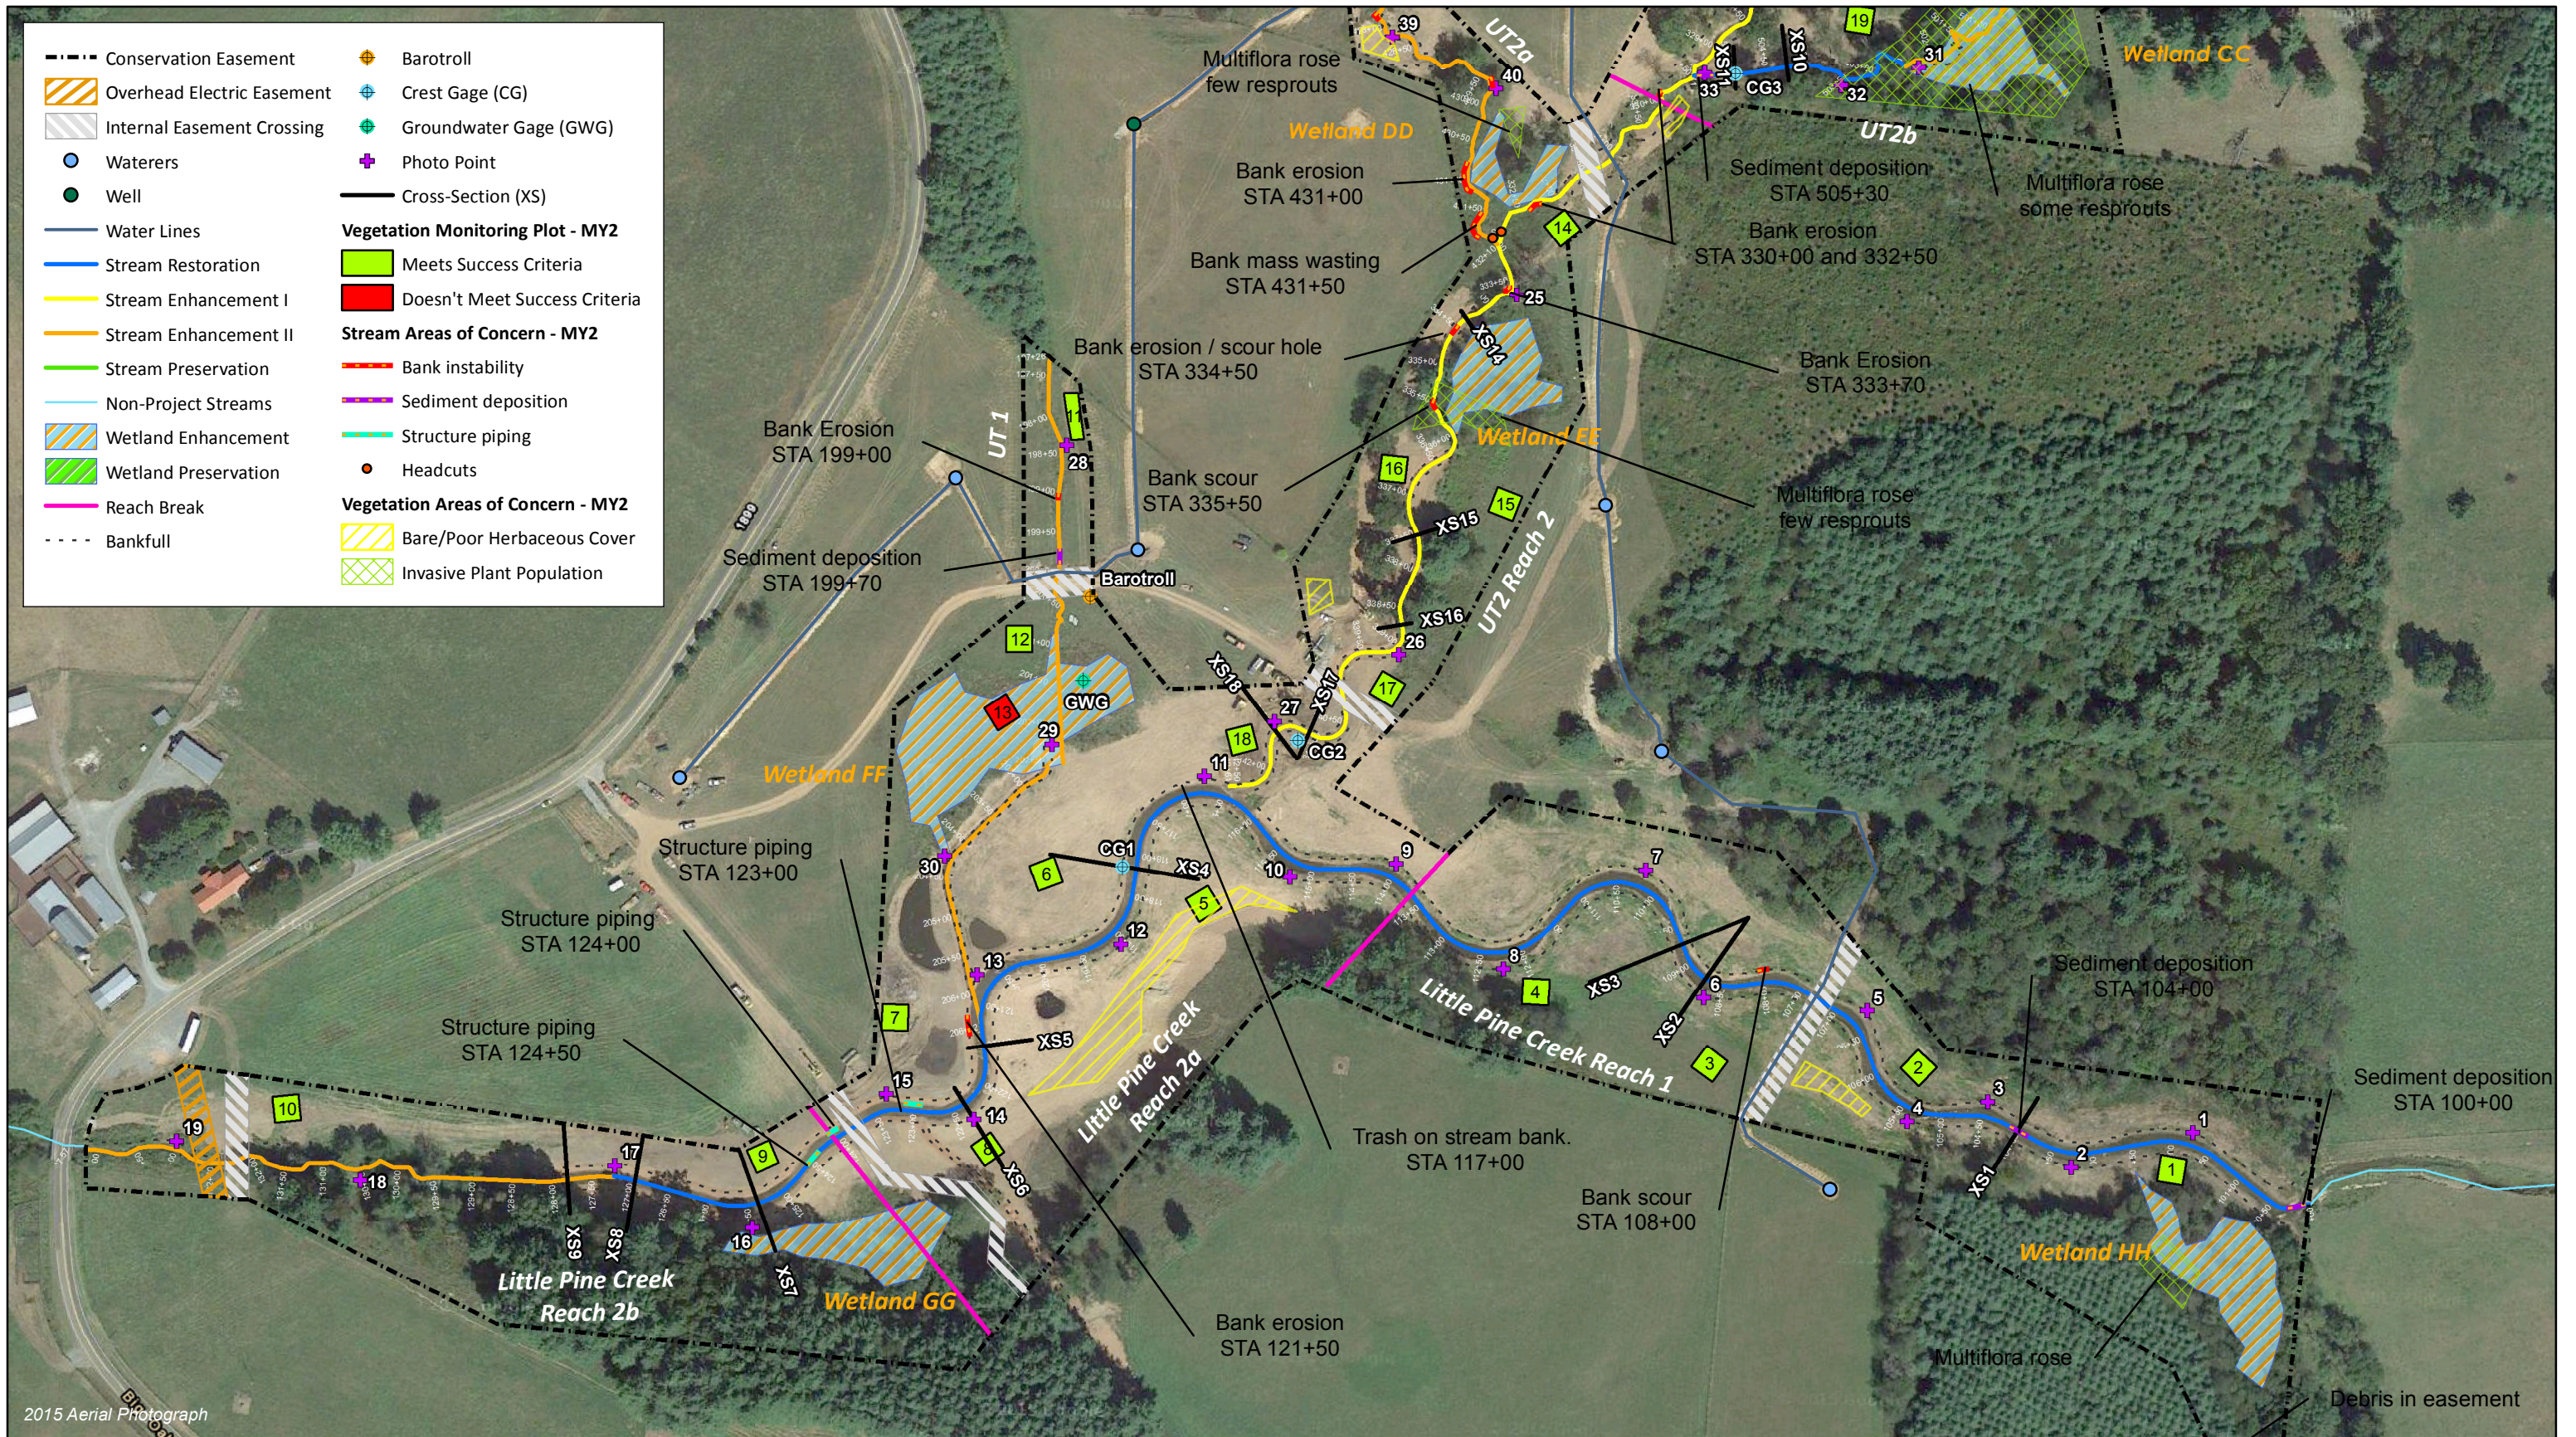
Figure 3.0 Integrated Current Condition Plan View Map (Key)
 Little Pine Creek III Stream & Wetland Restoration Project
 DMS Project No. 94903
 Monitoring Year 2 - 2017

The MY2 vegetation monitoring and visual assessment revealed some vegetation areas of concern. Small patches of poor/bare herbaceous cover in the left floodplain of Little Pine Creek Reach 1 and Reach 2a were identified in MY1. These areas were observed in MY2 and are showing growth in herbaceous cover. Some vegetation problem areas of invasive plant populations have been identified in MY2 throughout the Site with predominant species including: European barberry (*Berberis vulgaris*), Multiflora rose (*Rosa multiflora*), and Chinese privet (*Ligustrum sinense*). Areas of European barberry and Multiflora rose are becoming prevalent especially in the upper preservation reach of UT2a, upstream of the Wetland JJ on UT4, and UT2 Reach 1 upper riparian area. The project vegetation maintenance contract was recently terminated and vegetation areas of concern will continue to be monitored and addressed as needed by DMS. These vegetation areas of concern are shown in Figure 3 in Appendix 2.

Stream areas of concern included instances of structure piping, bank scour, sediment deposition, and clogged culverts. On Little Pine Creek Reach 1, a wedge of sediment has deposited forming a mid-channel bar at the upstream start of the project. At the riffle located at cross-section 1 (STA 104+00), sediment deposition was observed with some vegetation in the stream. Downstream of the confluence with UT1, Little Pine Creek Reach 2a has one small section of erosion on the right bank (STA 121+50) and flow piping under a log structure (STA 123+00). Little Pine Creek Reach 2b has instances of structure piping, located at STA 124+00 and 124+50.

During a field visit on 9/27/17, DMS observed areas of sediment aggradation on UT1 downstream of the culvert crossing through Wetland FF to STA 202+07 and beyond the installed rock A-vane (approximately 400 LF). In future years as woody vegetation becomes more established and shades out the herbaceous cover, the baseflow is expected to become stronger and transport the accumulated fine sediment in the reach. Currently a defined baseflow channel is still present and this area will continue to be monitored for additional sediment aggradation in future years.

UT2 Reach 1 Upper had 3 instances of structures piping (STA 303+16, 309+14, and 309+96) resulting in the degradation of one riffle at STA 303+20. UT2 Reach 1 Lower has an area of sediment deposition (STA 325+80 to 326+50), located directly upstream of a crossing where the culvert inlet has been clogged with debris and sediment. On UT2 Reach 2, the bank erosion from 333+75 to 334+00 was repaired in December 2016 and appears stable. In MY1, UT2 Reach 2 had one instance of streambed erosion from STA 338+50-339+30 resulting in riffle degradation, shifting of thalweg position, floodplain scour, and sediment deposition. This area was also repaired in December 2016 and the channel appears stable.

UT2a has instances of localized bank erosion (STA 427+80, 431+00) along the right outer bends of the channel. Just upstream of the confluence with UT2, UT2a is exhibiting an area of high instability with vertical eroding right bank at the channel bend (STA 431+50). The sections of eroding banks on UT2a and UT2 are in enhancement I and enhancement II reaches, in areas where no bank work was performed. Adaptive management is recommended in MY3 for sections of eroding banks on UT2a. These stream areas of concern are indicated in Table 6 and on Figure 3 in Appendix 2.

DMS has a repair design underway to address areas of stream instability along UT2a and UT2, including the formation of head-cuts, lateral stream migration, and excessive streambank erosion.
