Mitigation Project Name Little Pine Creek III Stream and Wetland Restoration Site
 DMS ID 94903
 River Basin New
 Cataloging Unit 05050001

MONITORING YEAR 3 ANNUAL REPORT

Final

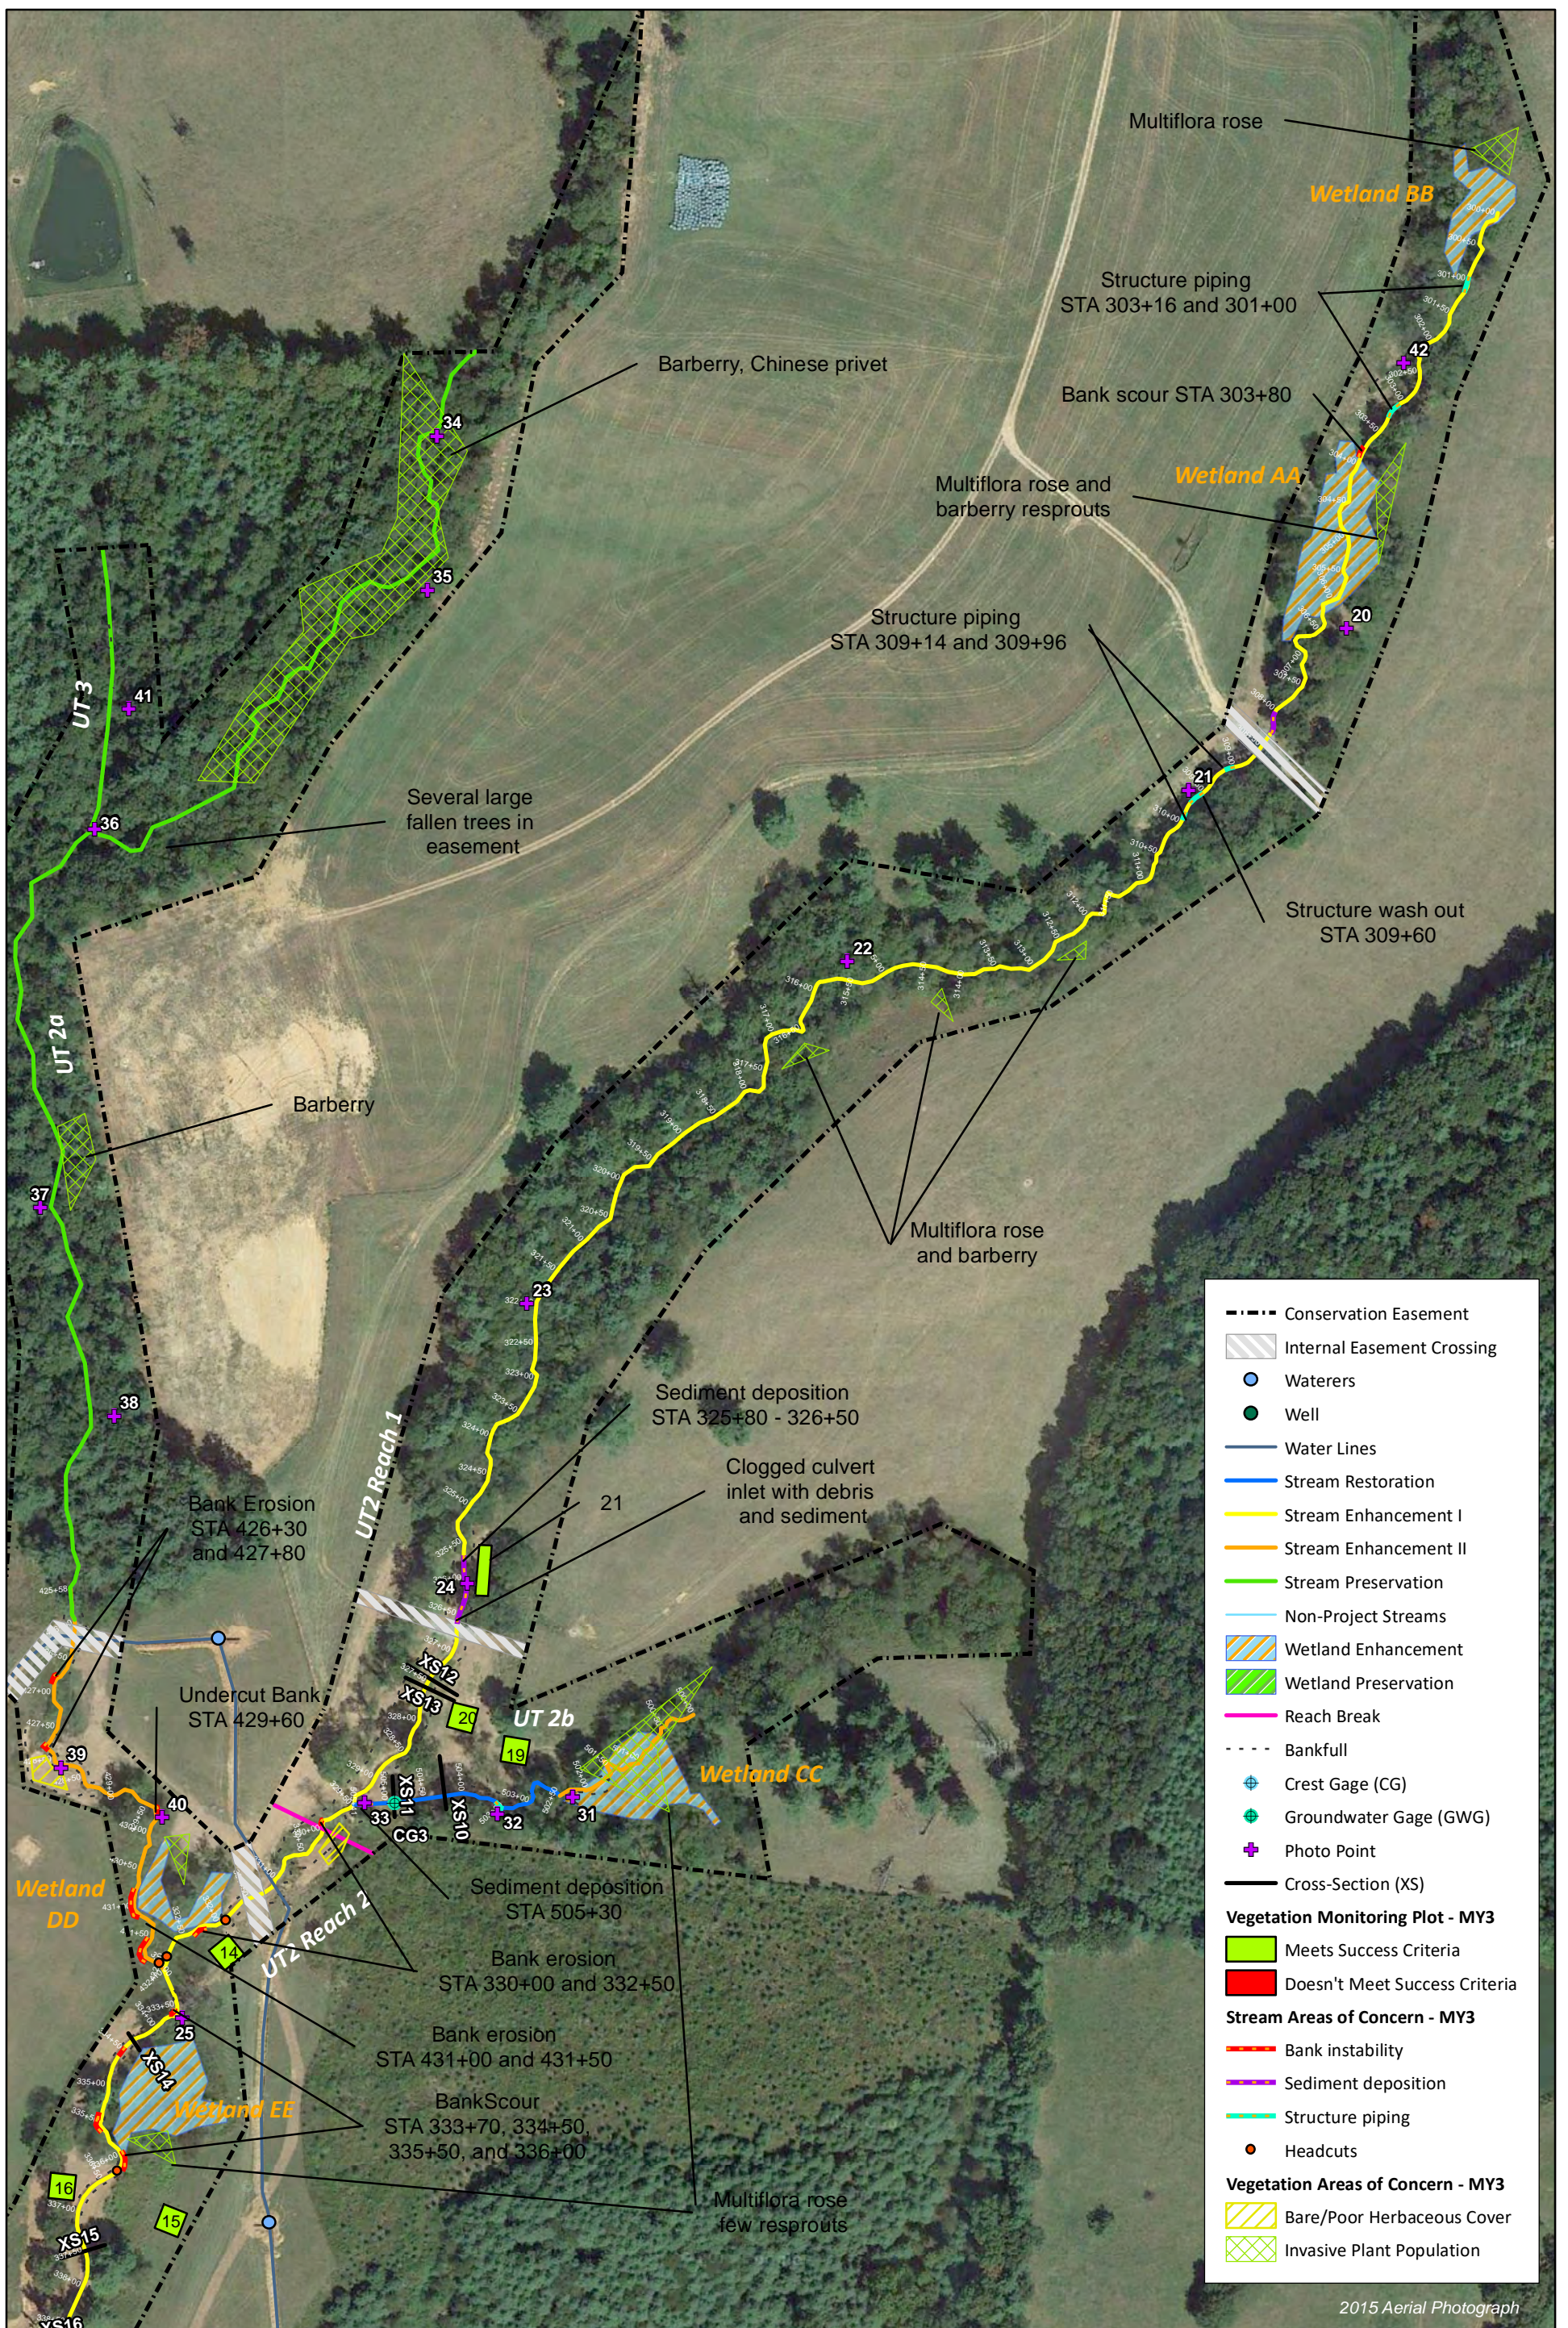
Figure 3.1 Current Condition Plan View Map (Sheet 1 of 2)
 Little Pine Creek III Stream & Wetland Restoration Project
 DMS Project No. 94903
 Monitoring Year 3 - 2018
 Alleghany County, NC

Stream areas of concern included instances of structure piping, bank scour, sediment deposition, and clogged culverts at internal easement crossings. On Little Pine Creek, stream areas of concern noted in MY2 persist into MY3 with new or expanded isolated areas of bank scour (STA 100+80, 121+50, 131+20, 131+60, and 132+50) observed after the storm events of fall 2018. Large established trees are undermined by bank scour along the enhancement II section of Little Pine Creek Reach 2b.

Along UT1, several headcuts have formed as the channel slope increases above the culvert crossing. In MY2, sediment aggradation was observed on approximately 192 linear feet of UT1 downstream of the culvert crossing (STA 200+36) and beyond the two installed boulder sills (STA 202+28). Adaptive management was performed in March 2018 along UT1 to improve stream function. In future years, as woody vegetation becomes more established and shades out the herbaceous cover, the baseflow is expected to become stronger and transport the accumulated fine sediment in the reach. Currently, a defined baseflow channel is still present and this area will continue to be monitored for additional sediment aggradation in future years.

Structure piping that was noted on UT2 Reach 1 Upper in MY2 persists into MY3 with an additional structure failure at approximately STA 309+60. Furthermore, sediment deposition is noted above both of the culvert crossings on UT2 Reach 1 (Upper and Lower). On UT2 Reach 2, new areas of bank instability (STA 334+50, 335+50, 336+00) and additional headcuts (STA 331+90 and 336+30) were observed in MY3 after the significant rainfall events of fall 2018. These rainfall events also caused significant aggradation at the bottom of UT2 Reach 2, thus directing sheet flow through the left floodplain above the culvert crossing.

Localized bank erosion is still apparent along UT2a (STA 427+80, 431+00) along the right outer bends of the channel. Just upstream of the confluence with UT2, UT2a continues to exhibit an area of high instability with vertical eroding right bank at the channel bend (STA 431+50). The sections of eroding banks on UT2a and UT2 are in enhancement I and enhancement II reaches, in areas where no bank work was performed. DMS has a repair design underway to address areas of stream instability along UT2a and UT2, including the formation of head-cuts, lateral stream migration, and excessive streambank erosion and are expected to occur in Spring 2019. These stream areas of concern are indicated in Table 6 and on Figure 3 in Appendix 2.
