MONITORING YEAR 4 ANNUAL REPORT

LITTLE PINE III STREAM AND WETLAND RESTORATION PROJECT

Alleghany County, NC

DMS Project Number 94903

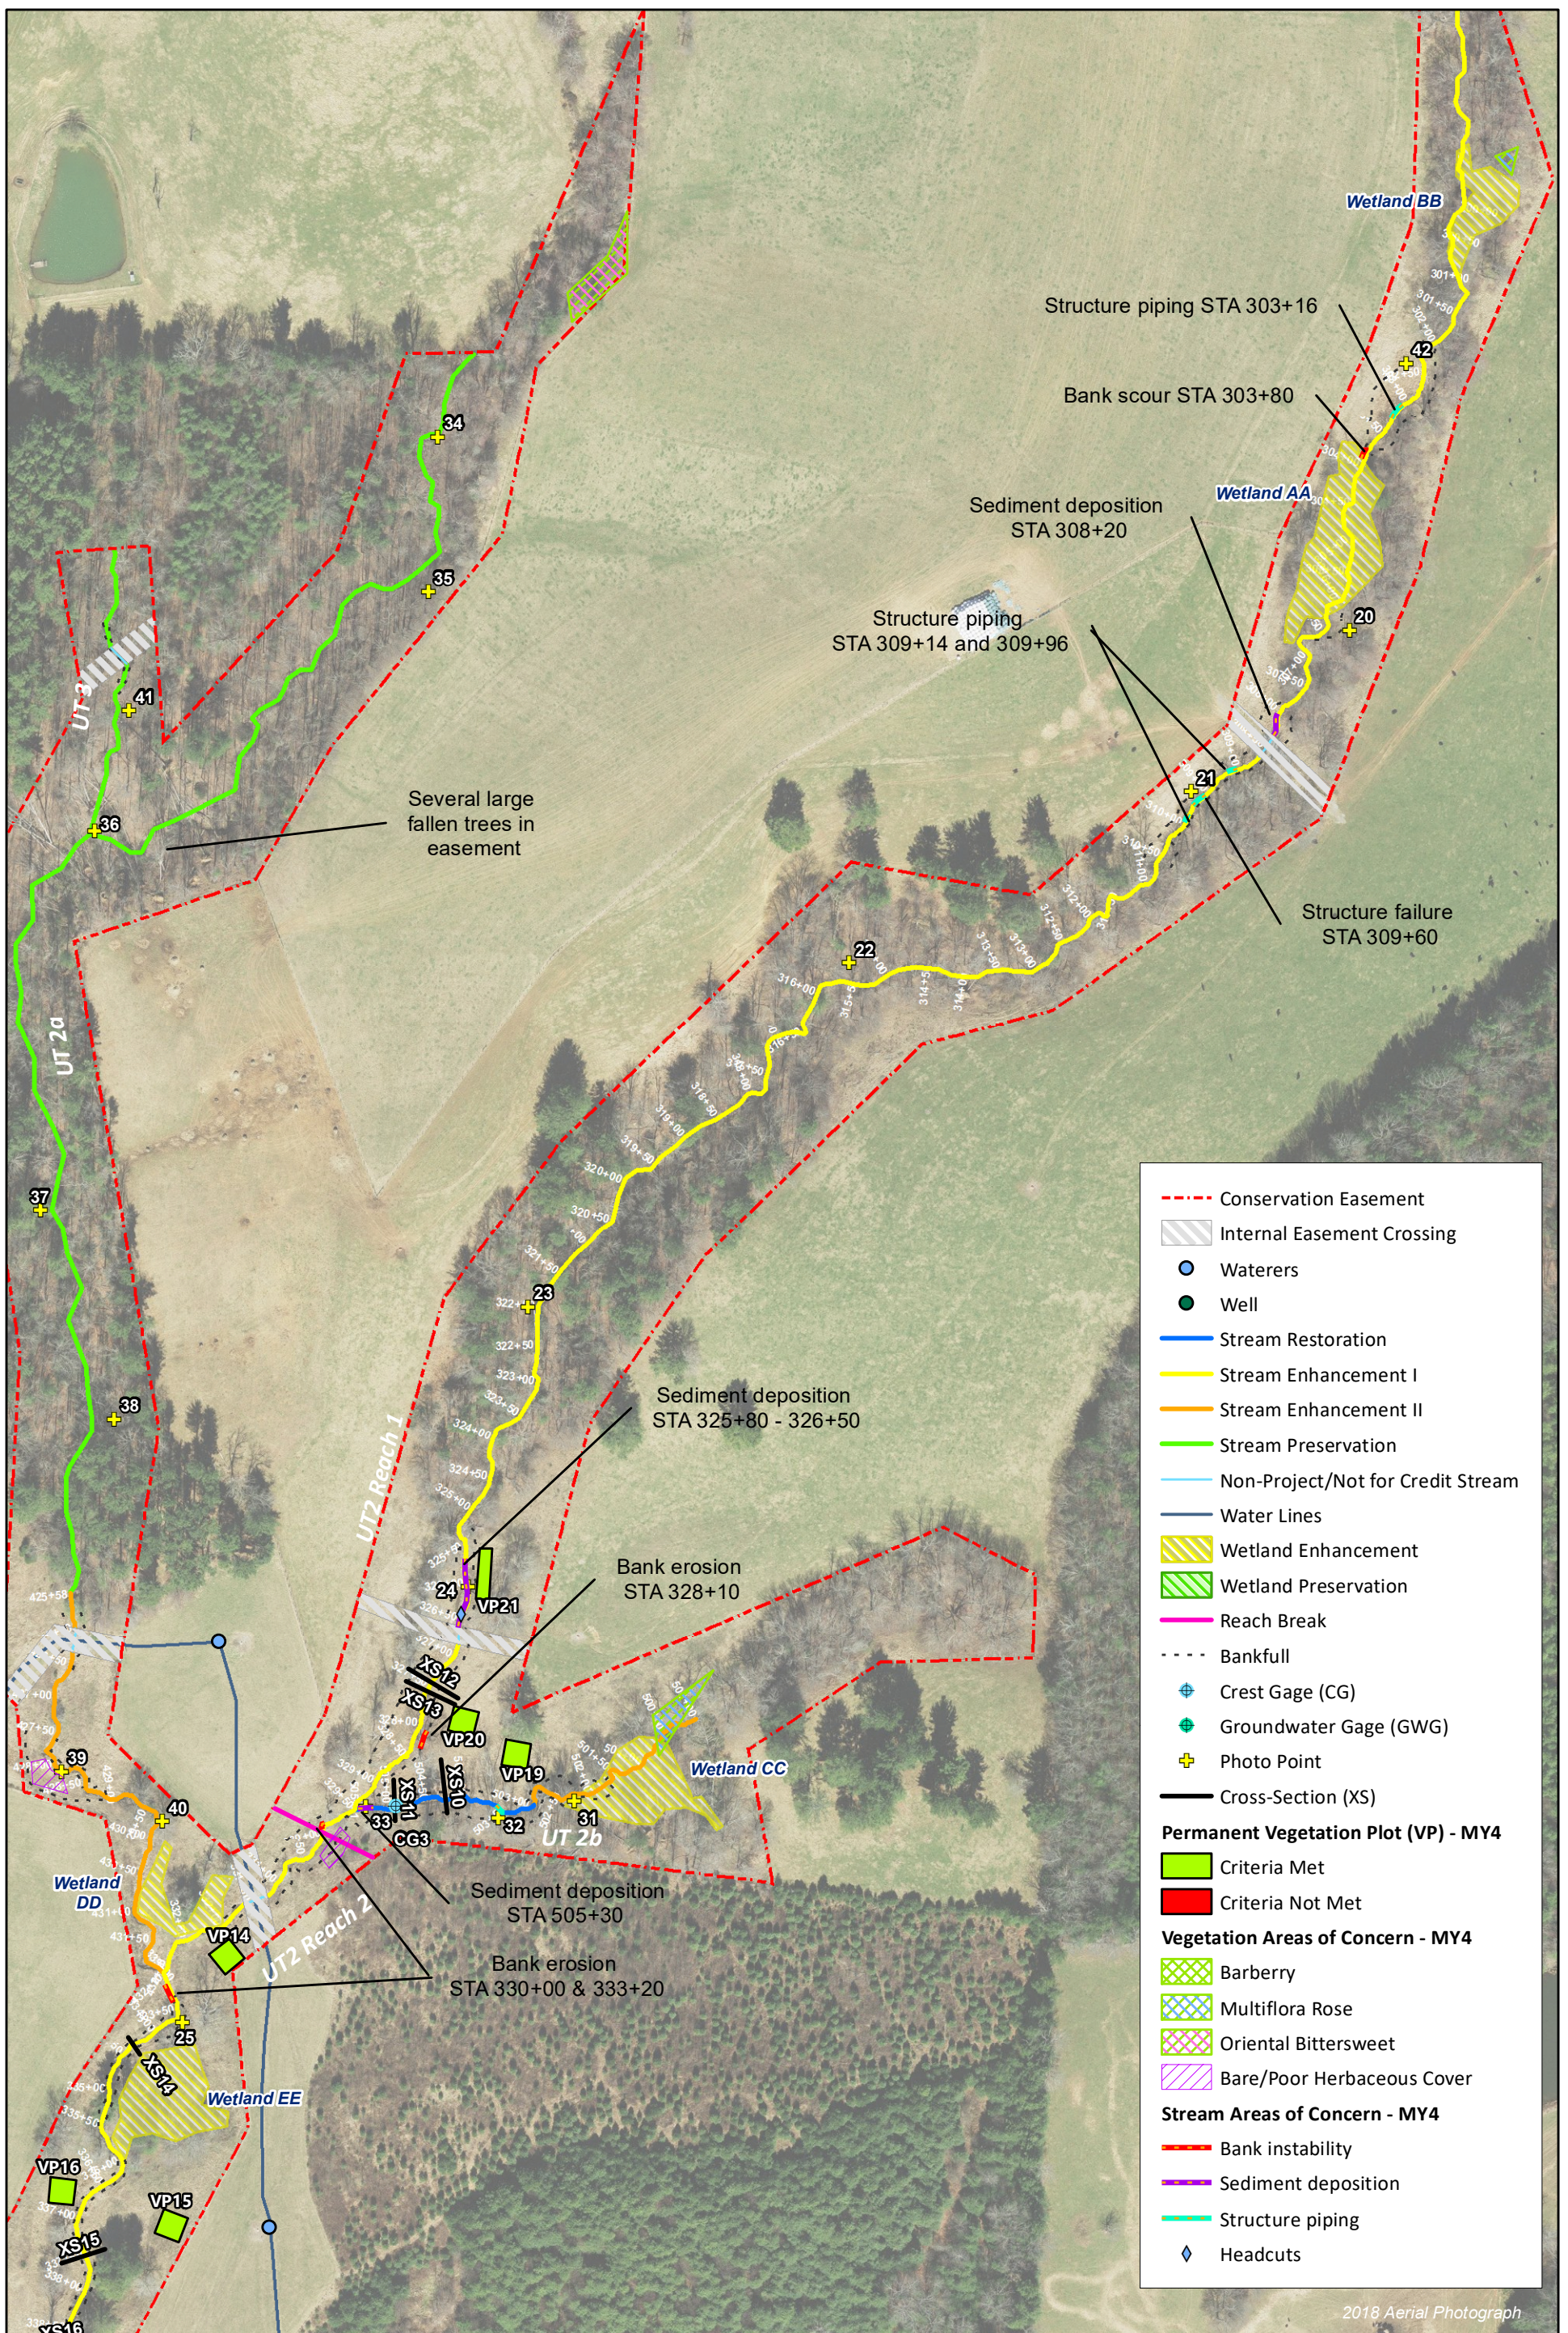
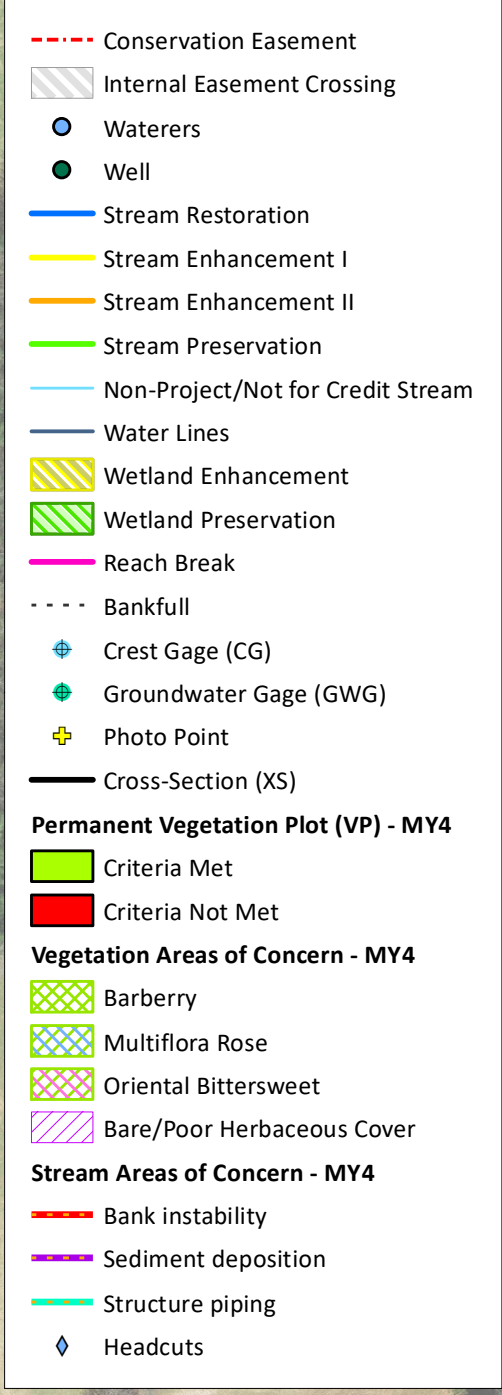
Figure 3.1 - Current Condition Plan View Map (Sheet 1)
Little Pine Creek III Stream & Wetland Restoration Project
DMS Project No. 94903
Monitoring Year 4 - 2019
Alleghany County, NC

Stream areas of concern included instances of structure piping, bank scour, sediment deposition, and clogged culverts at internal easement crossings. On Little Pine Creek, stream areas of concern noted in MY3 persist into MY4 with new or expanded areas of bank scour (STA 100+80, 121+50, 131+20, 131+60, and 132+50) observed after the storm events of fall 2018. DMS has a repair plan scheduled in 2020 for Little Pine Creek Reach 1 (STA 100+43 to 101+75) and Reach 2a (STA 121+25 to 122+50) to address areas of bank instability.

Along UT1, several headcuts have formed as the channel slope increases above the culvert crossing. DMS has a repair plan to address headcuts upstream of the culvert crossing also in 2020. In MY2, sediment aggradation was observed on approximately 192 linear feet of UT1 downstream of the culvert crossing (STA 200+36) and beyond the two installed boulder sills (STA 202+28). In future years, as woody vegetation becomes more established and shades out the herbaceous cover, the baseflow is expected to become stronger and transport the accumulated fine sediment in the reach. Currently, a defined baseflow channel is still present downstream of the two installed boulder sills and this area will continue to be monitored for additional sediment aggradation in future years.

Structure piping that was first noted on UT2 Reach 1 Upper in MY2 persists into MY4 with an additional structure failure. Furthermore, sediment deposition is noted in MY4 above both of the culvert crossings on UT2 Reach 1 (Upper and Lower). Several areas of concern previously noted along UT2a and UT2 Reach 2 included formation of headcuts, lateral stream migration, and excessive streambank erosion. DMS contracted with a provider to complete repairs along UT2 Reach 2 (STA 332+25 to 339+15) and UT2a (STA 427+00 to 432+00) which included spot bank grading, geolift, grade control installation, and structure repairs. The repairs were completed in the fall 2019. Please refer to Appendix 2 for stream stability tables and CCPV Figures 3.0-3.2.

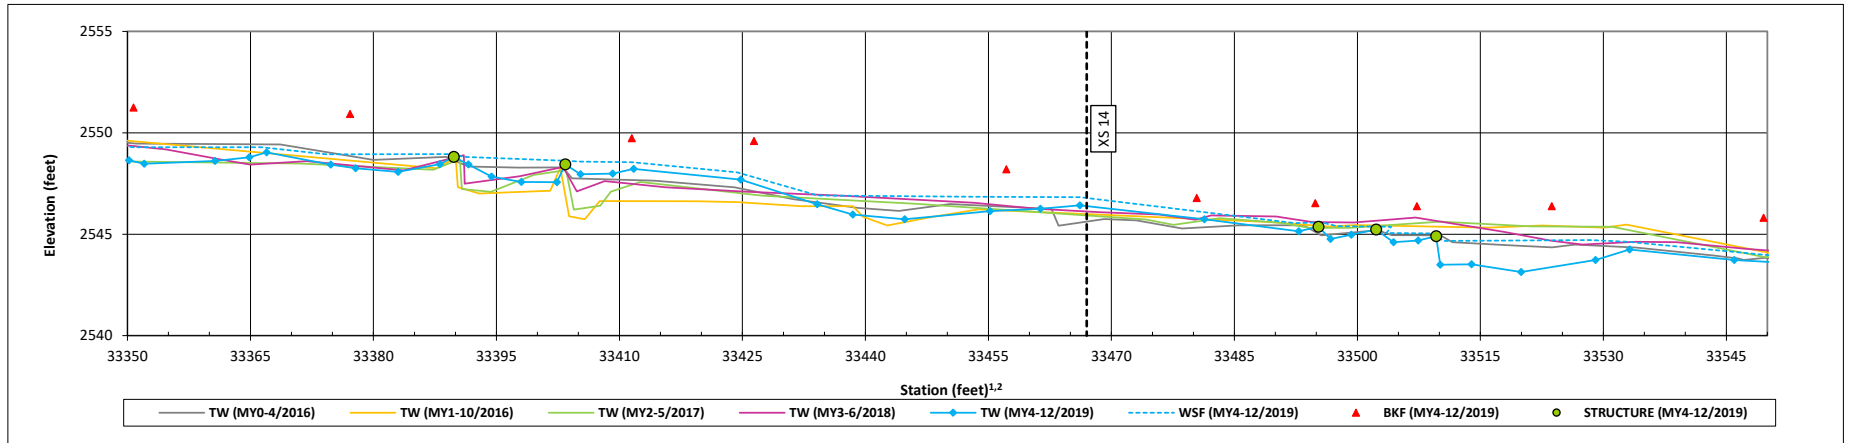
UT2 Reach 2 (STA 330+00 - 343+18)

² Stream repairs completed in September 2019 on UT2 Reach 2 STA 332+25 to 339+15.

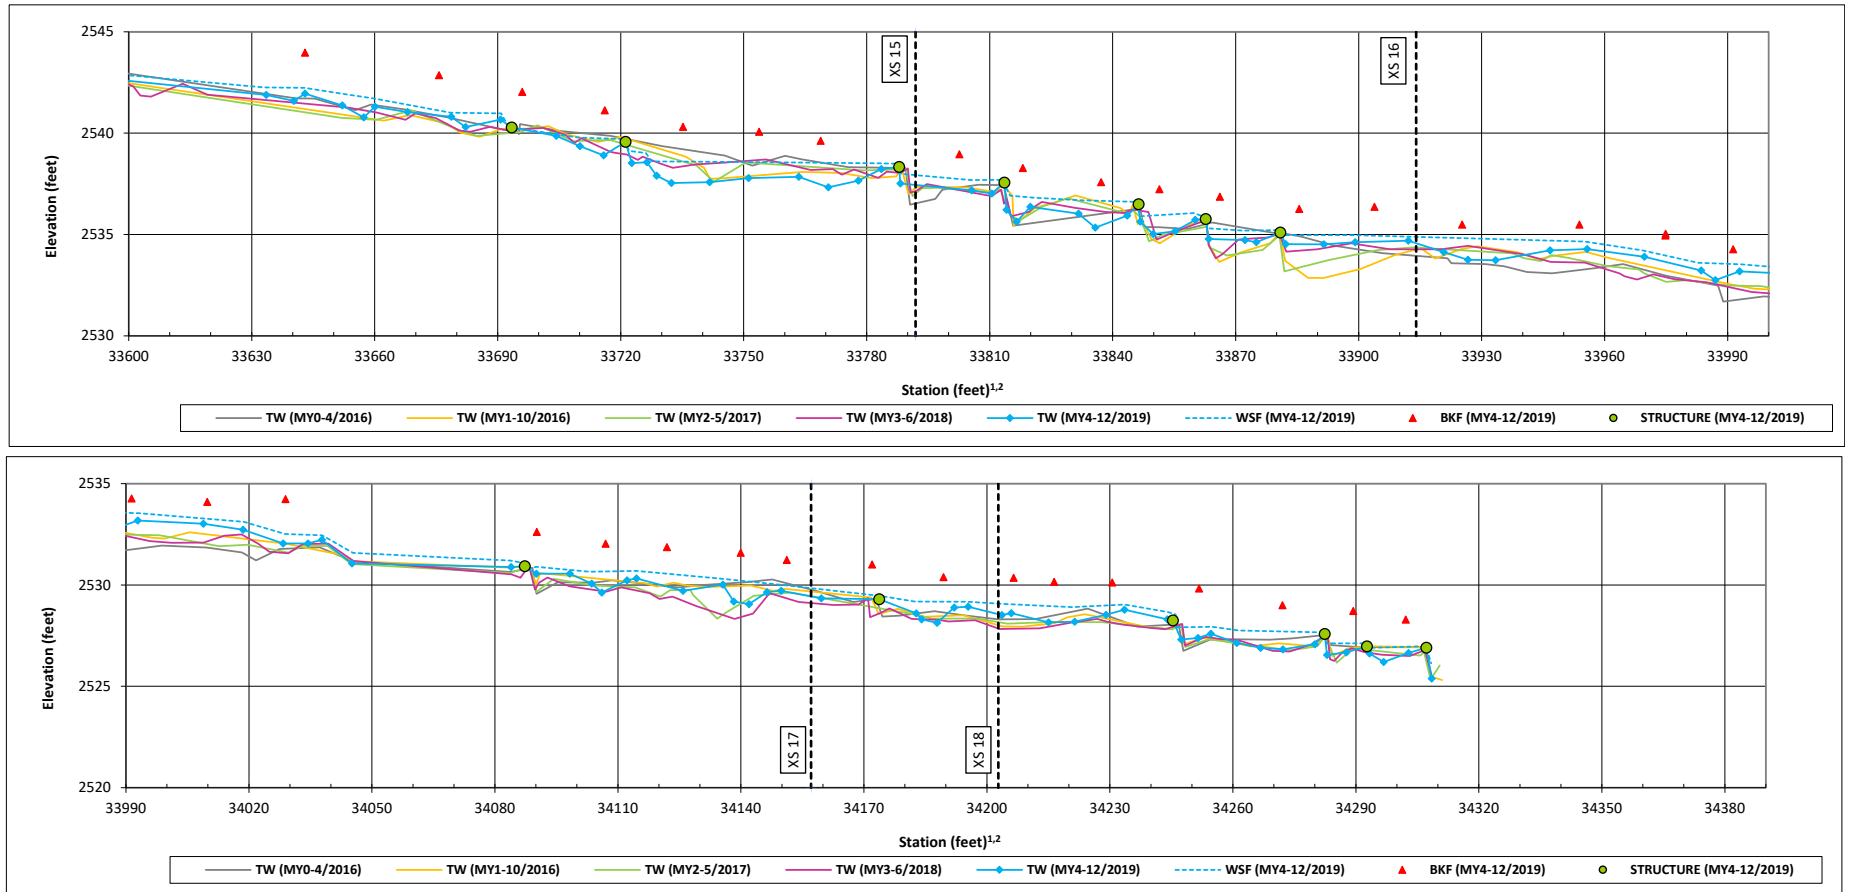
UT2 Reach 2 (STA 330+00 - 343+18)

² Stream repairs completed in September 2019 on UT2 Reach 2 STA 332+25 to 339+15.

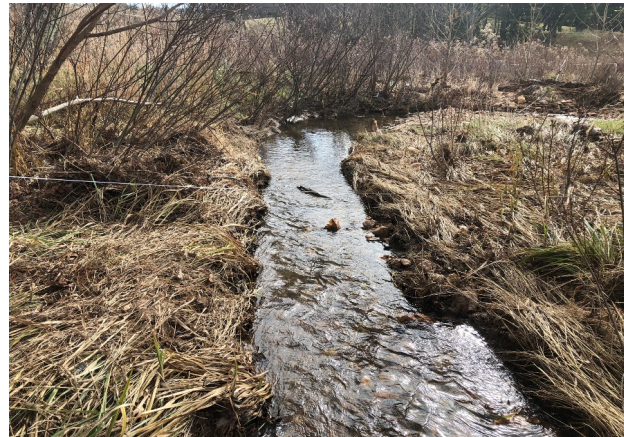
View Downstream

Stream repairs completed in September 2019
