MONITORING YEAR 5 ANNUAL REPORT

LITTLE PINE III STREAM AND WETLAND RESTORATION PROJECT

Alleghany County, NC

DMS Project Number 94903

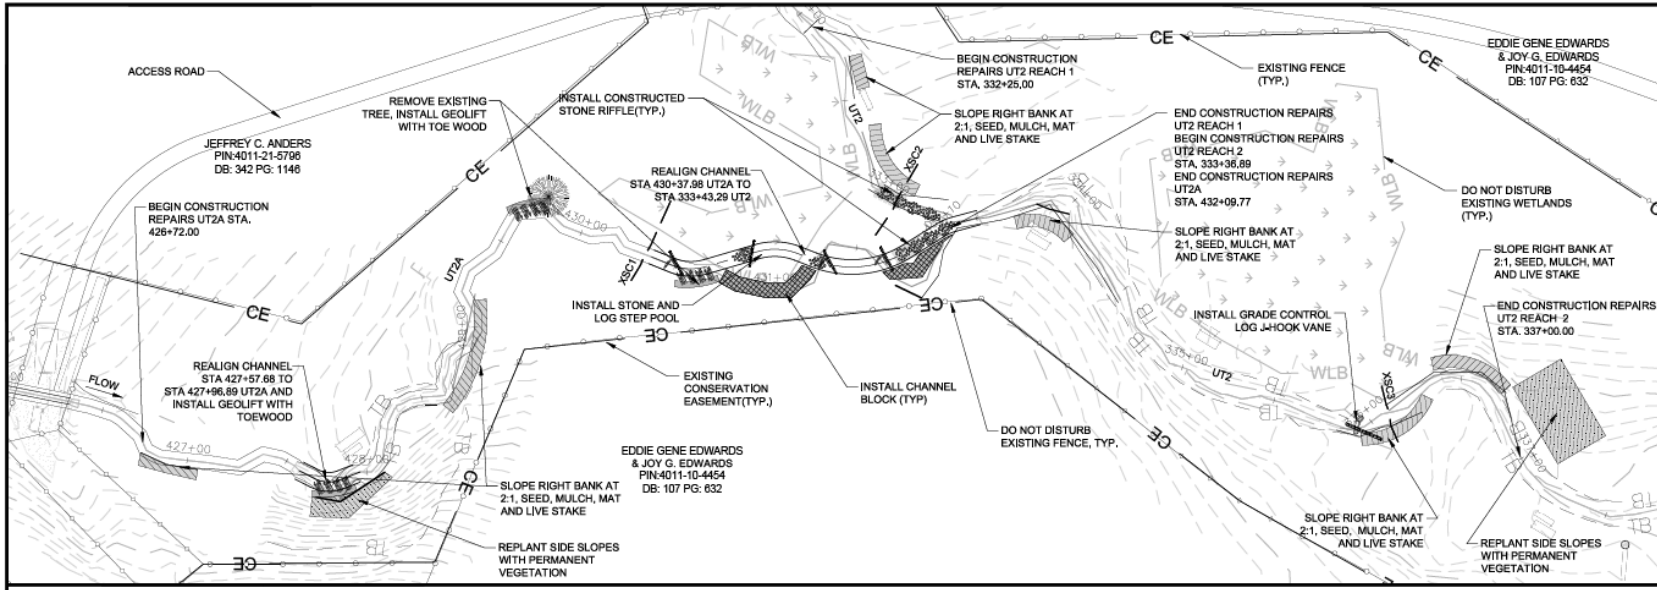
Phase 1 Stream Repair Design - UT2 / UT2A (September-October 2019)

Some structure piping that was previously noted along UT2 Reach 1 Upper persists into MY5 with an additional area of stream downcutting near STA 310+50. Furthermore, sediment deposition persists into MY5 above both culvert crossings on UT2 Reach 1 (Upper and Lower). In the fall 2019, DMS completed a plan to complete repairs along UT2 Reach 2 (STA 332+25 to 339+15) and UT2a (STA 427+00 to 432+00) which included spot bank grading, geolift, grade control installation, and structure repairs. Overall, the repair areas appear to be performing well. A few areas of bank scour and sediment deposition persist along UT2 but seem minor in severity. Please refer to Appendix 2 for stream stability tables and CCPV Figures 3.0-3.2.

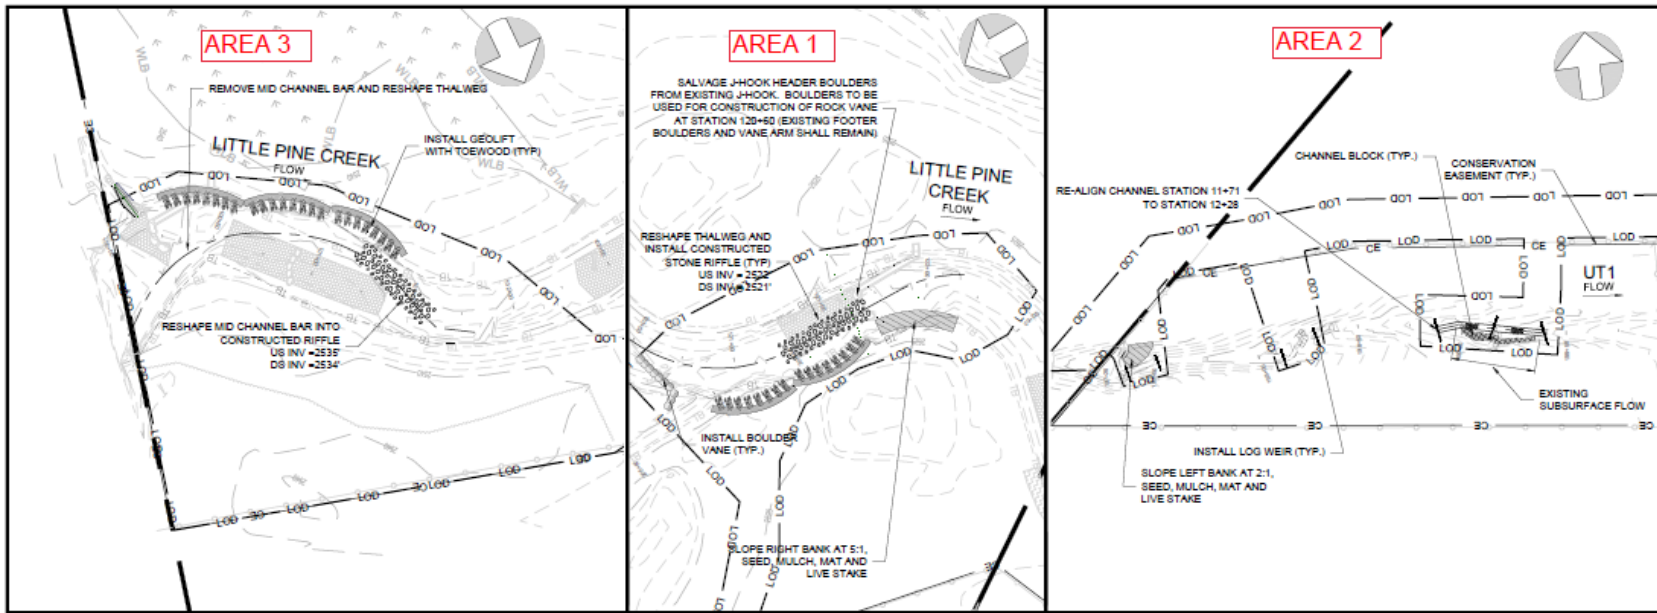
Phase 2 Stream Repair Design - Little Pine Creek / UT1 (September-October 2020)

Along Little Pine Creek, DMS completed a repair plan in fall 2020 for Reach 1 (STA 100+43 to 101+75) and Reach 2a (STA 121+25 to 122+50) to address areas of stream instability. Repair activities included installing constructed riffles, geolifts, and repairing rock vane structures. The remaining areas of bank scour along the restored reaches of Little Pine Creek (STA 108+00, 118+00, 123+00, 124+75, and 128+00) appear isolated and minor in severity.

The 2020 repair plan also addressed the formation of headcuts and bank erosion along UT1 (STA 10+00 to 12+28) by regrading banks and installing structures to improve grade control in the stream. In MY2, sediment aggradation was observed on approximately 192 linear feet of UT1 downstream of the culvert crossing (STA 200+36) and beyond the two installed boulder sills (STA 202+28). Currently, a defined baseflow channel is still present downstream of the two installed boulder sills and woody vegetation established along the banks is helping shade out the herbaceous cover, thus transporting more accumulated fine sediment in the reach.

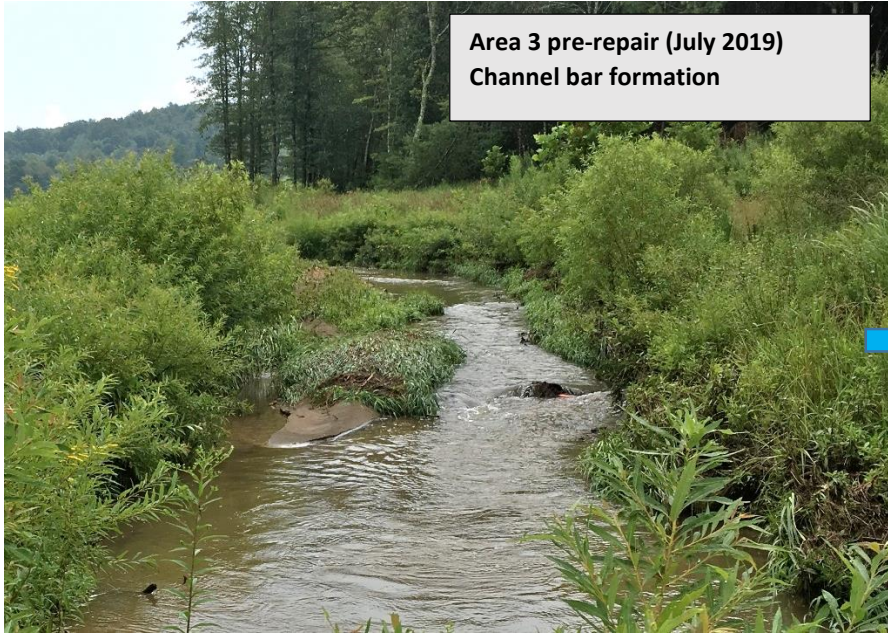
Area 3 pre-repair (July 2019)
Channel bar formation

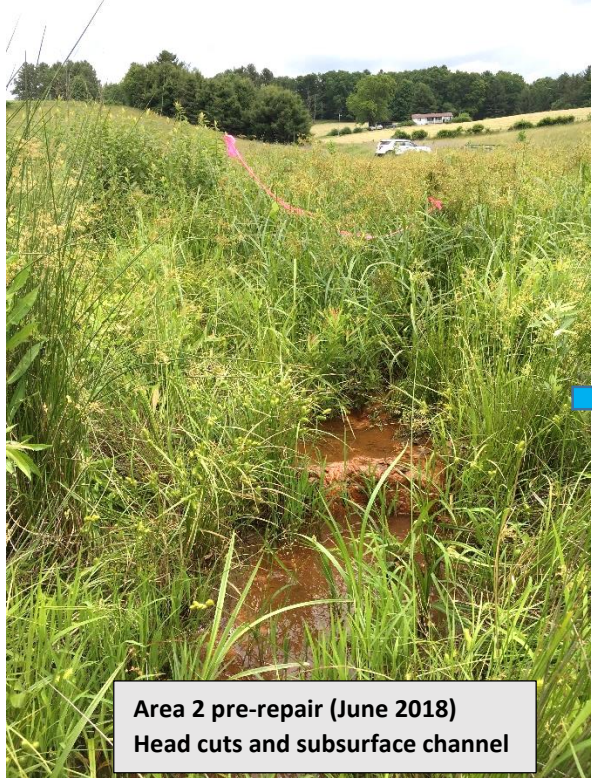
Area 2 pre-repair (June 2018)
Head cuts and subsurface channel
