# MONITORING YEAR 6 ANNUAL REPORT

## LITTLE PINE III STREAM AND WETLAND RESTORATION PROJECT

Alleghany County, NC

DMS Project Number 94903

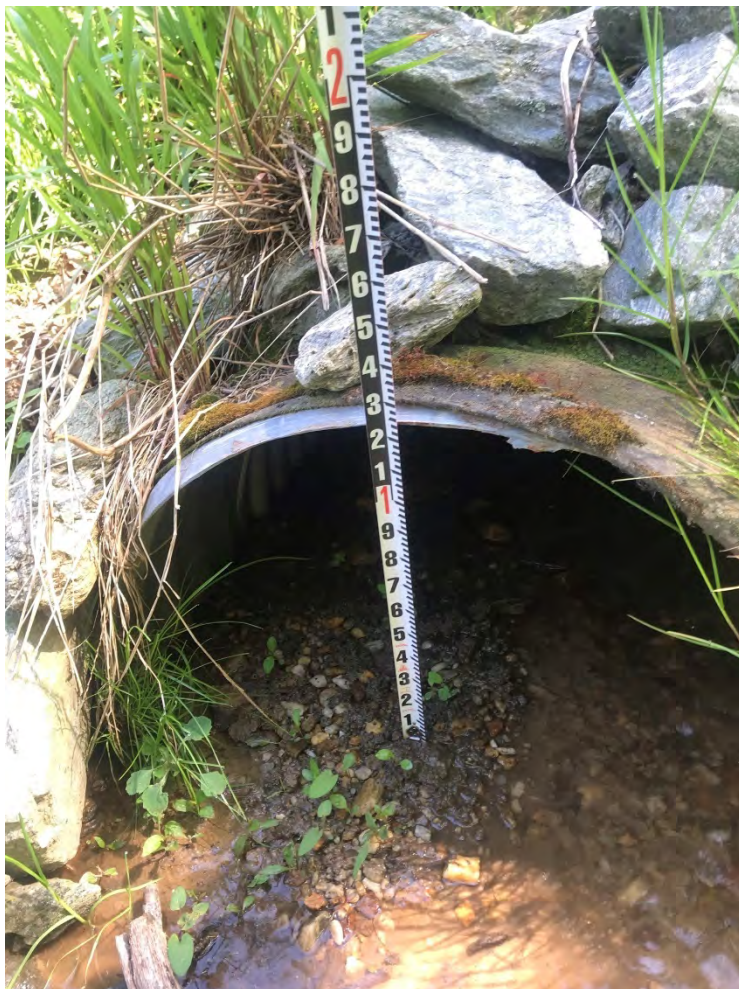
Culvert at Location #3

Based on hydraulic analysis of the culverts, both culverts are undersized for the 25-year storm. Replacement of the 30-inch culverts with 48-inch culverts will convey the 25-year discharge without overtopping the road. EPR will work with DMS to determine if installing a larger culvert or replacing the culvert crossing with a ford crossing is the best course of action. Bed and bank stabilization upstream and downstream of both crossings will be incorporated as needed and include grade control structures to step down the channel if required. Cross fencing will be repaired. Upstream of location #1 at approximate station 310+10 the streambed will be stabilized using in-stream structures and the banks will be graded, matted, seeded, mulched, and live staked.

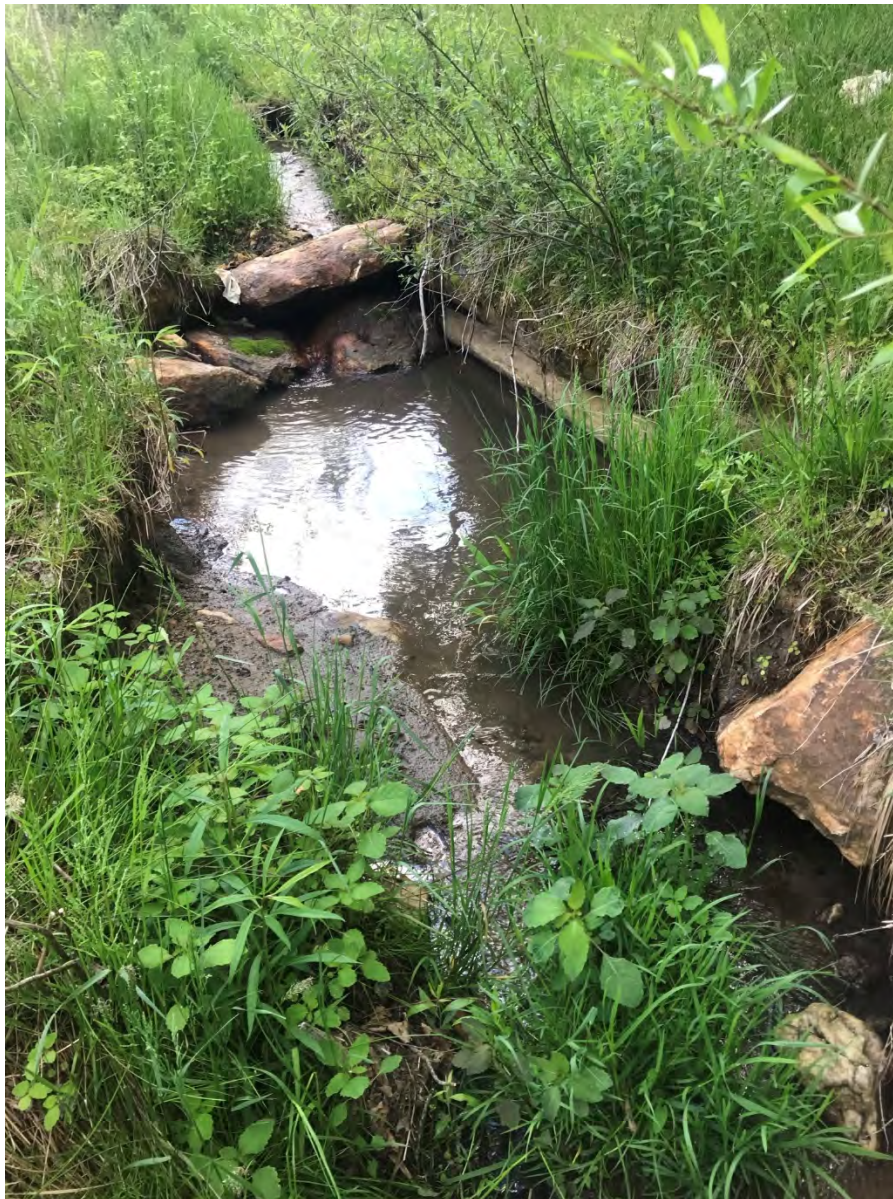
Piping structure and bank instability

EPR proposes to stabilize the bed instability by repairing or replacing the existing grade control structures. Structures will be repaired by excavating upstream and installing new filter fabric and bankfull to prevent piping or by rebuilding structures utilizing existing materials as much as possible. Banks will be graded to slopes of 3:1 or flatter, seeded, mulched, matted and live staked.

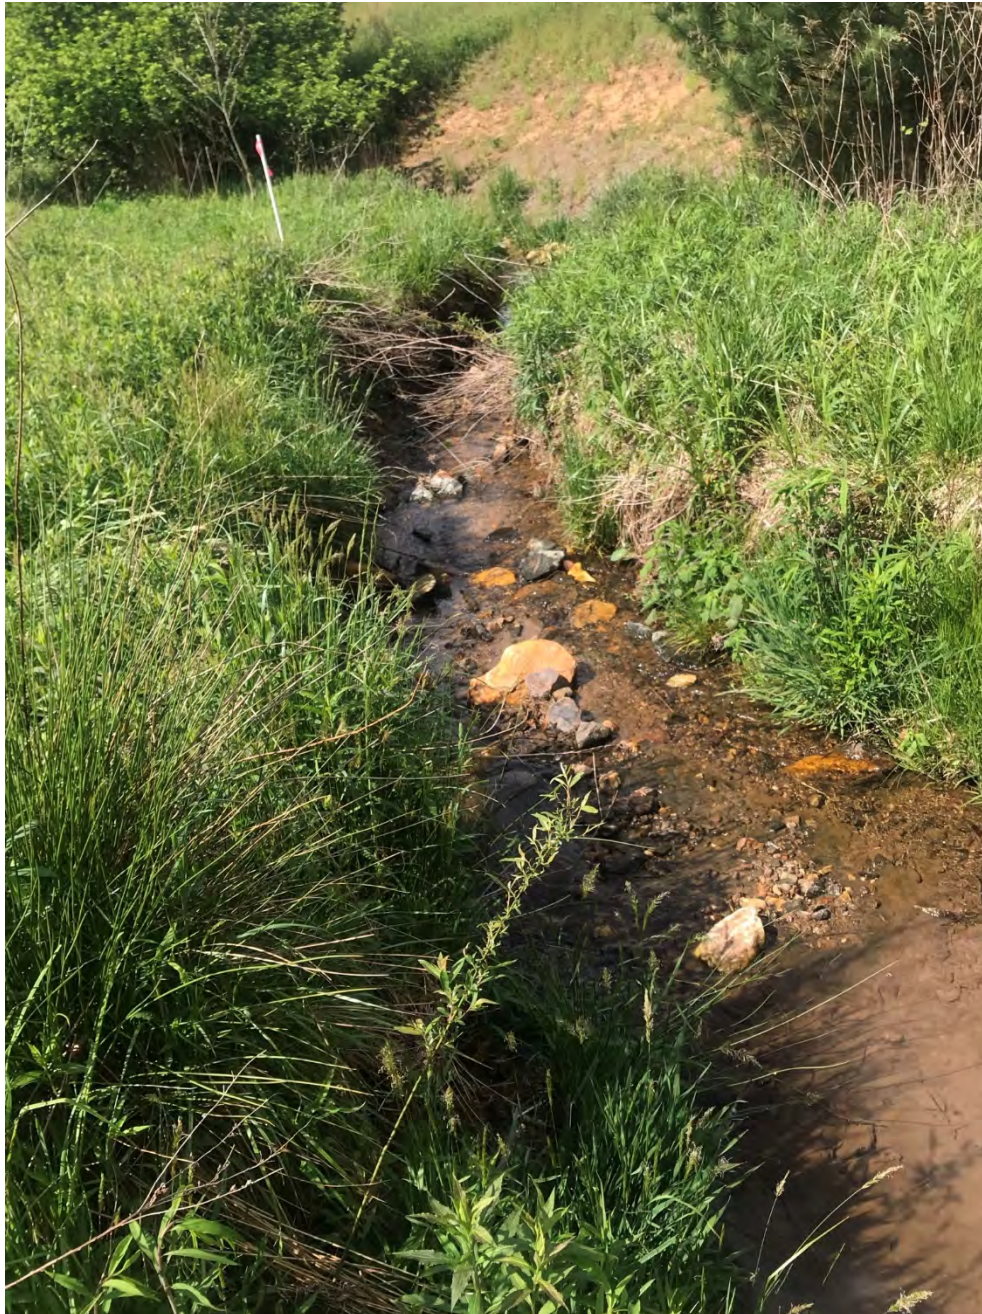
Bank erosion along UT2A

EPR proposes to stabilize stream banks utilizing bank grading, bio-engineering and potentially an in-stream structure to help protect the stream bank.

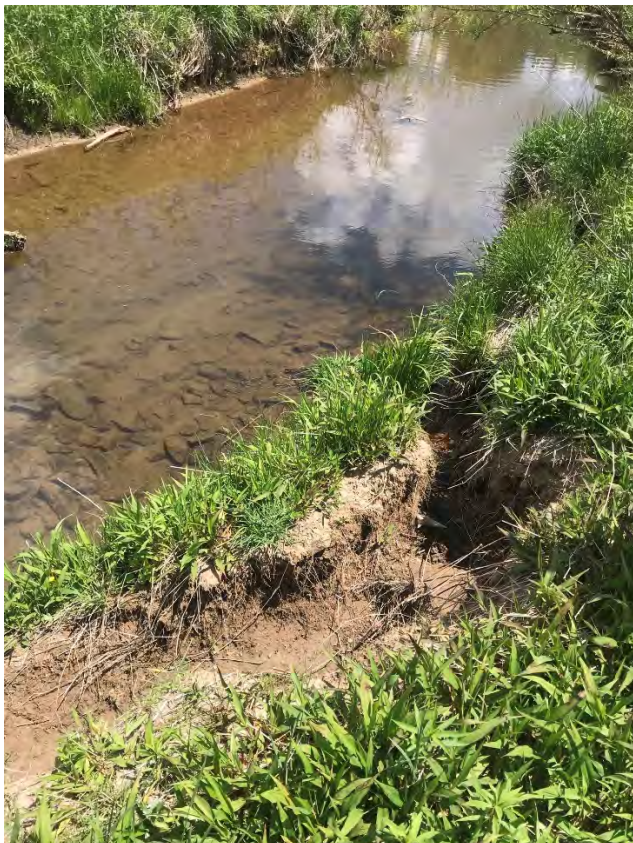
Bank slumping along Little Pine Creek  
**Little Pine Creek Repair Area:  
DMS Locations #10**

EPR proposes that areas suffering from bank erosion/slumping will be repaired and stabilized by a combination of grading and bioengineering with any seeps or overland flow being addressed with a stabilized outlet structure.

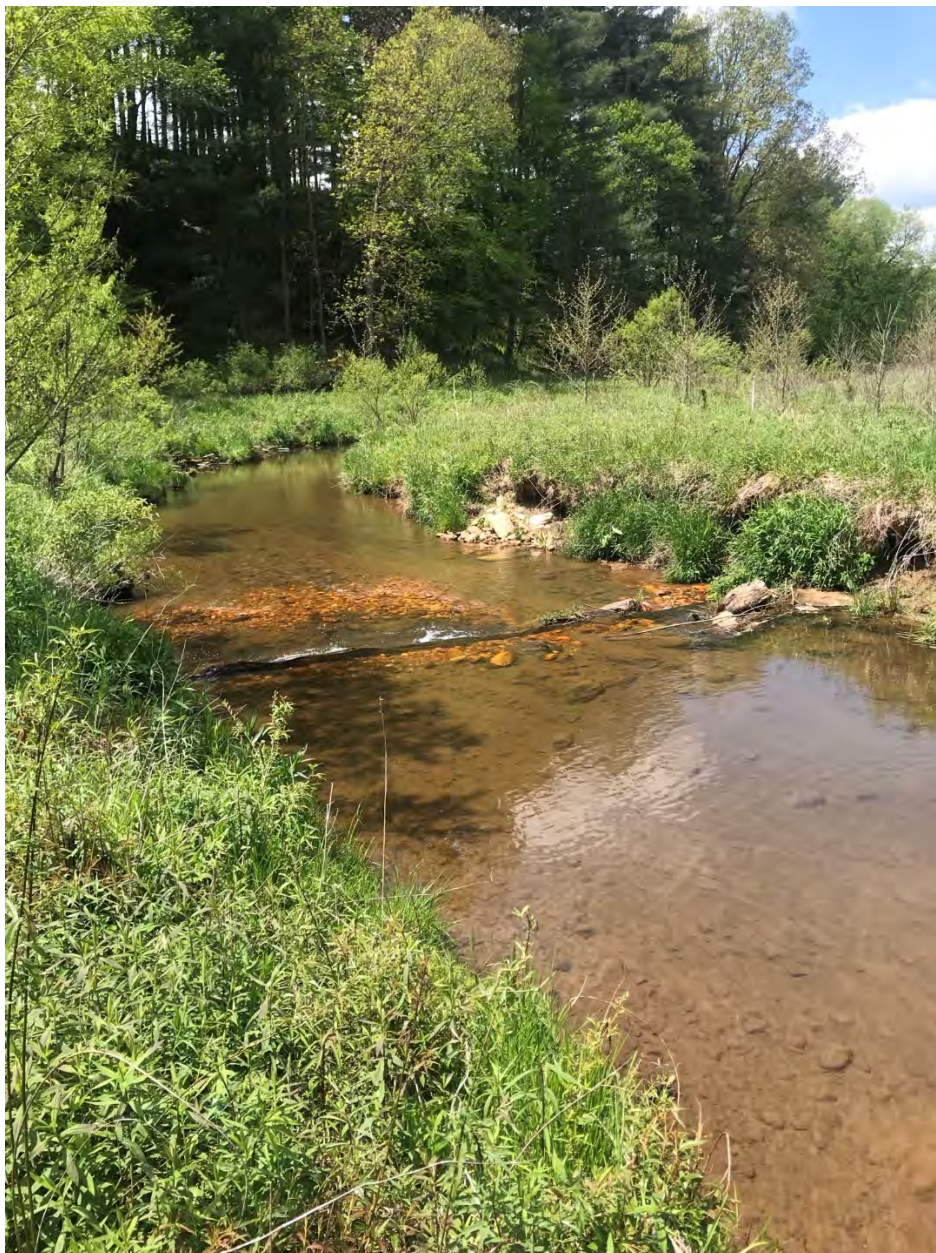
Bank erosion below log step structure on Little Pine Creek

These banks will be repaired and stabilized utilizing a combination of large stone and bioengineering. Geolifts utilizing live cuttings with a stone toe will be constructed in combination with the placement of some larger stone where needed.

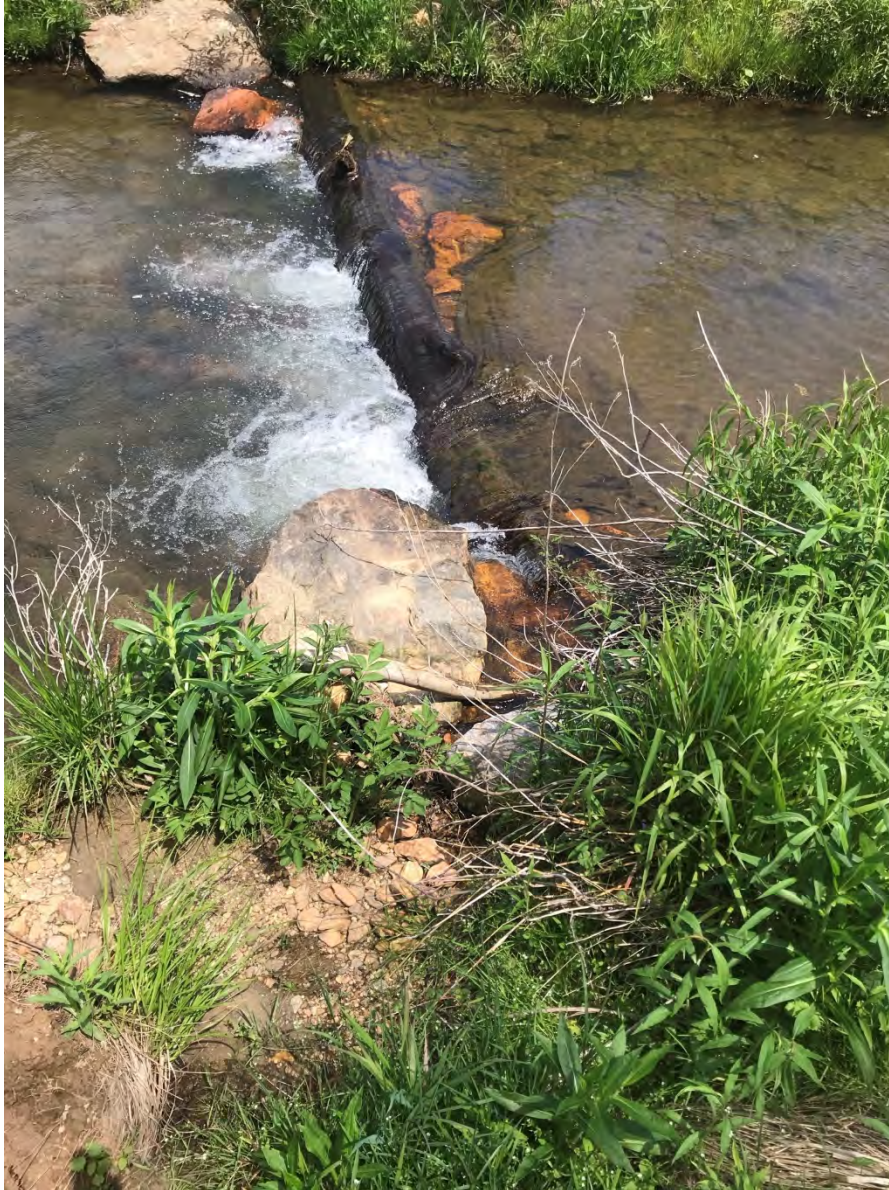
Bank erosion at log step on Little Pine Creek

This seep will be stabilized utilizing boulder step structures. This will also provide bank protection and prevent further bank erosion caused by this structure in this location.

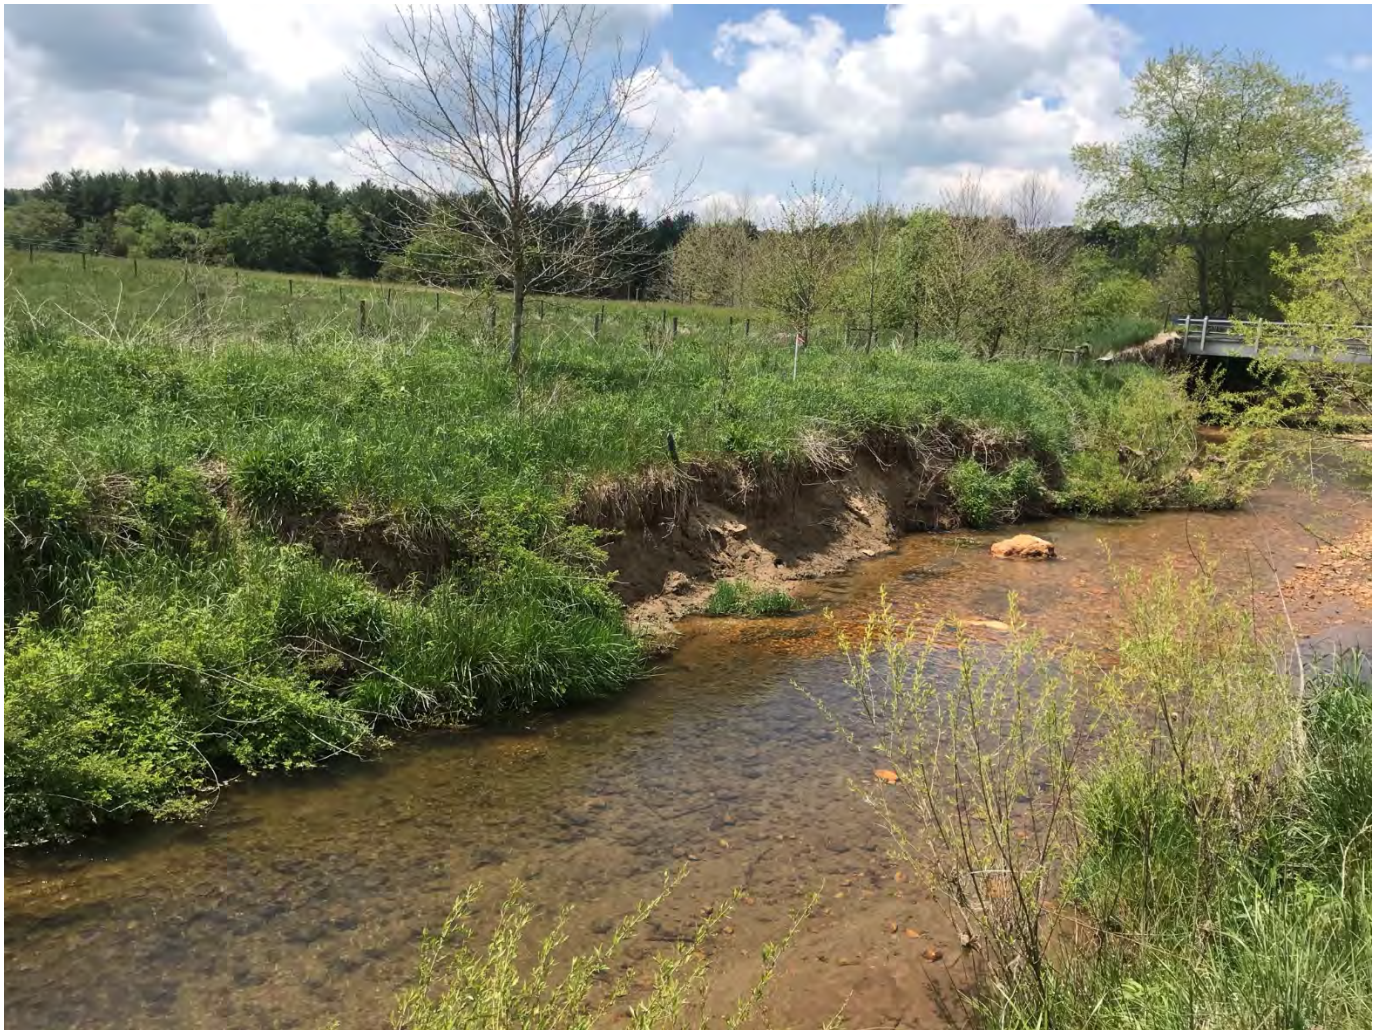
Little Pine Creek Repair Area: Bank erosion near station 131+00 (Location #13)

A combination of bank grading and bioengineering will be utilized to stabilize these streambanks. Live stakes will be replanted along both banks in areas that do not receive any additional bioengineering such as soil lifts.

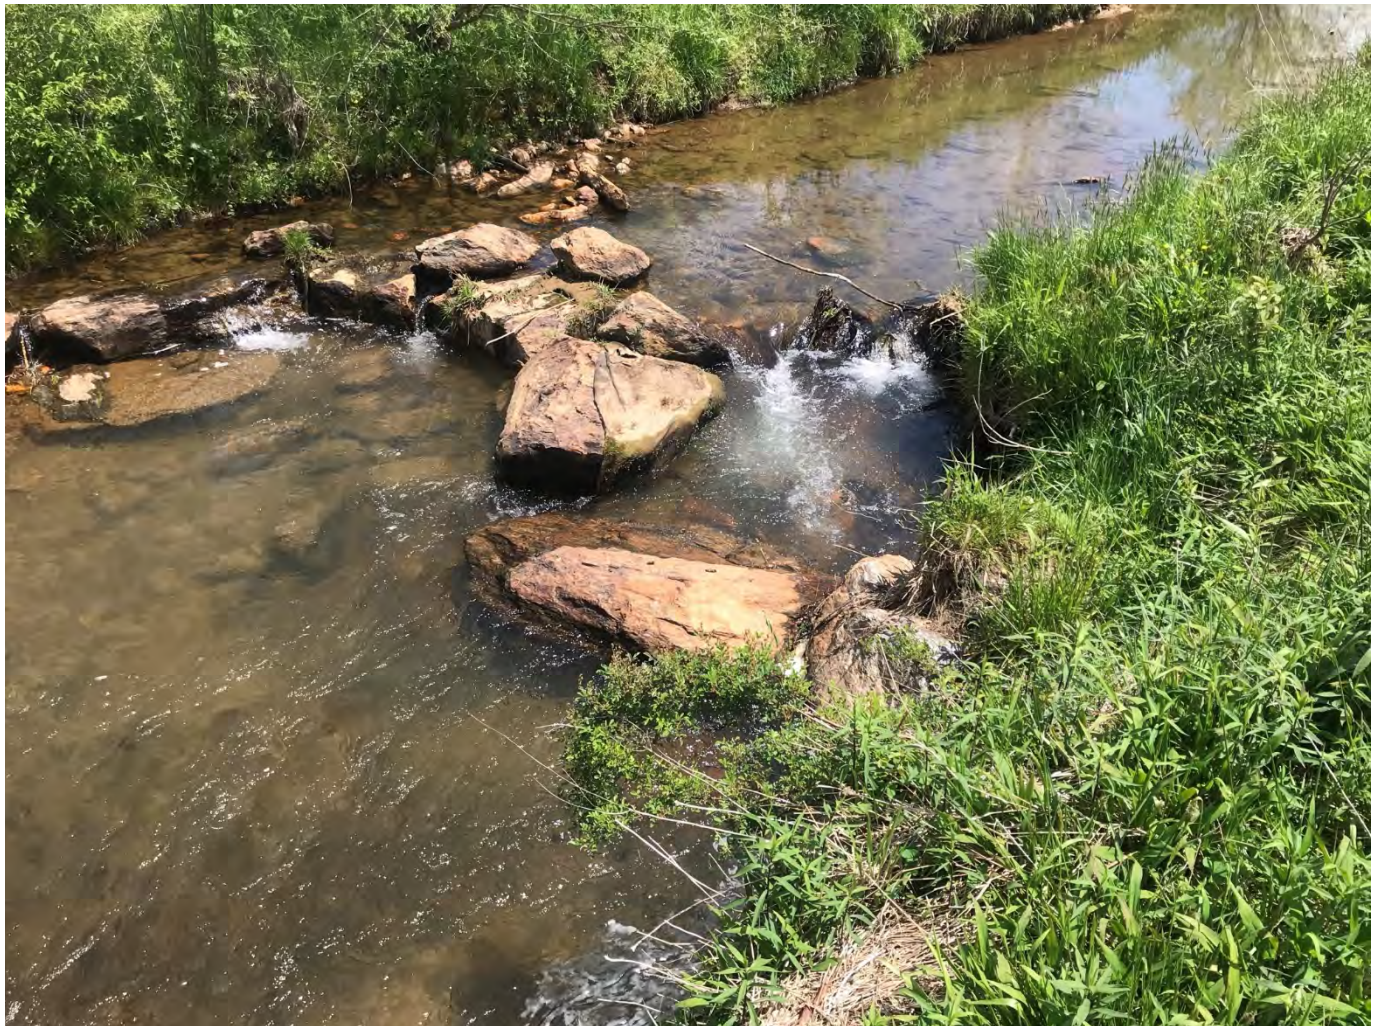
Failing J-hook structure along Little Pine Creek

EPR proposes to re-build the hook of this structure utilizing the existing boulders, new filter fabric and stone backfill and additional boulders for a longer sill. This will prevent future cutting around of this structure.
