Little River Farm Site – Stream Enhancement, Restoration, and Preservation Project Final Year 1 Monitoring Report (2010) Montgomery County, North Carolina

EEP Contract Number 000623

Data Collection Period: Nov. 2010

Submission Date: December 2010

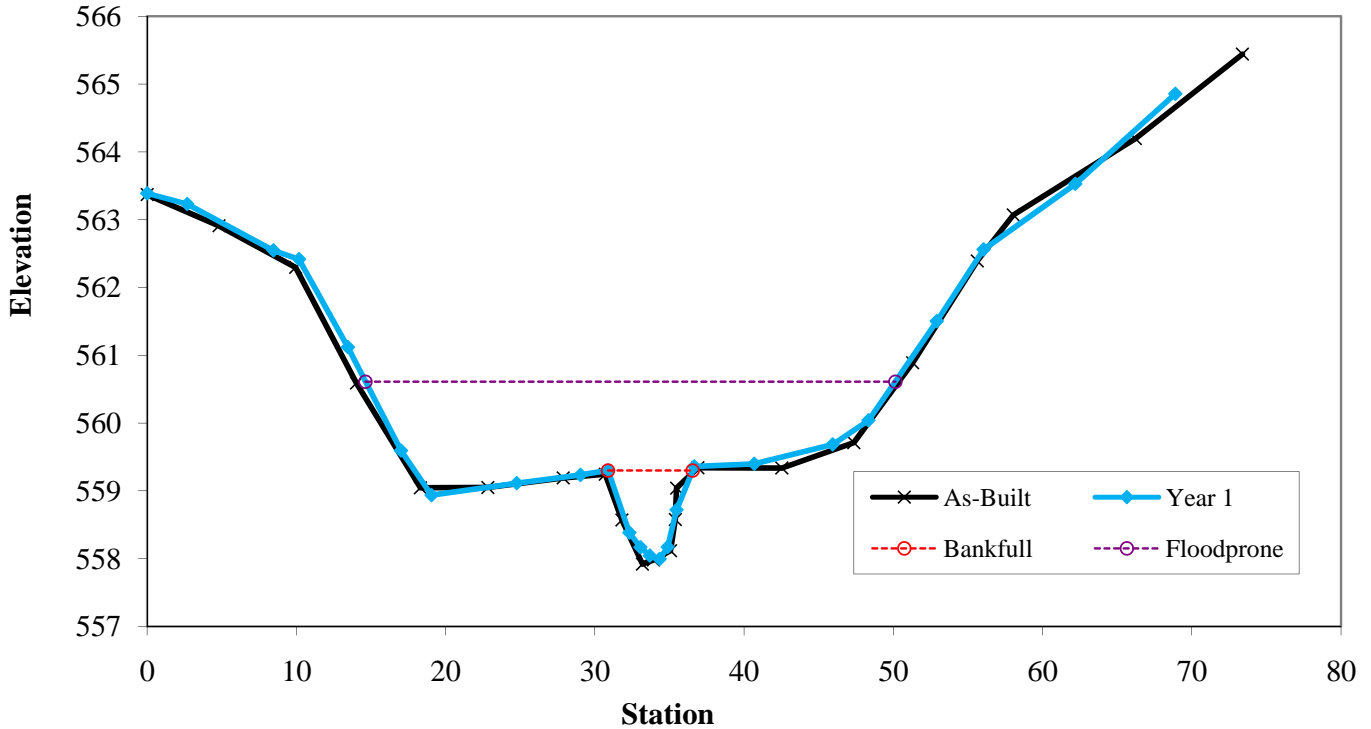
Permanent Cross-section X1

Riffle Cross-section X1 has aggraded slightly. The perceived aggradation reflects slight shifting of the coarse bed material rather than the deposition of fines. No deposition at these features was observed during Year 1 monitoring. Pool cross-section X2 has narrowed slightly within the channel bed. This type of adjustment is considered part of the normal fluvial process of the thalweg adjusting to flow velocities. Though both changes in channel geometry are normal, they will be monitored to assure the channel remains stable and functioning as designed.

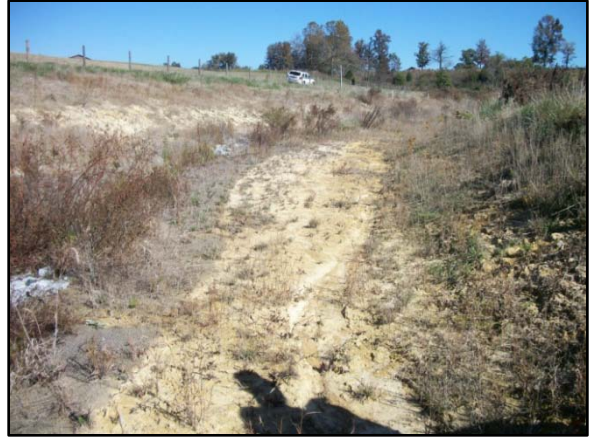
C.6-2. Station 10+00 – 13+50

Though bare and/or areas of sparse vegetation are common along the floodplain bench and slide slopes of UT4, only a few small erosion rills are present. Observations of bare and/or sparse vegetation were noted in the left floodplain at Stations 10+60 to 11+00, 11+25 to 12+00, and 12+50 to 14+50 and in the right floodplain at Stations 10+00 to 13+50 and 13+75 to 14+60.

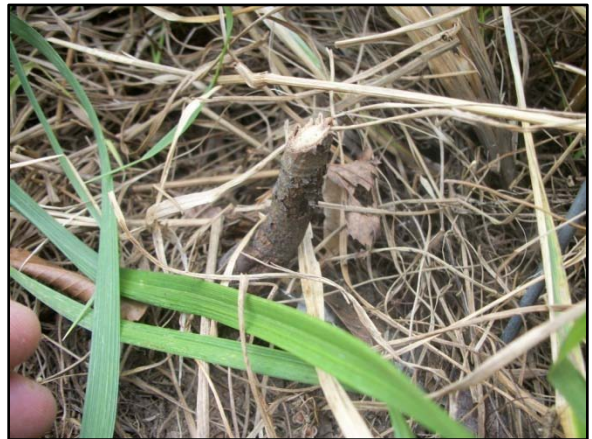
Vegetation plot counts were conducted in November 2010. During this assessment, damage to saplings in Veg Plot 13 by cutting was noted. In addition, evidence of herbicide overspray from an adjacent area outside of the easement was noted in Veg Plot 8. Neither incident should result in a significant loss of vegetation within the project area; however, these areas will be monitored to ensure their recovery and success. Supplemental planting may be required.

**Cut Tree – *Quercus nigra*
Veg Plot 13-8**

Overall the restored channels are functioning as designed with no structural areas of concern. The only areas within the project site with any potential issues of concern are the presence of a few small erosion rills located along the top of slope of portions of the floodplain bench along UT4 and the unintentional vandalism damage of a few saplings in Veg Plot 8 and 13. Reseeding along UT4 as well as some additional live stakes and bare root plants are scheduled for completion prior to the onset of the Year 2 growing season. Damaged saplings in Veg Plots 8 and 13 will be monitored and will be replaced if needed.

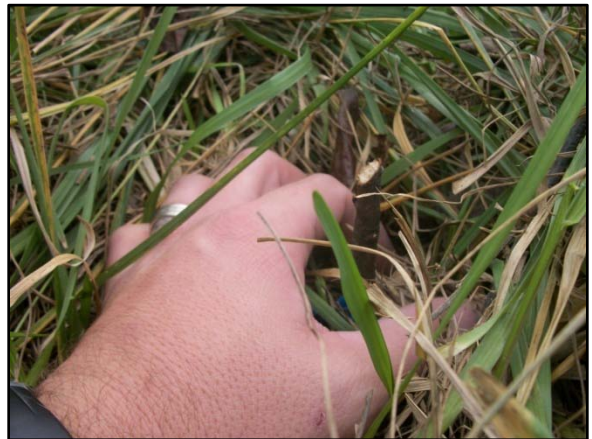
**Cut Tree – *Quercus michauxii*
Veg Plot 13-7**
