# Little River Farm Site – Stream Enhancement, Restoration, and Preservation Project Final Year 2 Monitoring Report (2011) Montgomery County, North Carolina

EEP Contract Number 000623

Data Collection Period: November – December 2011

Submission Date: March 2012

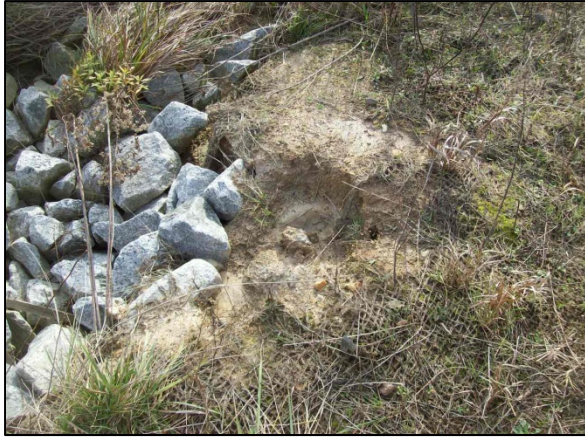
**C.6-1. Station 11+00**

During Year 2 monitoring, small pockets of erosion were noted on the left bank at Stations 11+55 to 11+65, 11+75 to 11+90, and 14+00 to 14+15 and on the right bank at Stations 11+00, 12+10 to 12+31, 12+70 to 12+80, 13+00 to 13+20, 13+65 to 13+80, 14+05 to 14+15, and 14+20 to 14+32. These areas appear to be the result of poorly established streambank vegetation.

Overall the restored channels are functioning as designed with no structural areas of concern. The only areas within the project site with any potential issues of concern are the pockets of streambank erosion along UT4. Reseeding in these areas as well as some additional live stakes and bare root plants are scheduled for completion prior to the onset of the Year 3 growing season. Damaged saplings in Veg Plots 3 and 4 will be monitored.
