# **Little River Farm Site – Stream Enhancement, Restoration, and Preservation Project Final Year 3 Monitoring Report (2012) Montgomery County, North Carolina**

**EEP Project ID #92759/EEP Contract #000623**

Data Collection Period: September 2012

Submission Date: March 2013

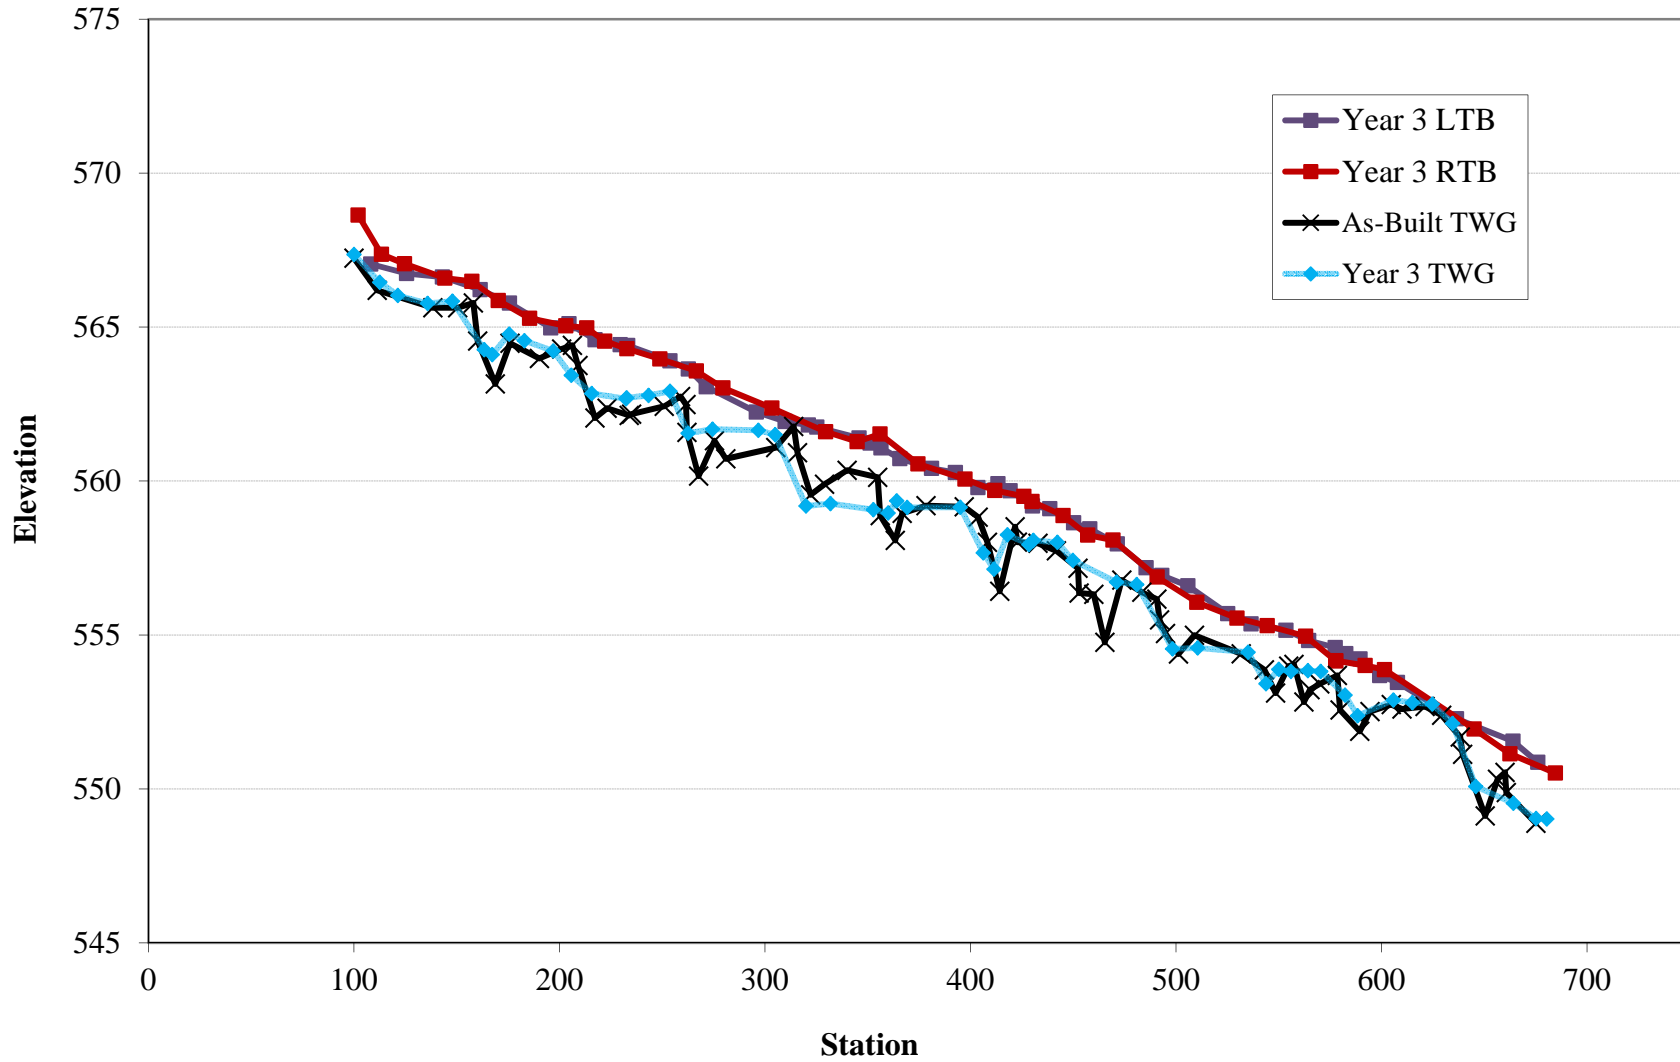
## Little River Farm Site - UT4 Profile Year 3 Monitoring

When compared to the As-built profile data, pools at stations 11+70, 13+50, and 15+45 appear slightly aggraded, while the riffle at station 12+25 has degraded. Both aggradation and degradation seem to correspond to areas along the reach where stream bank erosion is evident. Though the channel was designed to transport sediment pulses throughout the system, the lack of adequate precipitation in the past three years have exacerbated conditions conducive to erosion, as well as, to flows inadequate to sufficiently transport sediment as designed.

Though the Year 3 survey and field assessment did not identify areas of significant instability along UT4, the channel will require maintenance activities to be conducted to stabilize stream banks and ensure the stability of the channel's grade control. It is anticipated that channel stabilization will allow pools that are currently filling to reform through scour and transport when precipitation levels return to more normal conditions; therefore, ensuring a stable substrate.

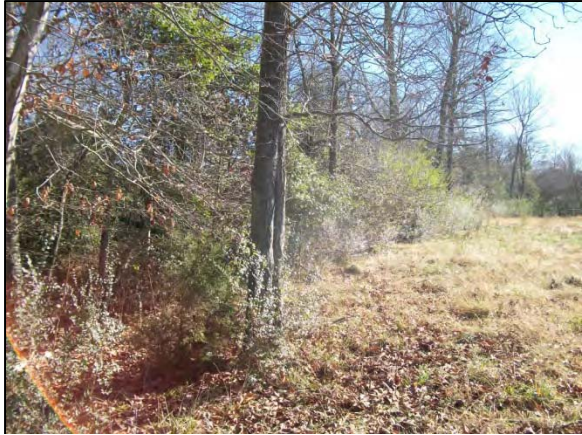
Other areas of concern were noted along UT1, UT3, the mainstem of Little River and its confluence with UT2. These areas were identified to have small established populations of *Ligustrum sinense* (Chinese privet), *Ipomoea eriocarpa* (morning glory), and *Rosa multiflora* (multi-flora rose) adjacent to and/or along their stream banks. Though present, these species are not dominant in any location throughout the project site. However, in order to prevent these species from spreading and becoming more densely populated, an herbicidal spot treatment application will be scheduled during 2013. See Table C.6 in Appendix C for problem area categories, locations, descriptions, causes, and photo log. See Figure C1a and C1b in Appendix C for an overview of noted invasive species locations.

**VPA 1 – Privet along right bank Little River,  
and along left bank UT2**

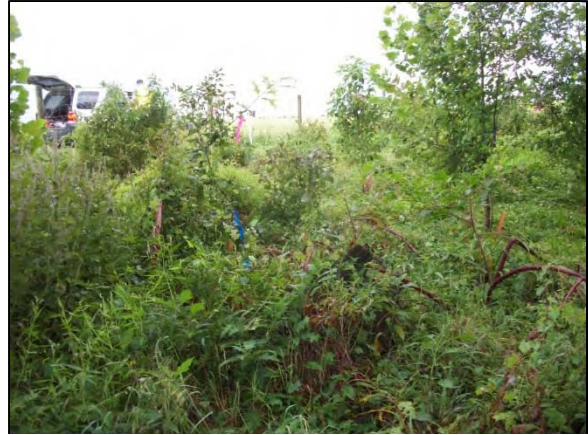
loss of vegetation within the project area; however, these areas will continue to be monitored to ensure their recovery and success. Additional areas (Vegetation Plots 2, 9, and 12 noted on figures C1a, C1b, and C1c) of concern included strangulation of planted species by vines mostly associated with *Ipomoea eriocarpa* (morning glory). Currently, the invasive species is limiting the growth of planted varieties; however, the effect within the plot has not damaged the vegetation to counts below the Year 3 success criteria. In order to prevent these species from spreading and becoming more densely populated, an herbicidal spot treatment application will be scheduled during 2013. See Figure C1a and C1b in Appendix C for the location of the vegetation plot problem areas.

**VPA 2 – Veg Plot 9 dominated by Morning  
Glory (*Ipomoea eriocarpa*)**

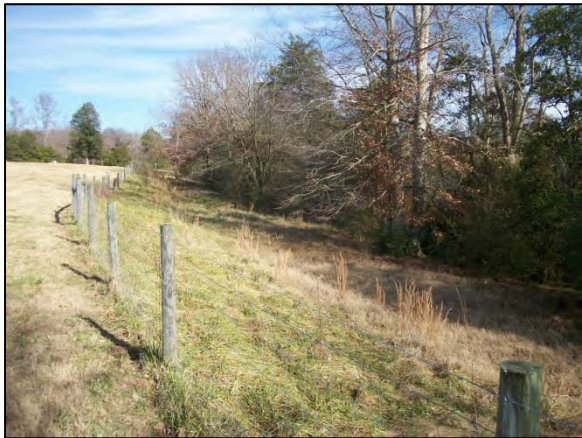
**VPA 3 – Privet along right bank of Little  
River near Vegetation Plot 1**

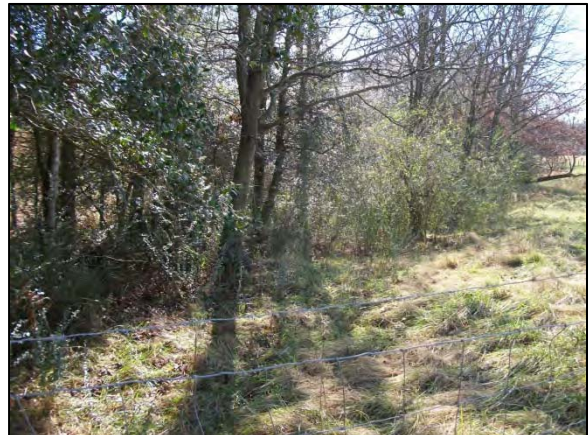
**VPA 4 – Privet along right bank near UT1  
crossing**

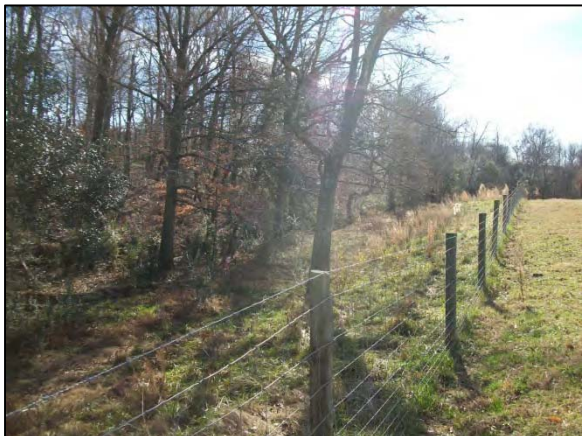
**VPA 5 – Privet becoming established along  
both banks of UT1 near confluence with  
Little River**

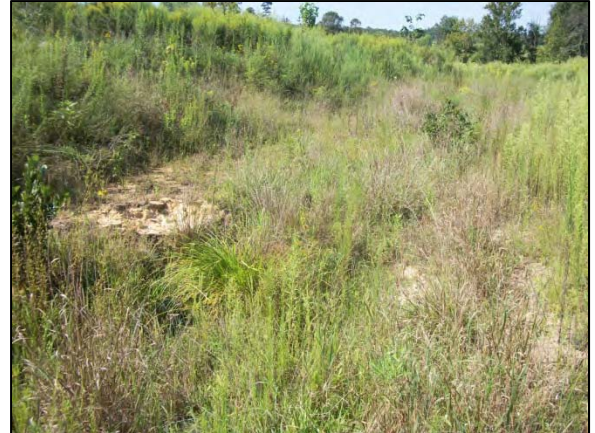
**C.6-2. Station 11+55 – 11+65**

During Year 2 monitoring, small pockets of erosion were noted on the left bank at Stations 11+55 to 11+65, 11+75 to 11+90, and 14+00 to 14+15 and on the right bank at Stations 11+00, 12+10 to 12+31, 12+70 to 12+80, 13+00 to 13+20, 13+65 to 13+80, 14+05 to 14+15, and 14+20 to 14+32. These areas were likely the result of poorly established streambank vegetation.

The visual assessment performed in Year 3 monitoring identified some identical areas of erosion as found in the previous monitoring season. Though the establishment of riparian vegetation along the restored reach has improved in comparison to Year 2, pockets of erosion were noted on the left bank at Stations 11+55 to 11+65, 11+75 to 11+90 and on the right bank at Stations 10+75 to 11+00, 12+20 to 12+50, 13+00 to 13+25, 13+75 to 13+90, and 14+25 to 14+50. Low vegetation density was also noted along the right floodplain near Station 12+50 through 13+00. See Figure C1c in Appendix C for an overview of all vegetative problem areas associated with the restored reach within UT4.

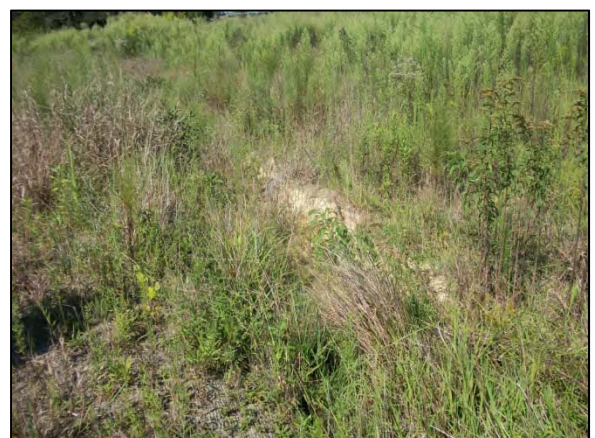
**C.6-4. Station 12+20 – 12+50**

Currently, the constructed sections of stream channel are functioning as designed and most of the rock step pool structures were noted as stable; however, areas of erosion downstream of the headwall structure at Station 12+50 are migrating upstream and are impacting the stability of the structure.
