# Little River Farm Site – Stream Enhancement, Restoration, and Preservation Project Year 4 Monitoring Report (2013) Montgomery County, North Carolina

EEP Project ID #92759/EEP Contract #000623

## Final Year 4 Monitoring Report (2013)

Michael Baker Engineering, Inc.  
NC Engineering License: F-1084

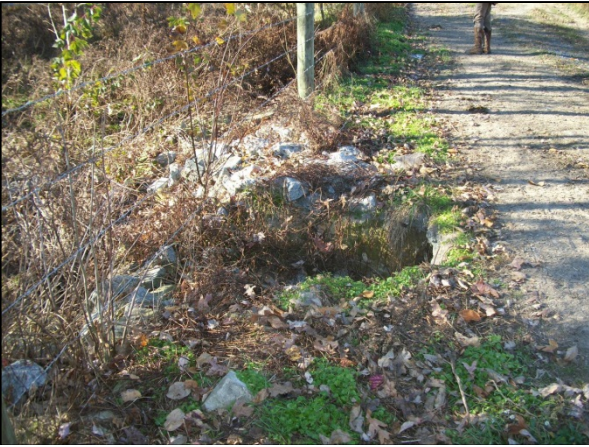
areas of instability were noted. Minor erosion and stability issues were noted on the crossings of UT2, UT2A, and UT3A.

SPA 1 – Sink Hole Developing at Culvert on UT2 Crossing

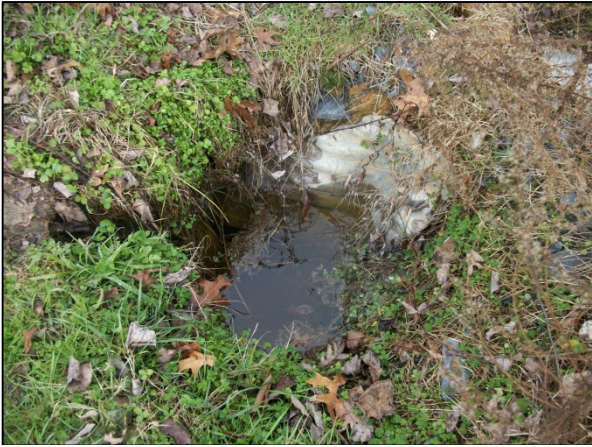
SPA 4 – Culvert & Sinkhole Repair Needed on UT3 Crossing

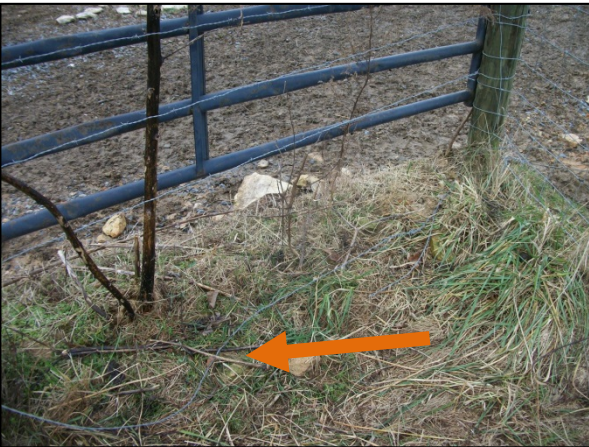
SPA 2 – Fence Repair Needed on UT2 Crossing

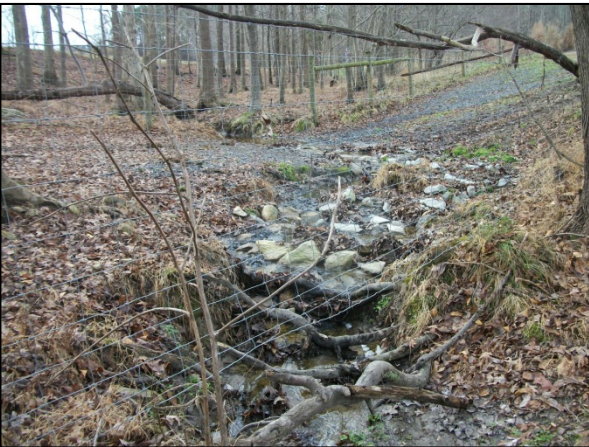
SPA 3 – Ford Crossing is Washing Out

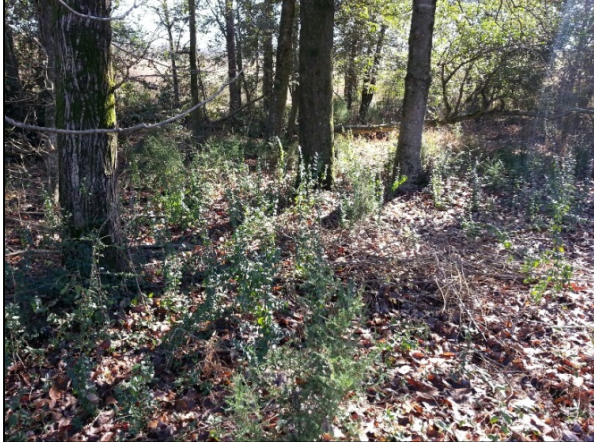
In areas along the Little River, UT1, UT2, and UT3 invasive species were noted to be of concern in Year 3. These areas were treated with an herbicidal spot treatment application or physically removed during 2013. Because some regrowth of invasives in the treated areas and additional areas of concern were noted during Year 4 additional invasive removal implementation measures will be conducted prior to Year 5 Monitoring.

**VPA 1 – Chinese Privet along Right Bank of UT1**

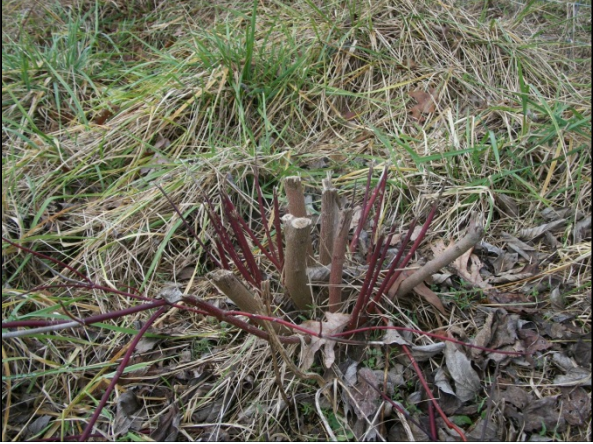
Beaver activities were also noted in small pockets primarily along UT2A, UT3A, and on the main stem of the Little River, just downstream the farm crossing.

**VPA 4 – Beaver Cutting on Silky Dogwood**

monitored. Removal of beavers will be conducted if the physical presence of their habitat is located. See Figures C1a and C1b in Appendix C for an overview of noted beaver activity locations.

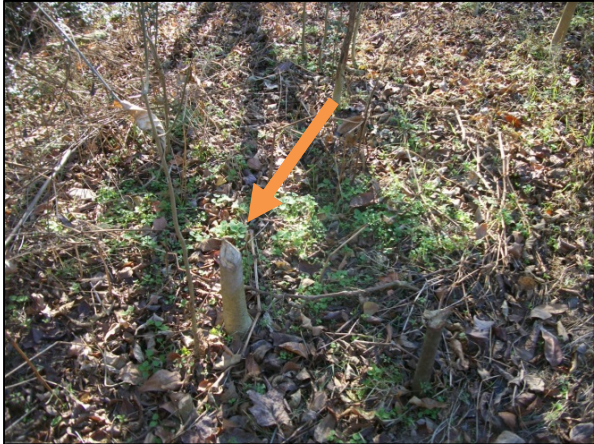
**VPA 2 – Beaver Activity**

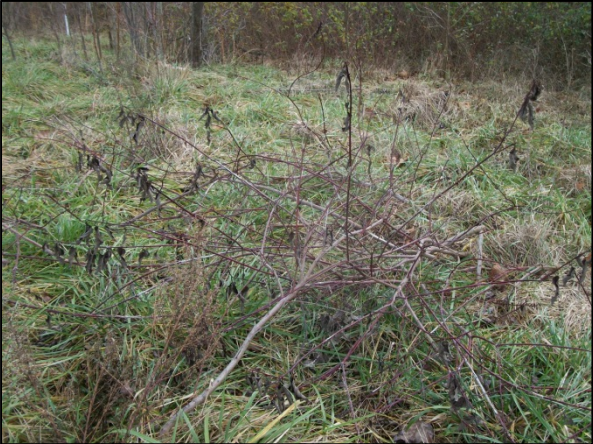
**VPA 5 – Silky Dogwood Left in Floodplain by Beaver Activity**

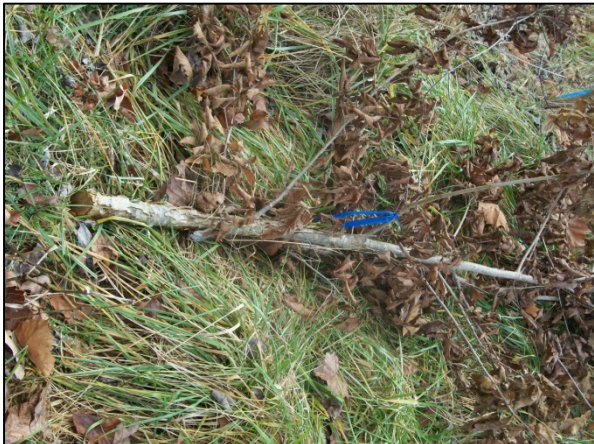
**VPA 3 – Beaver Activity VP-16**
