**Baseline Monitoring Report
Little Troublesome Stream Restoration Site
Project # 749
Rockingham County**

**Construction Completed: December 2009
Data Collection: February 2010
Submitted: May 2010**

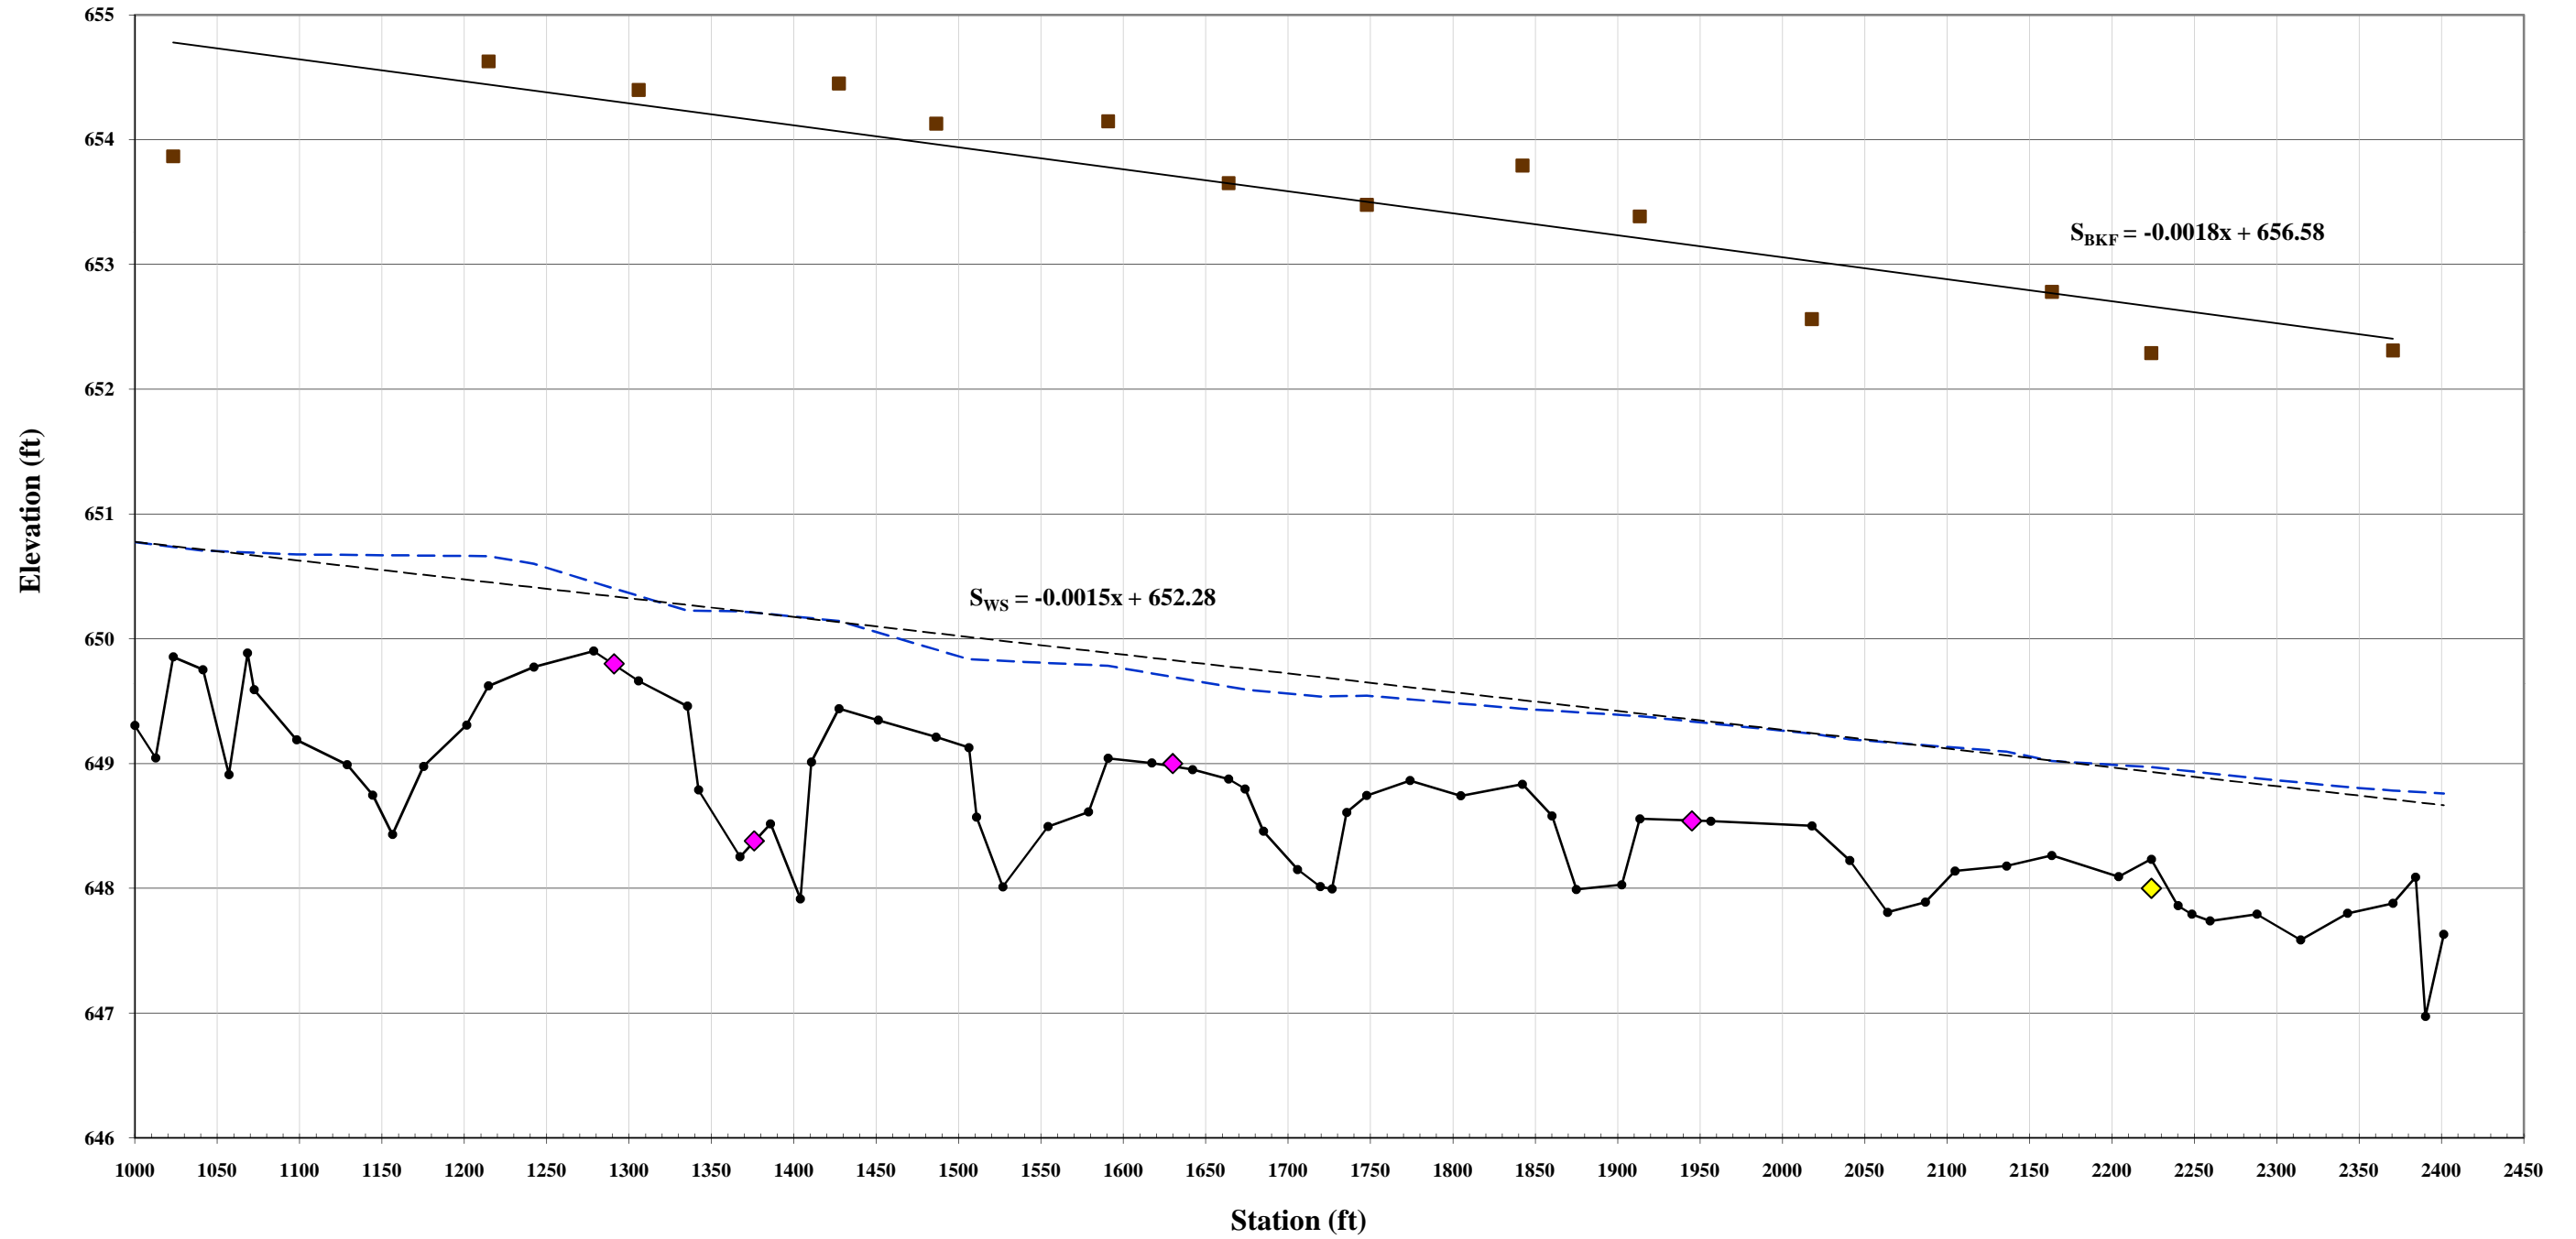
**Longitudinal Profile
Little Troublesome Creek
EEP Project Number - 749
Station 10+00 - 24+50**

*Cross Vane header stone at Station 22+24 beneath deposited sand.

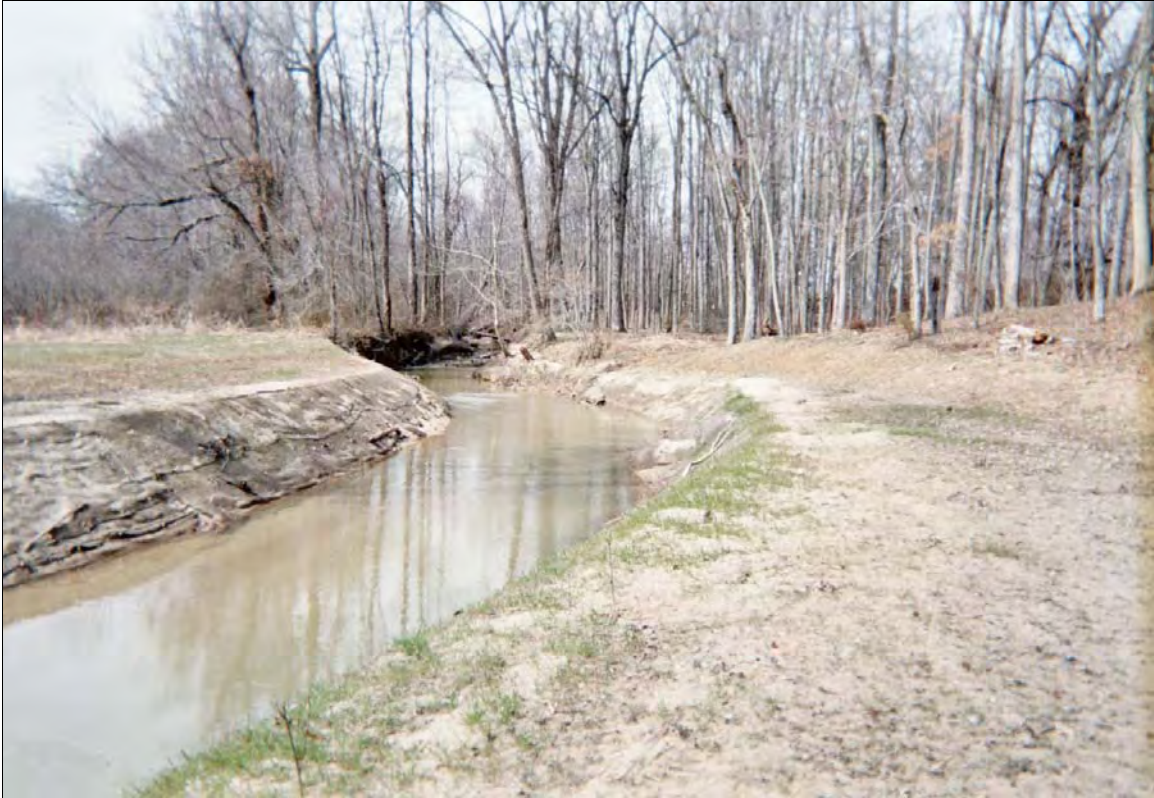
Photo Point 1u: View looking upstream near Station 11+10. 2/23/10 – Baseline

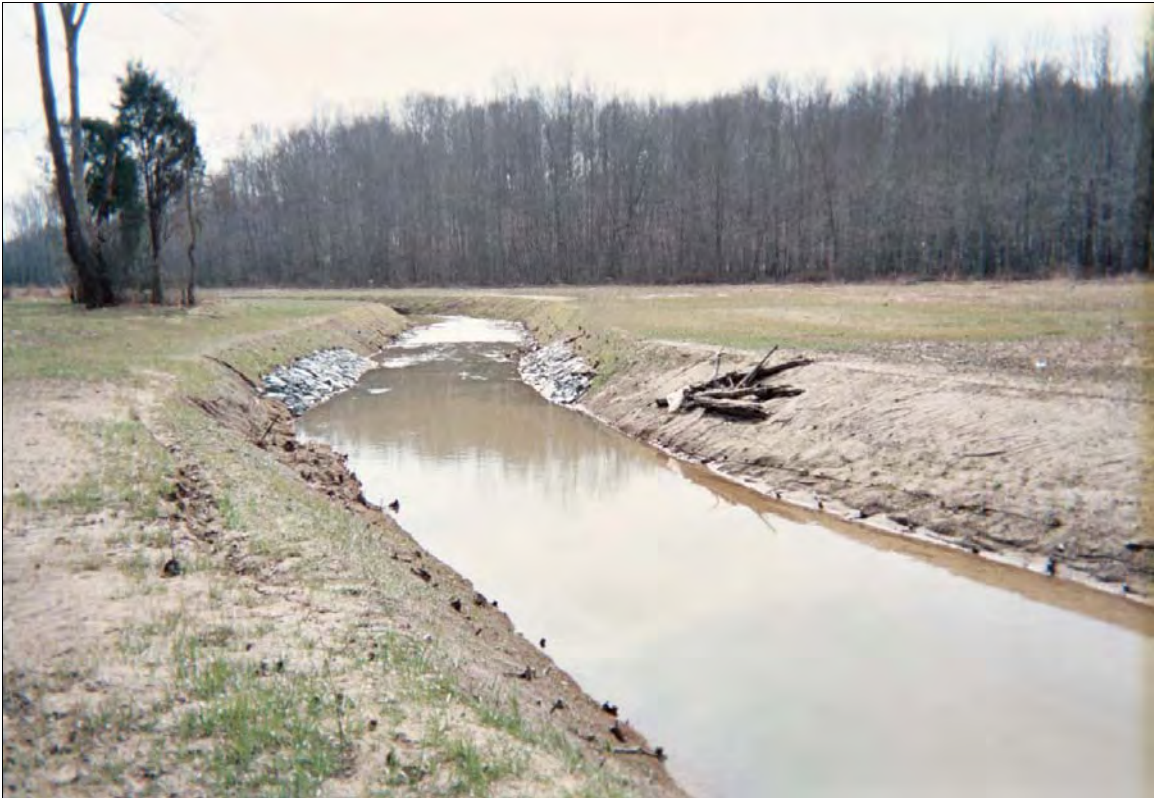
Photo Point 1d: View looking downstream near Station 11+10. 2/23/10 – Baseline

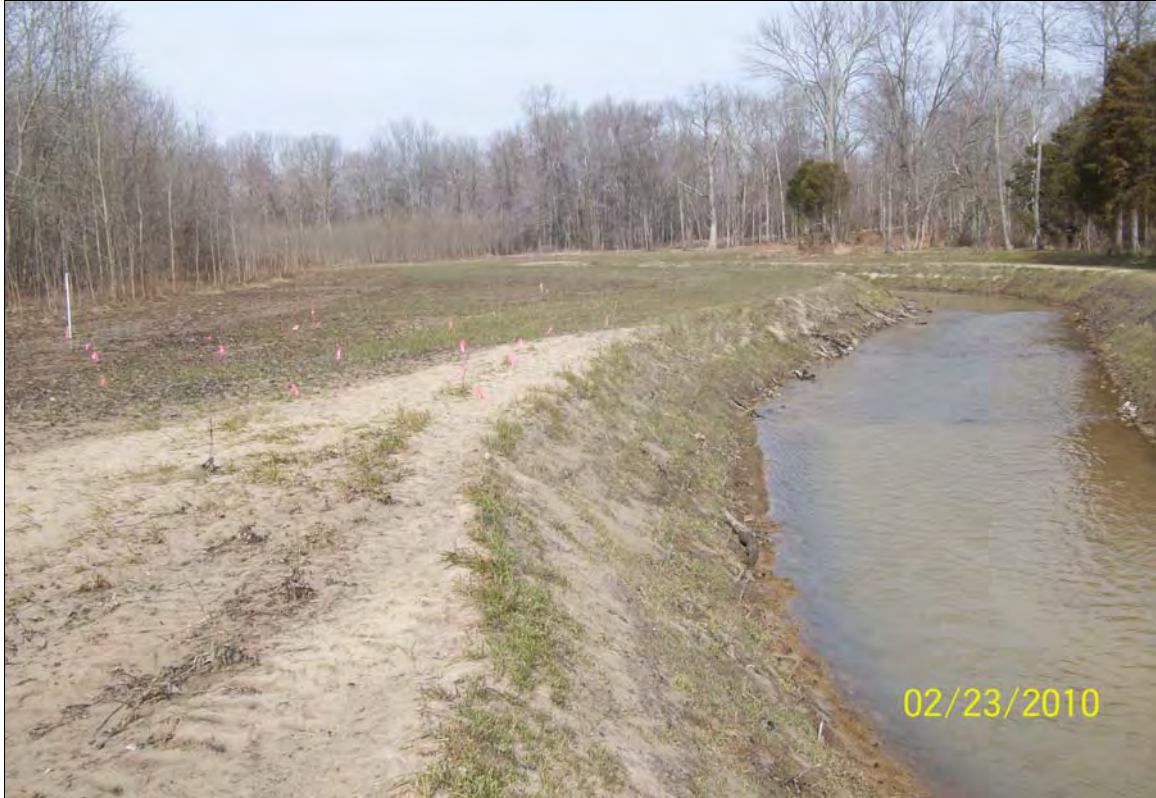
Photo Point 2u: View looking upstream taken near Station 17+40. 2/23/10 – Baseline

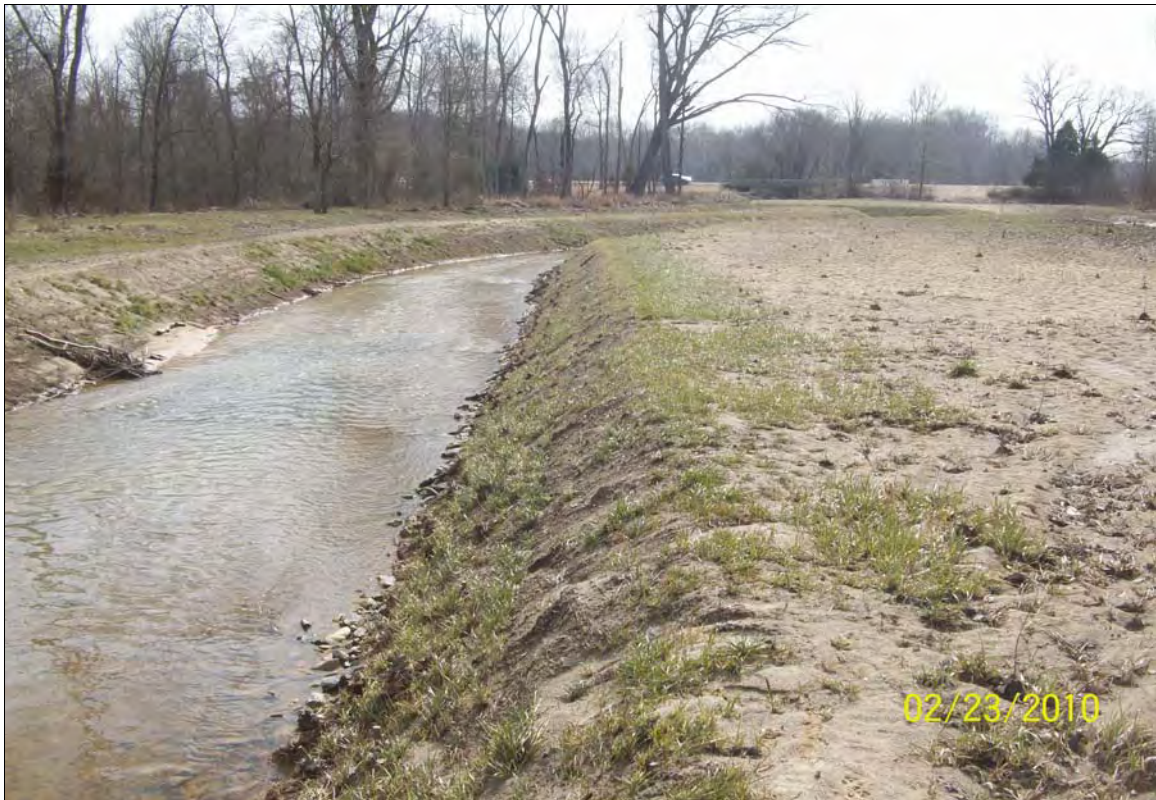
Photo Point 2d: View looking downstream taken near Station 17+40. 2/23/10 – Baseline

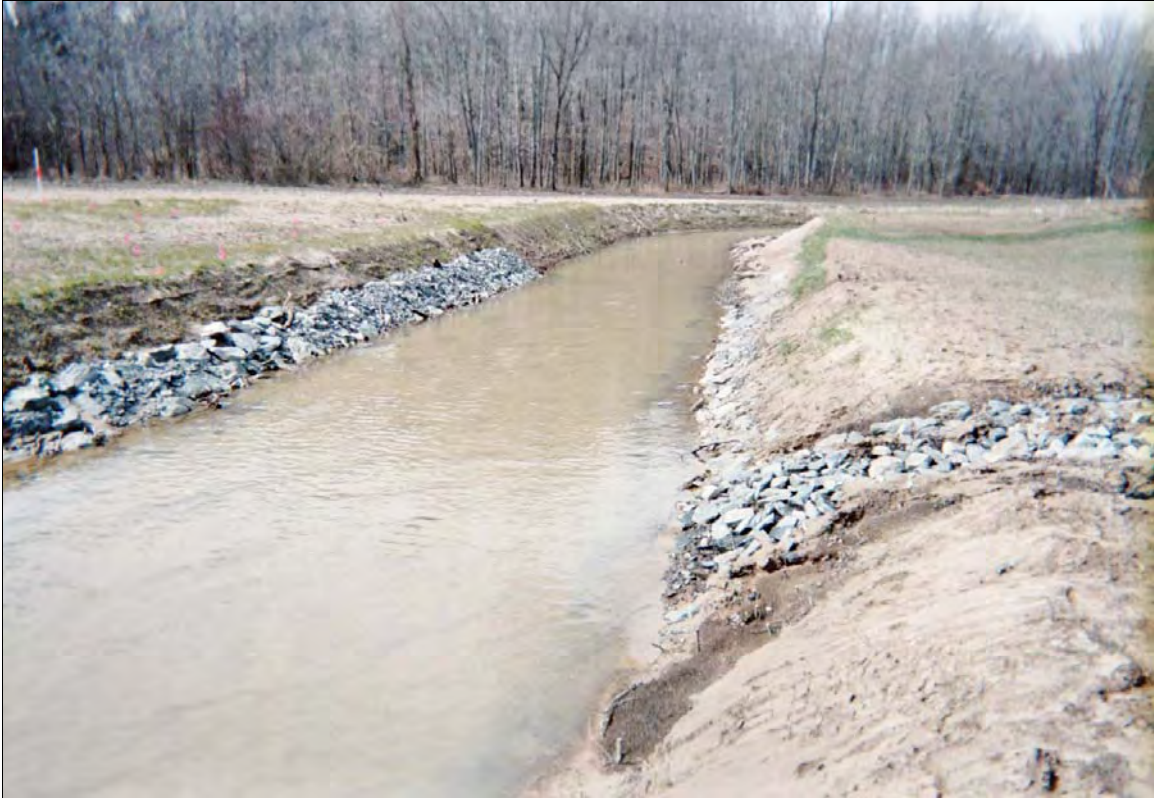
Photo Point 3u: View looking upstream near Station 22+25. 2/23/10 – Baseline

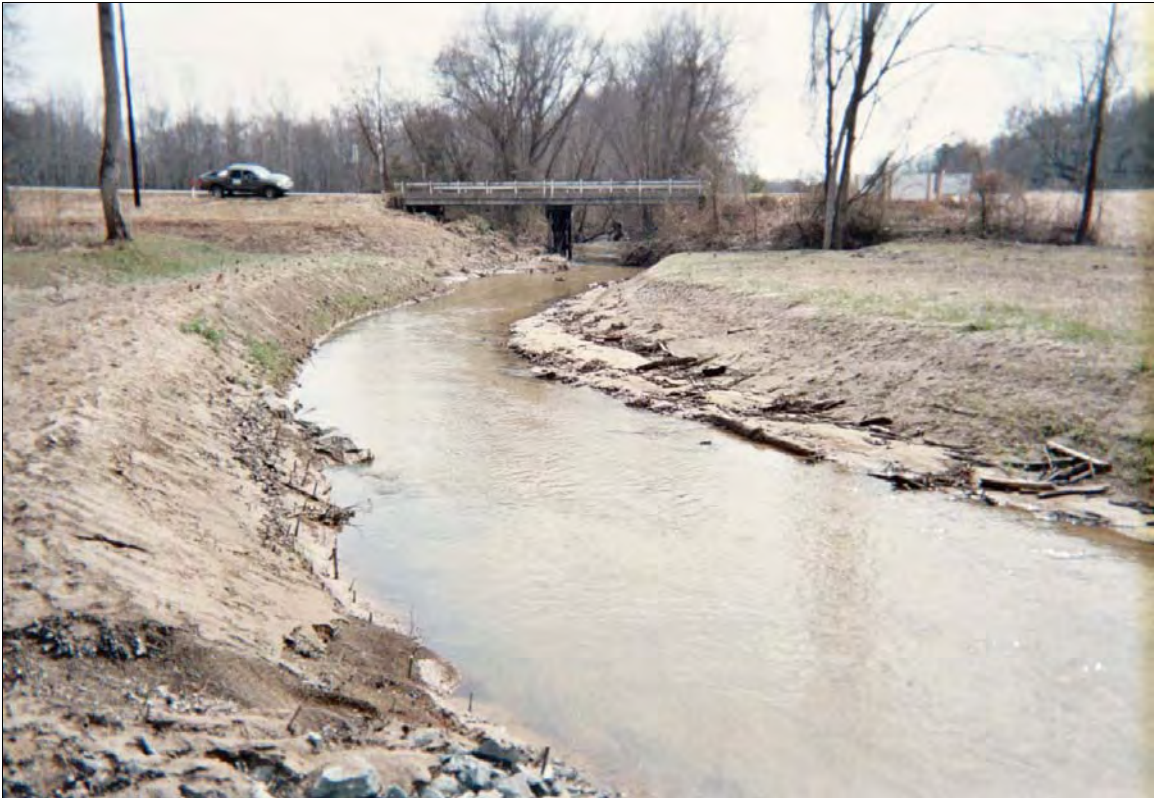
Photo Point 3d: View looking downstream near Station 22+25. 2/23/10 – Baseline

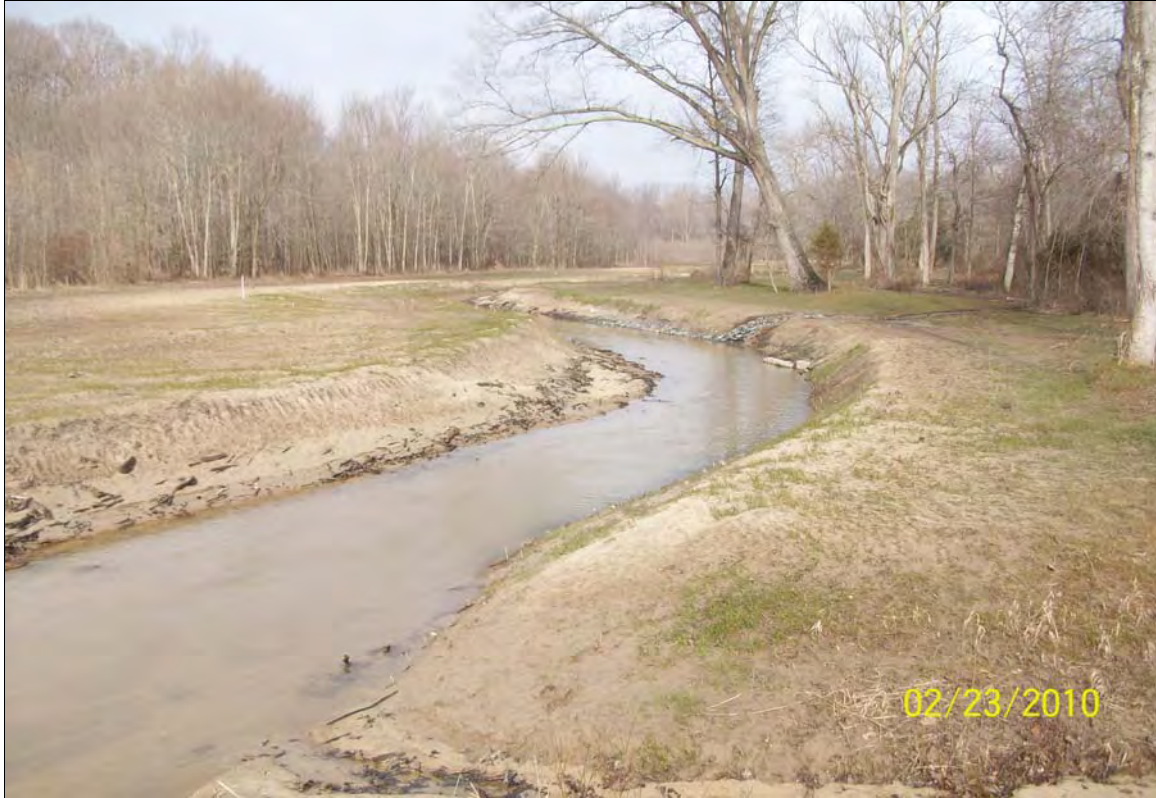
Photo Point 4: View looking upstream near Station 24+00. 2/23/10 – Baseline

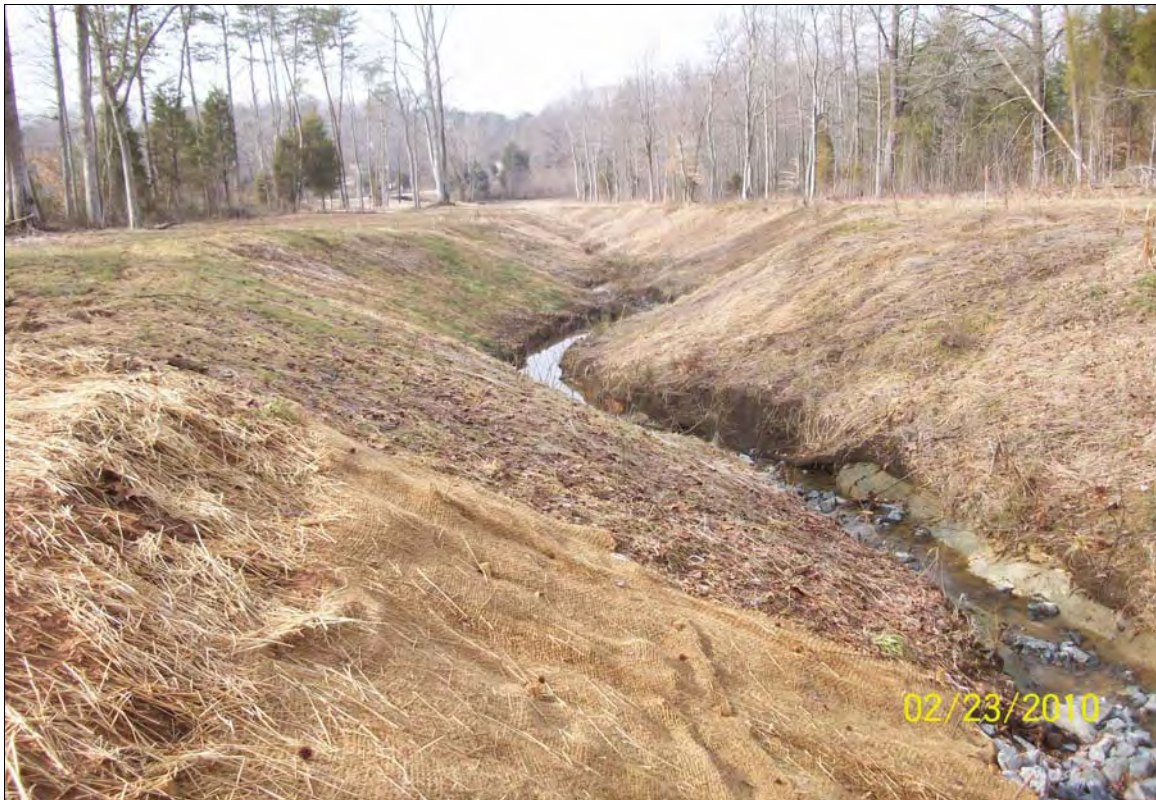
Photo Point 5: View looking downstream near Station 50+00. 2/23/10 – Baseline

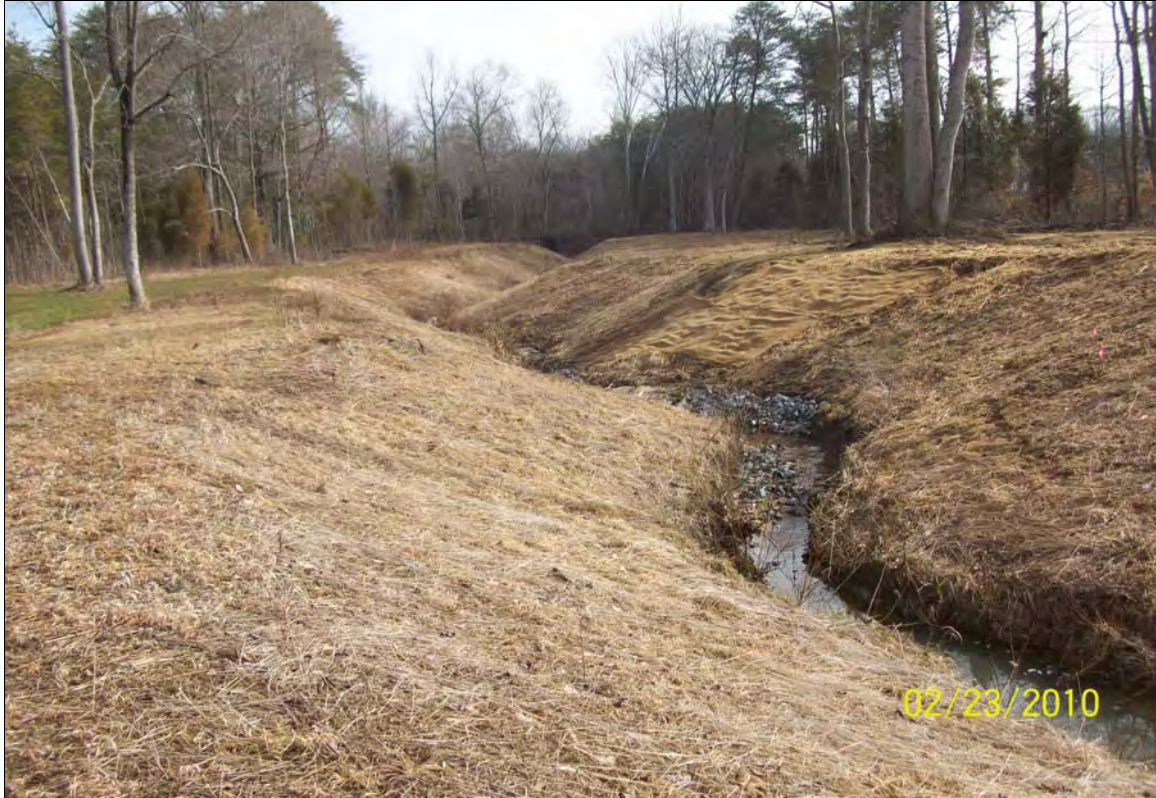
Photo Point 6u: View looking upstream near Station 54+90. 2/23/10 – Baseline

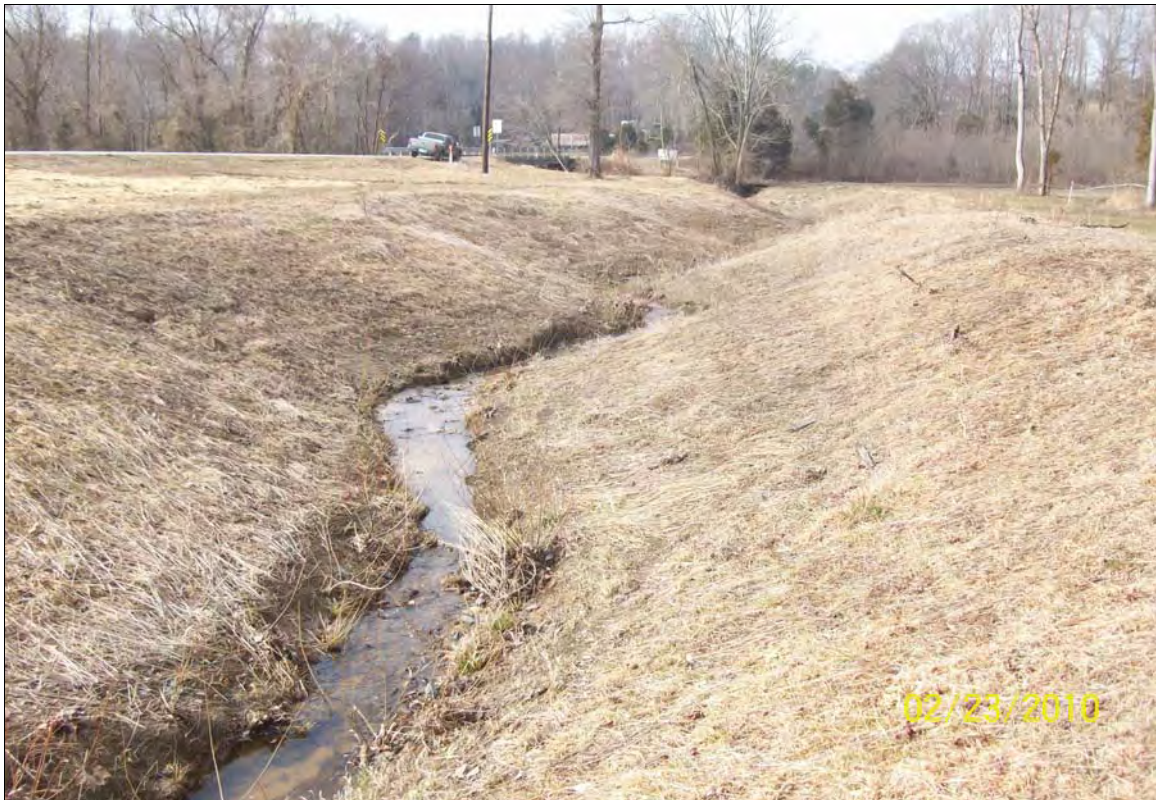
Photo Point 6d: View looking downstream near Station 54+90. 2/23/10 – Baseline

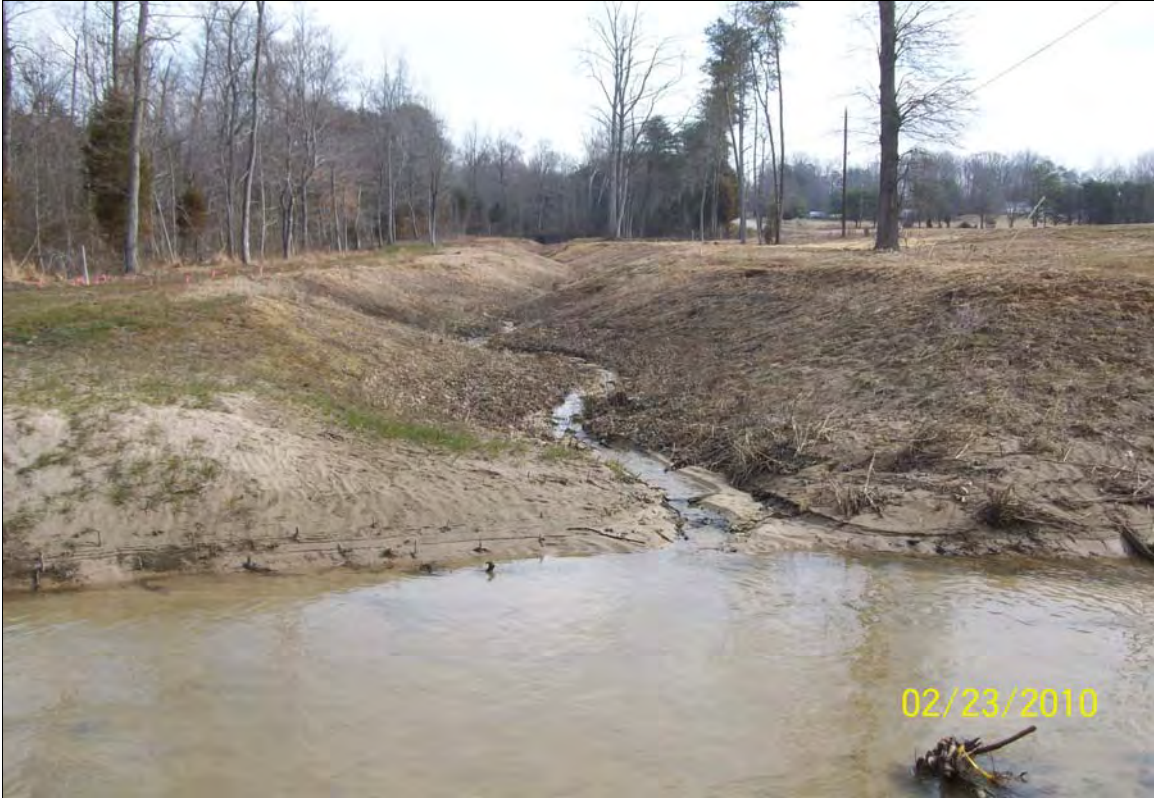
Photo Point 7: View looking upstream tributary at confluence. 2/23/10 – Baseline
