**Little Troublesome Site  
Stream Restoration Monitoring Report  
EEP Project # 749  
Monitoring Year 01**

**Construction Completed: December 2009**

**Data Collection: 2010**

**Submitted: December 2010**

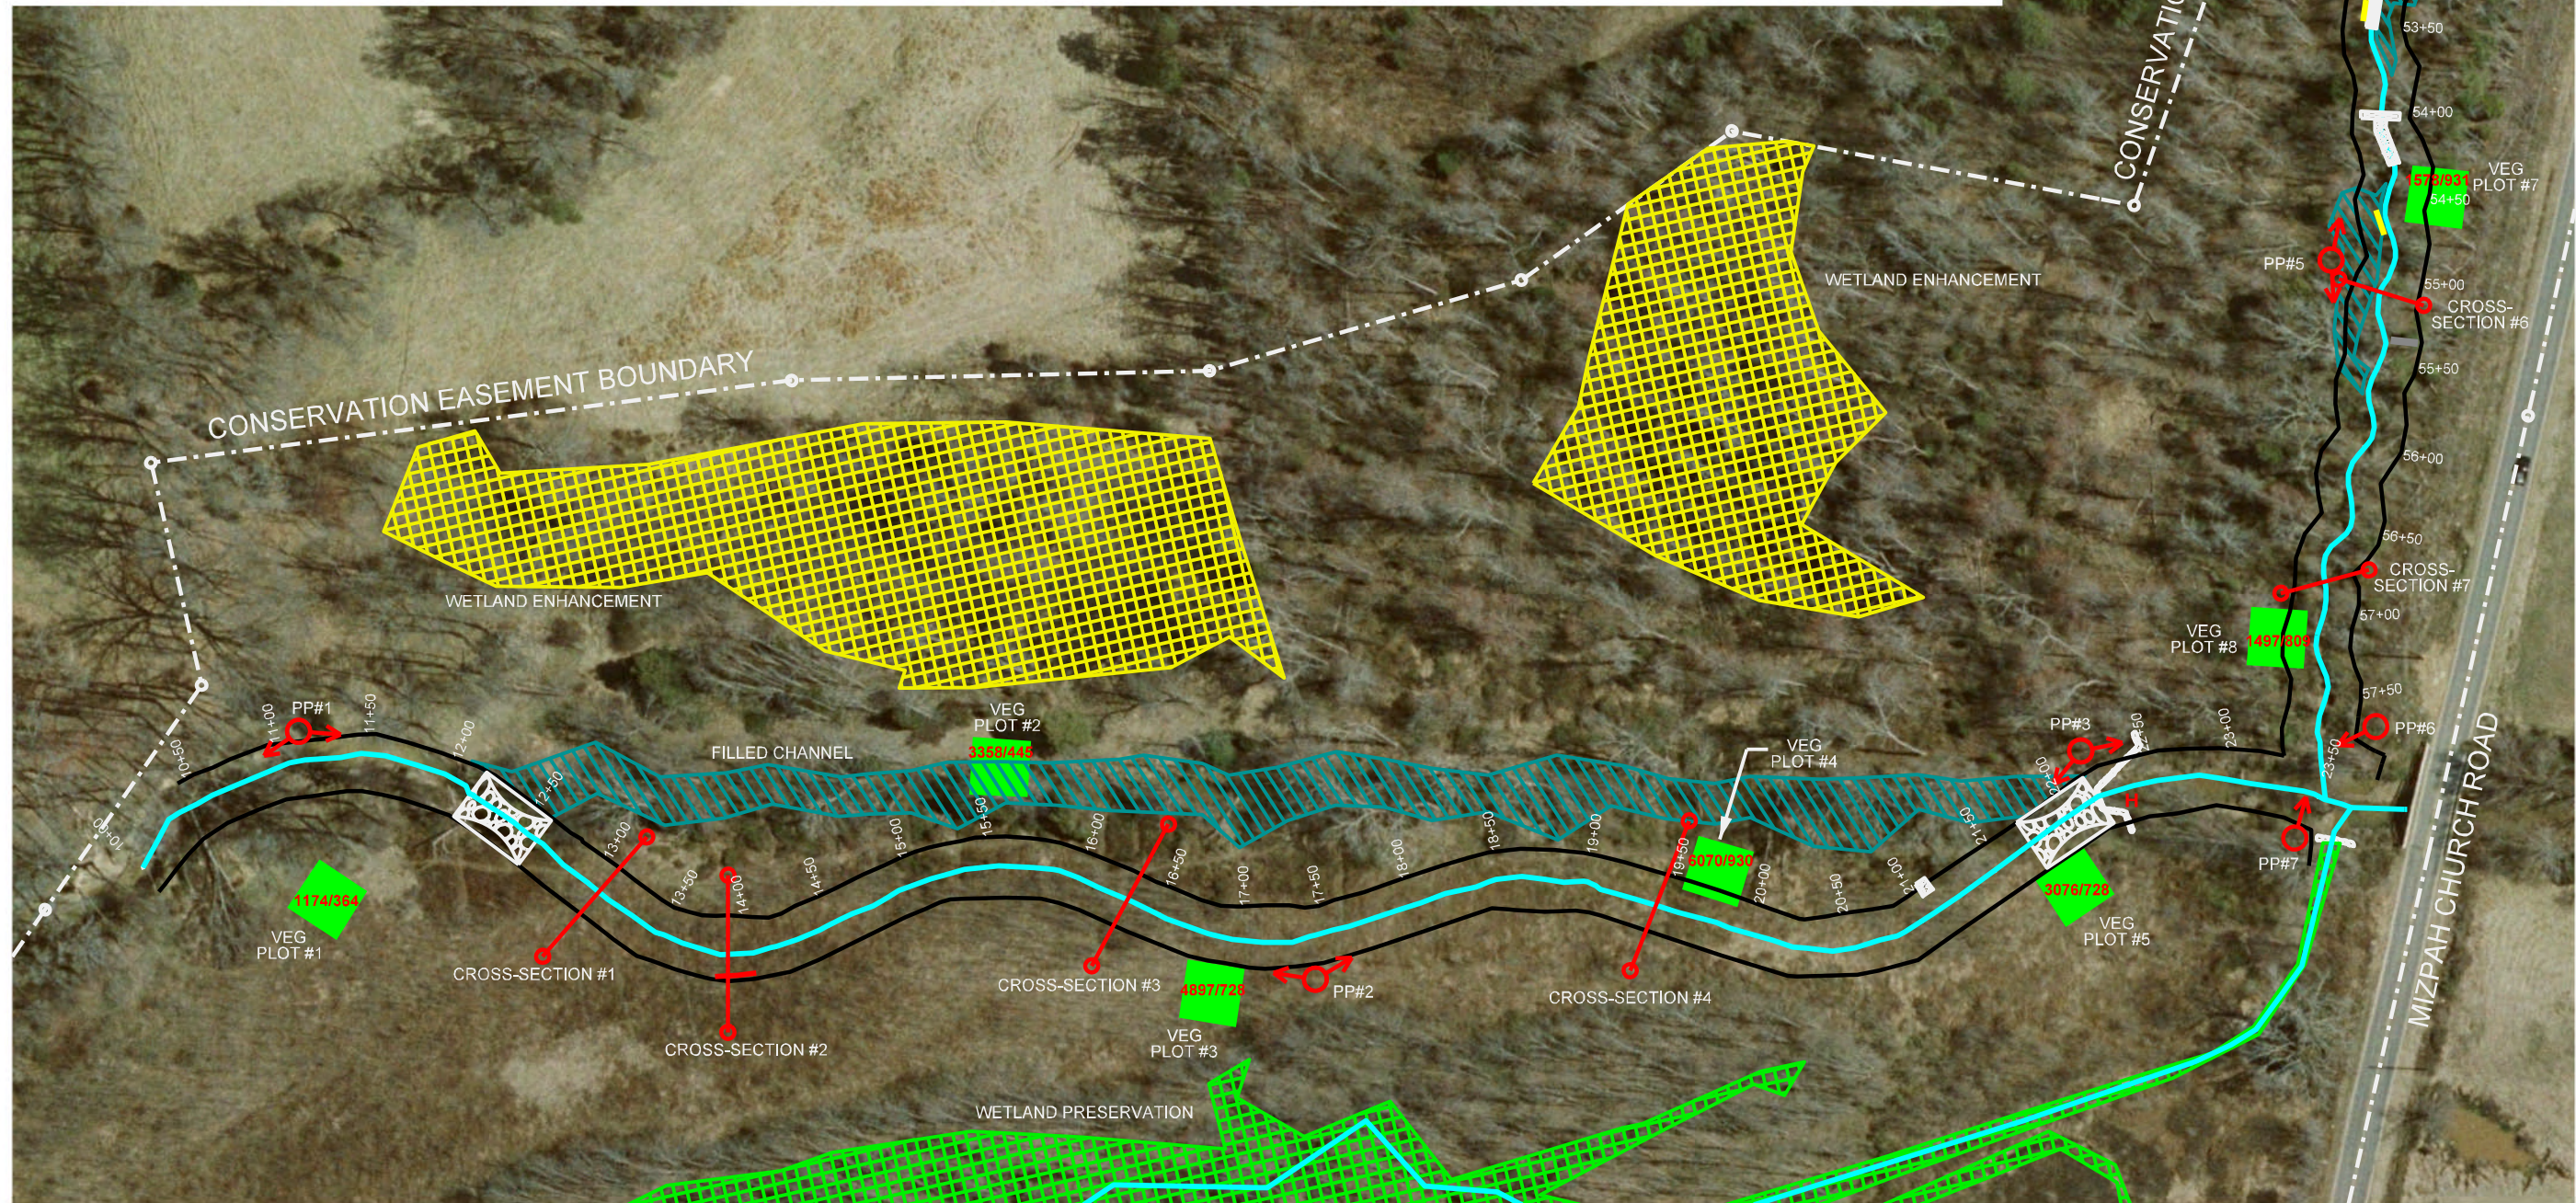
DATE: DEC 2010  
 SCALE: 1" = 100'  
 CURRENT CONDITION PLAN VIEW  
 SHEET 1 OF 1

First-year monitoring found Little Troublesome Creek to be stable, with only minor changes from the as-built conditions. The tributary has had areas of localized bed degradation and bank erosion since construction. These areas do not appear to be destabilizing and the plentiful streamside vegetation should continue to help stabilize these parts of the tributary. The longitudinal and cross-section data also reflect overall stability in the project streams. As a part of the stream success criterion, the stream must experience at least two bankfull events, each in separate monitoring years. The site has experienced multiple bankfull events since construction.

<sup>+</sup>These areas were not depicted on the CCPV. Generally, the left and right slopes of UT1 have many scattered areas of noticeable low stem densities that are below the mapping threshold, but are significant when combined.

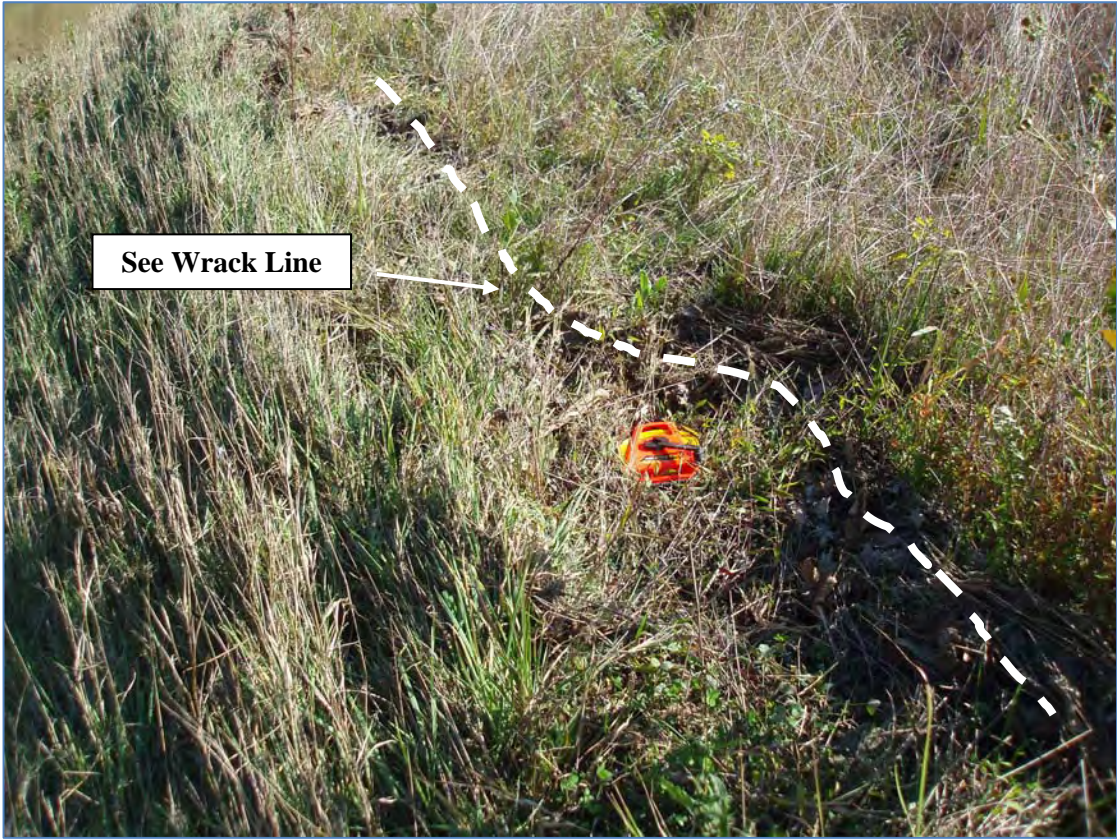
**Bankfull Photo #1**

<b>Table 12. Verification of Bankfull Events</b>			
<b>Little Troublesome / Project No. 749</b>			
<b>Date of Data Collection</b>	<b>Date of Occurrence</b>	<b>Method</b>	<b>Photo Number</b>
6/14/2009	6/11/2009	Site visit to evaluate indicators of stage after storm event	N/A
11/11/2009	11/11/2009	Site visit to evaluate indicators of stage after storm event	N/A
12/25/2009	12/25/2009	Land owner, eye-witness account	N/A
1/25/2010	1/25/2010	Site visit to evaluate indicators of stage after storm event	N/A
10/7/2010	9/26/2010	Site visit to evaluate indicators of stage after storm event	1, see below
