**Little Troublesome Site
Stream Restoration Monitoring Report
EEP Project # 749
Monitoring Year 02**

Data Collection: 2011

Submitted: December 2011

**Project Manager: Adam Spiller
Email: adam.spiller@kci.com
Project No: 12071067C_LT11**

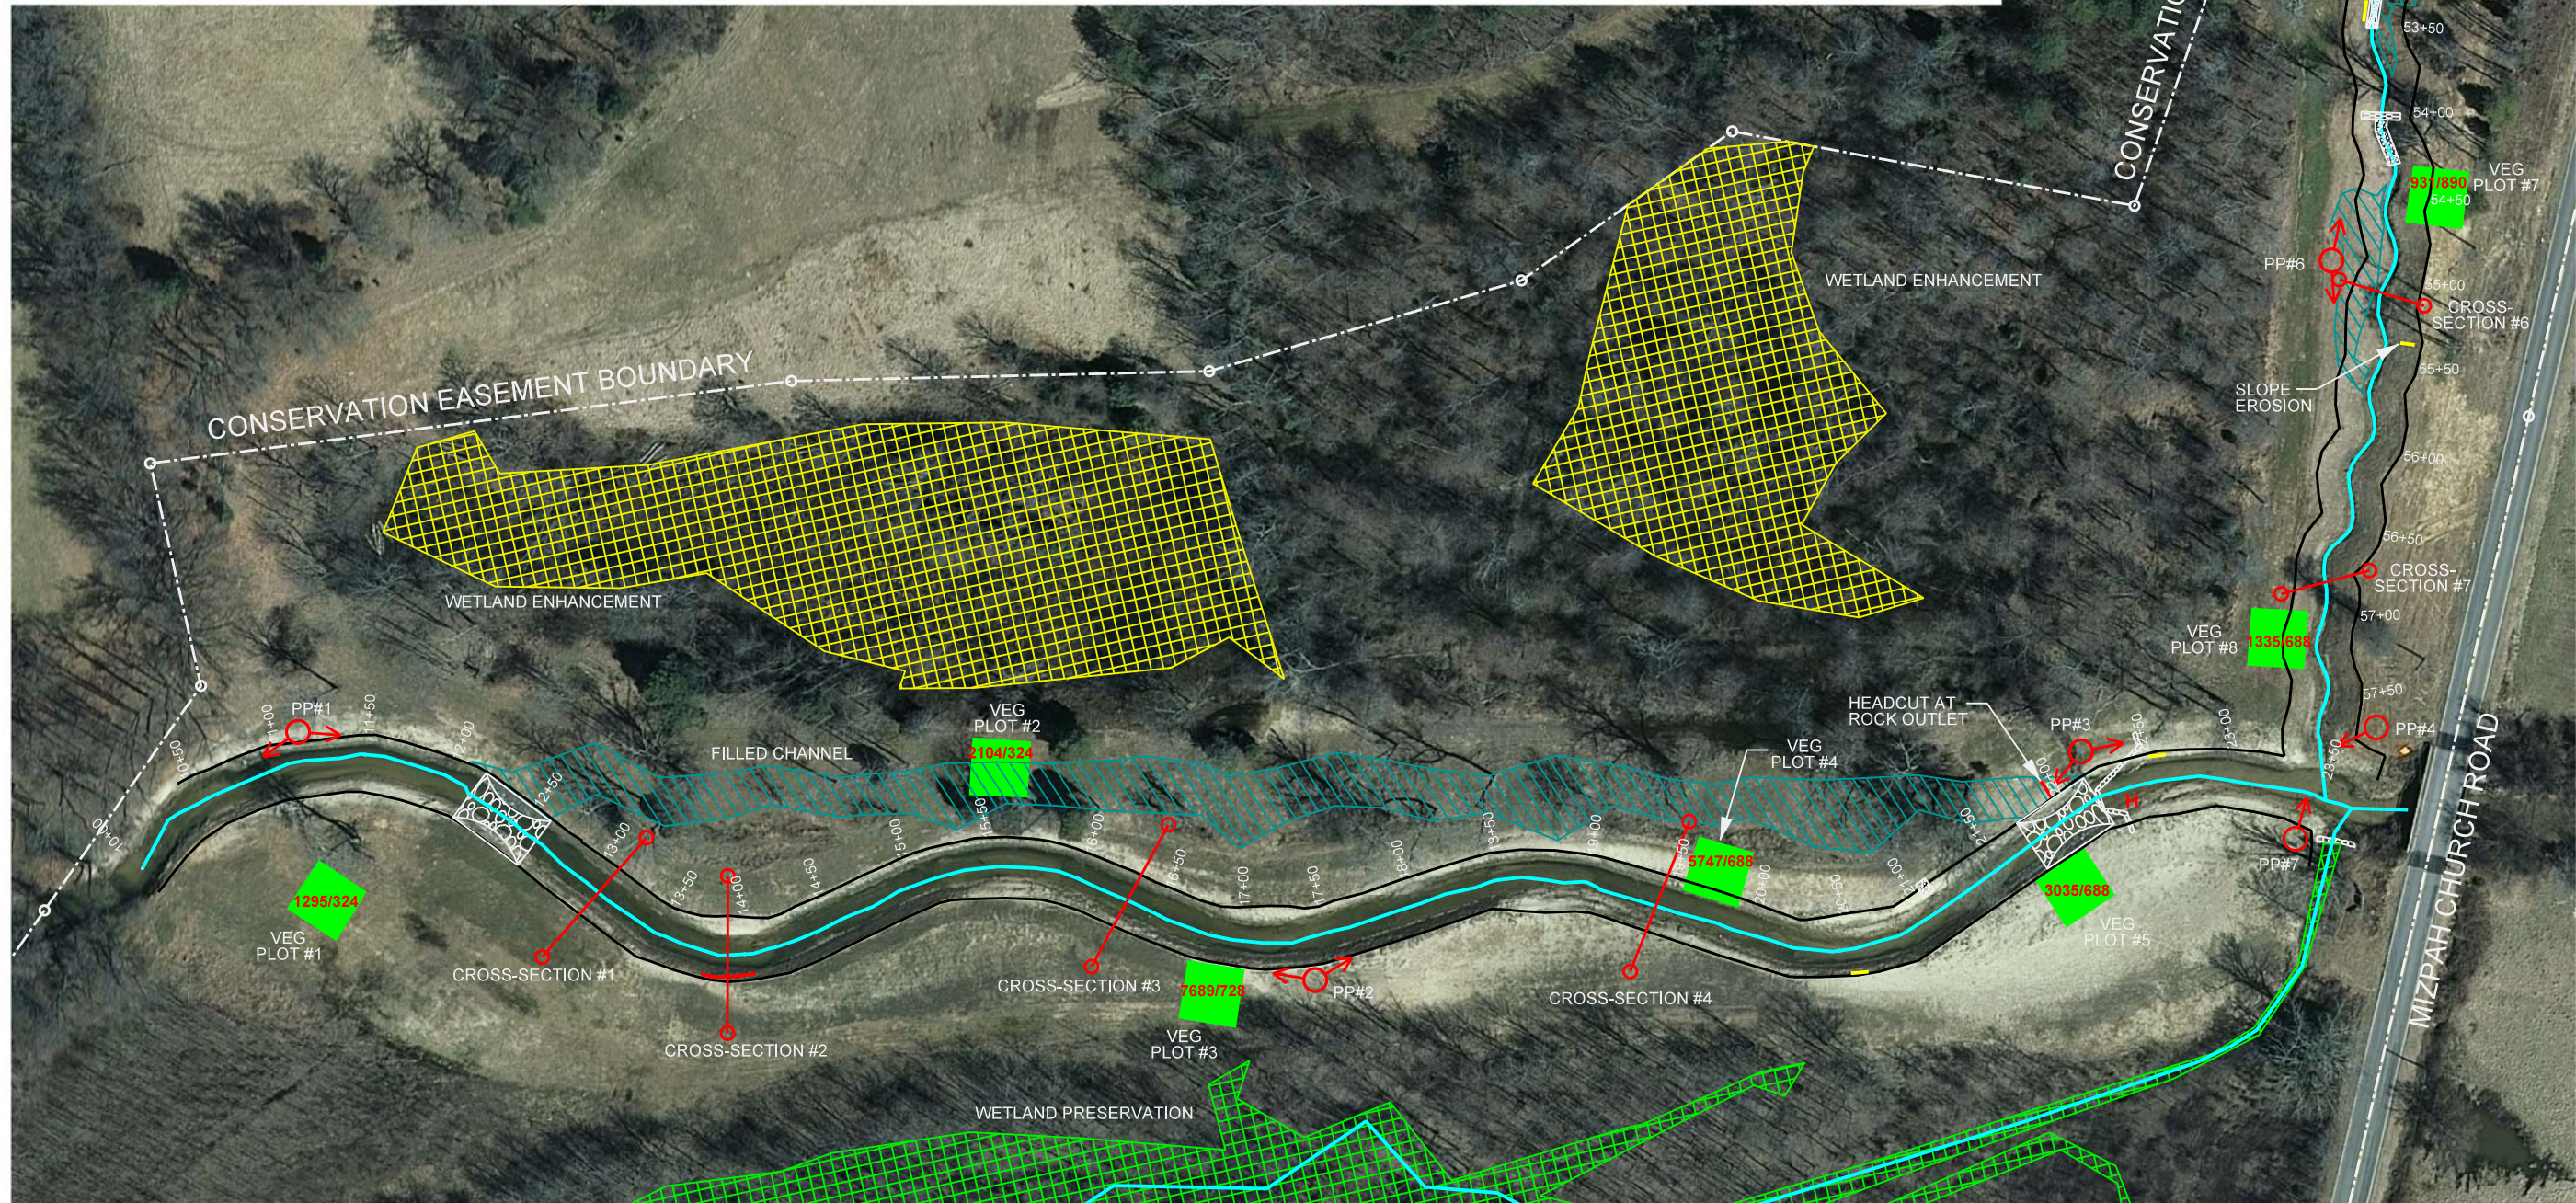
DATE: NOV 2011
 SCALE: 1" = 100'
 CURRENT
 CONDITION
 PLAN VIEW
 SHEET 1 OF 1

Second-year monitoring found Little Troublesome Creek to be stable, with only minor changes from the as-built and Year One conditions. The tributary has had areas of localized bed degradation and bank erosion since construction. These areas do not appear to be actively destabilizing and the plentiful streamside vegetation should continue to help stabilize these parts of the tributary. There are isolated areas of erosion on the south slope leading down to the tributary and on outer bends of Little Troublesome. These areas are not presently causing destabilization of the project, but should continue to be monitored. The longitudinal and cross-sectional data also reflect overall stability in the project streams. As a part of the stream success criterion, the stream must experience at least two bankfull events, each in separate monitoring years. The site has experienced multiple bankfull events since construction.

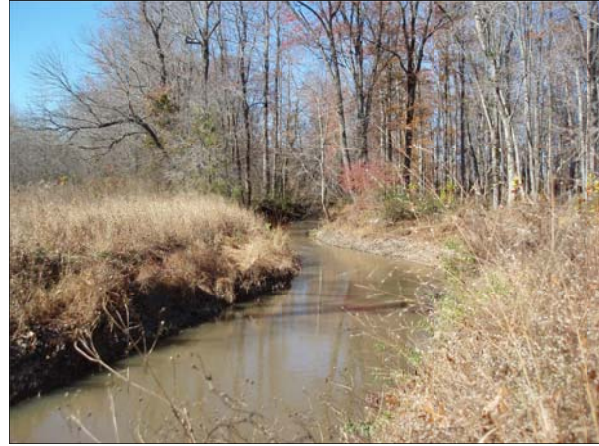
Photo Point 1u: View looking upstream near Station 11+10. 11/18/2011 – MY-02

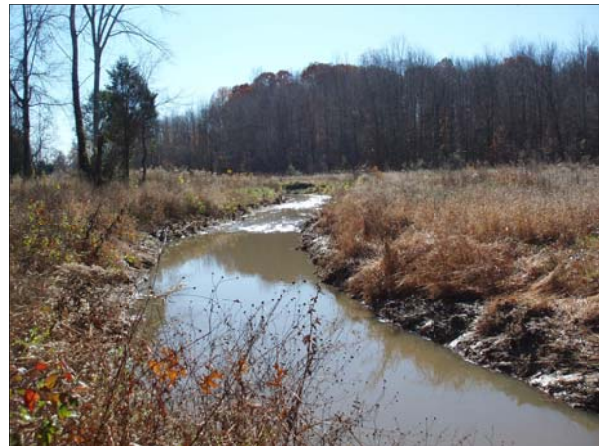
Photo Point 1d: View looking downstream near Station 11+10. 11/18/2011 – MY-02

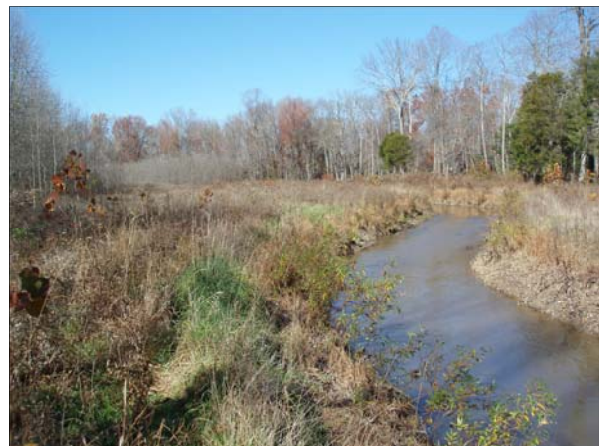
Photo Point 2u: View looking upstream taken near Station 17+40. 11/18/2011 – MY-02

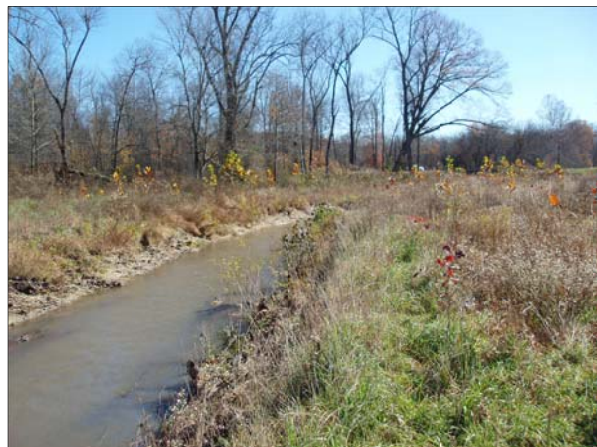
Photo Point 2d: View looking downstream taken near Station 17+40. 11/18/2011 – MY-02

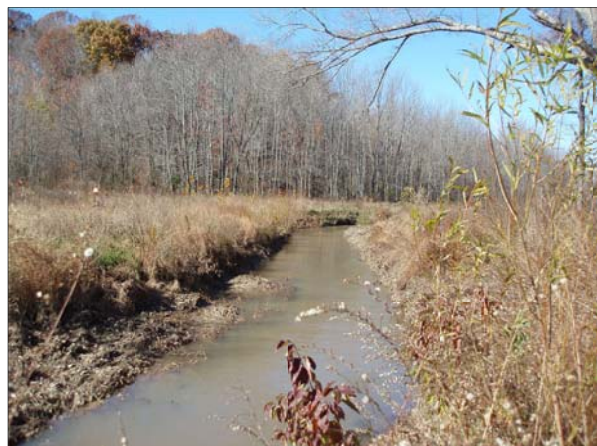
Photo Point 3u: View looking upstream near Station 22+25. 11/18/2011 – MY-02

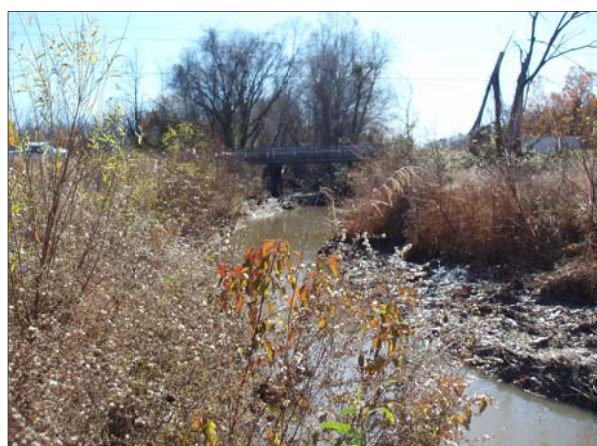
Photo Point 3d: View looking downstream near Station 22+25. 11/18/2011 – MY-02

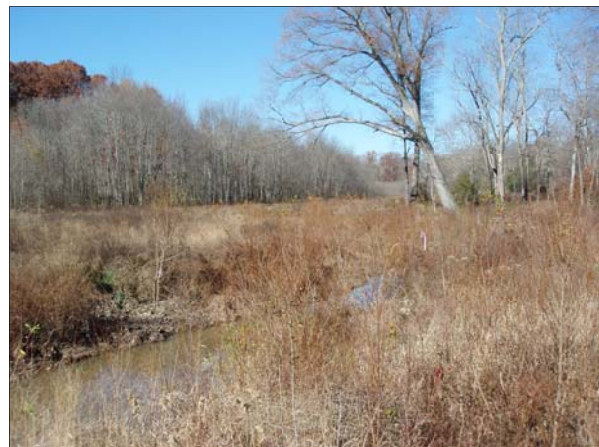
Photo Point 4: View looking upstream near Station 24+00. 11/18/2011 – MY-02

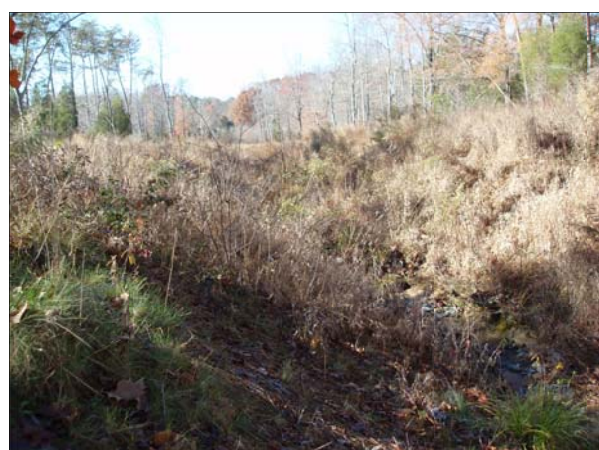
Photo Point 5: View looking downstream near Station 50+00. 11/18/2011 – MY-02

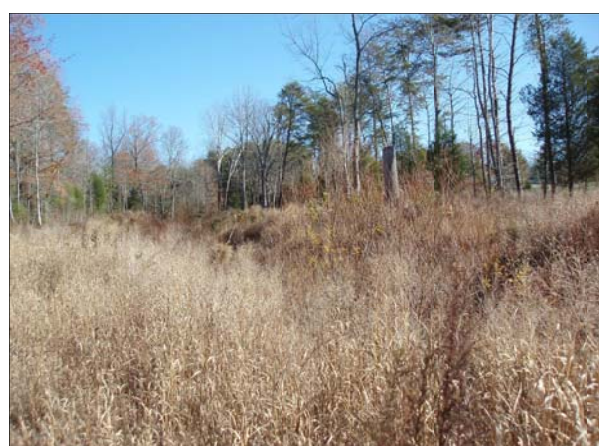
Photo Point 6u: View looking upstream near Station 54+90. 11/18/2011 – MY-02

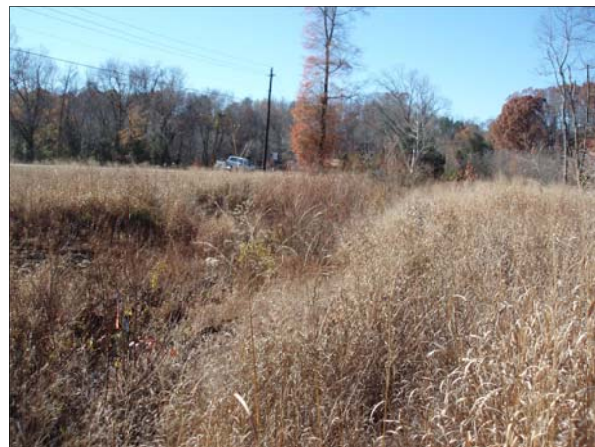
Photo Point 6d: View looking downstream near Station 54+90. 11/18/2011 – MY-02

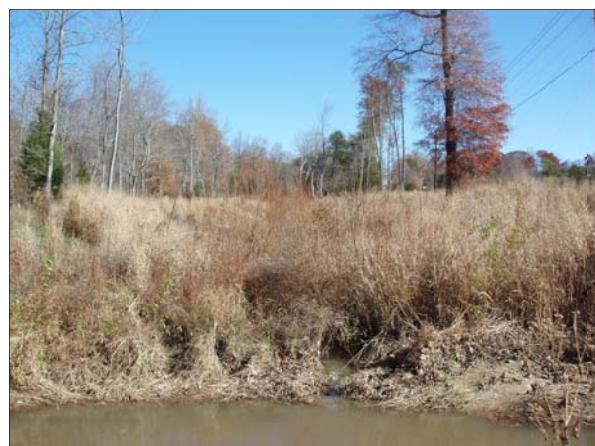
Photo Point 7: View looking upstream at the tributary confluence. 11/18/2011 – MY-02
