**Little Troublesome Site
Stream Restoration Monitoring Report
EEP Project # 749
EEP Contract # 004711
Monitoring Year 03**

**Construction Completed: December 2009
Data Collection: 2012**

**Project Manager: Adam Spiller
Email: adam.spiller@kci.com
Project No: 16121975_LT12**

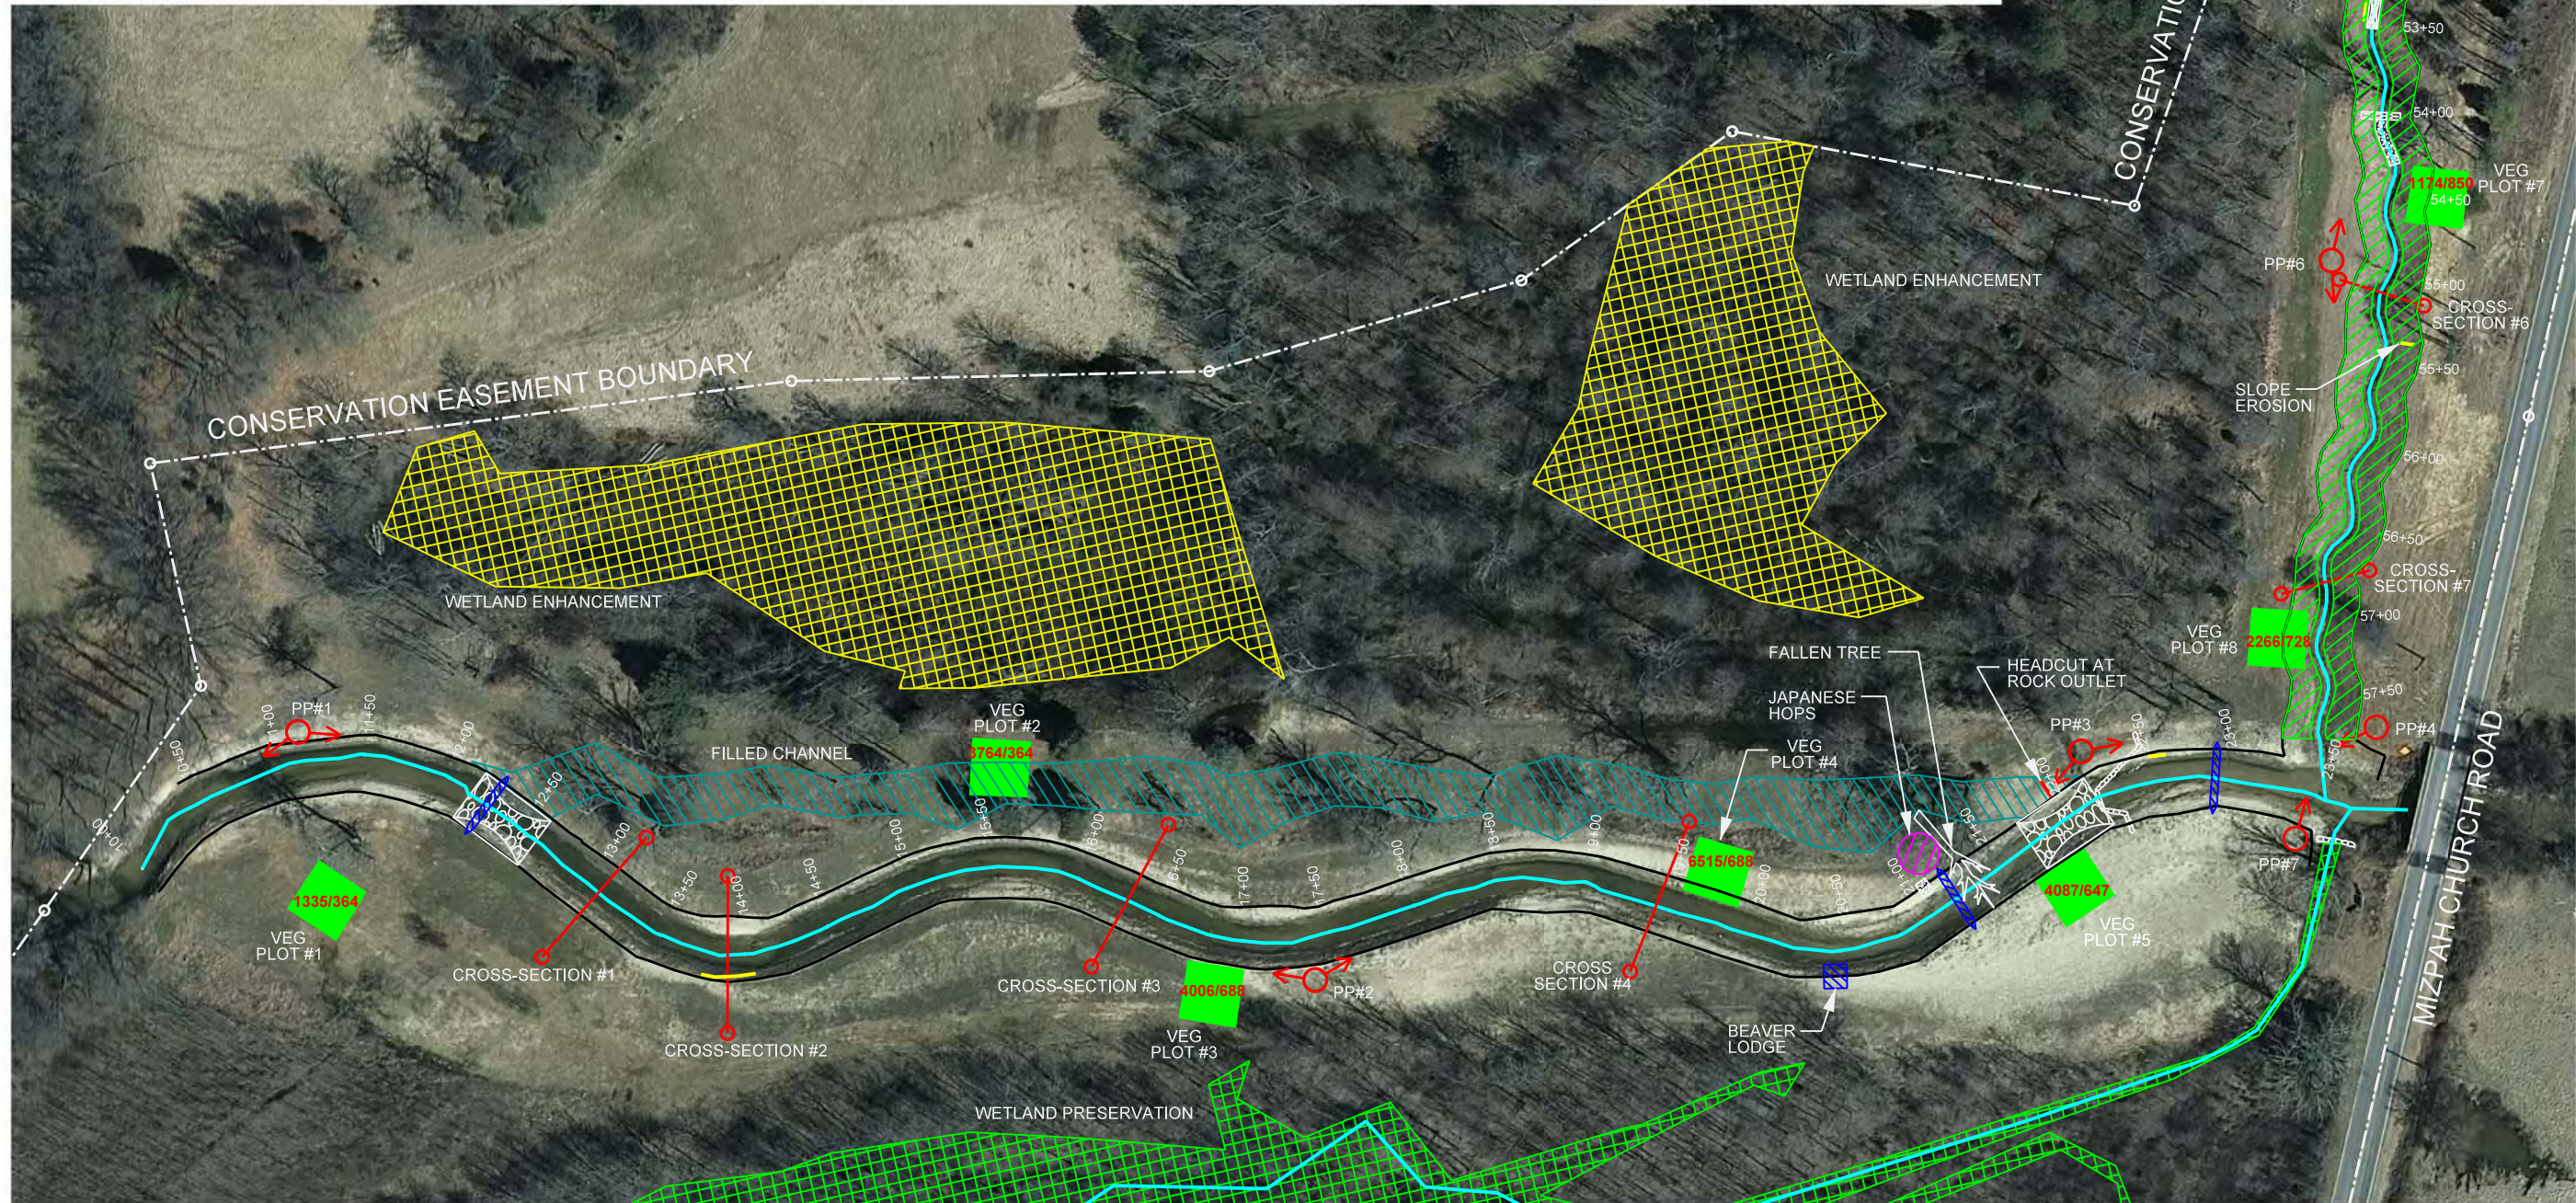
DATE: NOV 2012
SCALE: 1" = 100'
CURRENT CONDITION PLAN VIEW
SHEET 1 OF 1

The 2012 monitoring found that the slope from the left bank of the tributary to the terrace (the north-facing slope) had sparse vegetation coverage with some bare areas. There has been high live stake survival along the tributary and variable survival along Little Troublesome Creek. Multiflora rose (*Rosa multiflora*) is scattered throughout the easement along Little Troublesome Creek and UT1. A small area of Japanese hops (*Humulus japonicas*) is located on Little Troublesome at Station 21+30.

Third-year monitoring found Little Troublesome Creek to be stable, with only minor changes from the previous monitoring conditions. The tributary has had isolated areas of localized bed degradation and bank erosion since construction. For the third monitoring year these areas (predominantly from Station 52+80 to 53+40) appear to be stabilizing. The isolated areas of erosion on the outer bends of Little Troublesome are trending toward stability, with only two areas still displaying minor bank erosion. There are three beaver dams on Little Troublesome Creek. The first one is located near the start of Little Troublesome at Station 12+25 on the riffle grade control structure. The second beaver dam is located at approximately Stations 21+25 in conjunction with a fallen tree, and the third dam is located at 22+90. The longitudinal and cross-sectional data also reflect overall stability in the project streams. As a part of the

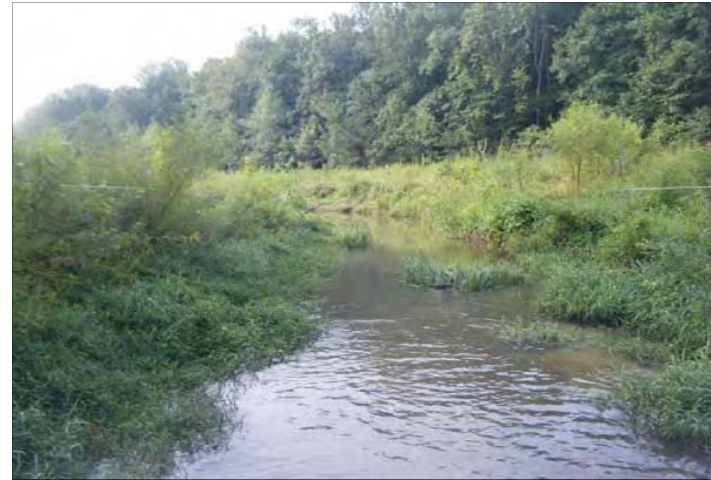
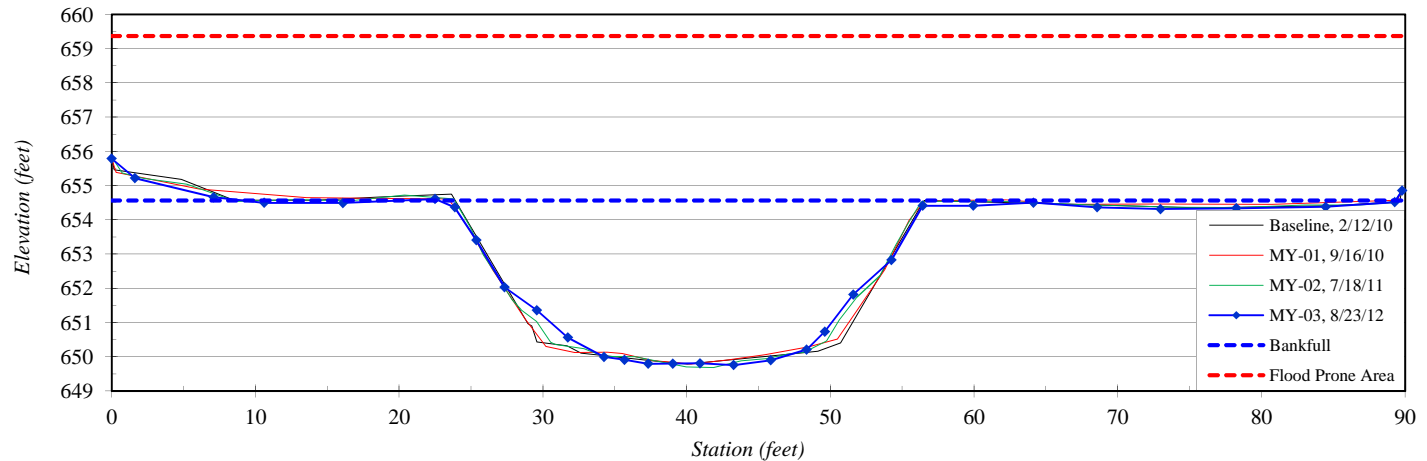
Cape Fear River Basin, Little Troublesome Creek, MY-03, LTC (XS - 1, Riffle) Station 13+08

SUMMARY DATA	
Bankfull Elevation:	654.6
Bankfull Cross-Sectional Area:	115.5
Bankfull Width:	33.6
Flood Prone Area Elevation:	659.4
Flood Prone Width:	>90
Max Depth at Bankfull:	4.8
Mean Depth at Bankfull:	3.4
W / D Ratio:	9.8
Entrenchment Ratio:	2.7
Bank Height Ratio:	1.0

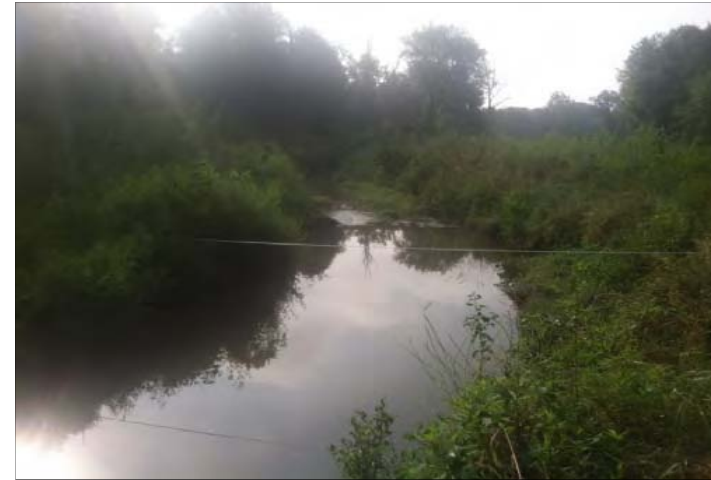
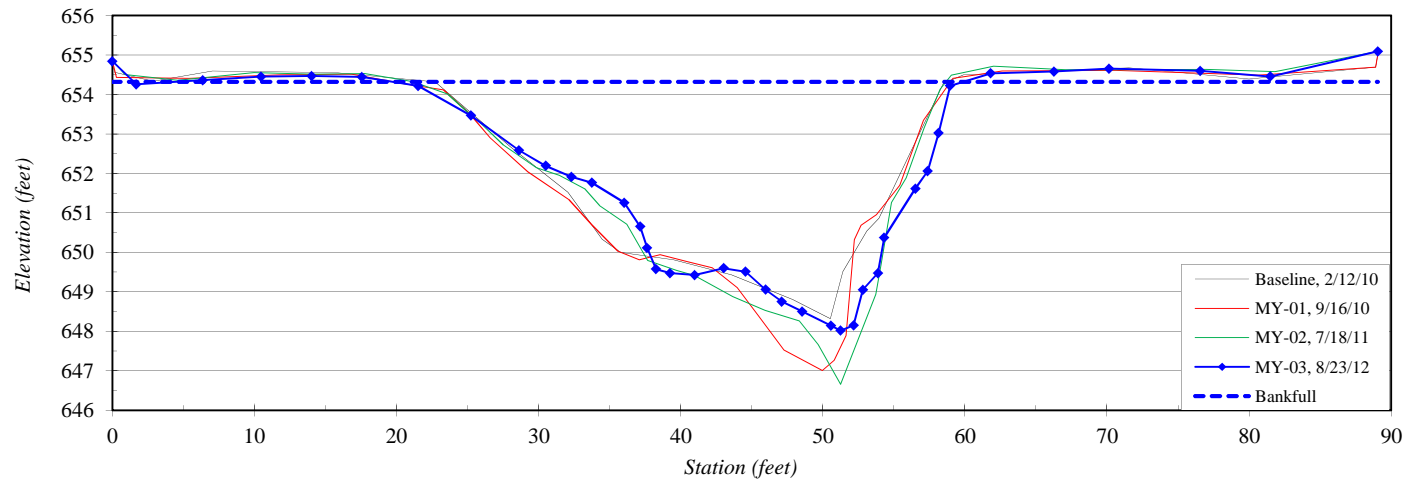
Cape Fear River Basin, Little Troublesome Creek, MY-03, LTC (XS - 2, Pool) Station 13+90

SUMMARY DATA	
Bankfull Elevation:	654.3
Bankfull Cross-Sectional Area:	128.8
Bankfull Width:	40.2
Flood Prone Area Elevation:	-
Flood Prone Width:	-
Max Depth at Bankfull:	6.3
Mean Depth at Bankfull:	3.2
W / D Ratio:	
Entrenchment Ratio:	-
Bank Height Ratio:	-

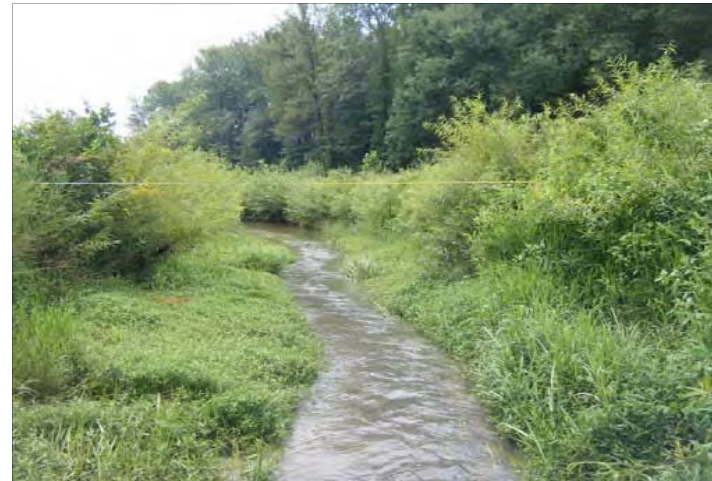
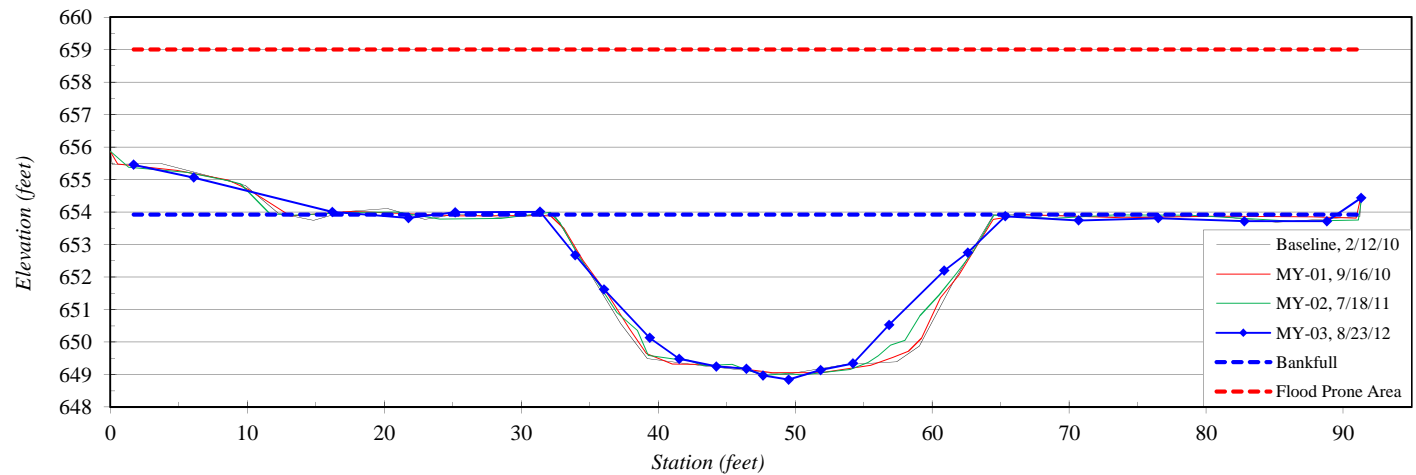
Cape Fear River Basin, Little Troublesome Creek, MY-03, LTC (XS - 3, Riffle) Station 16+30

SUMMARY DATA	
Bankfull Elevation:	653.9
Bankfull Cross-Sectional Area:	109.7
Bankfull Width:	33.8
Flood Prone Area Elevation:	659.0
Flood Prone Width:	>90
Max Depth at Bankfull:	5.1
Mean Depth at Bankfull:	3.2
W / D Ratio:	27.7
Entrenchment Ratio:	2.7
Bank Height Ratio:	1.0

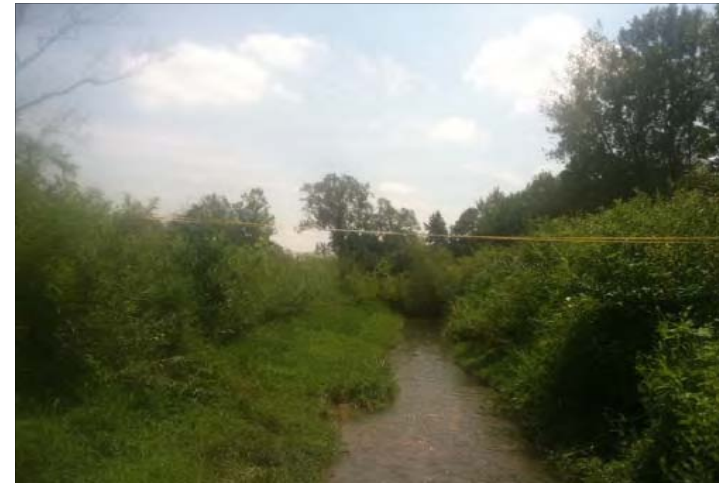
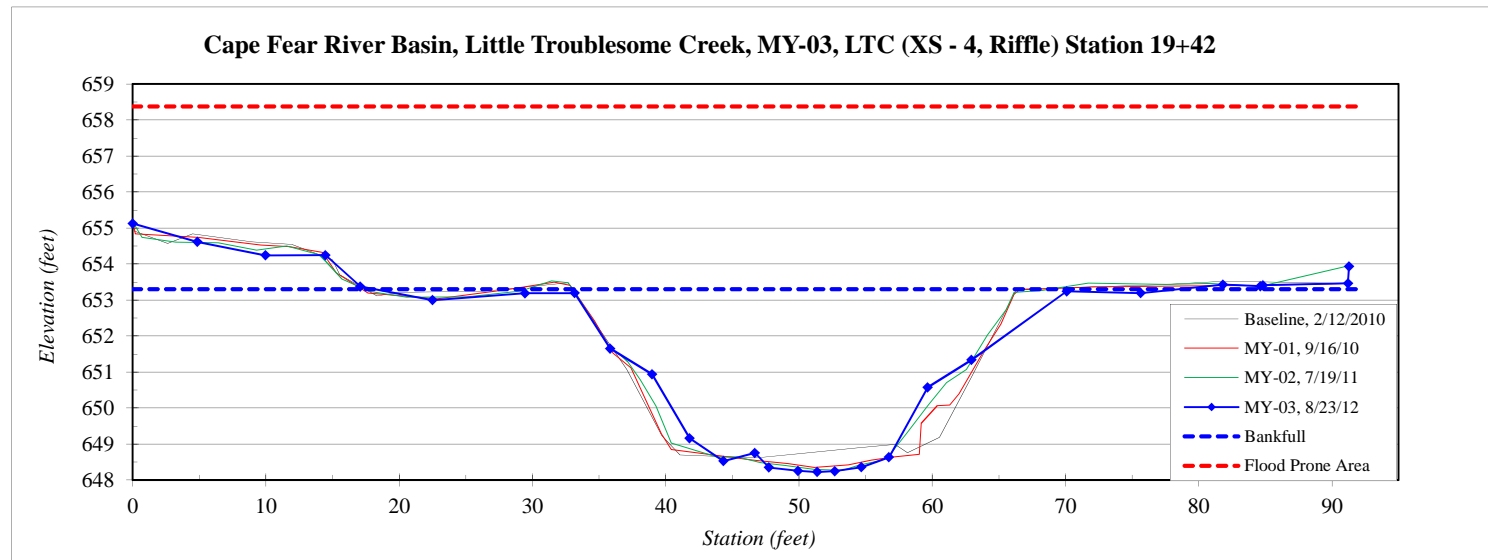
River Basin:	Cape Fear
Watershed:	Little Troublesome Creek, MY-03
XS ID	LTC (XS - 4, Riffle) Station 19+42
Drainage Area (sq mi):	12.09
Date:	8/23/2012
Field Crew:	A. Helms, F. Davis

SUMMARY DATA	
Bankfull Elevation:	653.3
Bankfull Cross-Sectional Area:	115.6
Bankfull Width:	36.9
Flood Prone Area Elevation:	658.4
Flood Prone Width:	>90
Max Depth at Bankfull:	5.1
Mean Depth at Bankfull:	3.1
W / D Ratio:	11.8
Entrenchment Ratio:	2.4
Bank Height Ratio:	1.0

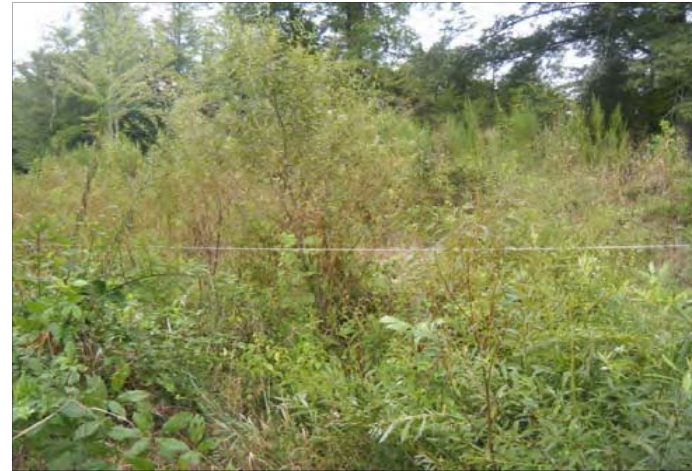
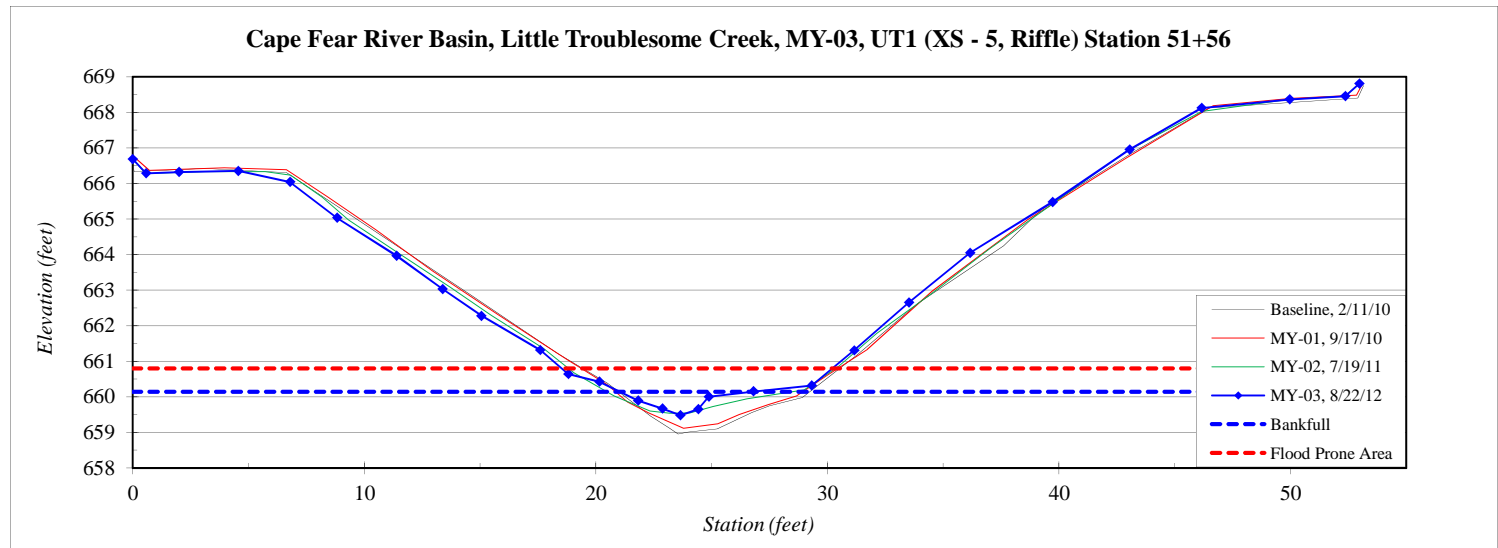
River Basin:	Cape Fear
Watershed:	Little Troublesome Creek, MY-03
XS ID	UT1 (XS - 5, Riffle) Station 51+56
Drainage Area (sq mi):	0.10
Date:	8/22/2012
Field Crew:	A. Helms, F. Davis

SUMMARY DATA	
Bankfull Elevation:	660.1
Bankfull Cross-Sectional Area:	1.6
Bankfull Width:	5.6
Flood Prone Area Elevation:	660.8
Flood Prone Width:	11.0
Max Depth at Bankfull:	0.7
Mean Depth at Bankfull:	0.3
W / D Ratio:	19.6
Entrenchment Ratio:	2.0
Bank Height Ratio:	1.0

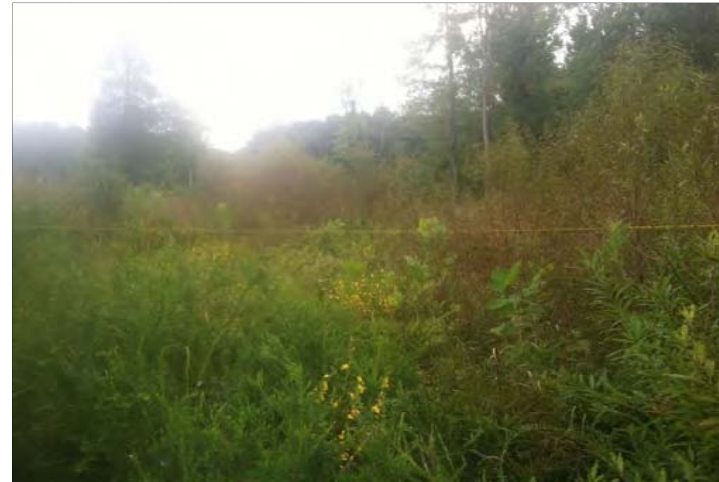
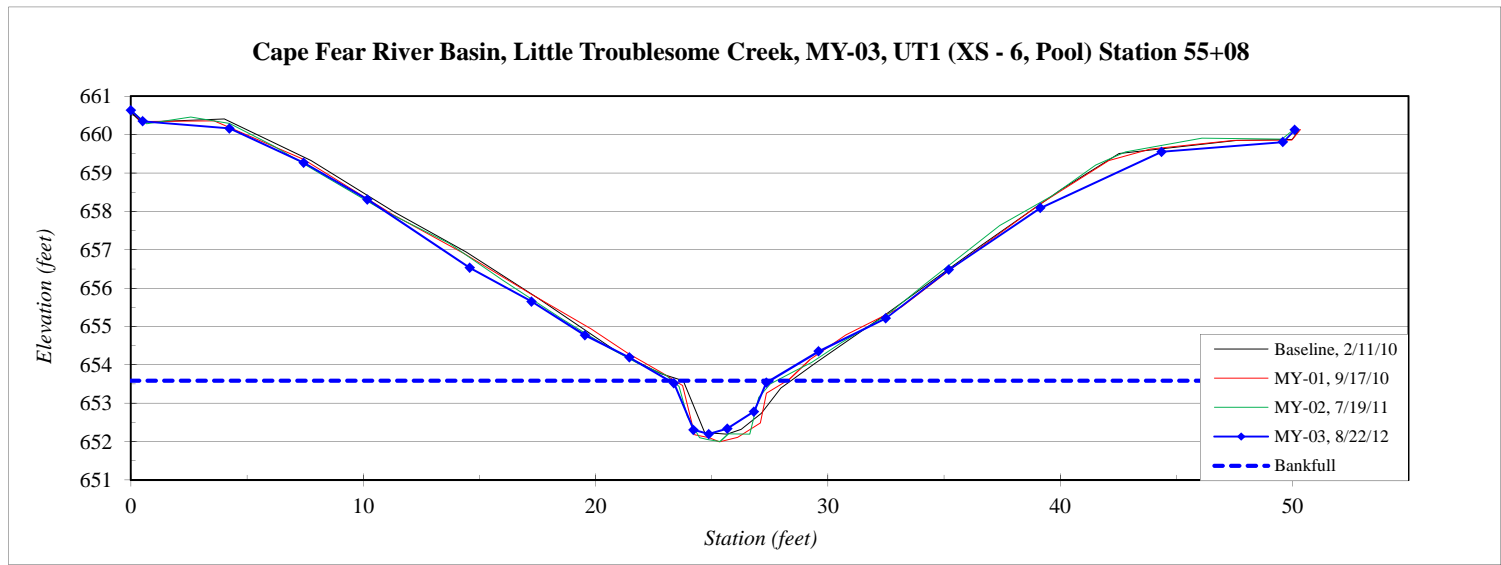
River Basin:	Cape Fear
Watershed:	Little Troublesome Creek, MY-03
XS ID	UT1 (XS - 6, Pool) Station 55+08
Drainage Area (sq mi):	0.10
Date:	8/22/2012
Field Crew:	A. Helms, F. Davis

SUMMARY DATA	
Bankfull Elevation:	653.6
Bankfull Cross-Sectional Area:	3.9
Bankfull Width:	4.3
Flood Prone Area Elevation:	-
Flood Prone Width:	-
Max Depth at Bankfull:	1.4
Mean Depth at Bankfull:	0.9
W / D Ratio:	-
Entrenchment Ratio:	-
Bank Height Ratio:	-

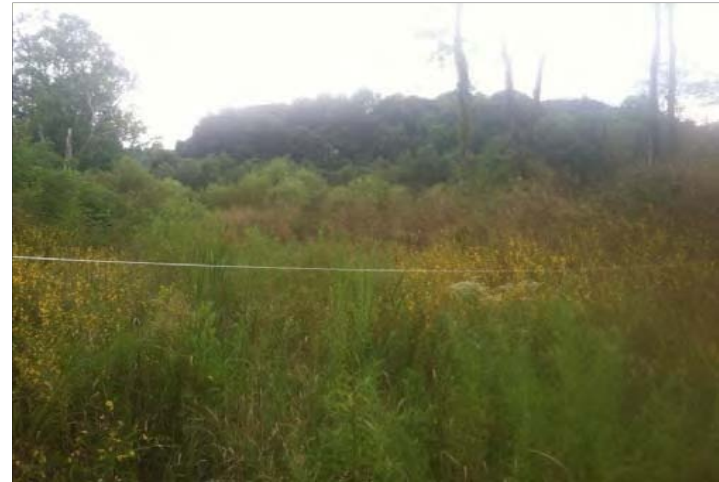
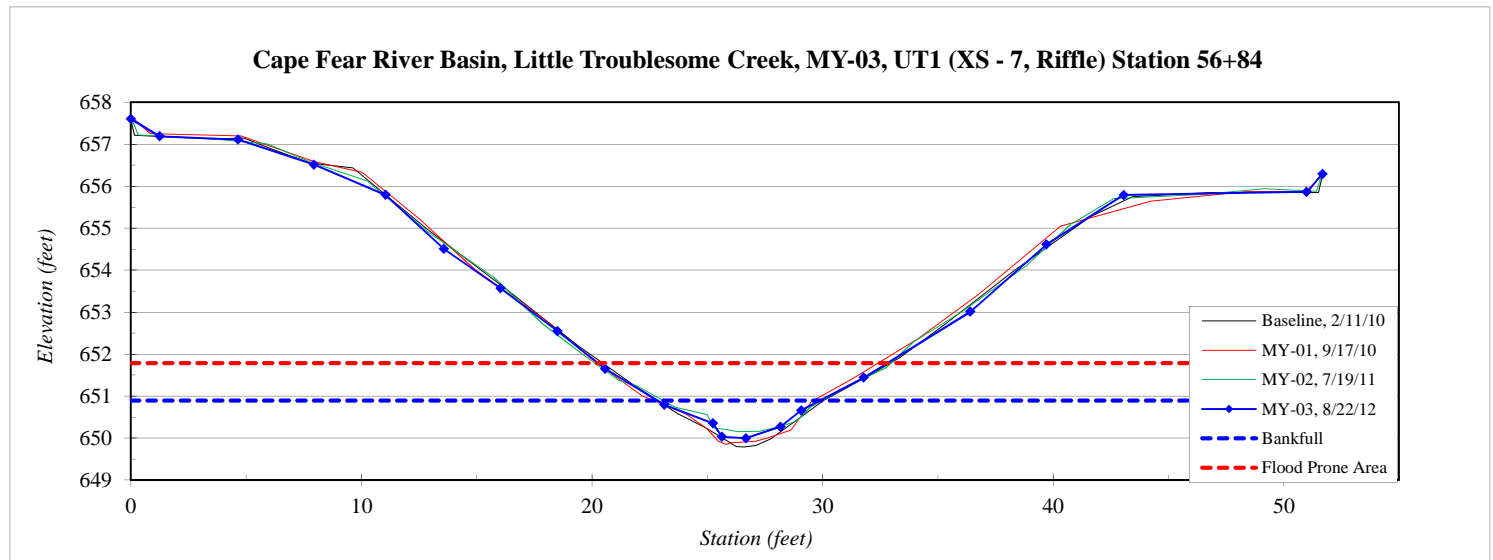
River Basin:	Cape Fear
Watershed:	Little Troublesome Creek, MY-03
XS ID	UT1 (XS - 7, Riffle) Station 56+84
Drainage Area (sq mi):	0.10
Date:	8/22/2012
Field Crew:	A. Helms, F. Davis

SUMMARY DATA	
Bankfull Elevation:	650.9
Bankfull Cross-Sectional Area:	3.5
Bankfull Width:	7.0
Flood Prone Area Elevation:	651.8
Flood Prone Width:	12.6
Max Depth at Bankfull:	0.9
Mean Depth at Bankfull:	0.5
W / D Ratio:	14.0
Entrenchment Ratio:	1.8
Bank Height Ratio:	1.0
