**Little Troublesome Site  
Stream Restoration Final Monitoring Report  
EEP Project # 749  
EEP Contract # 004711  
Monitoring Year 05**

**Construction Completed: December 2009**

**Data Collection: 2014**

**Submitted: January 2015**

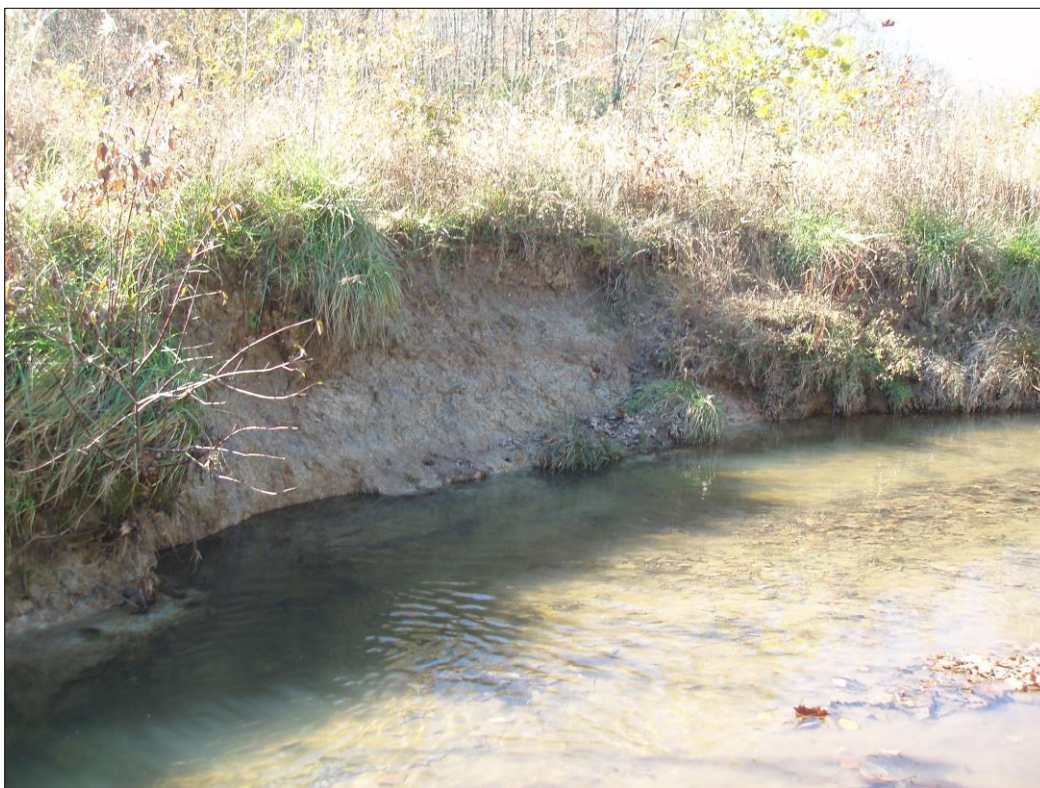
The 2014 monitoring found that areas along the slope from the left bank of the tributary to the terrace (the north-facing slope) previously reported as having sparse vegetation coverage had begun to show more robust coverage. Herbaceous coverage along the slope achieved 100% cover and many volunteer woody species have begun to grow along this area. There has been high live stake survival along the tributary and variable survival along Little Troublesome Creek. Small patches of Multiflora rose (*Rosa multiflora*) and Chinese lespedeza (*Lespedeza cuneata*) are scattered throughout the easement along Little Troublesome Creek and UT1. Two areas of air yam (*Dioscorea bulbifera*) are located along UT1 between stationing 51+50 and 54+50 and stationing 56+75 and 58+50. Small areas of Japanese hops (*Humulus japonicas*) are also located on Little Troublesome Creek between stationing 13+80 and 15+75 and stationing 19+50 and 21+00.

Bank Erosion at Station 13+80 11/10/14 – MY05
