MONITORING YEAR 5 ANNUAL REPORT

LITTLE TROUBLESOME CREEK MITIGATION SITE

Rockingham County, NC
NCDEQ Contract 003267
DMS Project Number 94640

Data Collection Period: April 2016-November 2016
Draft Submission Date: November 23, 2016
Final Submission Date: December 19, 2016

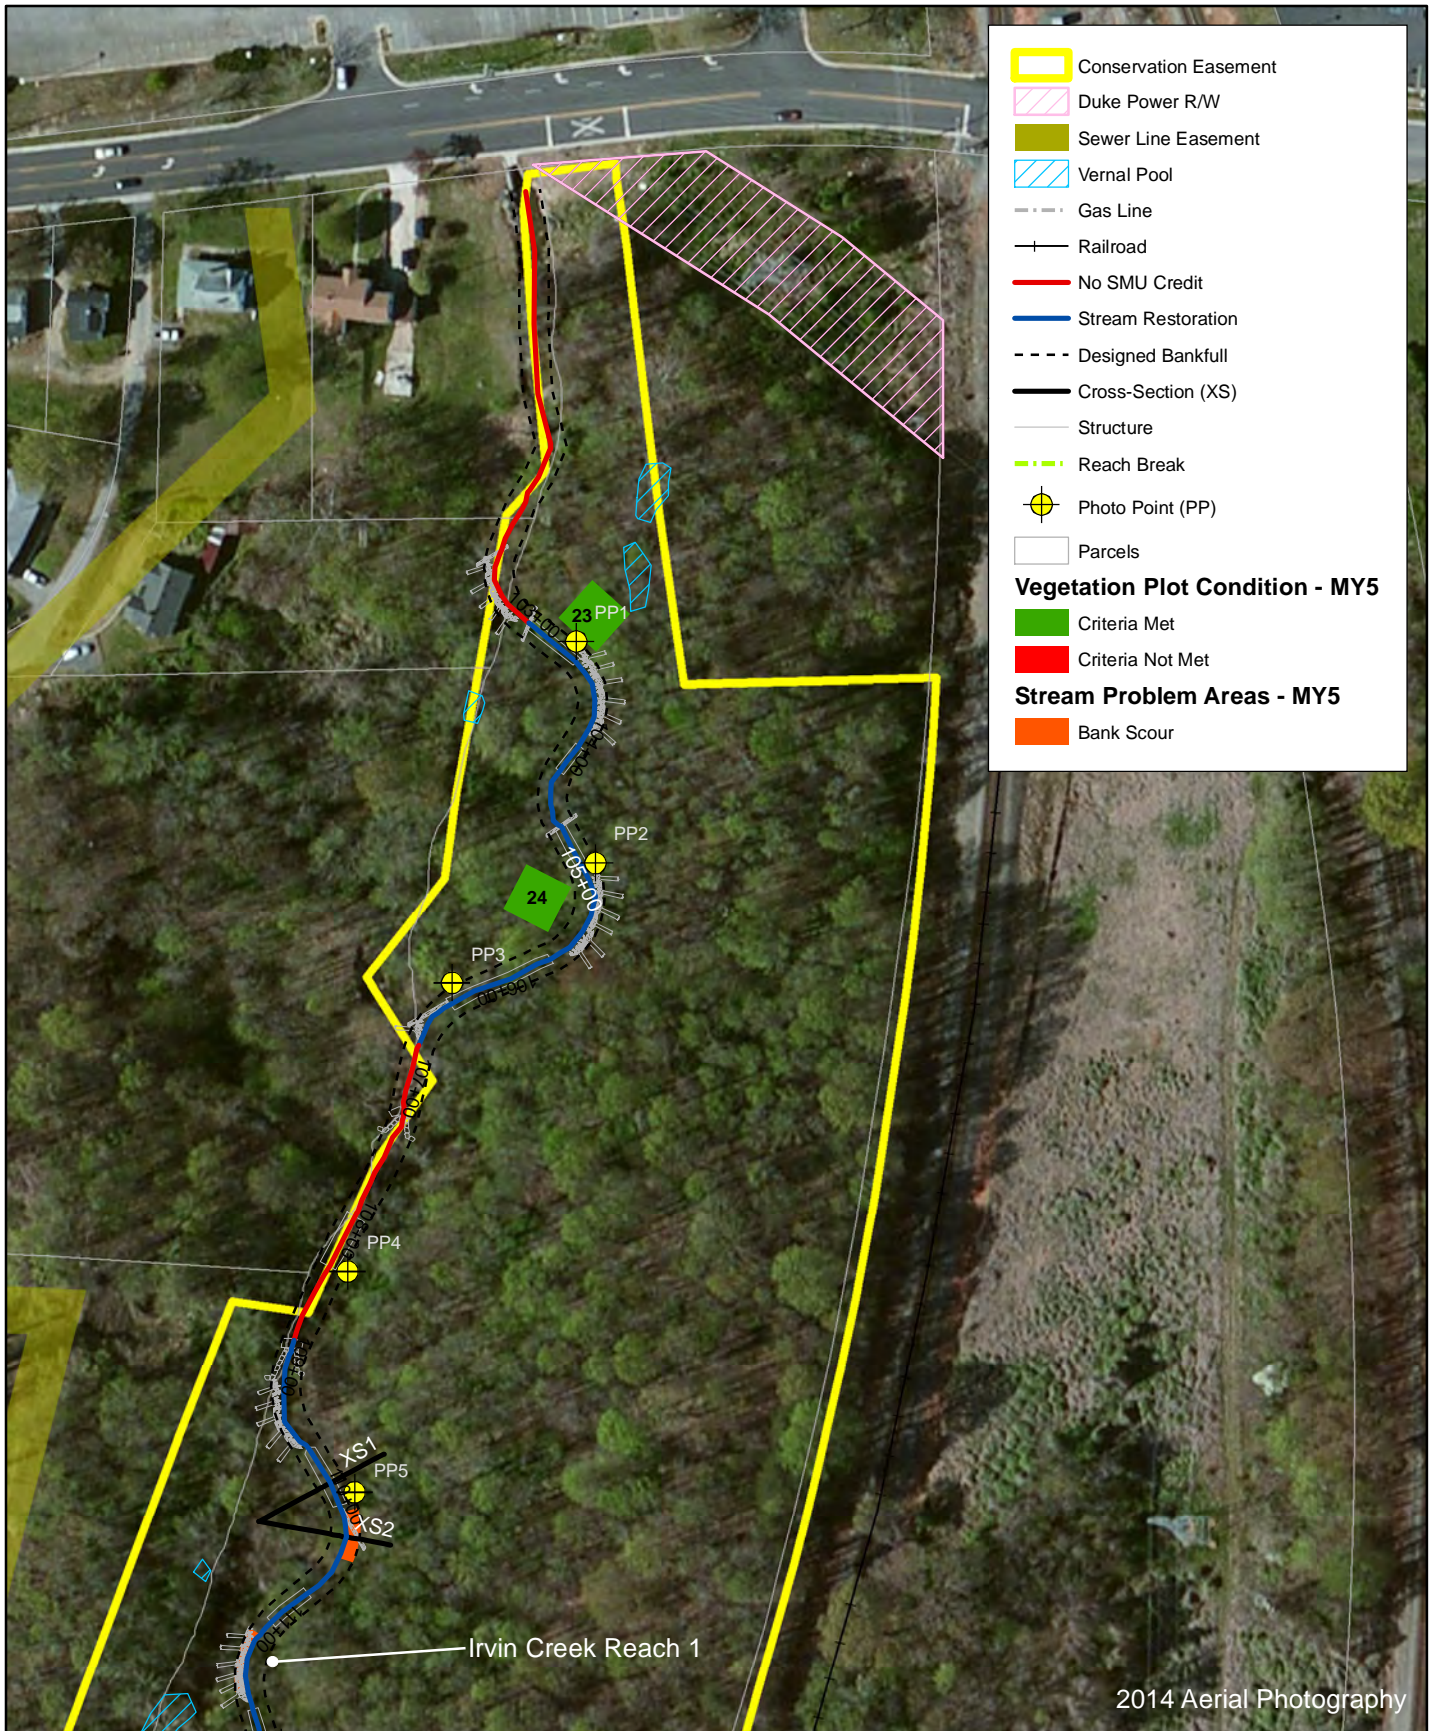
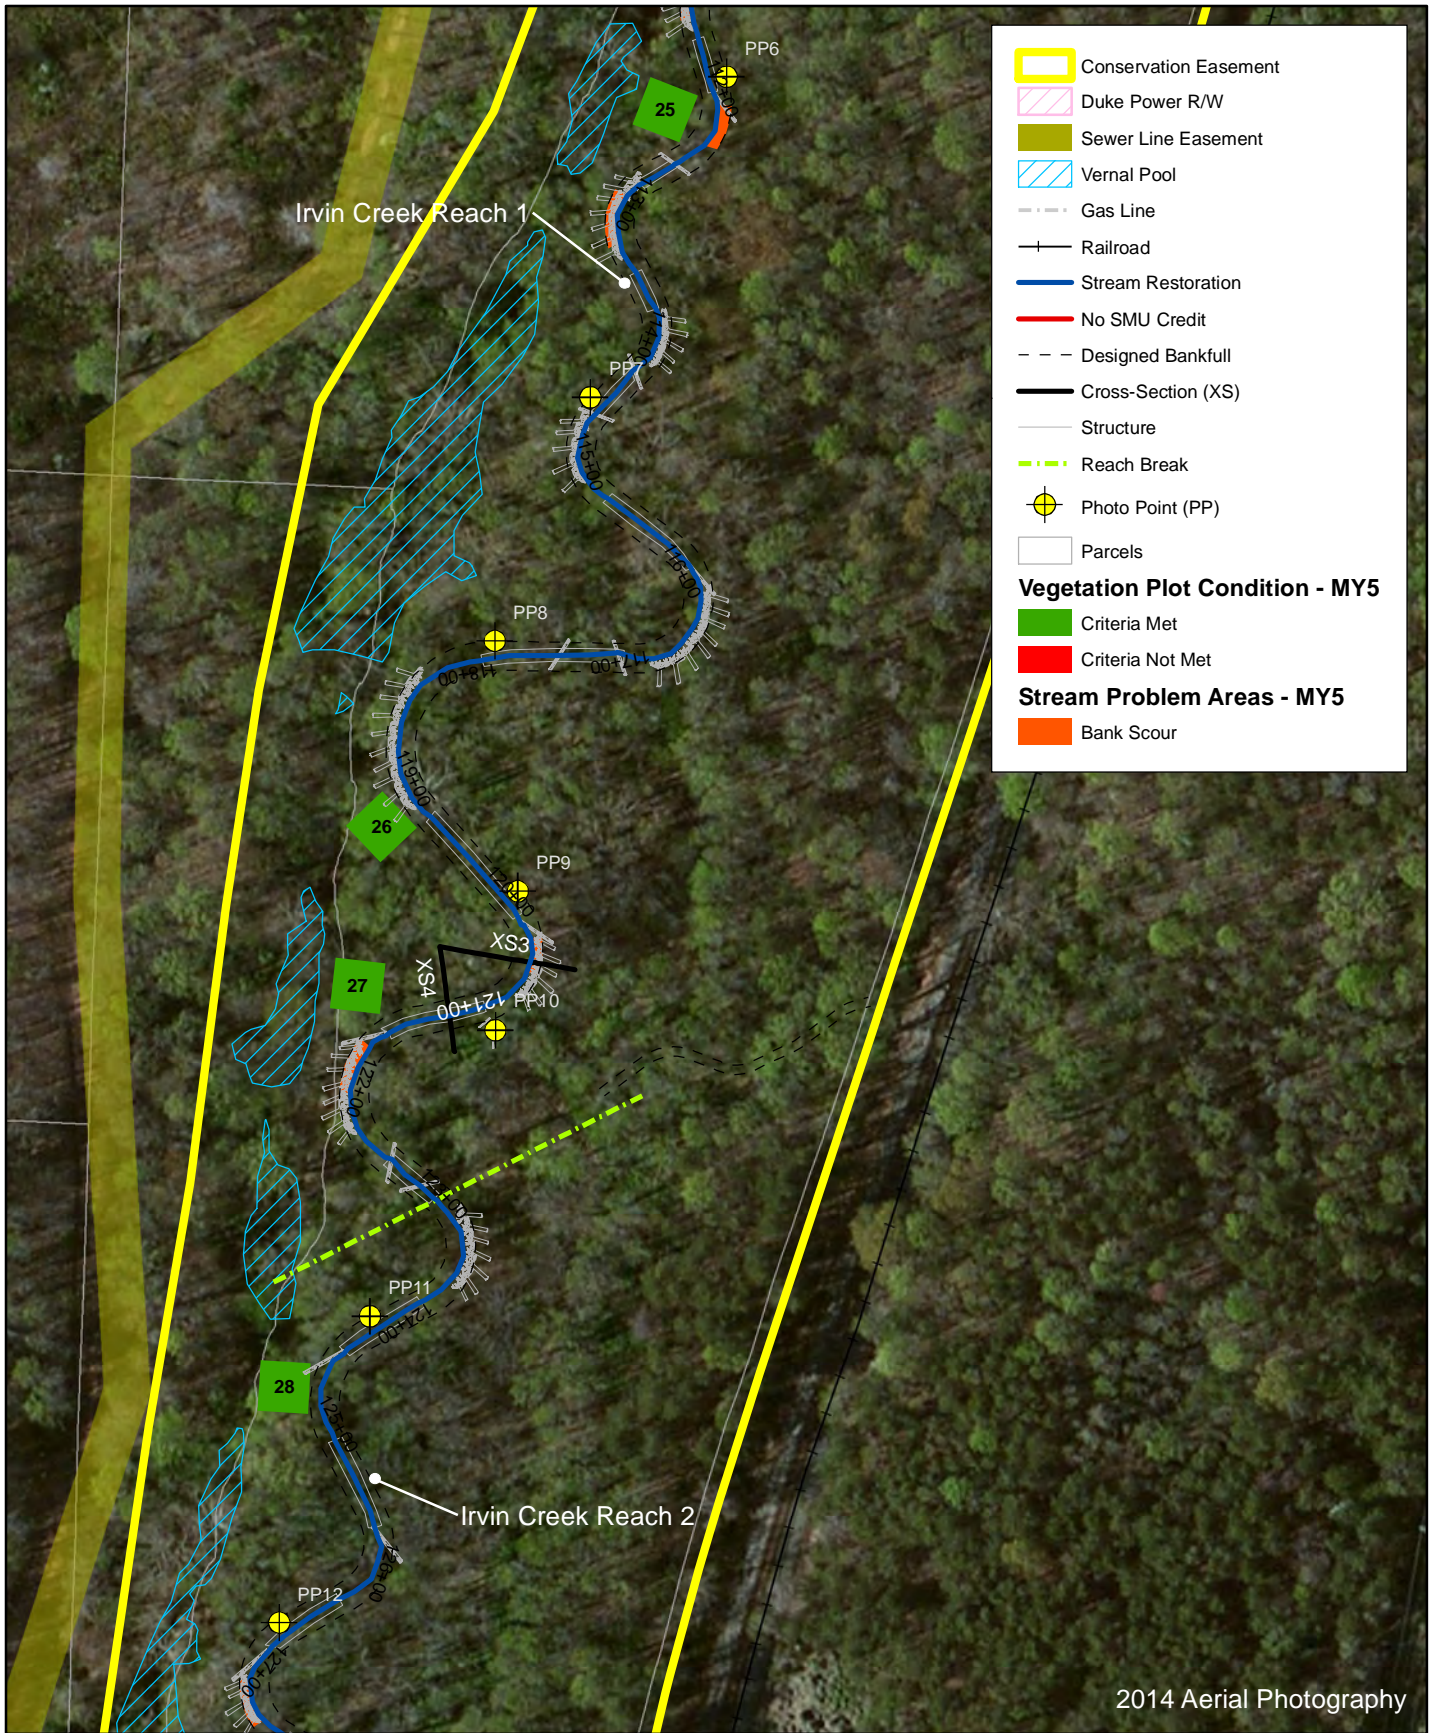
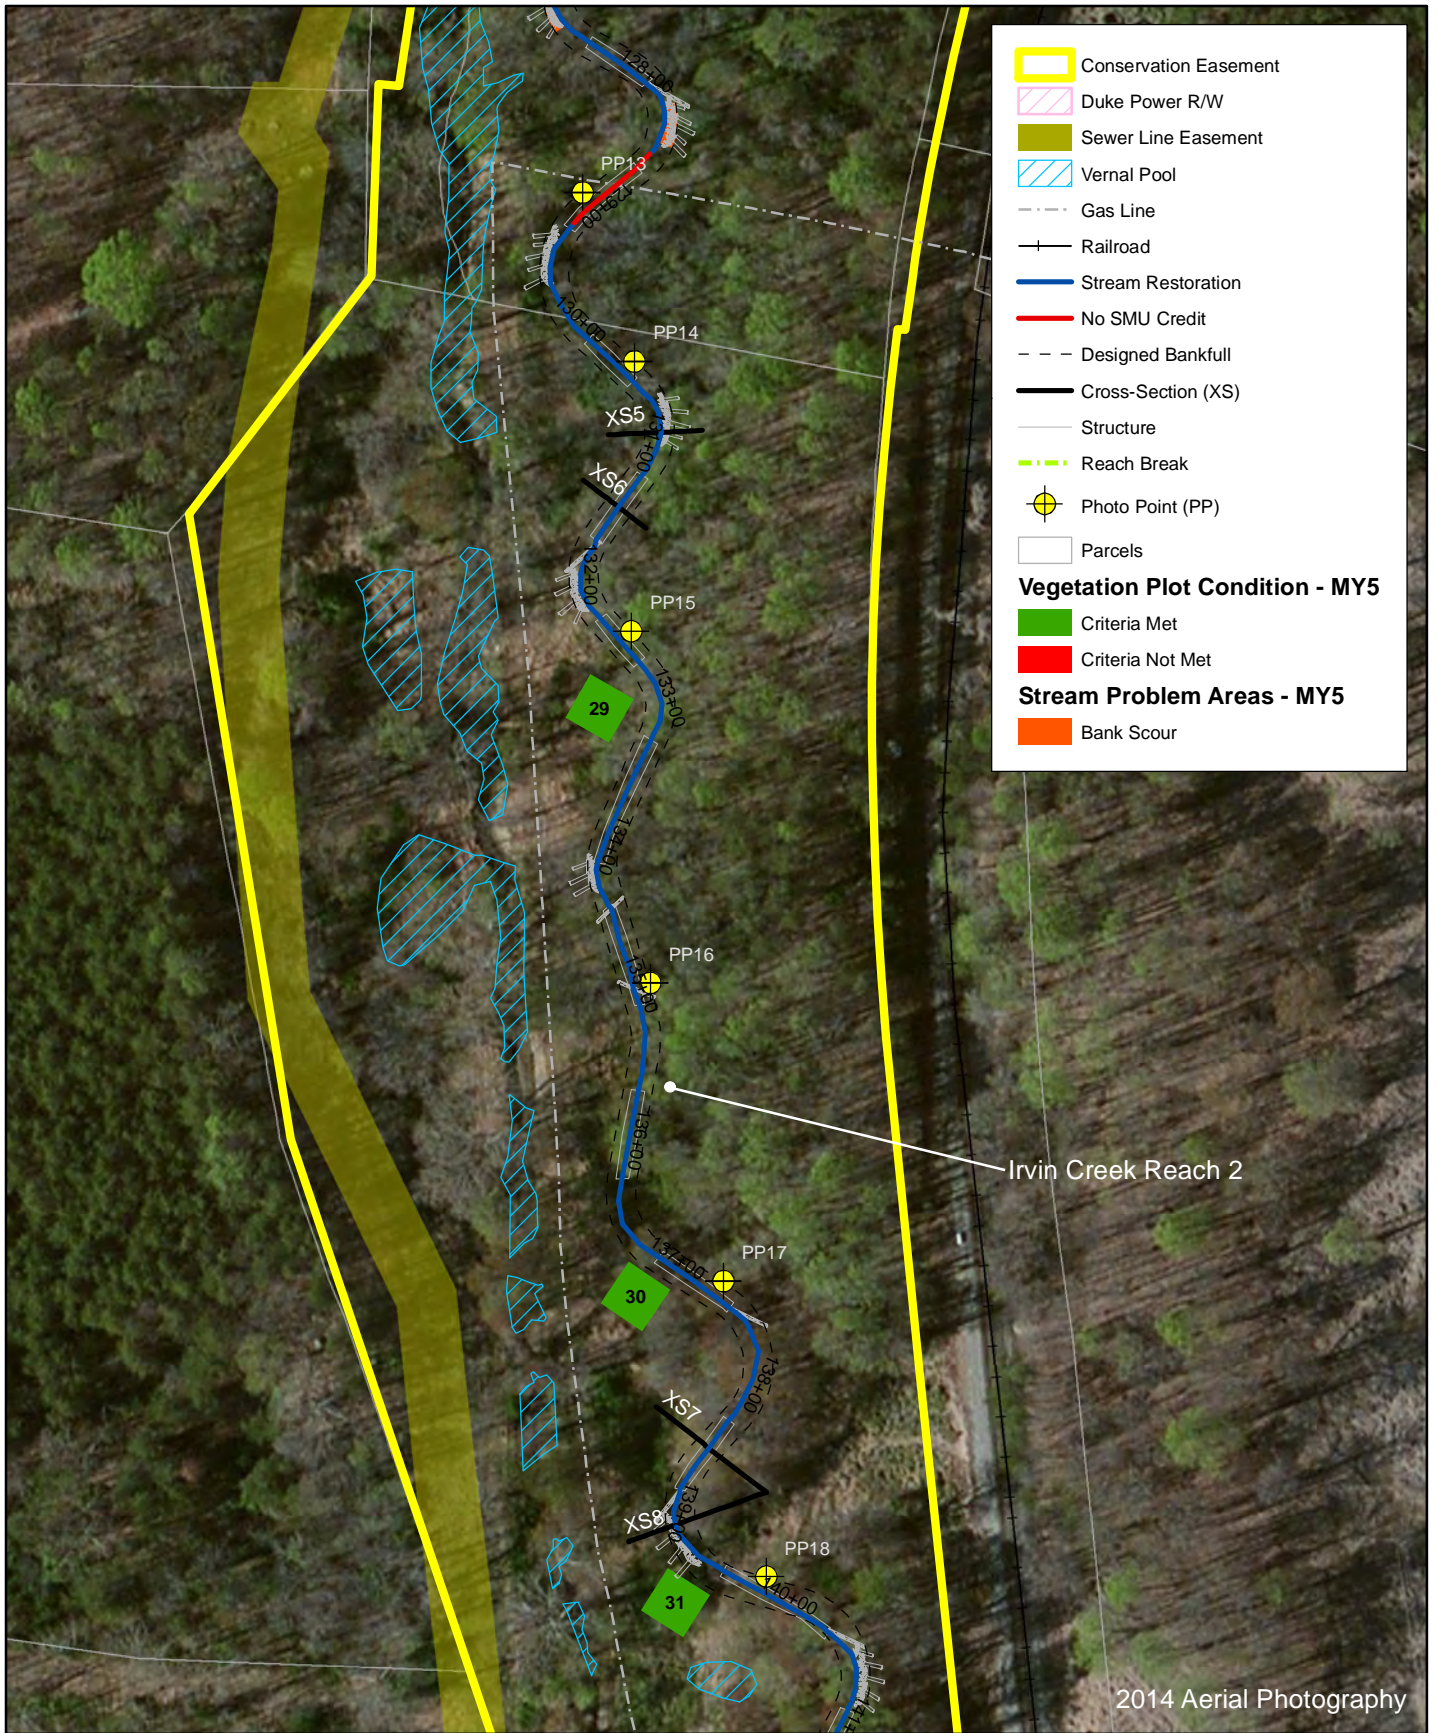
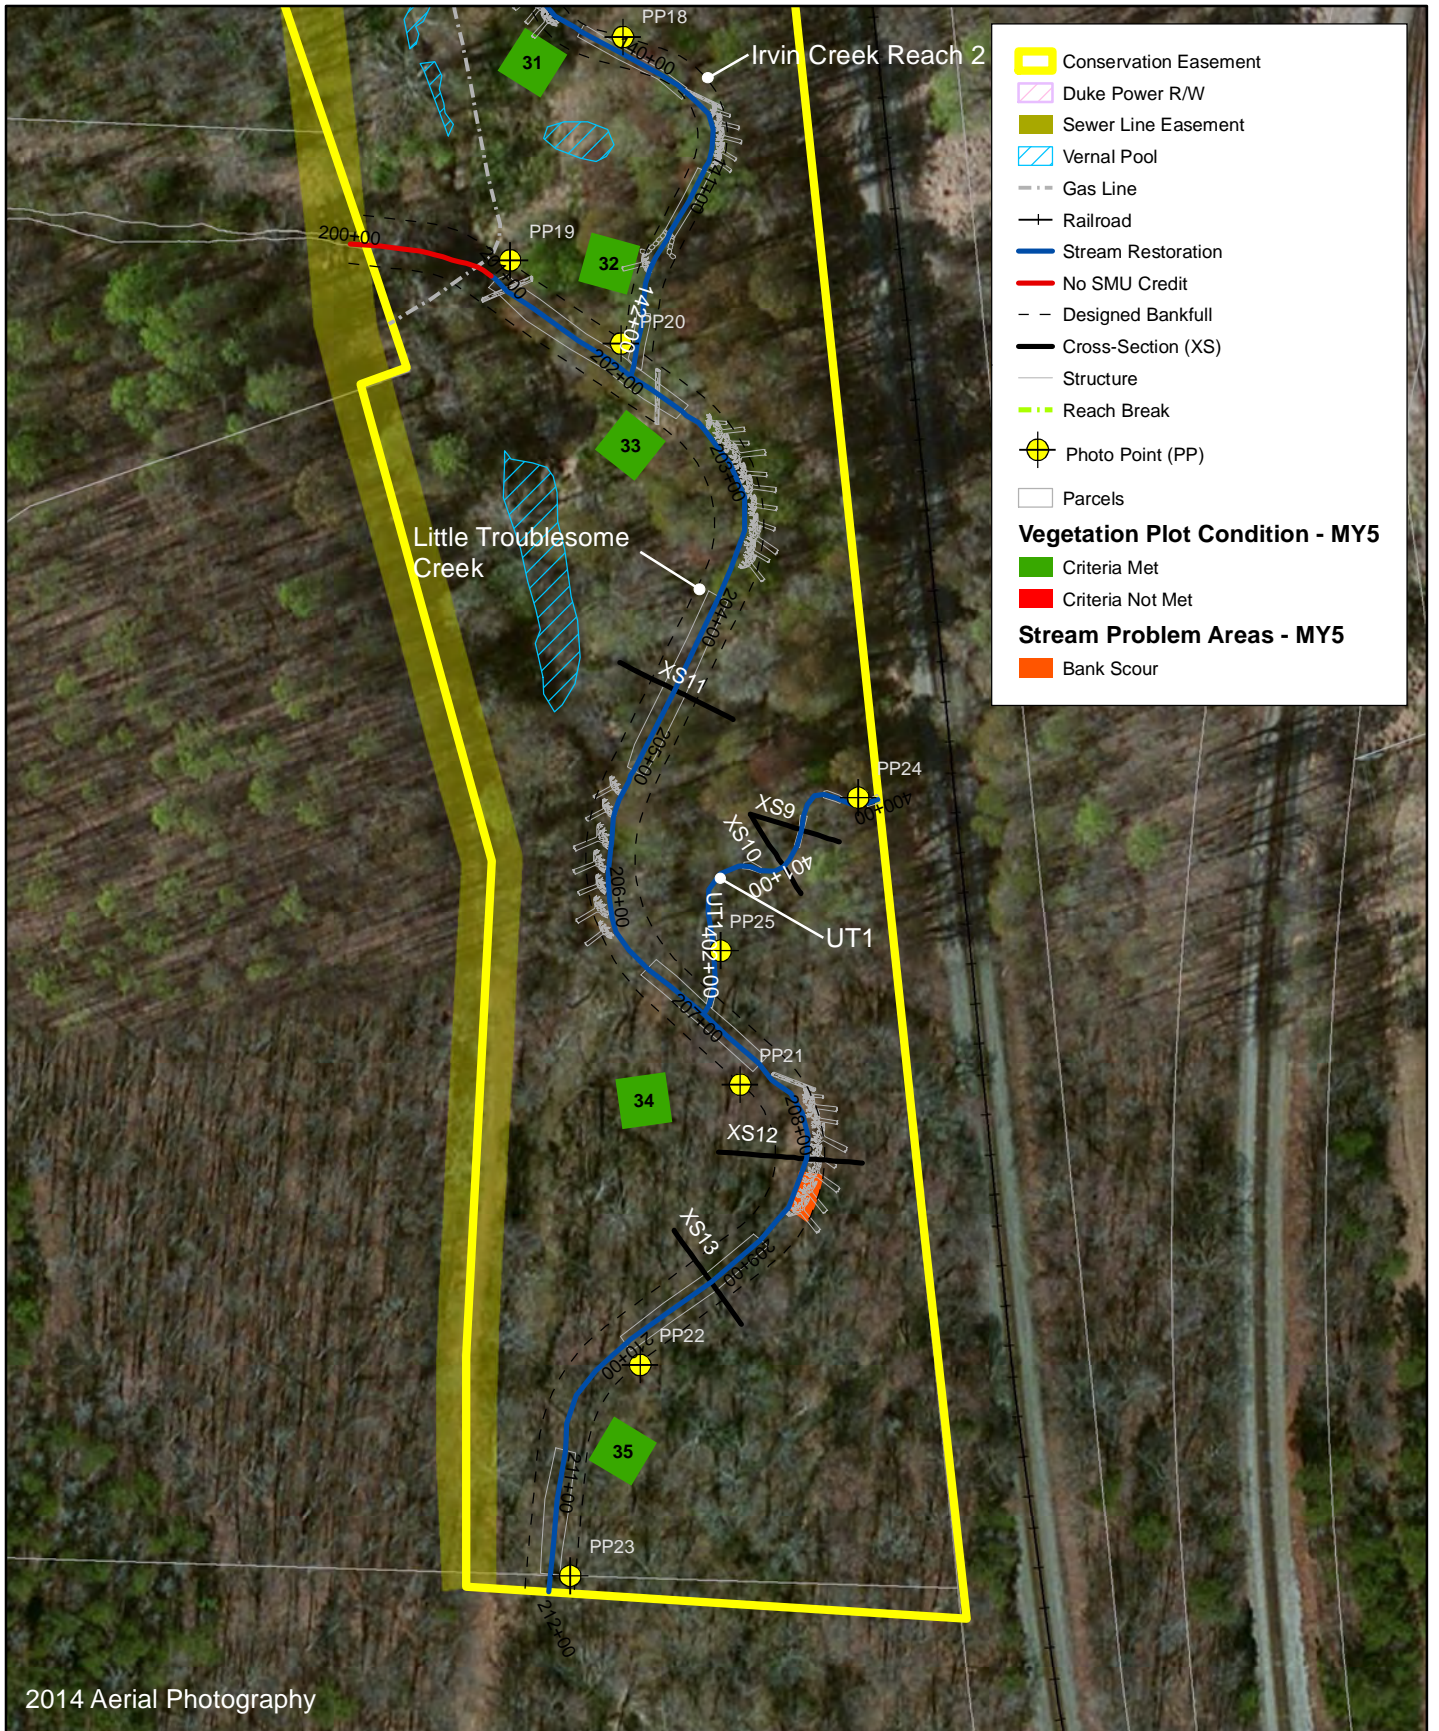
In-stream structures such as root wads, used to enhance channel habitat and stability on the outside bank of meander bends are providing stability and habitat as designed. During MY-5 a few isolated areas of bank scour were documented on Little Troublesome Creek and Irvin Creek. These areas will be repaired during the winter of 2016/ 2017 as described below in section 1.2.4.

The Stream Site had a significant flow event during Hurricane Mathew, resulting in a few isolated areas of bank scour on Little Troublesome Creek and Irvin Creek. Wildlands is currently working with a contractor to repair these areas prior to project close-out. This repair will include installing brush toe and soil lifts with live willow whips. Most of the repair work will be done by hand and will include planting live stakes on the stream banks. Heavy equipment will only be used when necessary to avoid causing any damage to the Site. The only area that will require heavy equipment is one bend on Little Troublesome Creek. Refer to Appendix 2, Current Condition Plan View Maps for the location of bank scour on these streams.

Wildlands is currently working with a contractor to repair the isolated area of bank erosion as described in section 1.2.4 above.

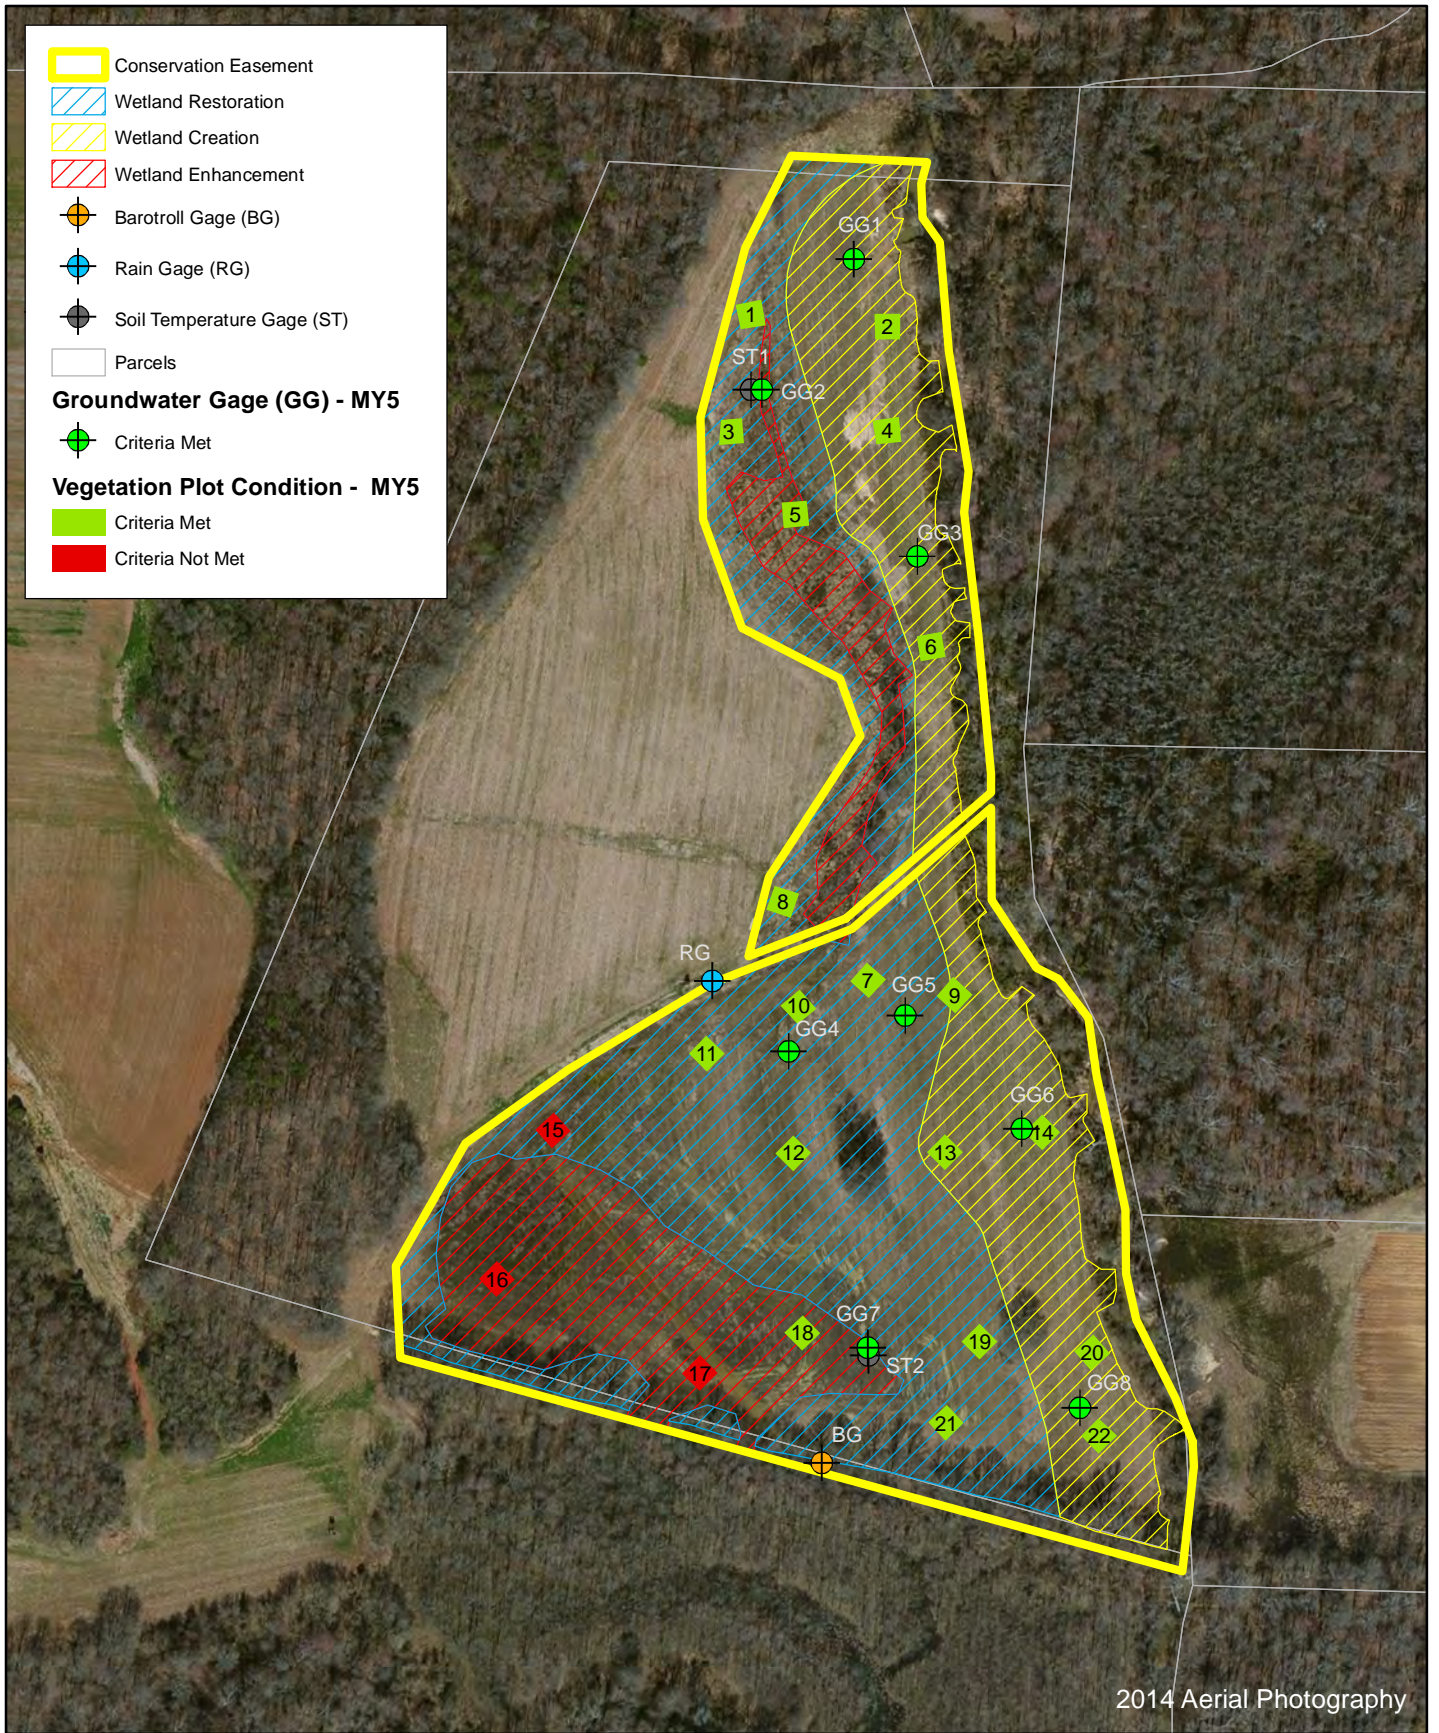
Figure 3.5 Integrated Current Condition Plan View
 Little Troublesome Creek Mitigation Site
 Wetland Site
 DMS Project Number 94640
 Monitoring Year 5 - 2016

At the Wetland Site, three of the plots did not meet the final success criteria and averaged 189 stems per acre; however with the inclusion of volunteer species the three plots average 499 stems per acre which is well above the final requirement of 260 stems/acre. These three plots are located on one of the wettest parts of the Wetland Site. In the past, Wildlands has observed higher planted tree mortality in areas with frequently standing water, compared to the drier parts of projects. There was an average of 12 stems per plot in MY-5 as compared to 17 stems per plot during MY-0 for the Wetland Site. Although three wetland vegetation plots are not meeting for planted stems, the volunteer stems consist of desirable hardwood species from the planting plan. With the inclusion of volunteer species, all 22 plots at the Wetland Site meet the MY-5 success criteria.
