ANNUAL MONITORING REPORT

YEAR 2 (2008)

LLOYD STREAM AND WETLAND RESTORATION SITE ONslow COUNTY, NORTH CAROLINA

November 2008

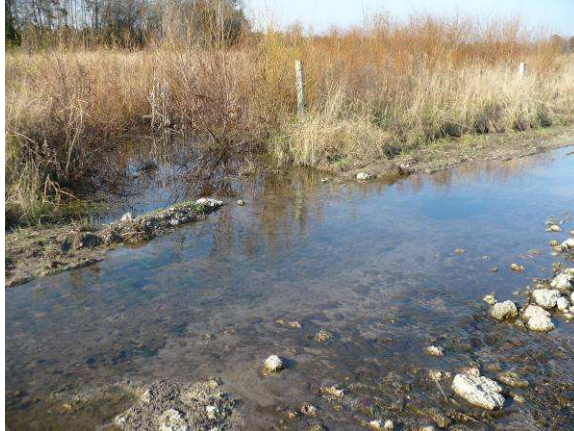
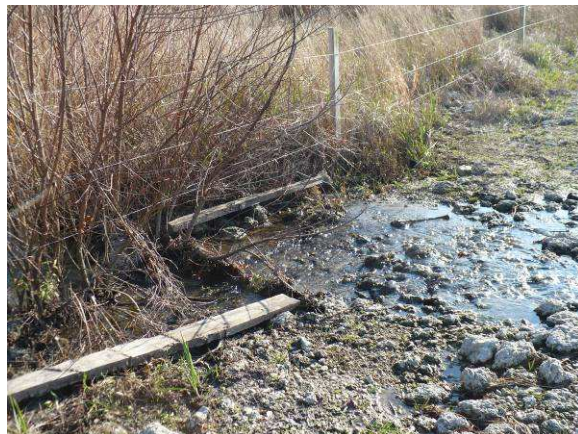
One stream problem area was noted at the forded stream crossing located within Monitoring Reach 1. Heavy trucks used the ford during a logging operation affecting the integrity of the structure and causing water to pond within approximately 100 linear feet of stream channel behind the ford; pictures are included in Appendix B. Restoration Systems is currently assessing the problem and will either install a culvert or lower the level of the ford during the winter of 2008-2009. No other stream problem areas were noted within the Site during the Year 2 (2008) monitoring year.

Ford within Reach 2 that was
compromised by heavy logging
truck use.
