ANNUAL MONITORING REPORT

YEAR 3 (2009)

CONTRACT D06003-1

LLOYD STREAM AND WETLAND RESTORATION SITE ONSLOW COUNTY, NORTH CAROLINA

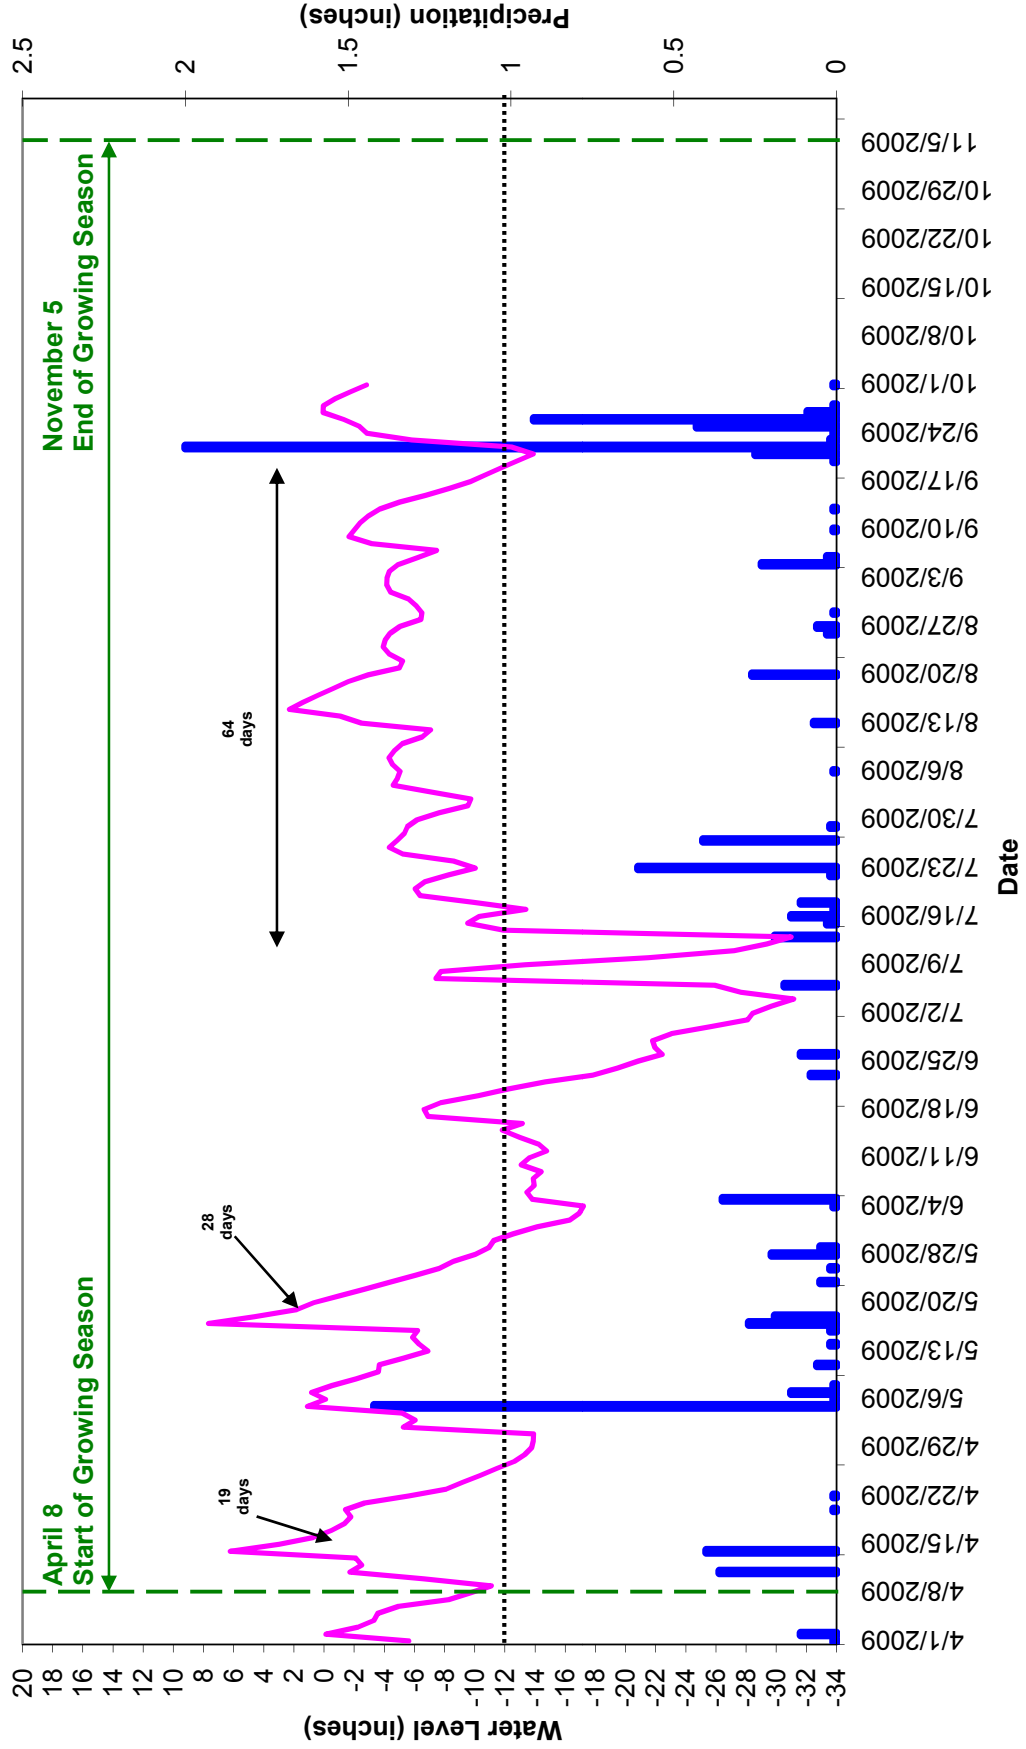
Lloyd Restoration Site - Groundwater Gauge LG4 Year 3 (2009 Data)

Four restoration Site groundwater gauges and one reference groundwater gauge were operated for the Year 3 (2009) monitoring season. One of the 4 groundwater gauges (Gauge 4) should be considered successful for the Year 3 (2009) monitoring period according to success criteria. Two additional gauges (Gauges 1 and 2) were comparable to the reference gauge, but were slightly below success criteria. In addition, Gauge 3 is located along the upland/wetland margin, which may be affecting its success.
