ANNUAL MONITORING REPORT

YEAR 4 (2010)

CONTRACT D06003-1

LLOYD STREAM AND WETLAND RESTORATION SITE ONSLow COUNTY, NORTH CAROLINA

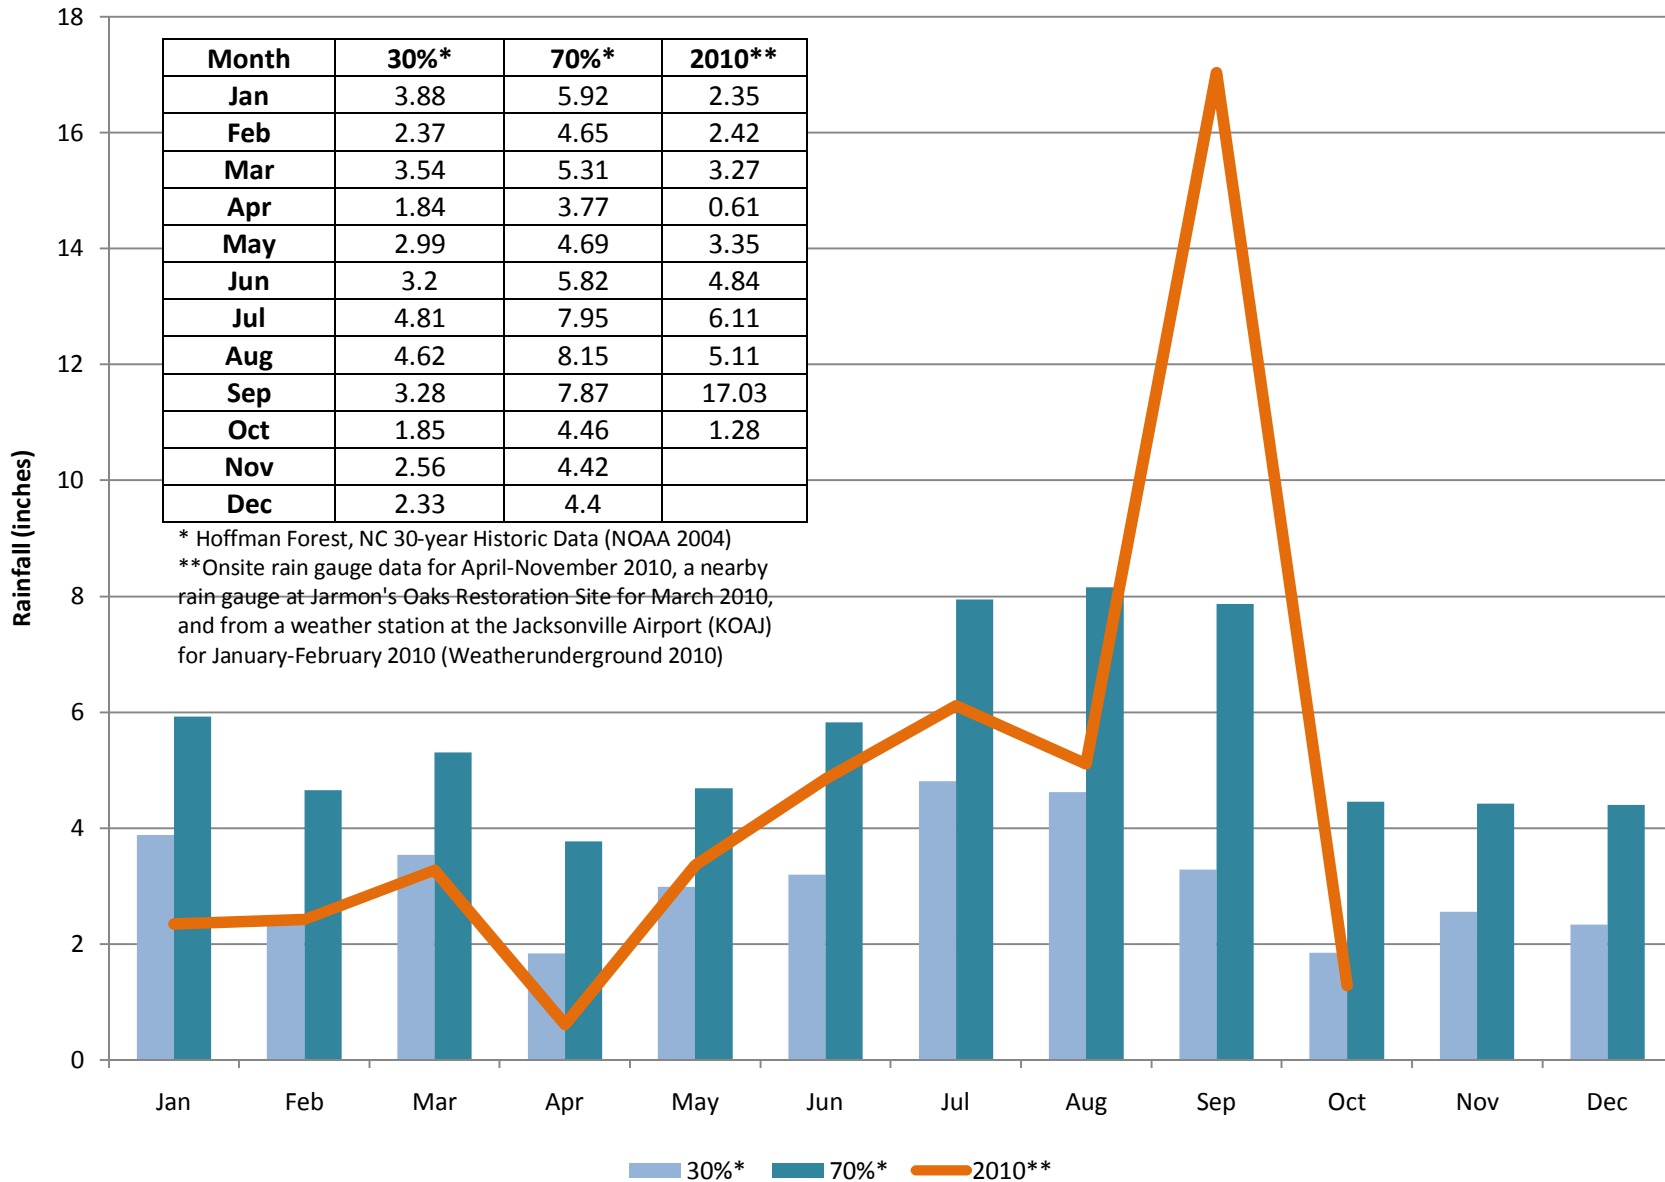
Figure 2. 2010 Annual Climatic Data vs. 30-year Historic Data

Rainfall data at the Site were compared to 30-year historic rainfall totals. During January and March-April 2010 rainfall totals were well-below the 30th percentile and during the month of February 2010 was approximately equal to the 30th percentile (Figure 2). Therefore, success criteria of restoration gauges are based on comparisons to reference gauge data and all gauges should be considered successful for Year 4 (2010) (Table 10). Hydrographs containing groundwater and precipitation data for each gauge can be found in Appendix C.

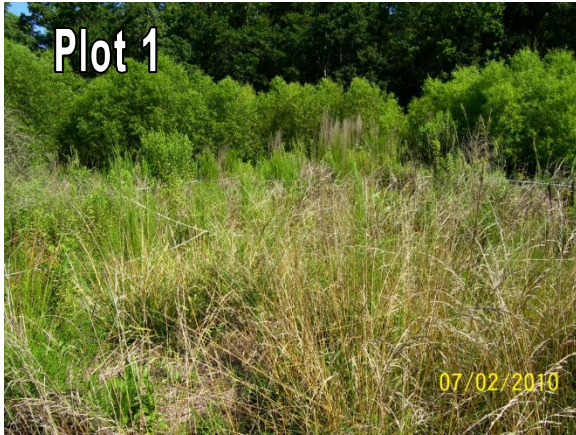
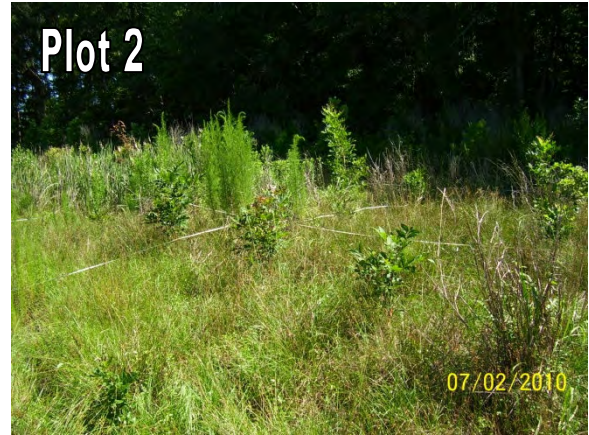
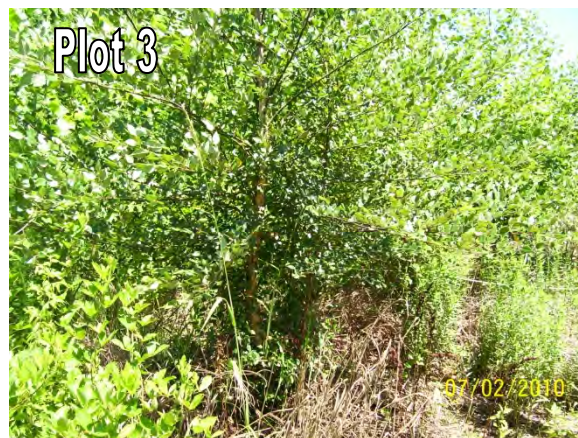
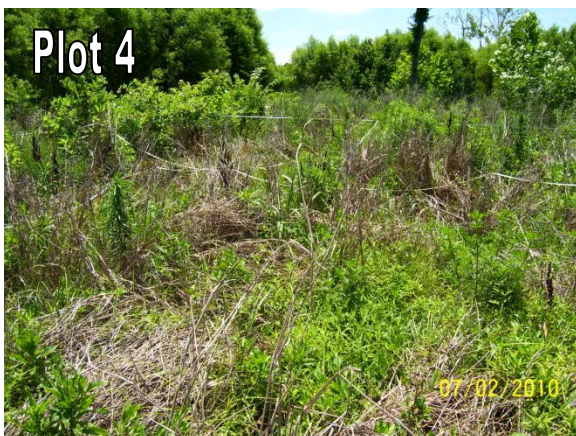
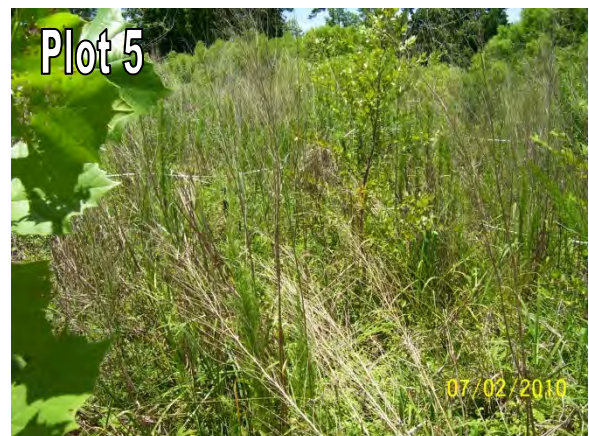
Lloyd Stream and Wetland Restoration Site
Year 4 (2010) Annual Monitoring
Vegetation Plot Photos
Taken July 2010

Vegetation sampling across the Site was above the required average density with 656 planted stems per acre with individual plot densities ranging from 405 to 850 planted stems per acre. A small area of poor vegetation growth is located near groundwater monitoring Gauge 4, most likely due to a lack of nutrients in the soil after construction. This area will continue to be monitored; however, is expected to recover naturally. No other vegetation problem areas were noted during the Year 4 (2010) monitoring season.

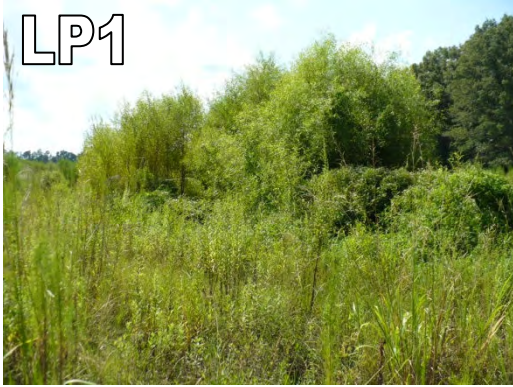
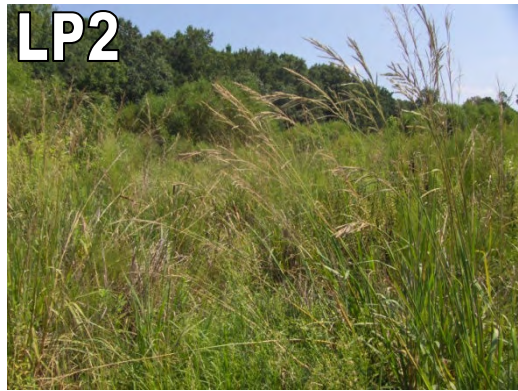
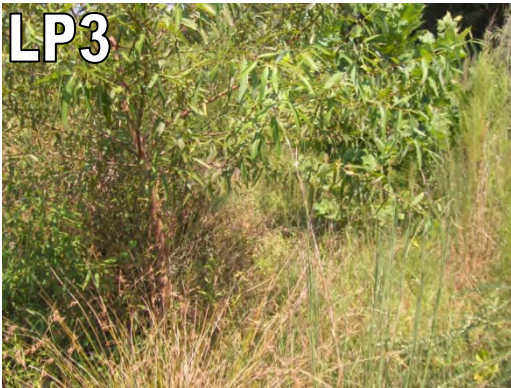
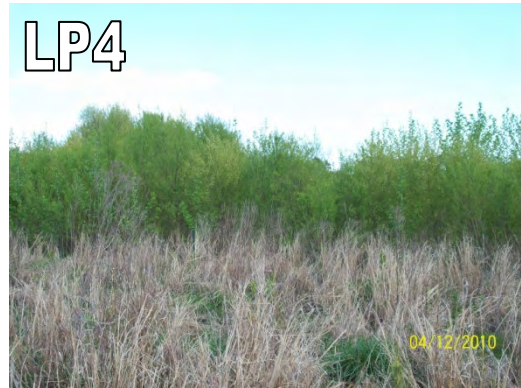
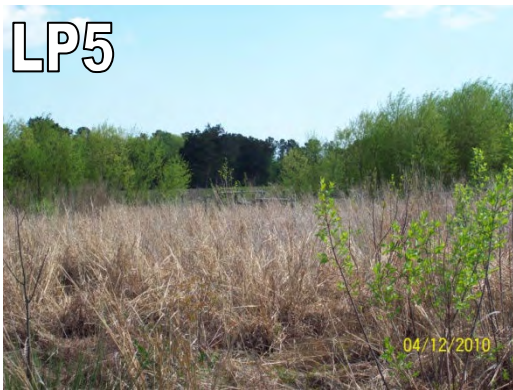
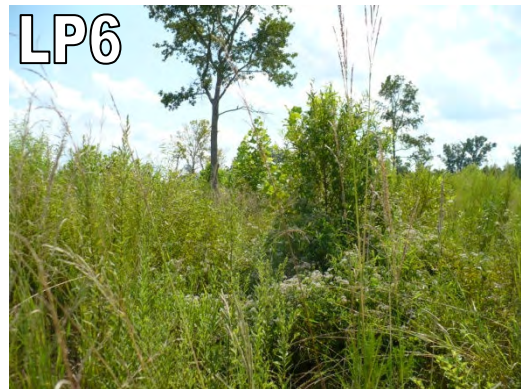
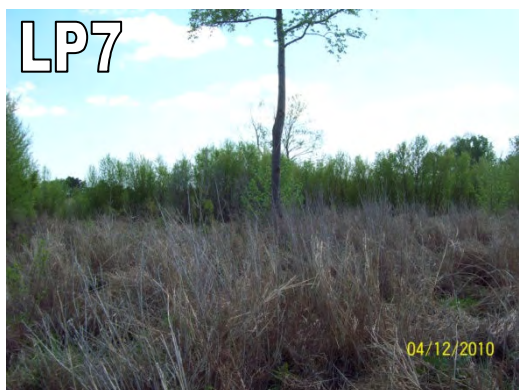
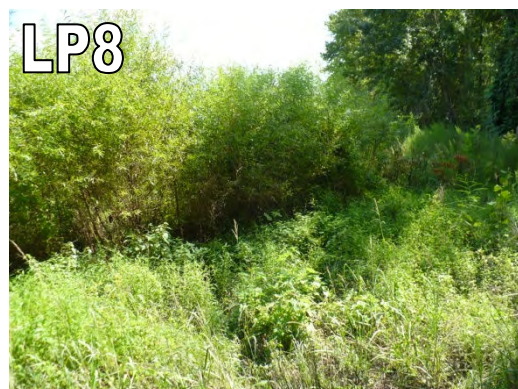
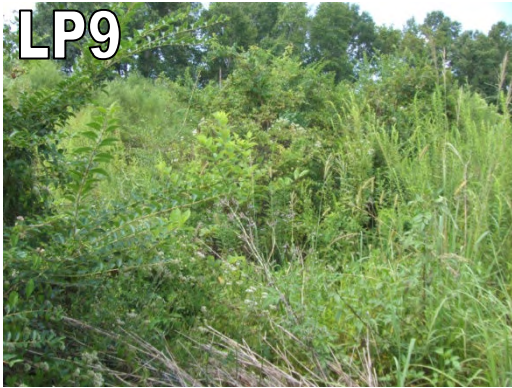
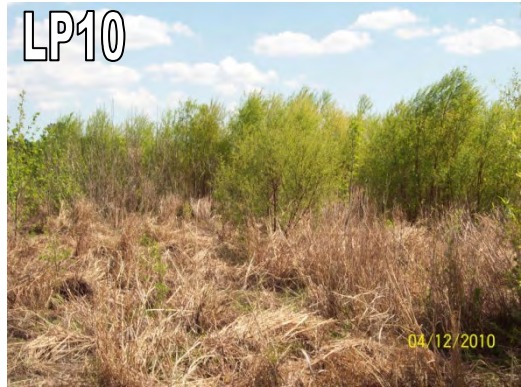
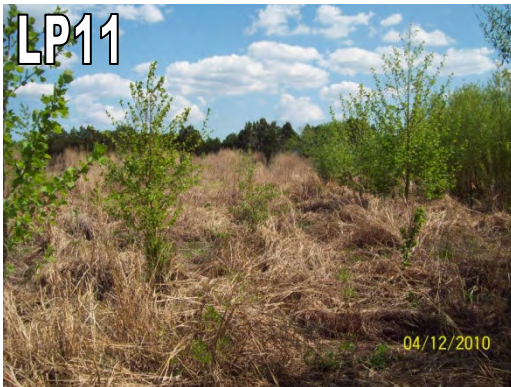
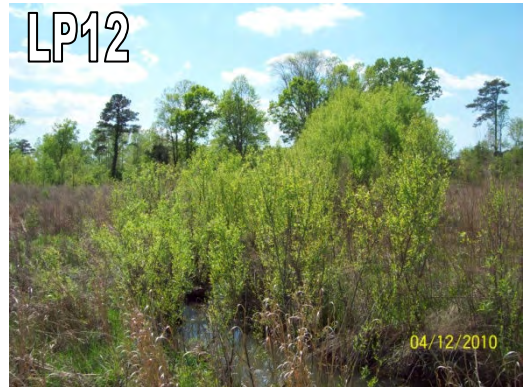
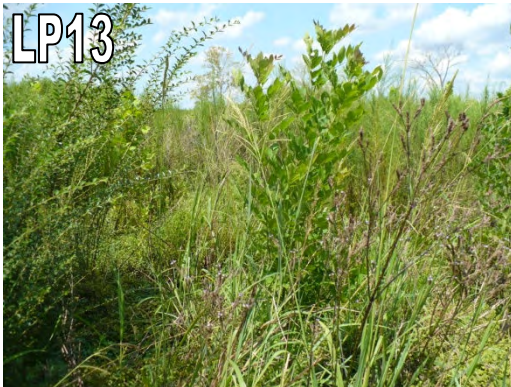
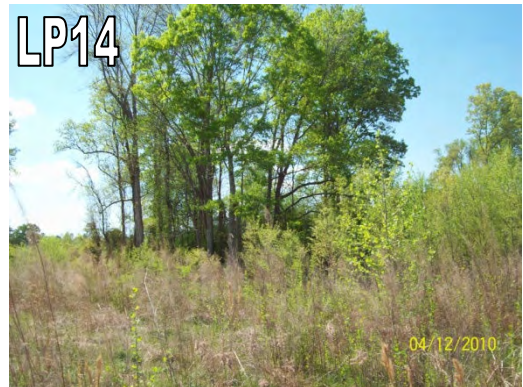
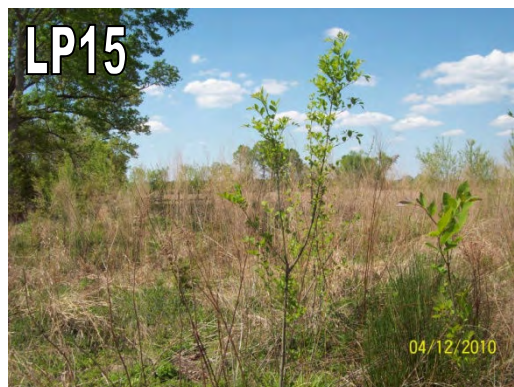
Lloyd Stream and Wetland Restoration Site
Year 4 (2010) Annual Monitoring
Stream Fixed Photo Stations
Taken April and July 2010

No stream problem areas were noted within the Site during the Year 4 (2010) monitoring year. Beaver are being controlled, as necessary.
