ANNUAL MONITORING REPORT

YEAR 5 (2011)

CONTRACT D06003-1

LLOYD STREAM AND WETLAND RESTORATION SITE ONSLOW COUNTY, NORTH CAROLINA

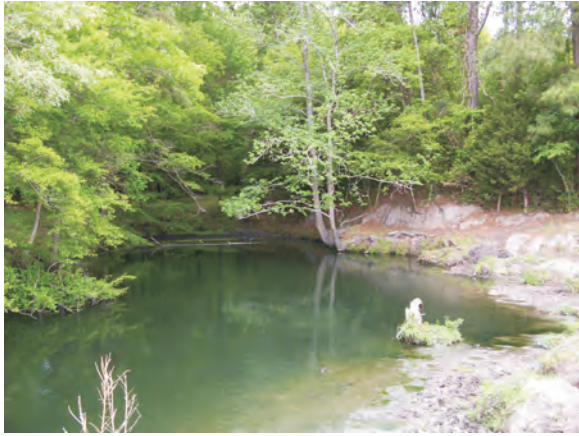
Looking upstream on abandoned channel at Site infall.

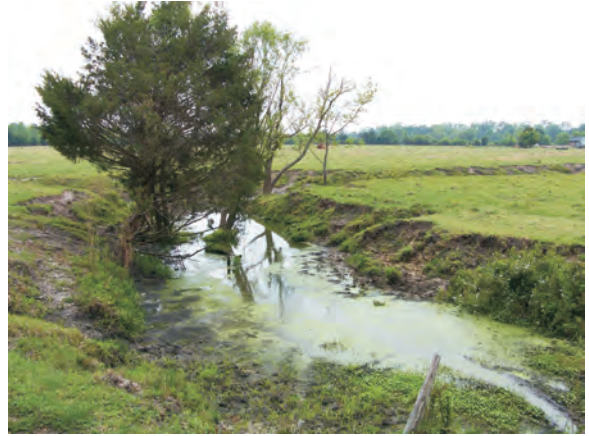
Looking downstream on abandoned channel from Site infall.

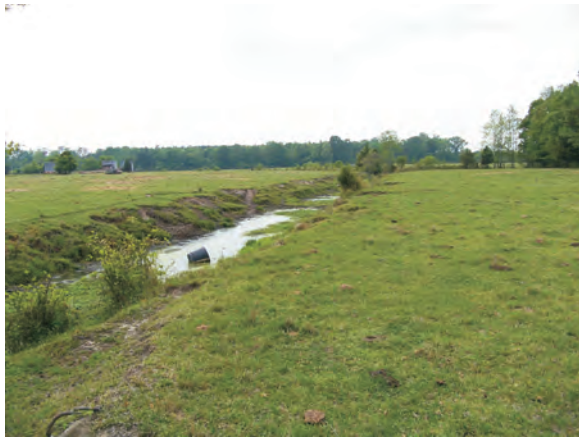
Looking downstream on abandoned channel.

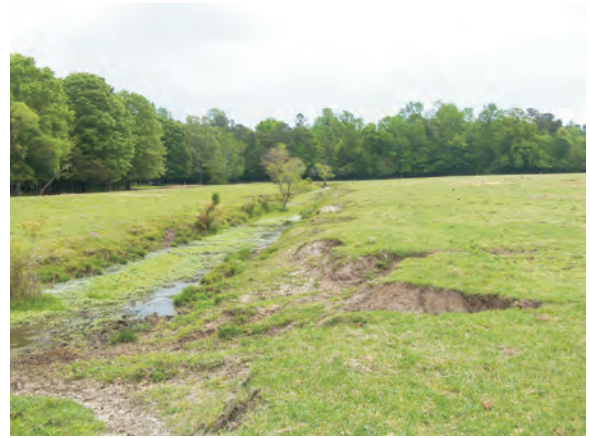
Looking upstream on abandoned channel.

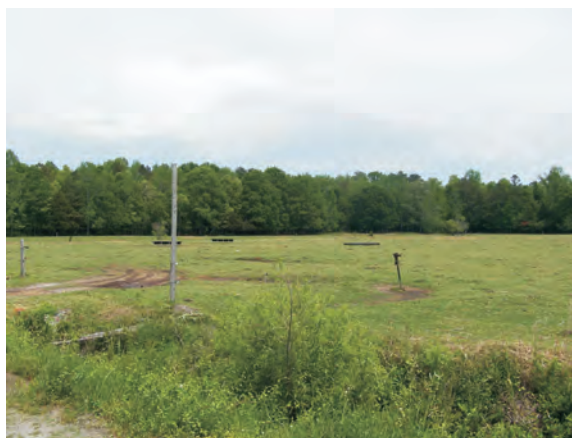
Looking across the abandoned channel toward the main tributary adjacent to the tree line.

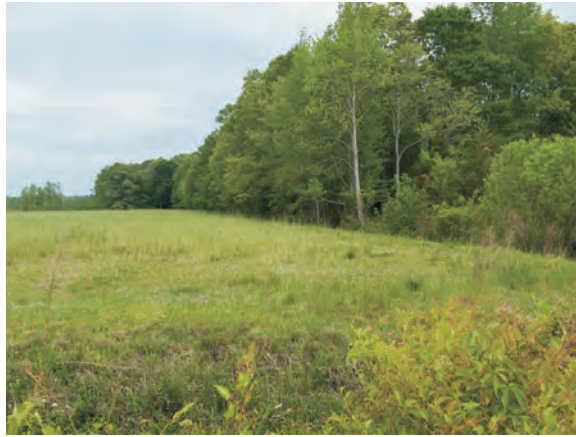
Looking across the abandoned channel toward the area of Rains soils proposed for nonriverine wetland restoration.

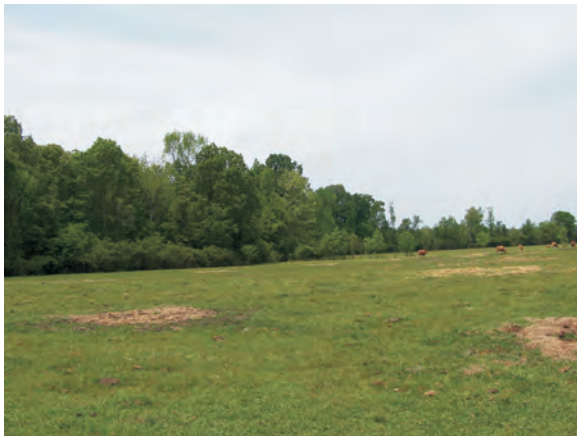
Looking upstream at the main channel adjacent to the tree line.

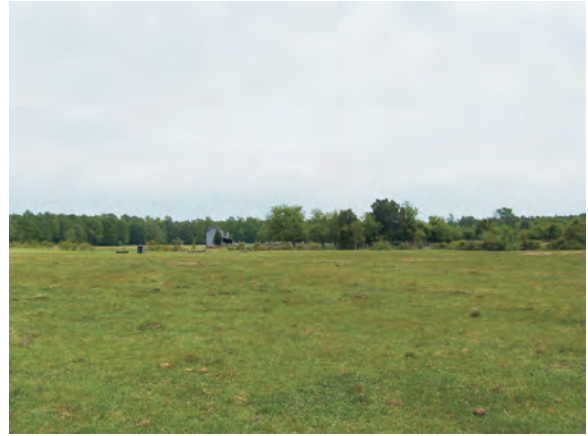
Looking towards the abandoned channel near the location of the culverted crossing that will bisect the easement.

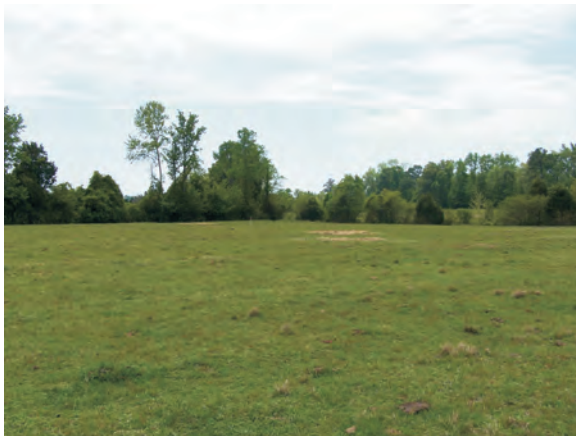
Looking downstream at the confluence of the main channel and the abandoned channel.

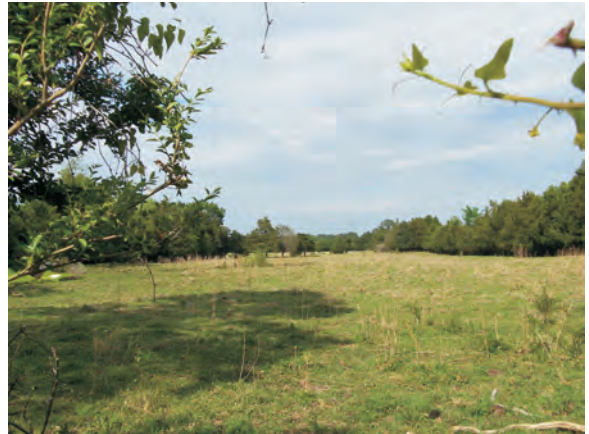
Looking upstream towards the confluence of the main channel and the existing eastern channel/roadside ditch.
