# Lochill Farm Stream Mitigation Project Year 1 (2019) Monitoring Report Final

DMS Project ID No. 97083, DEQ Contract No. 6828  
USACE Action ID No. SAW-2016-00881, DWR# 16-0370  
Orange County, North Carolina, Neuse River Basin: 03020201-030030  
MY1 Data Collection Period: October 2019

**Subject:** Response to DMS Comments for DRAFT MY1 Report  
Lochill Farm Stream Mitigation Project, Orange County  
DMS Project # 97083, DEQ Contract #6828, Neuse-01 River Basin

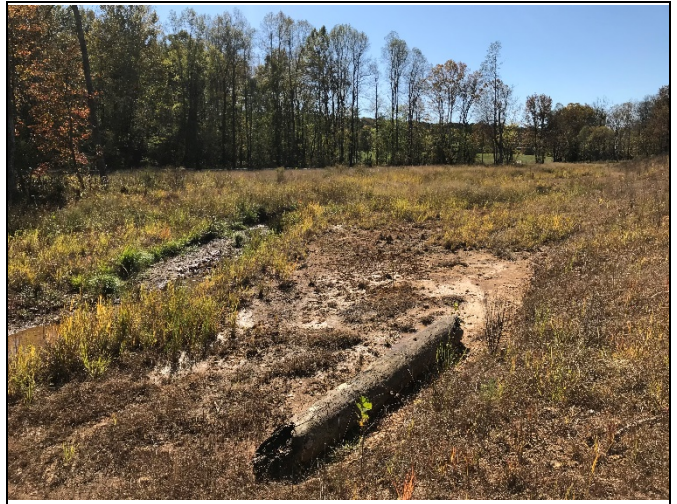
Privet Re-Sprouts along Reach 3 at Station 22+50

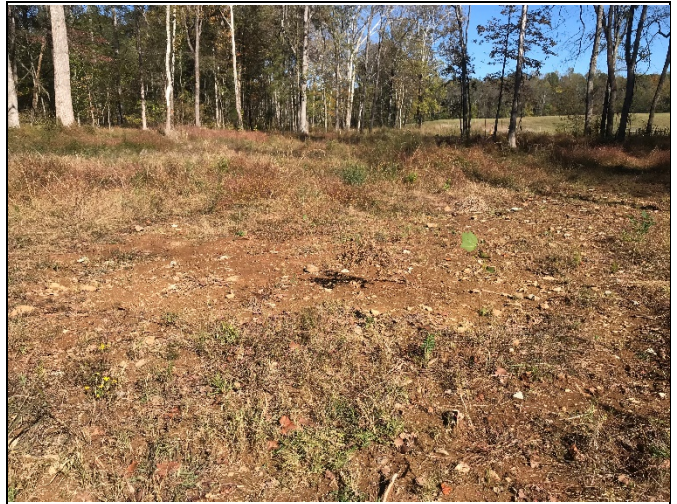
Thin herbaceous vegetation establishment in floodplain on R1 at Station 13+50

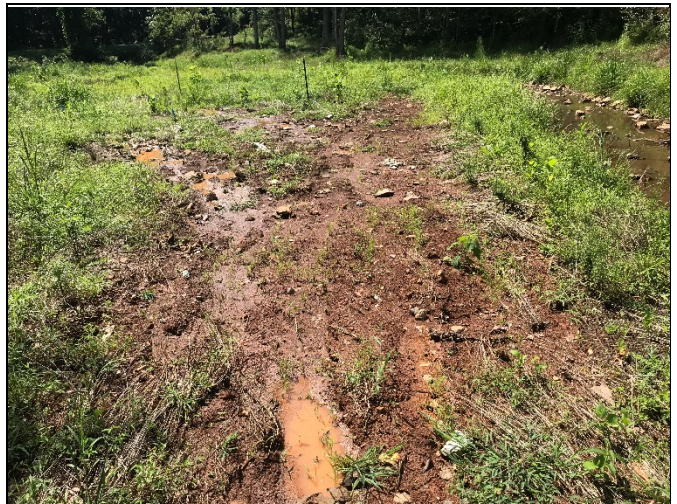
Thin herbaceous vegetation establishment in floodplain on R1 at Station 37+50

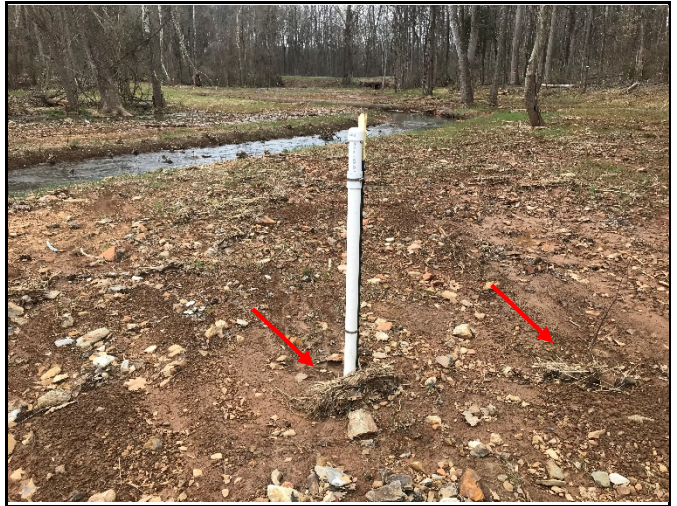
Debris jams by automated crest gauge and tree stem on lower R1 floodplain (photo: 3/7/19)

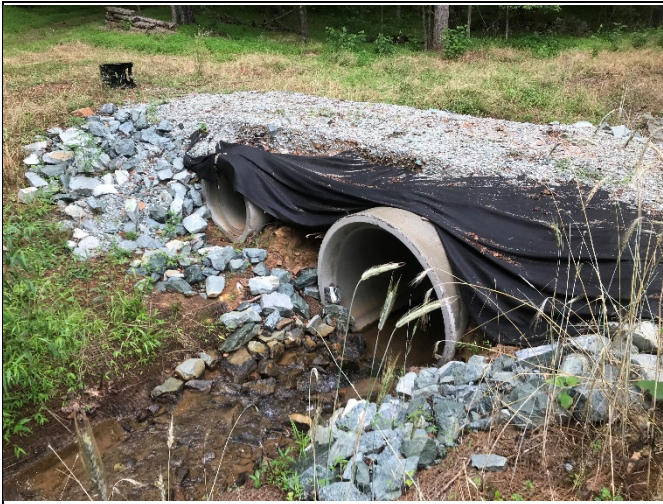
Additionally, during Year 1 monitoring the pipe crossing on Reach R3 was repaired. The rock side slopes had collapsed and washed out during the heavy fall and winter rains of 2018-2019 that occurred so soon after construction. The crossing slopes were rebuilt using Envirolok bags and backfilled with a soil/fill mix, and then covered on top with filter fabric and crusher-run gravel. The sidewalls of the crossing will be livestaked in the winter of 2019-2020 to establish vegetation for additional stability (see the Maintenance and Repair Photographs in Appendix B).

Pipe crossing collapse on R3 (upstream side) at Station 16+20

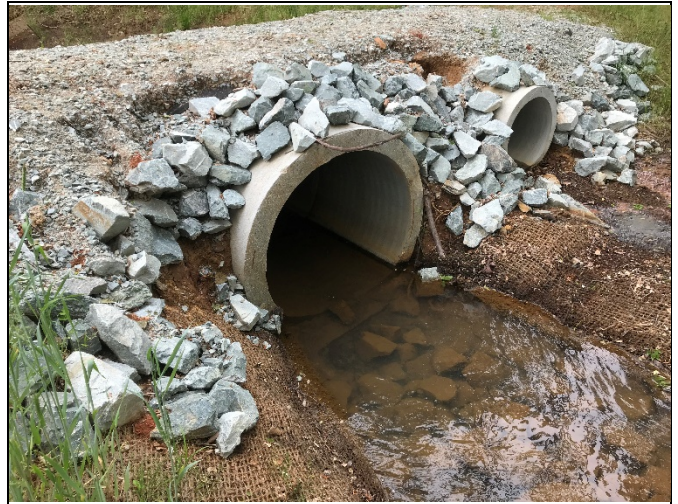
Pipe crossing collapse on R3 (downstream side) at Station 16+50

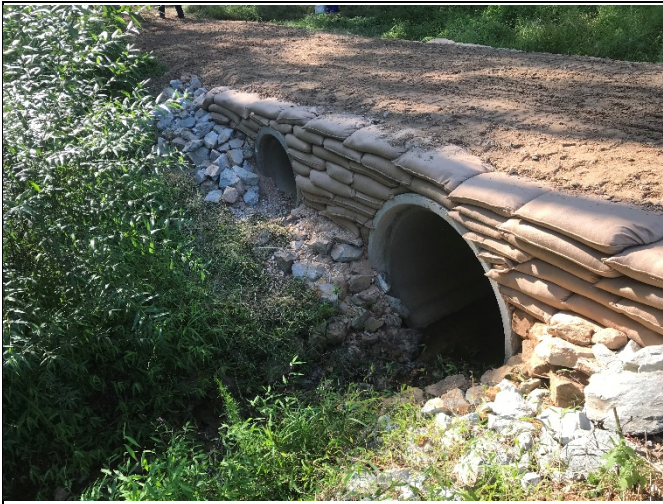
Repaired pipe crossing on R3 (upstream side) at Station 16+20

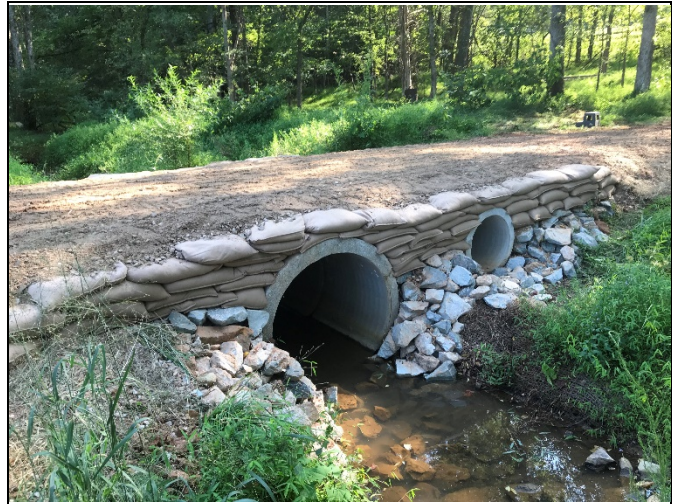
Repaired pipe crossing on R3 (downstream side) at Station 16+50

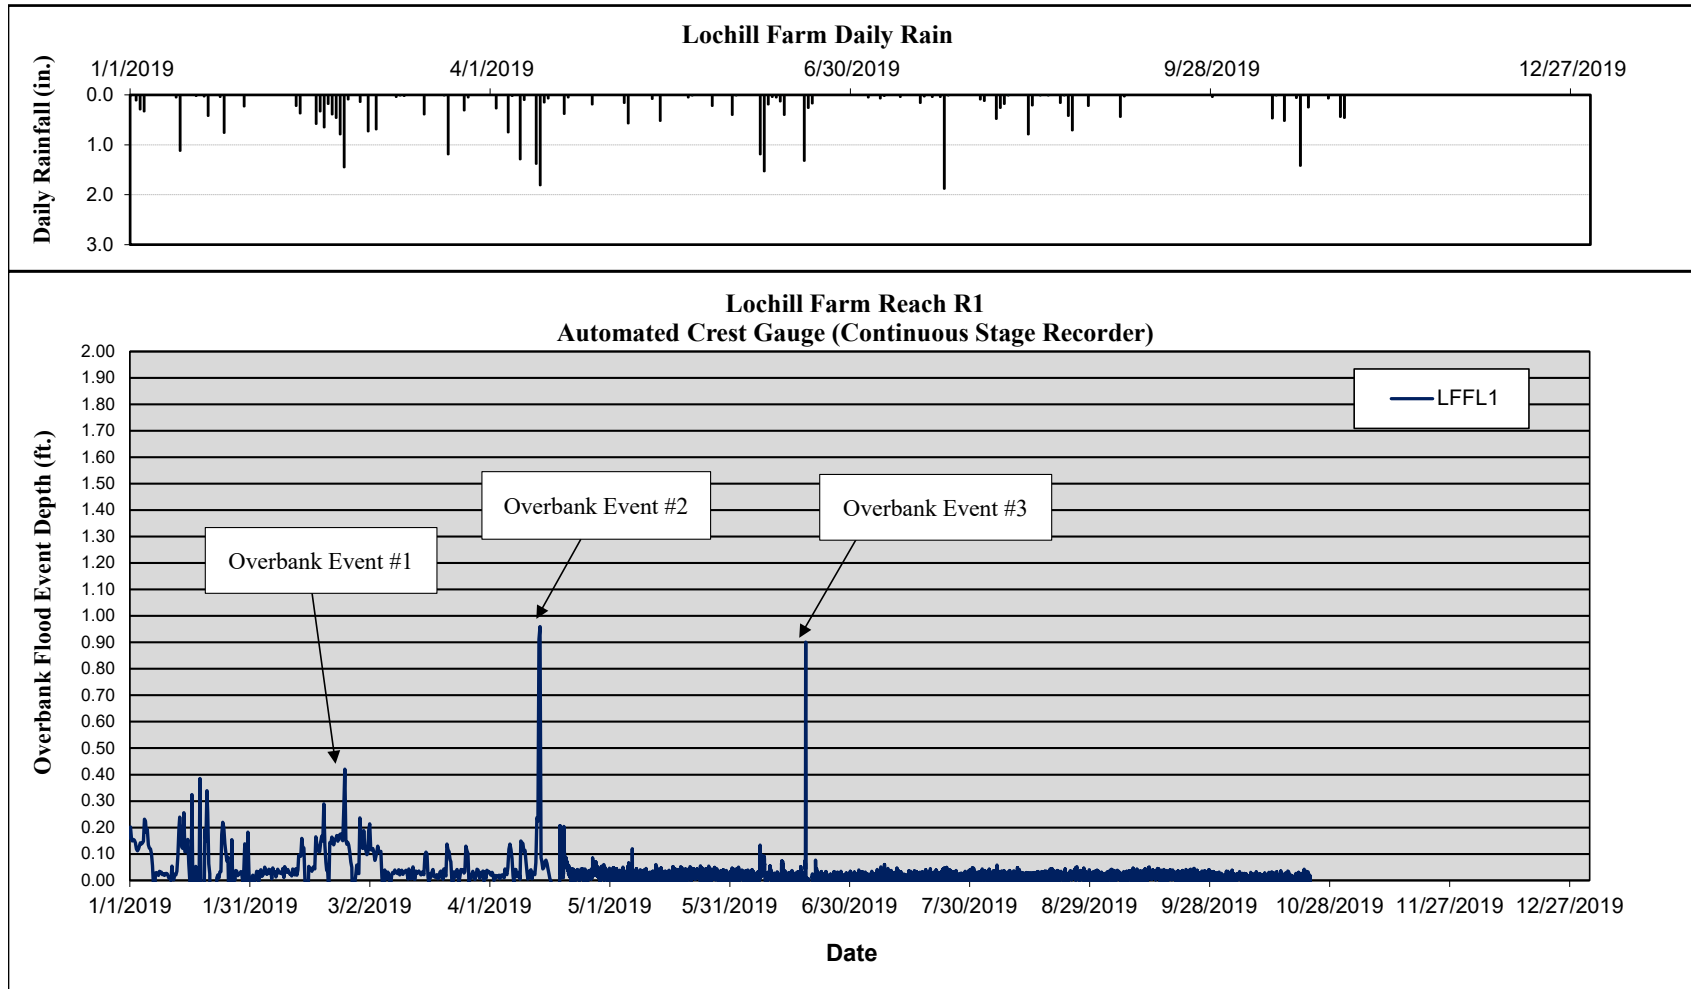
**Figure 4. Automated Crest Gauge (Continuous Stage Recorder) Graph**

\* Readings observed in January 2019 appear to be from floodplain surface inundation caused by extreme saturated conditions. No other evidence of an overbank event was observed.
