# Lochill Farm Stream Mitigation Project Year 2 (2020) Monitoring Report Final

DMS Project ID No. 97083, DEQ Contract No. 6828  
USACE Action ID No. SAW-2016-00881, DWR# 16-0370  
Orange County, North Carolina, Neuse River Basin: 03020201-030030  
MY2 Data Collection Period: October 2020

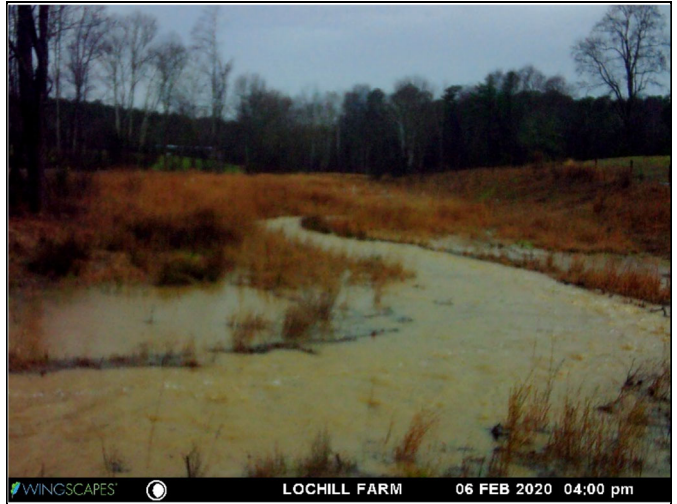
Manual crest gauge reading of 0.41 ft on upper R1 (photo from 2/27/20, storm on 2/27/20)

Stream camera on upper R1 from 2/6/20 at 16:00 (3 hours before flood event peak)

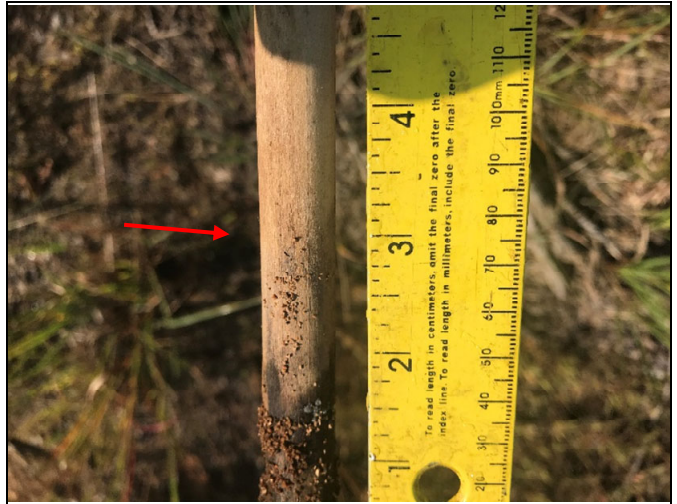
Manual crest gauge reading of 0.23 ft on upper R1 (photo from 5/8/20, storm on 3/25/20)

Close-up of manual crest gauge reading of 0.23 ft on upper R1 floodplain (photo 5/8/20 for storm on 3/25/20)

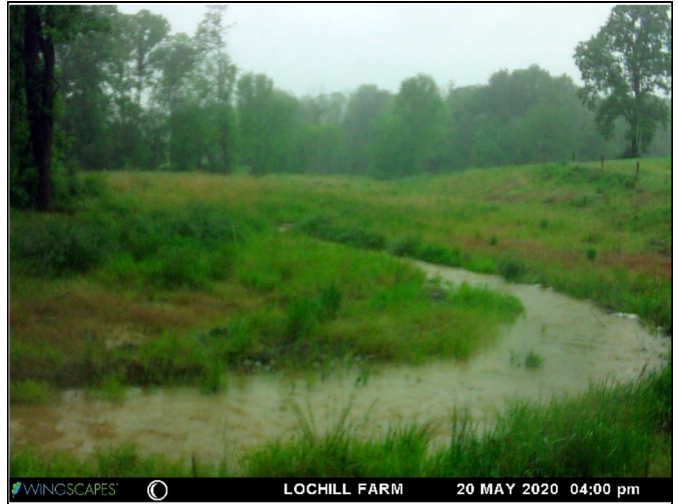
Close-up of manual crest gauge reading of 0.69 ft on upper R1 (photo from 7/10/20, storm on 5/20/20)

Stream camera on upper R1 from 5/20/20 at 16:00 (9 hours before flood event peak)

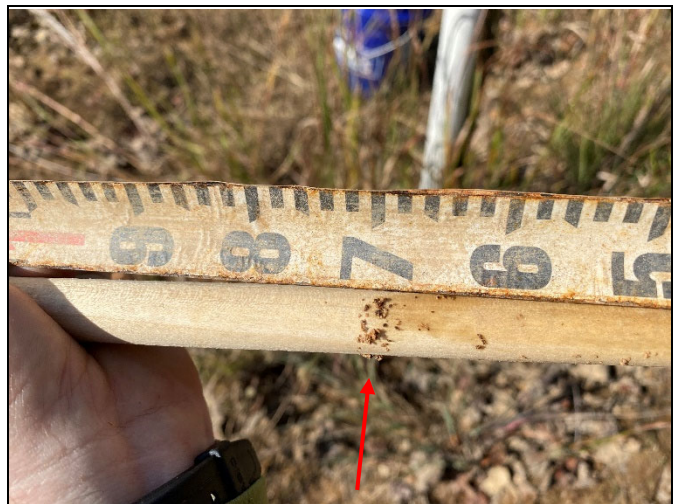
Manual crest gauge reading of 0.71 ft on upper R1 (photo from 10/14/20, storm [Hurricane Delta] on 10/11/20)

Close-up of manual crest gauge reading of 0.71 ft on upper R1 (photo from 10/14/20, storm [Hurricane Delta] on 10/11/20)

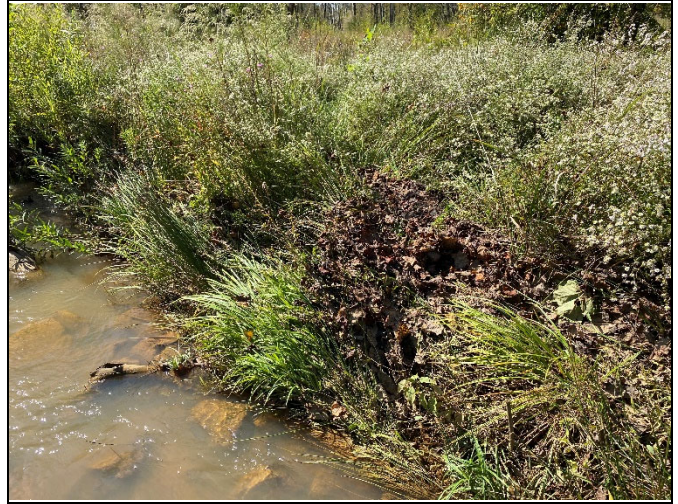
Debris lines along banks of upper R1 (10/14/20)

Debris along bank of middle R1 (10/14/20)

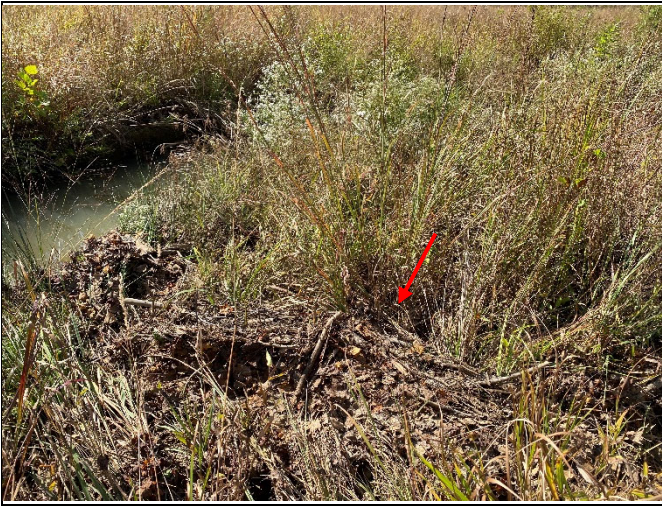
Debris along banks of upper R1 (10/14/20)

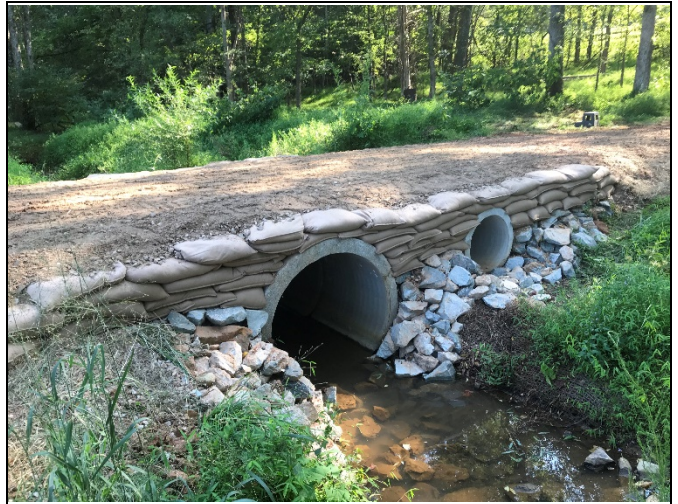
Repaired pipe crossing on R3 (downstream side) at Station 16+50 in Sept. 2019

During the previous Year 1 monitoring effort, a pipe crossing in the upper portion of Reach R3 was repaired. The sidewalls of the crossing were livestaked on 1/27/20 to help establish vegetation for additional stability. Inspections over the course of Year 2 monitoring observed that the livestakes are growing and establishing well and the crossing as a whole is stable (see the Maintenance and Repair Photographs in Appendix B).

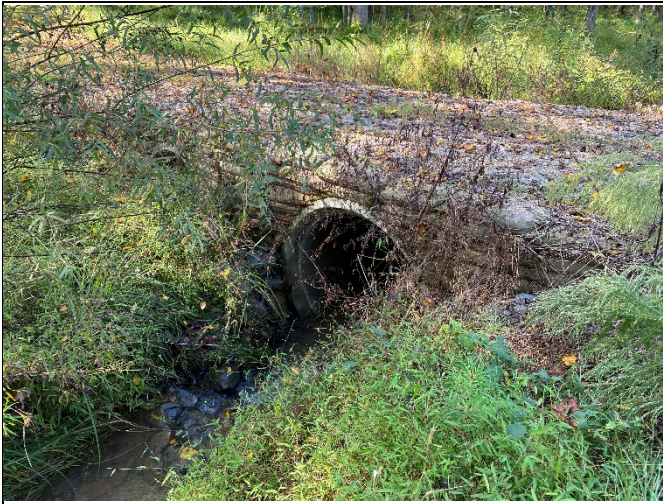
Repaired pipe crossing on R3 (upstream side) at Station 16+20 in October 2020

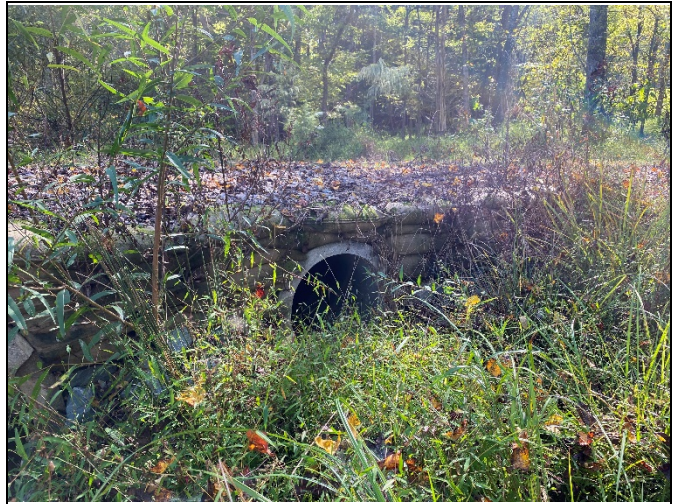
Repaired pipe crossing on R3 (downstream side) at Station 16+50 in October 2020

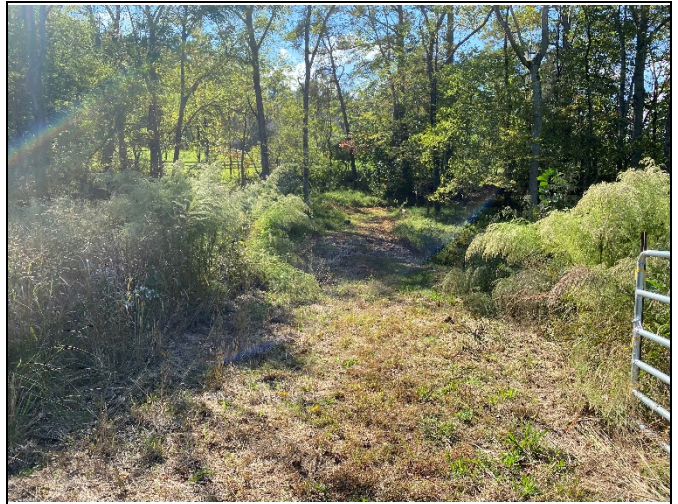
Pipe at crossing on R3 at Station ~16+30 (10/13/20)

Crossing over pipe on R3 at Station ~16+30 (10/13/20)

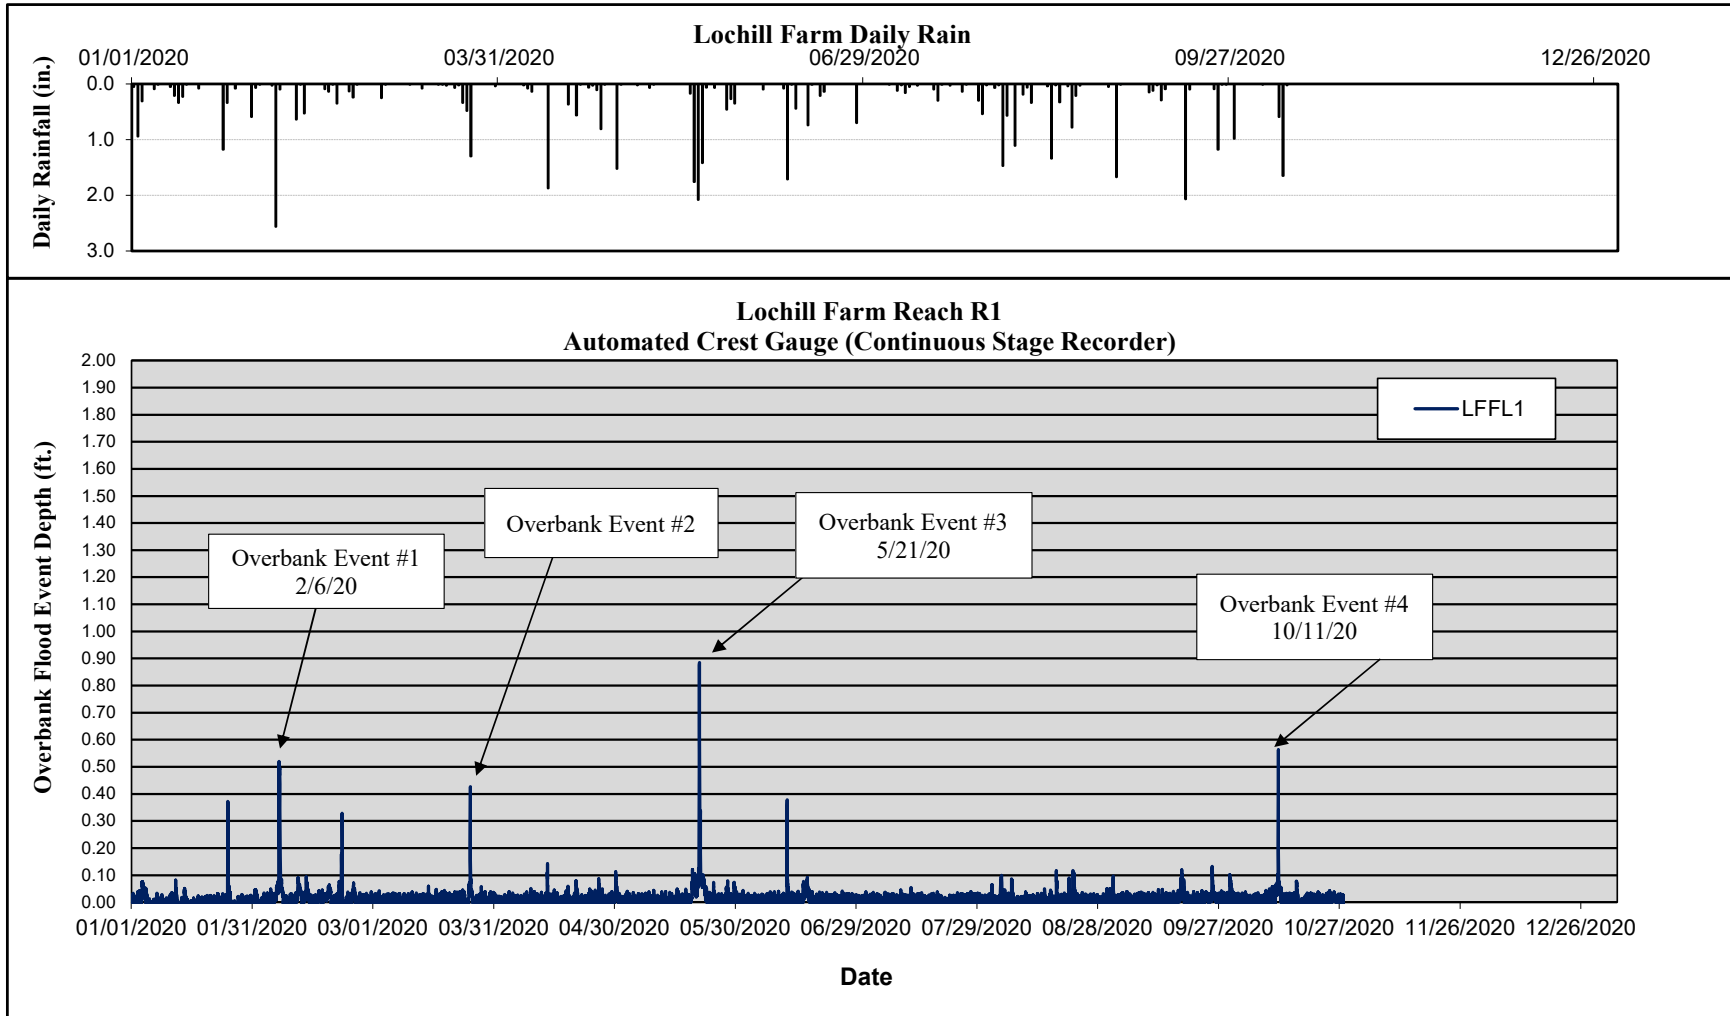
**Figure 5. Automated Crest Gauge (Continuous Stage Recorder) Graph**

During Year 2 monitoring, four separate post-construction bankfull events were observed (see Table 10 and Figure 5 in Appendix E and the Overbank Event Photographs in Appendix B). They were documented primarily through the use of an automated crest gauge, but also through manual cork crest gauge readings, stream camera photographs, and post-flood event site inspection photographs.

Note: Data presented here is from 1/1/20 thru 9/30/20

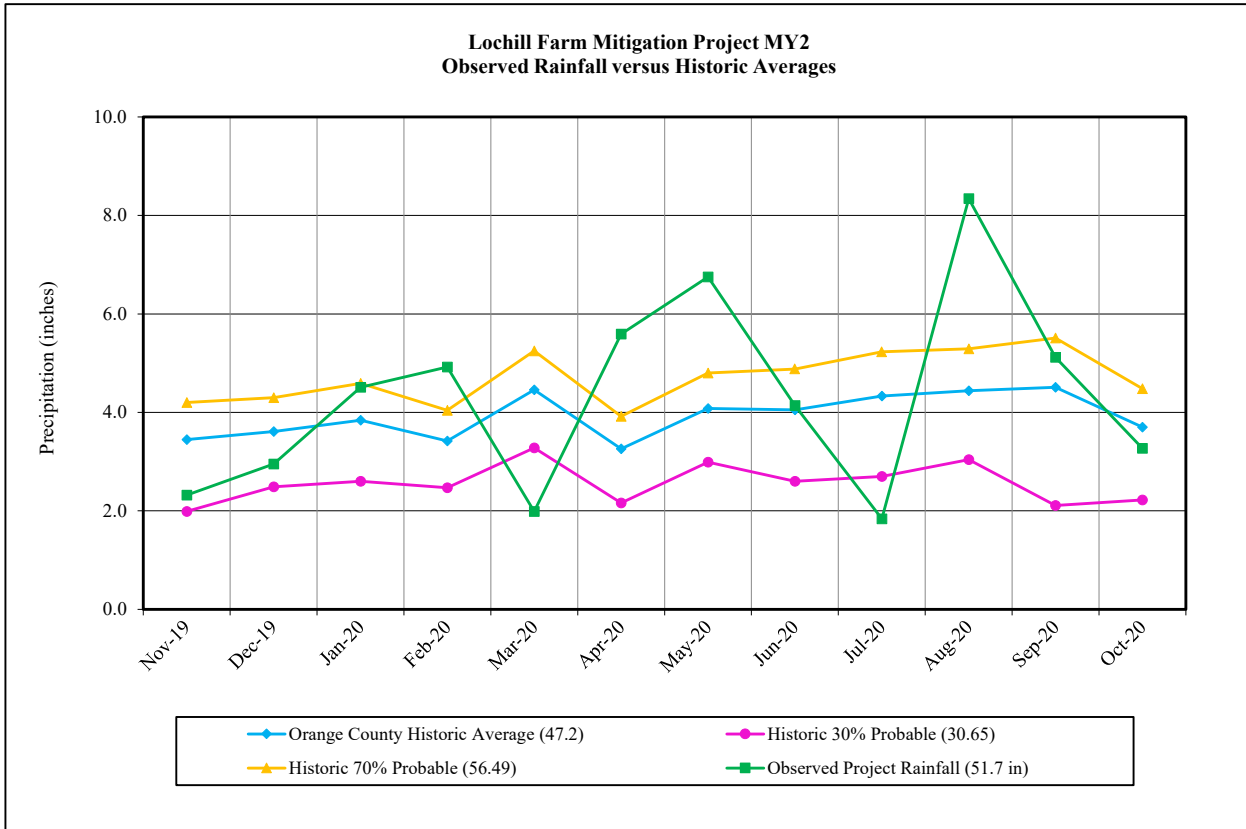
**Figure 7. Observed Rainfall Versus Historic Averages**

As the observed monthly rainfall data for the project presented in Figure 7 in Appendix E demonstrates, the past 12 months have seen wide variability as compared to historic average precipitation, with four months exceeding the 70% probable average and two months below the 30% probable average. A total of 51.7 inches of rainfall was observed for the project, an excess of 4.5 inches above the Orange County historic average of 47.2 inches.

Note: Historic average annual rainfall for Orange County is 47.2", while the observed project rainfall recorded a total of 51.7" over the previous 12 months (from 11/1/2019 to 10/31/2020). Project rainfall was collected from the nearest NC-CRONOS station.
