Lochill Farm Stream Mitigation Project Year 3 (2021) Monitoring Report FINAL

DMS Project ID No. 97083, DEQ Contract No. 6828

Orange County, North Carolina, Neuse River Basin: 03020201-030030

MY3 Data Collection Period: September 2021

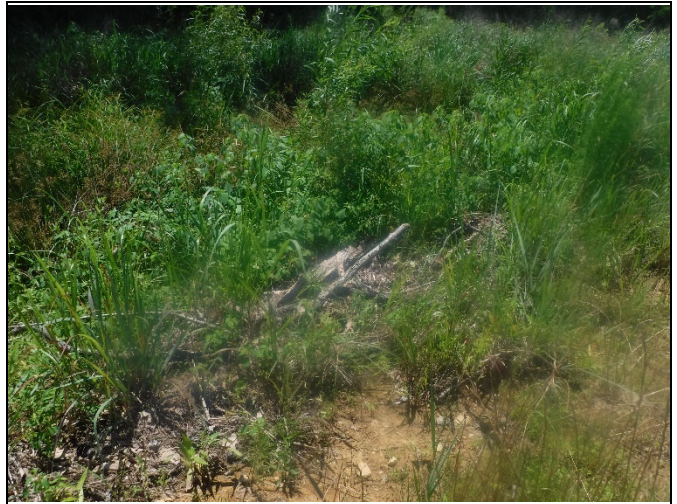
Closeup of wrack line on R1 showing evidence of overbank flow

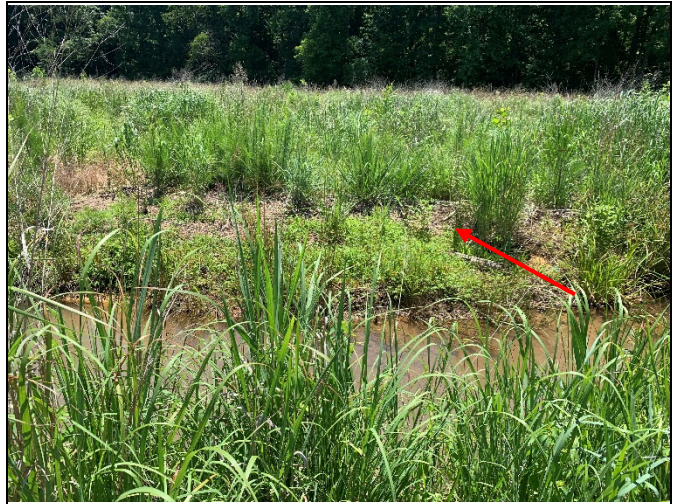
Location of wrack line on R1 for evidence of overbank flow

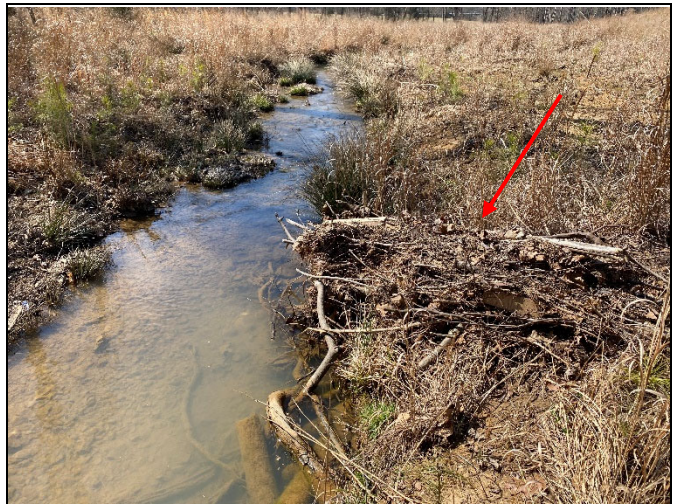
Debris jam/wrack line on right floodplain of R1 next to manual crest gauge (photo from 3/11/21)

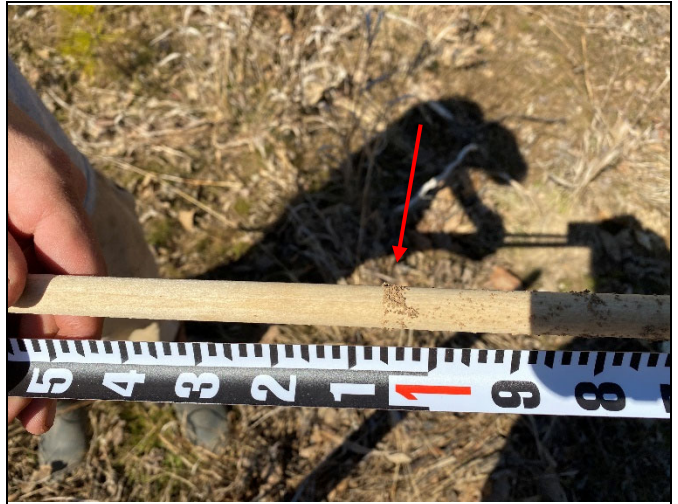
Close-up of manual crest gauge reading of 1.01 ft on upper R1 (photo from 3/11/21, storm on 2/16/21)

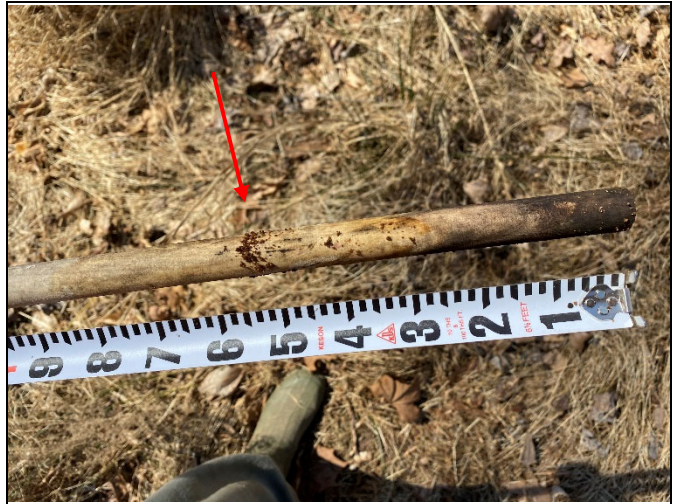
Manual crest gauge reading of 0.56 ft on upper R3 (photo from 3/11/21, storm on 2/16/21)

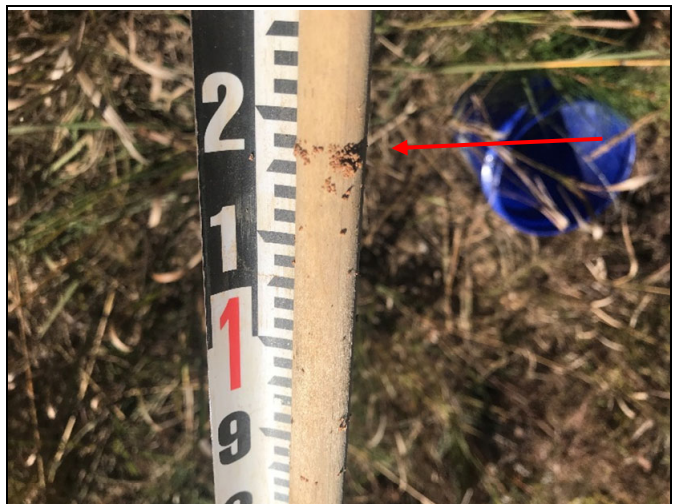
Close-up of manual crest gauge reading of 1.17 ft on upper R1 (photo from 10/20/21, storm from 7/19/21)

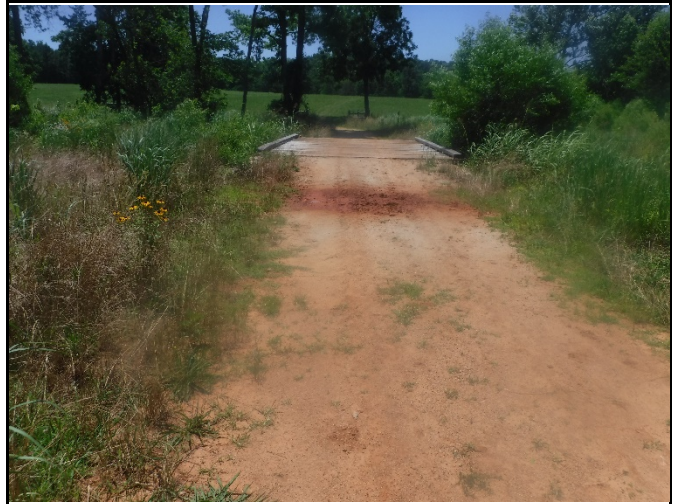
Stable crossing over bridge on R1 at Station ~18+20 (6/21/21)

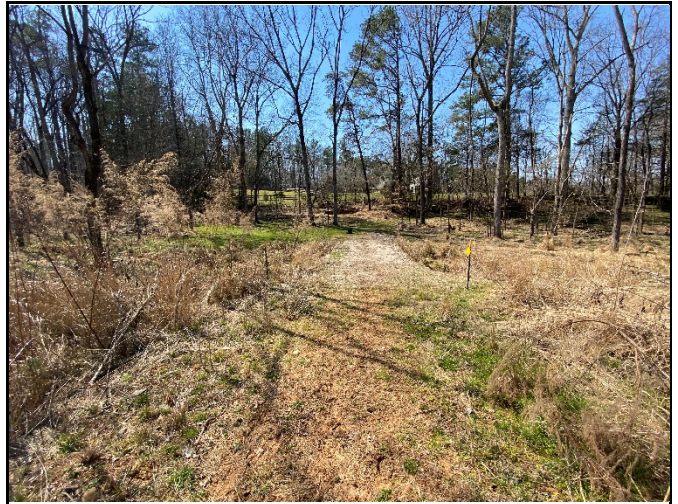
Stable pipe crossing on R3 at Station ~16+30 (3/11/21)

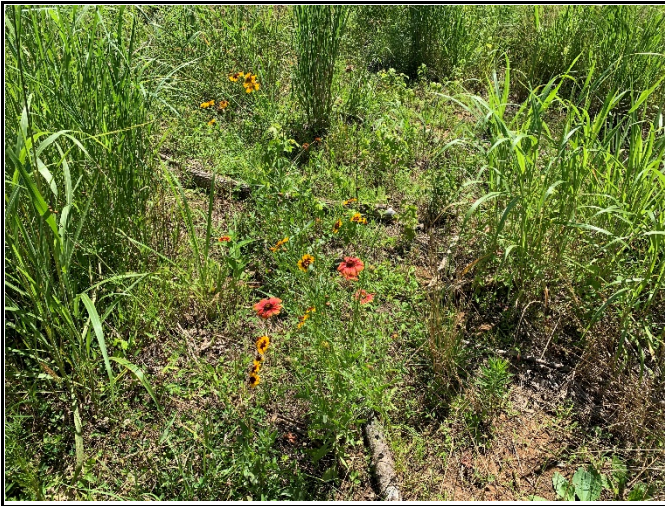
Previously thin/sparse herbaceous area of R1 floodplain (as noted in MY1) revegetating well (photo 6/24/21)

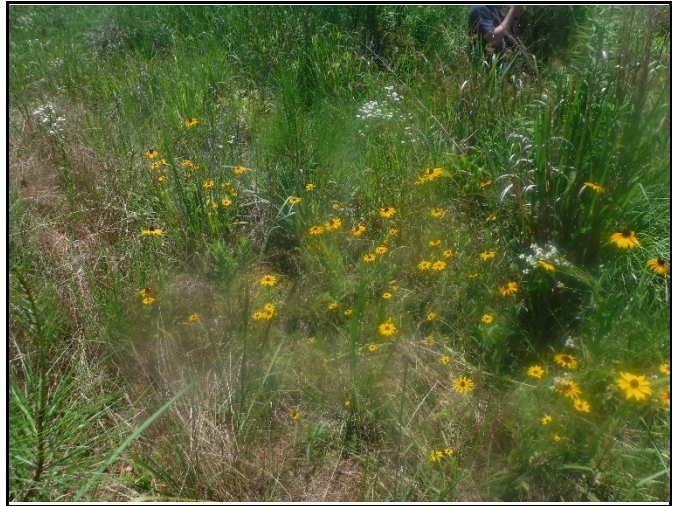
Previously thin/sparse herbaceous area of R1 floodplain (as noted in MY1) revegetating well (photo 6/24/21)

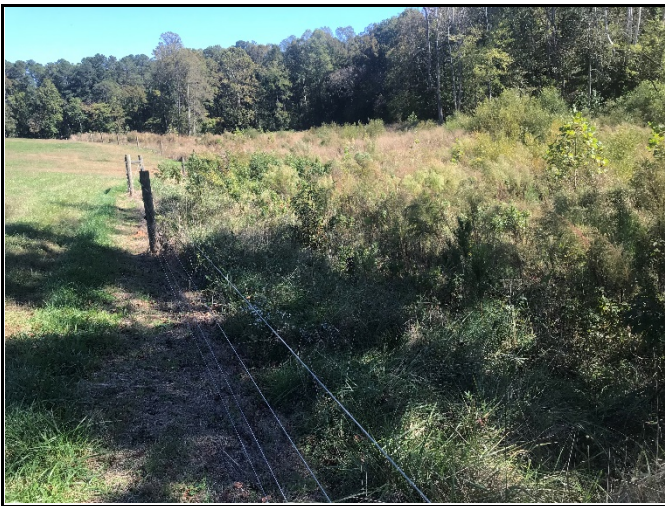
Area of supplemental planting in February 2021 establishing well (photo from 10/20/21)

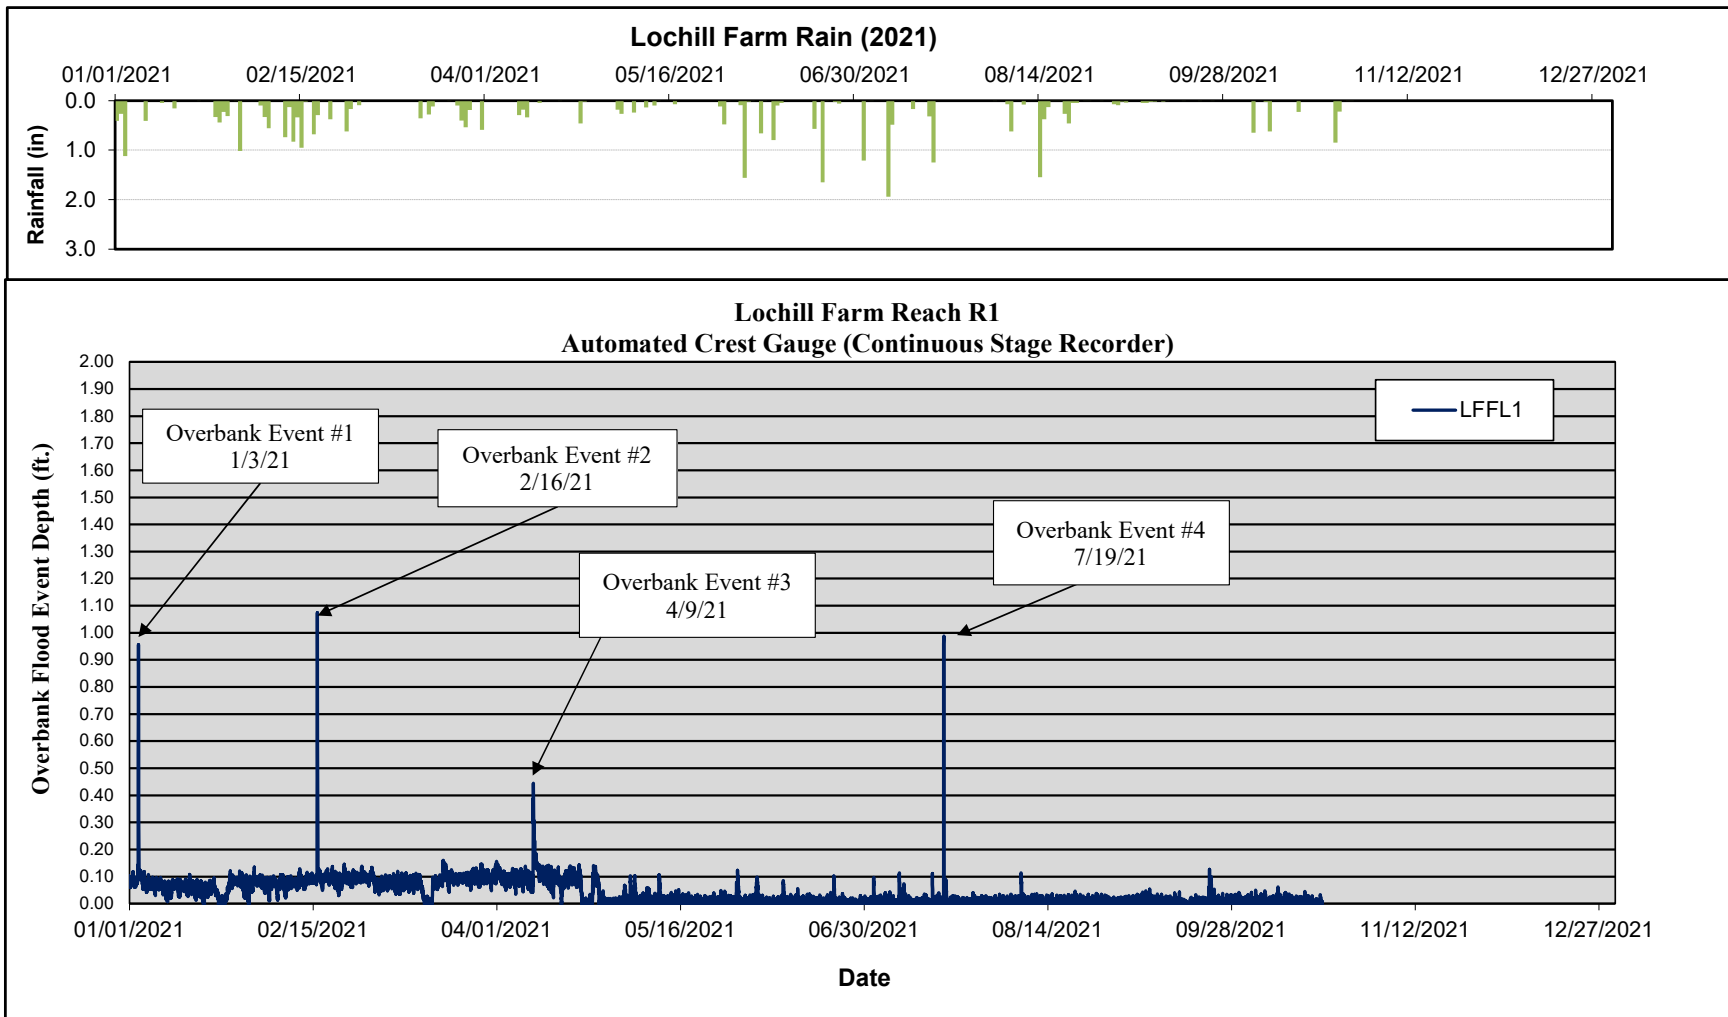
Figure 5. Automated Crest Gauge (Continuous Stage Recorder) Graph

Only the four largest overbank events are called out here and in the report. However, several smaller overbank events also appear to have occurred as shown in the graph above.

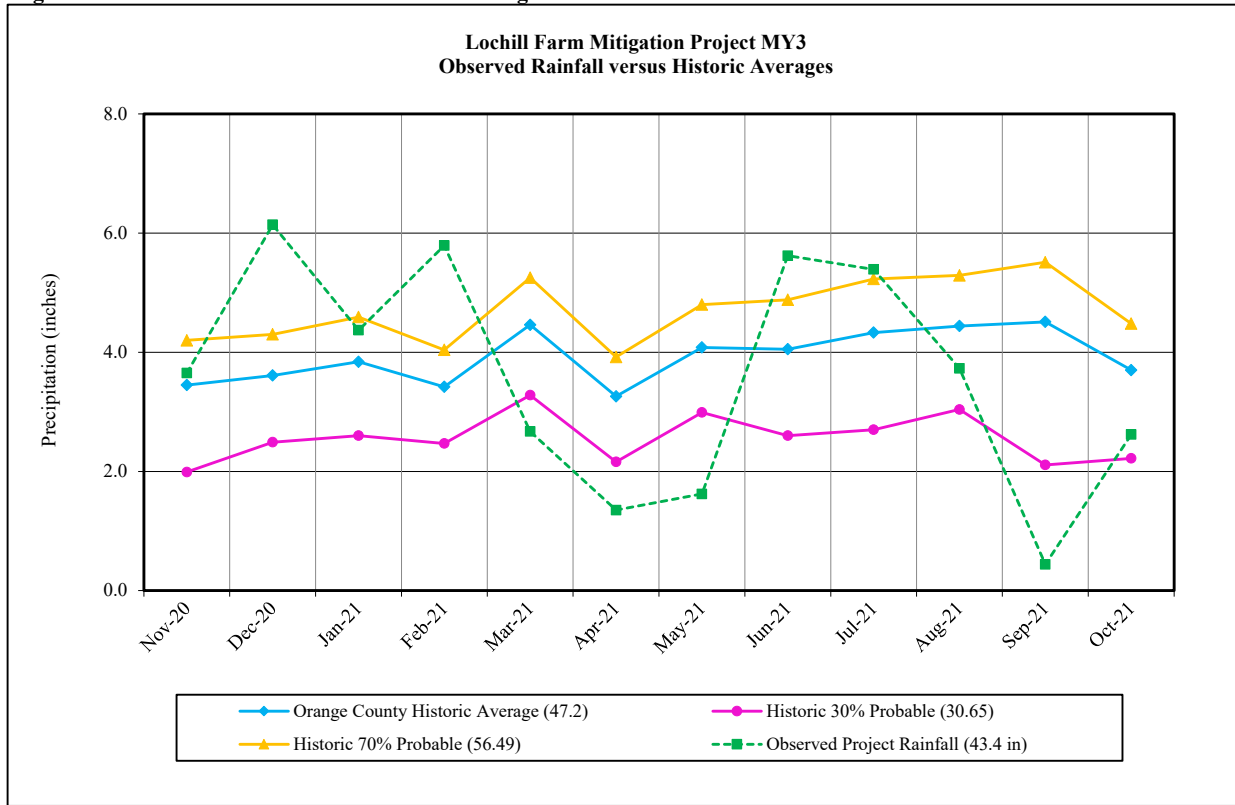
Figure 7. Observed Rainfall Versus Historic Averages

Note: Historic average annual rainfall for Orange County is 47.2", while the observed project rainfall recorded a total of 43.4" over the previous 12 months (from 11/1/2020 to 10/31/2021).
