Lochill Farm Stream Mitigation Project Year 4 (2022) Monitoring Report FINAL

DMS Project ID No. 97083, DEQ Contract No. 6828
USACE Action ID No. SAW-2016-00881, DWR# 16-0370
Orange County, North Carolina, Neuse River Basin: 03020201-030030
MY4 Data Collection Period: November 2022

Lochill Farm: MY4 Stream Station Photo-Points (taken 3/15/22)

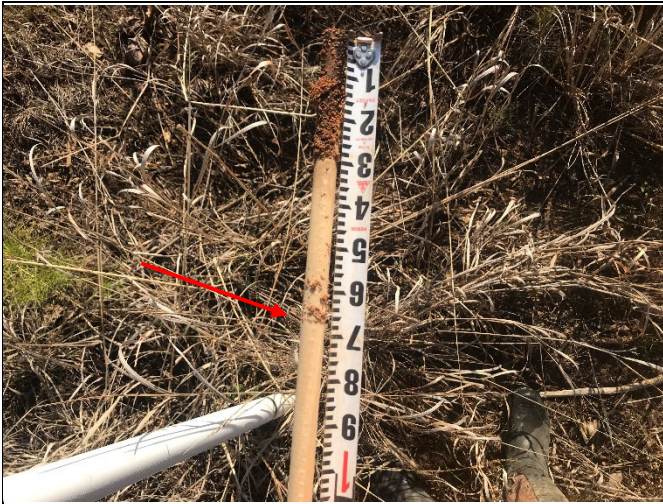
Manual crest gauge reading of 0.67 ft on upper R1 (photo from 3/15/22)

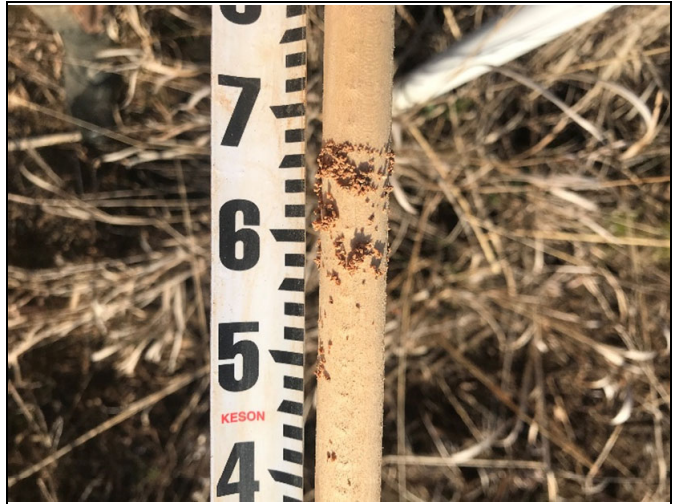
Closeup of crest gauge reading

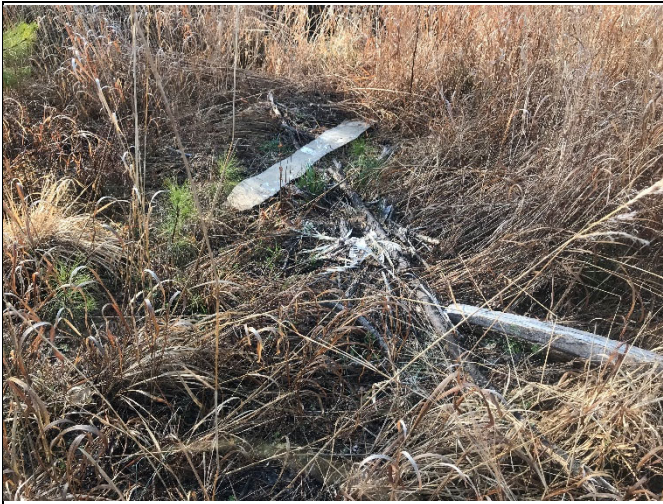
Closeup of wrack line on R1 showing evidence of overbank flow

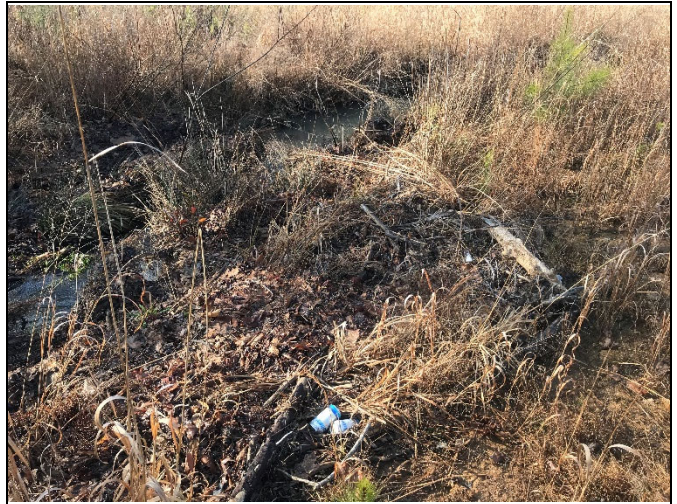
Closeup of wrack line on R1 showing evidence of overbank flow

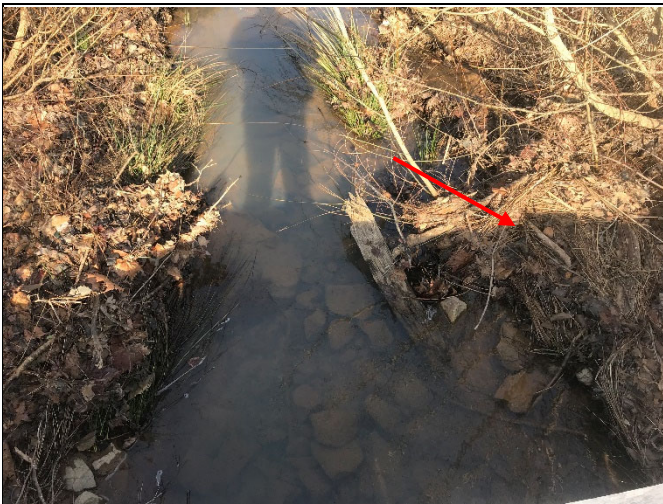
Debris jam/wrack line near crossing (photo from 3/15/22)

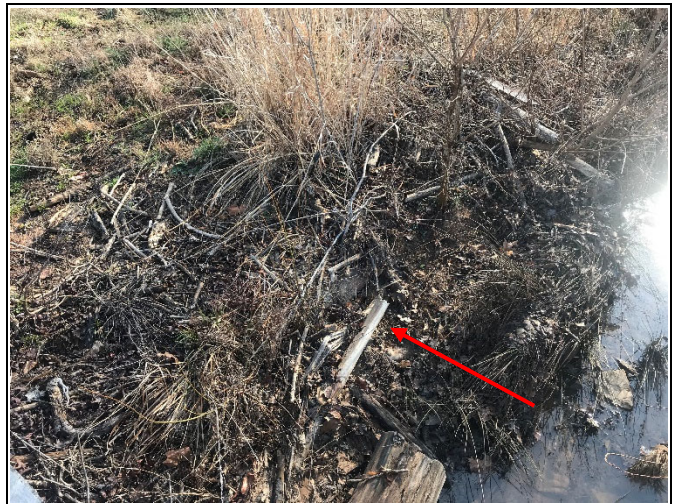
Debris jam/wrack line near crossing (photo from 3/15/22)

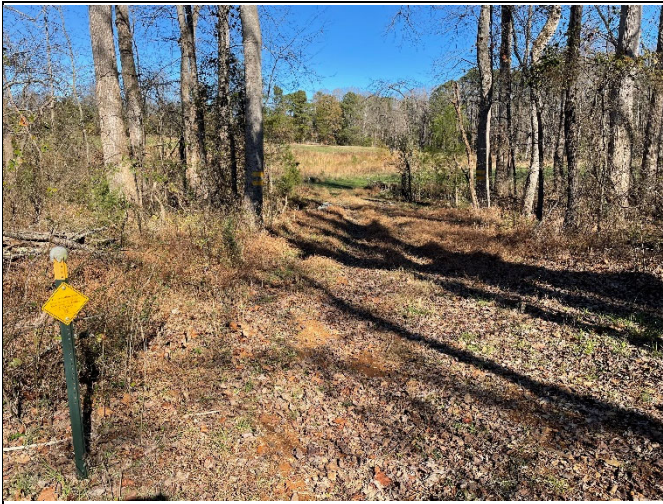
Stable crossing over Reach 2 (11/21/22)

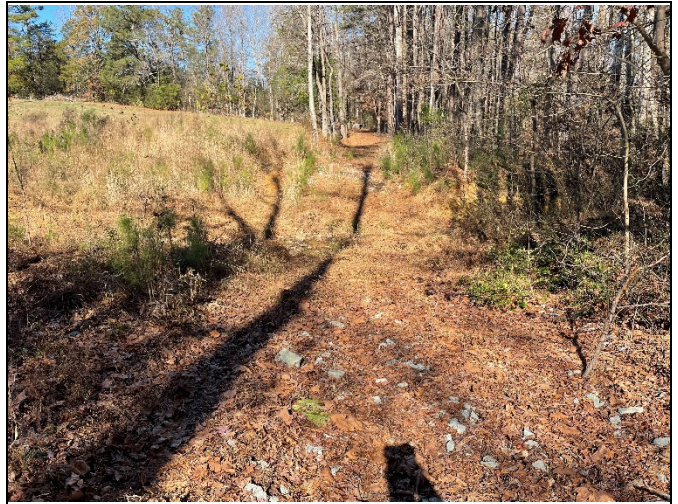
Stable crossing at the top of R1 (11/21/22)

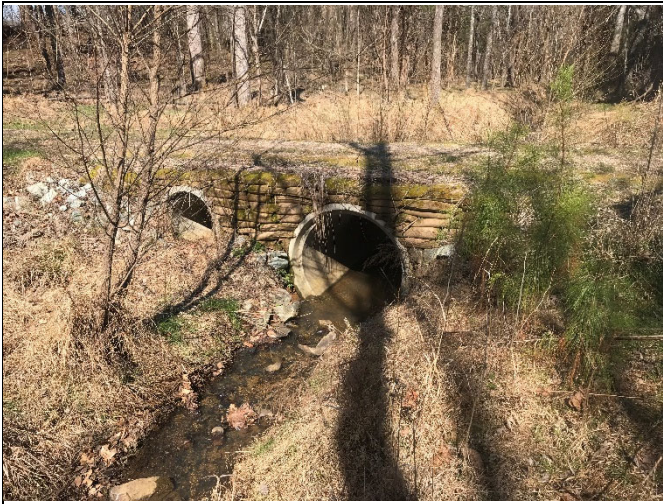
Pipe crossing on R3 at Station ~16+30 (3/15/22)

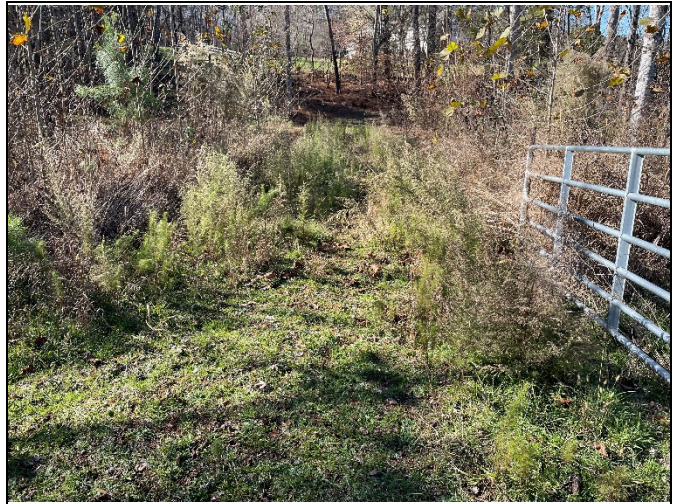
Stable pipe crossing on R3 at Station ~16+30 (11/21/22)

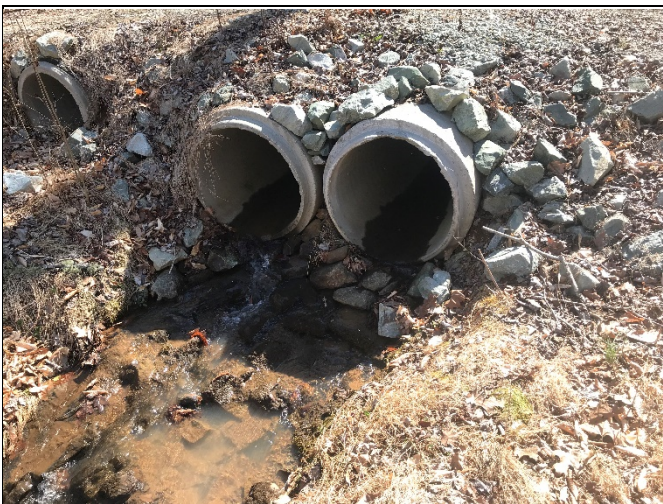
Pipes at crossing at top of R3 at Station 10+00
(3/15/22)

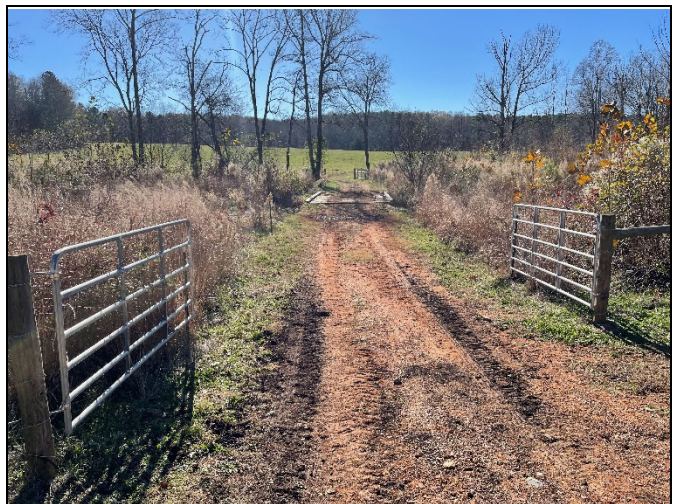
Stable bridge crossing over Reach 1 (11/21/22)

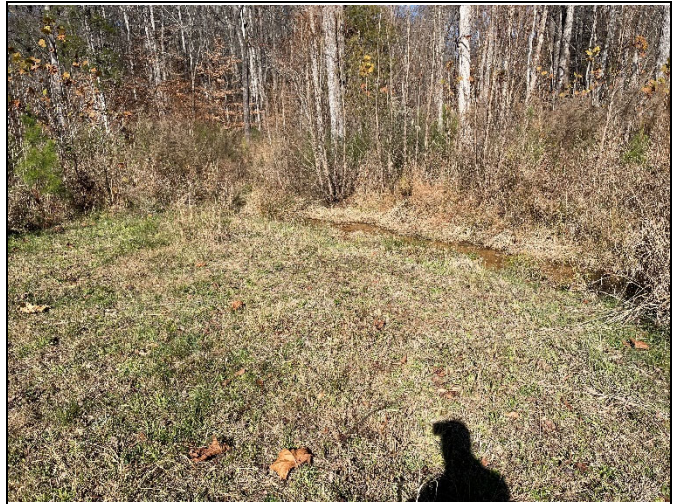
Stable crossing on R1 station 30+40 (11/21/22)

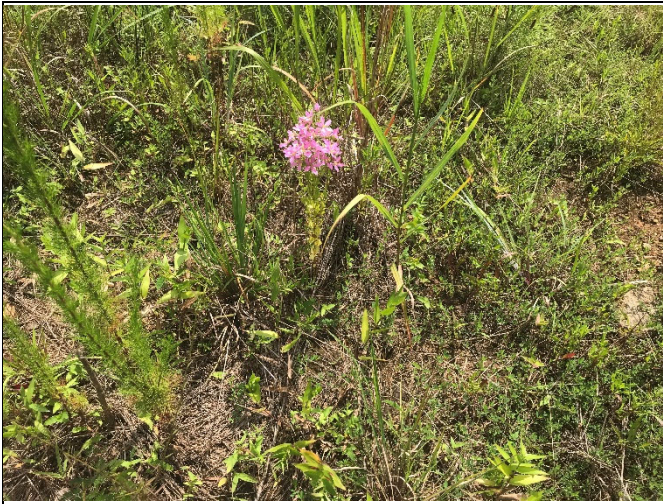
Previously thin/sparse herbaceous area of R1 floodplain (as noted in MY1) revegetating well (photo 7/14/22)

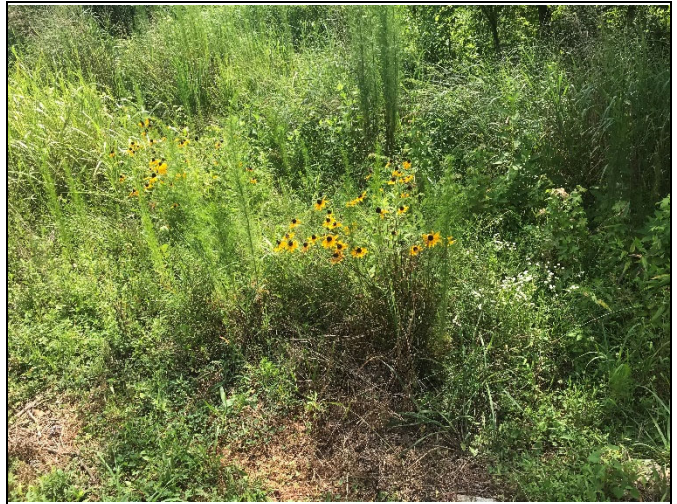
Previously thin/sparse herbaceous area of R1 floodplain (as noted in MY1) revegetating well (photo 7/14/22)

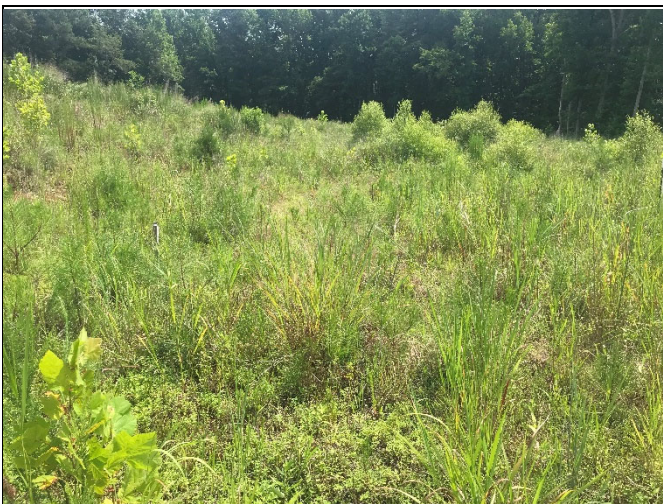
Pine thinning along upper R1 (photo from 7/14/22)

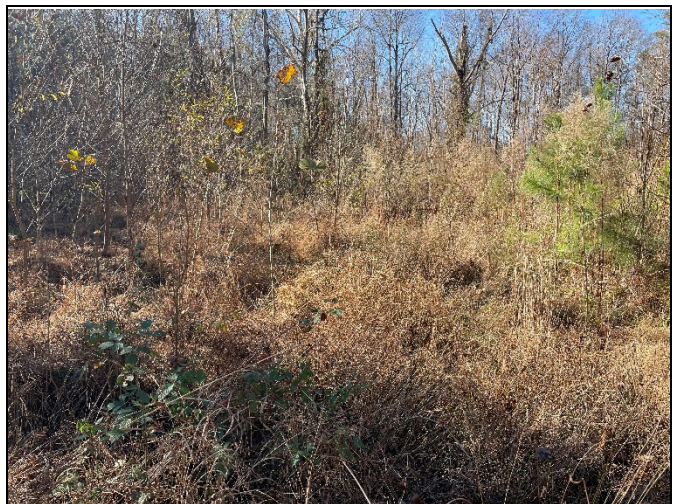
Pine thinning along lower R1 (11/21/22)

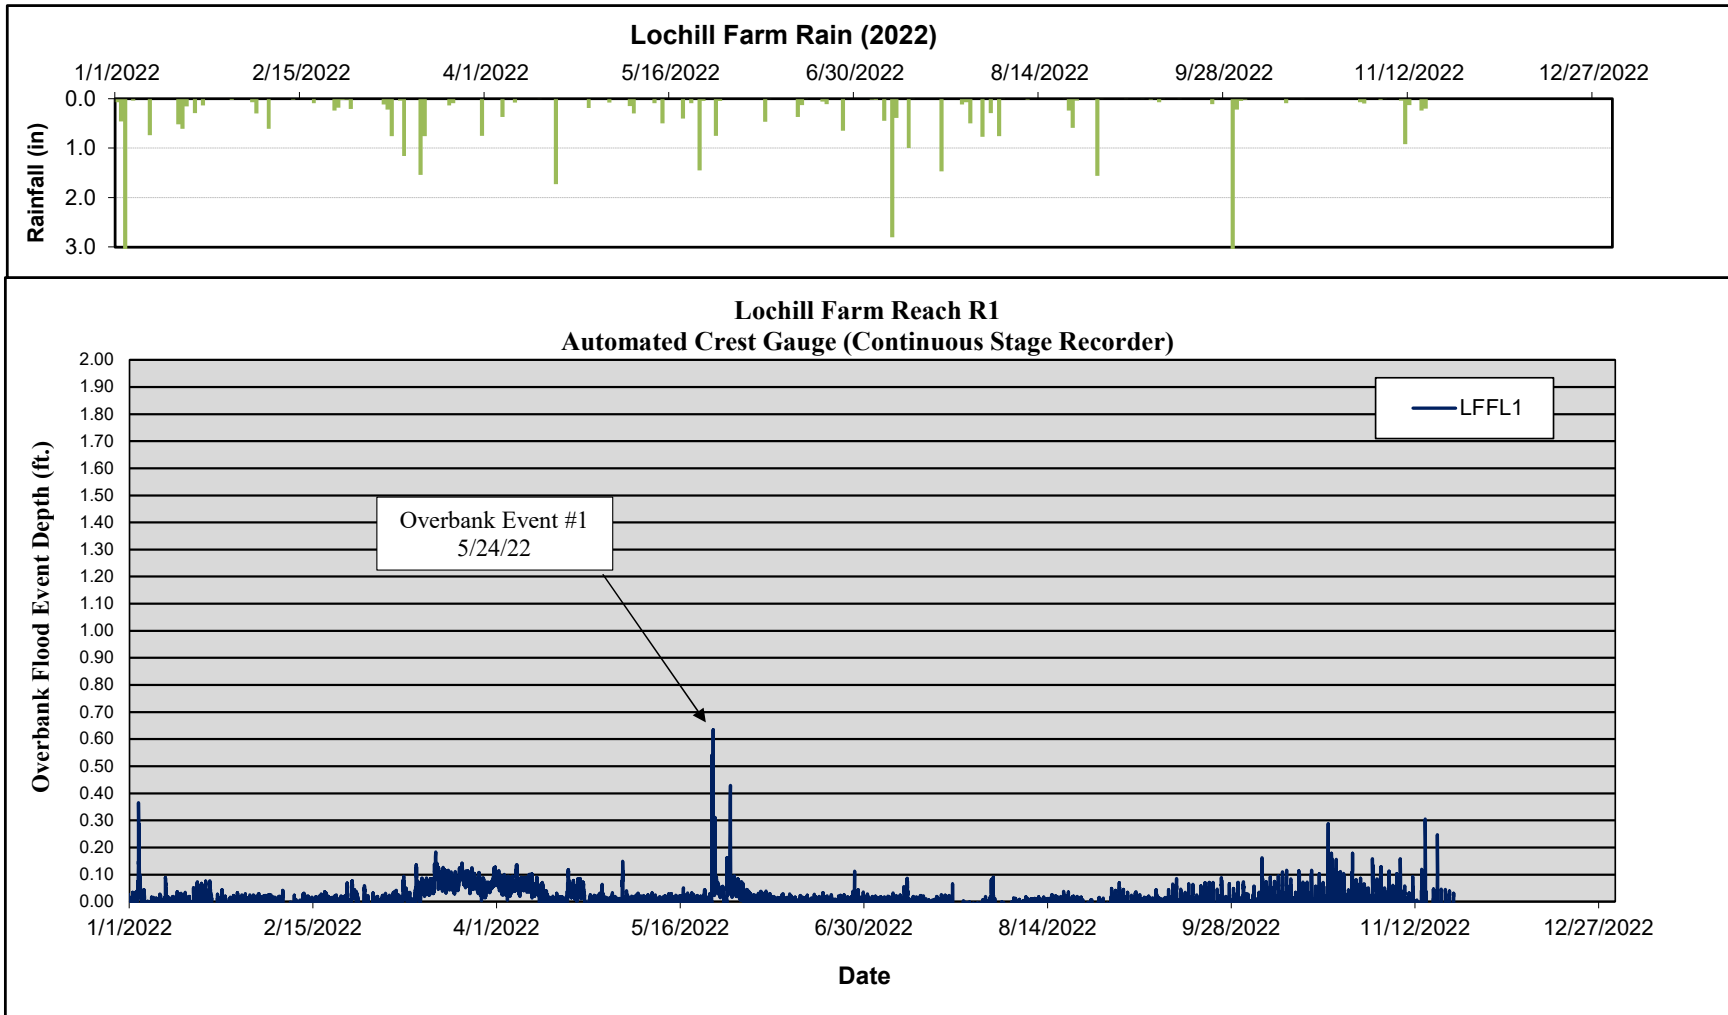
Figure 5. Automated Crest Gauge (Continuous Stage Recorder) Graph

During Year 4 monitoring, two separate post-construction bankfull events were documented (see Table 10 and Figure 5 in Appendix E and the Overbank Event Photographs in Appendix B). They were documented primarily through the use of an automated crest gauge, but also through manual cork crest gauge readings, and post-flood event site inspection photographs. Crest gauge 3 was changed to an automated in-stream crest gauge to better show overbank events due to the thick vegetation surrounding the gauge. It was noticed during site visits that overbank events happened on R3 but never captured by the original cork gauge.

Only the largest overbank event is called out here and in the report. However, several smaller overbank events also appear to have occurred as shown in the graph above.
