# **Lochill Farm Stream Mitigation Project Year 5 (2023) Monitoring Report FINAL**

DMS Project ID No. 97083, DEQ Contract No. 6828  
USACE Action ID No. SAW-2016-00881, DWR# 16-0370  
Orange County, North Carolina, Neuse River Basin: 03020201-030030  
MY5 Data Collection Period: November 2023

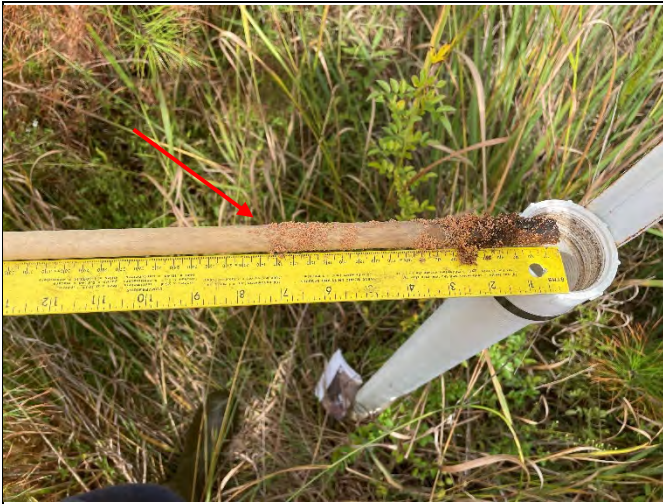
Manual crest gauge reading of 0.59 ft on upper R1 (photo from 8/5/23)

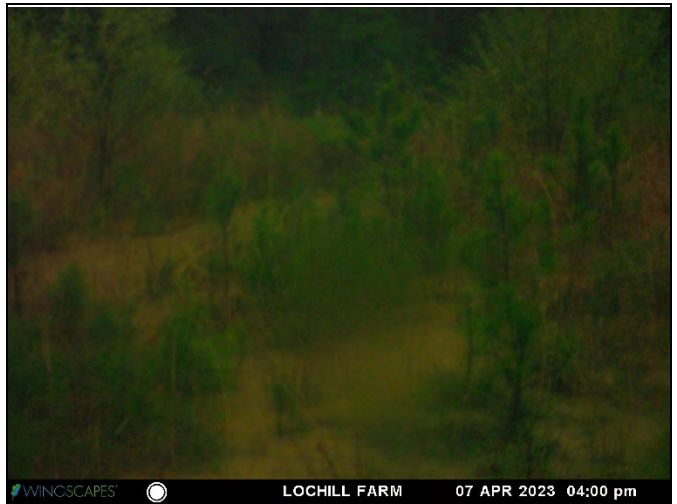
Overbank photo located at Crest Gauge 2 (4/7/2023)

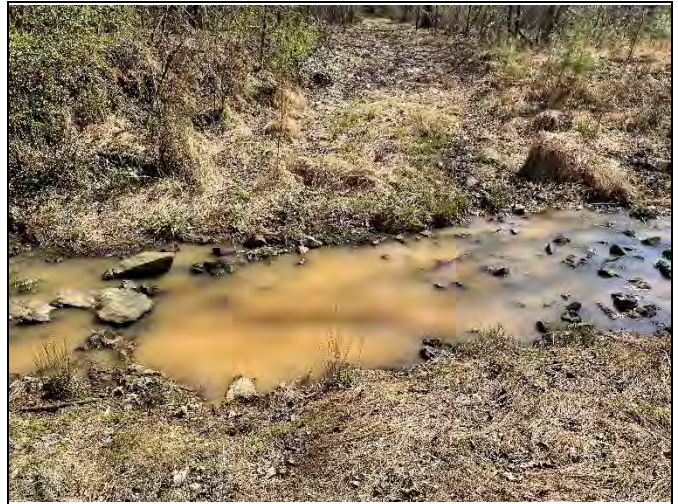
Stable crossing at the top of R1 (3/23/23)

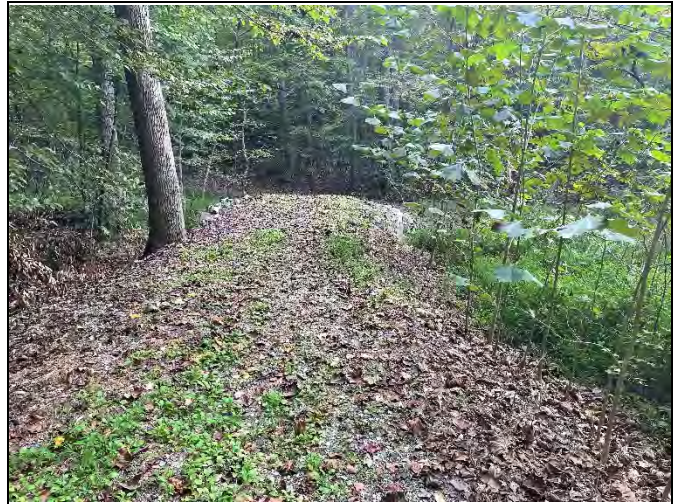
Stable pipe crossing on R3 at Station ~16+30 (10/5/23)

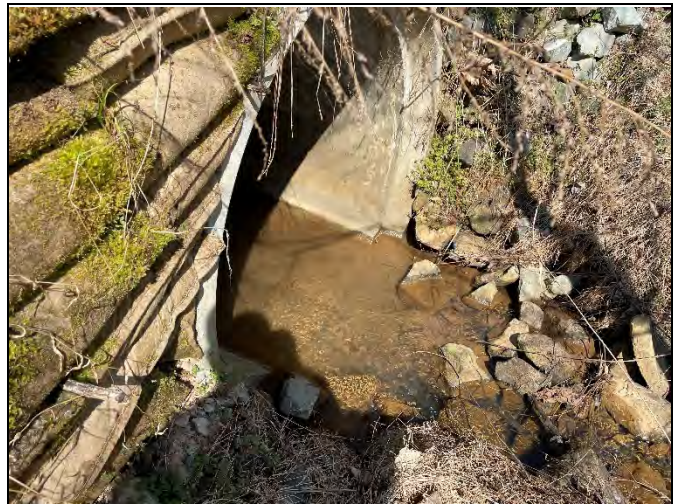
Pipe crossing on R3 at Station ~16+30 (3/23/23)

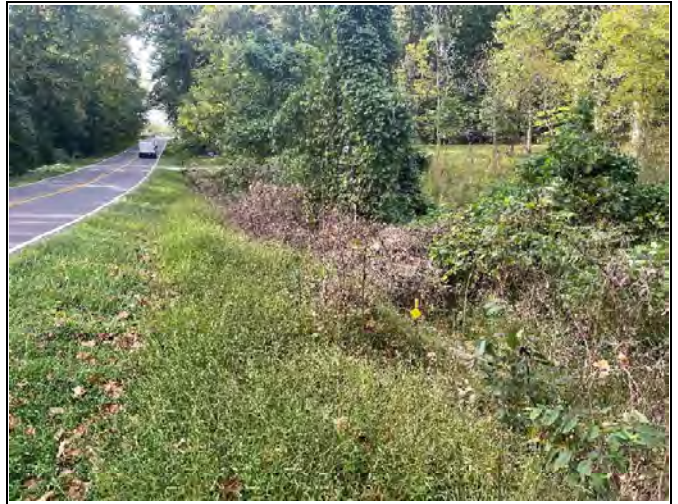
First kudzu treatment results (10/5/23)

**Response: Michael Baker will continue invasive treatment throughout the easement including the kudzu patch at the bottom of the project.**

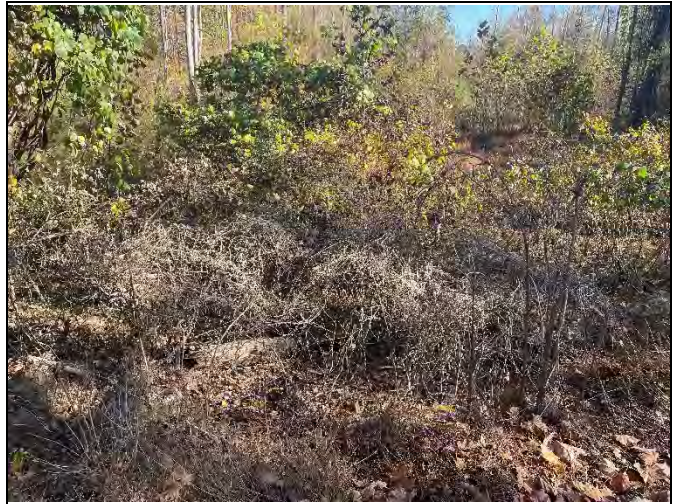
Second kudzu treatment results (11/1/23)

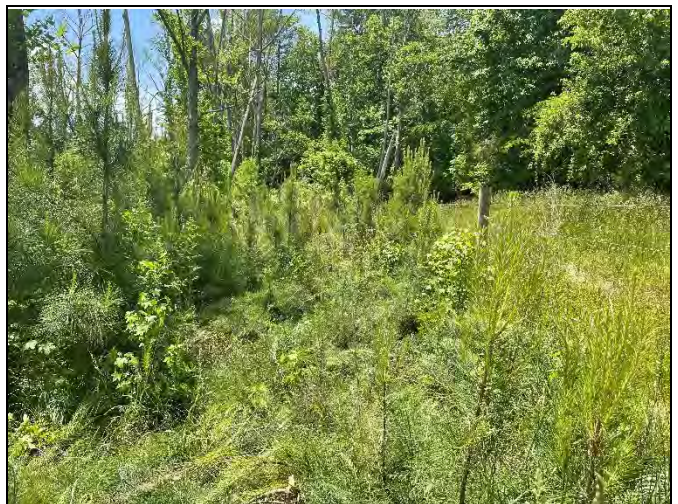
Pine thinning along middle R1 (5/11/23)

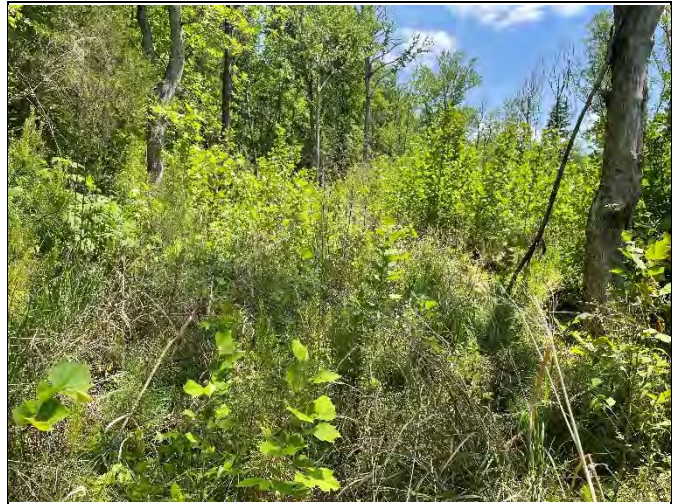
Pine thinning along lower R1 (5/11/23)

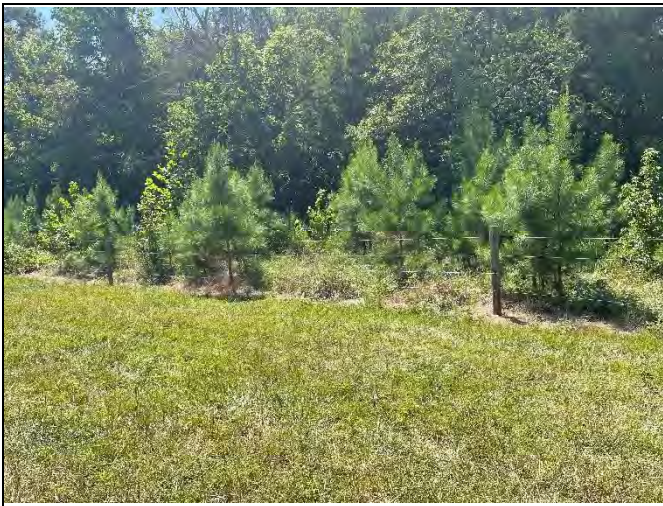
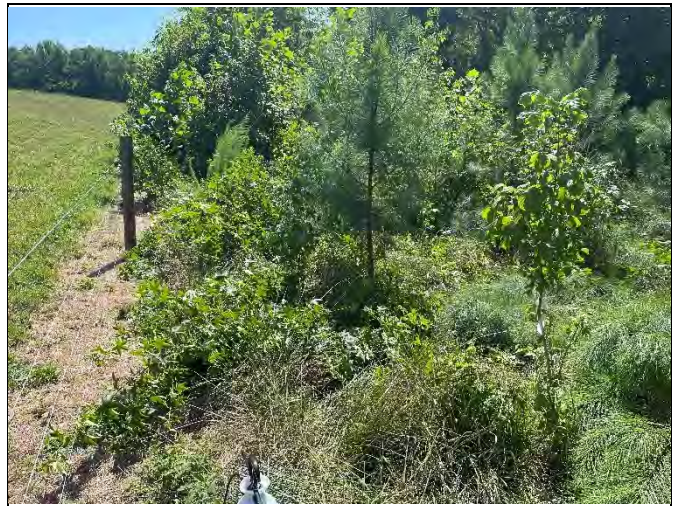
Pine thinning along R3 (8/23/23)

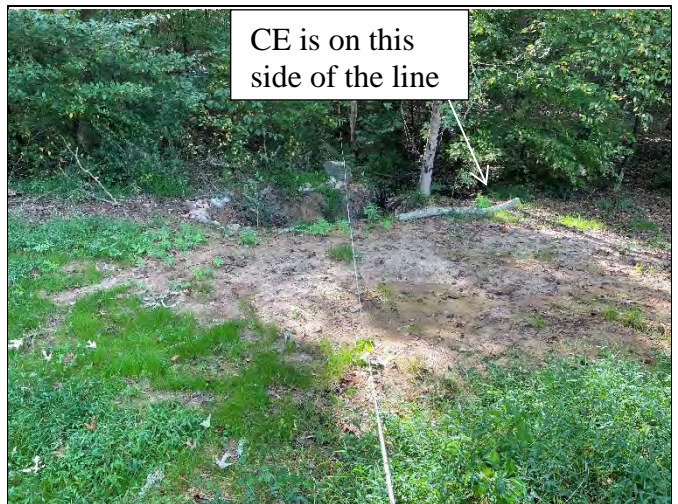
During the September 13<sup>th</sup> site visit, the landowner informed Michael Baker that there was a misguidance between he and his son resulting in an encroachment to the conservation easement at the head of Reach 2. A hole approximately 5ft by 10ft and 3ft deep was dug out in the easement and the excess spoil pile was spread into the floodplain. The total encroachment area is approximately 530 square feet. Michael Baker has discussed the violation with the landowner and developed a plan to resolve the issue. The landowner

Encroachment area at the head of R2. The white tape is the easement boundary (8/5/2023)

has since filled in the hole and plans on replanting the area using 3 gal containerized trees this winter in the dormmate season with species approved by Michael Baker staff. An additional encroachment area was identified on the left floodplain at the upper section of R1 where the landowner mowed into the easement while trying to make a turn in his pasture. This was an area that had previously been marked with horse tape to locate the boundary line but has since been torn down. The landowner is aware of the problem and Michael Baker intends to remark the boundary with t-post for a more permanent solution. Before and after photos of this area can be found in Appendix B Additional Monitoring Photos.

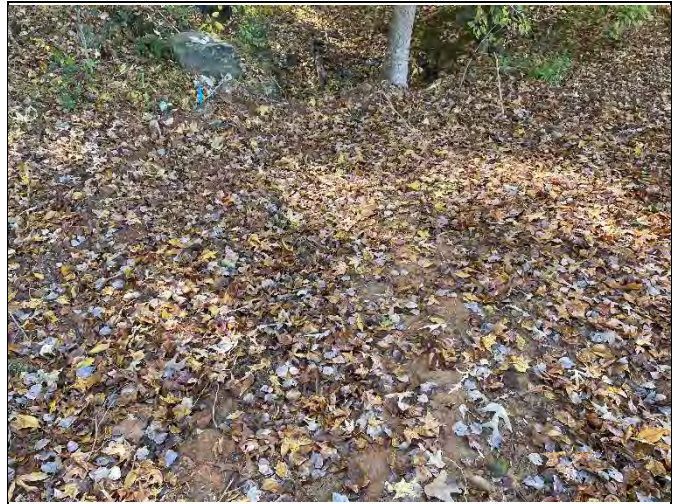
Encroachment area filled back in and graded out (photo from (11/1/23))

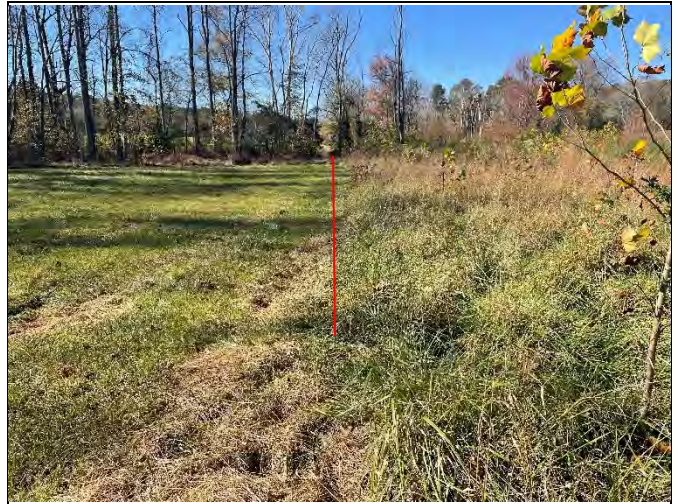
Mowing encroachment along left floodplain on the upper section of R1 (11/1/2023)

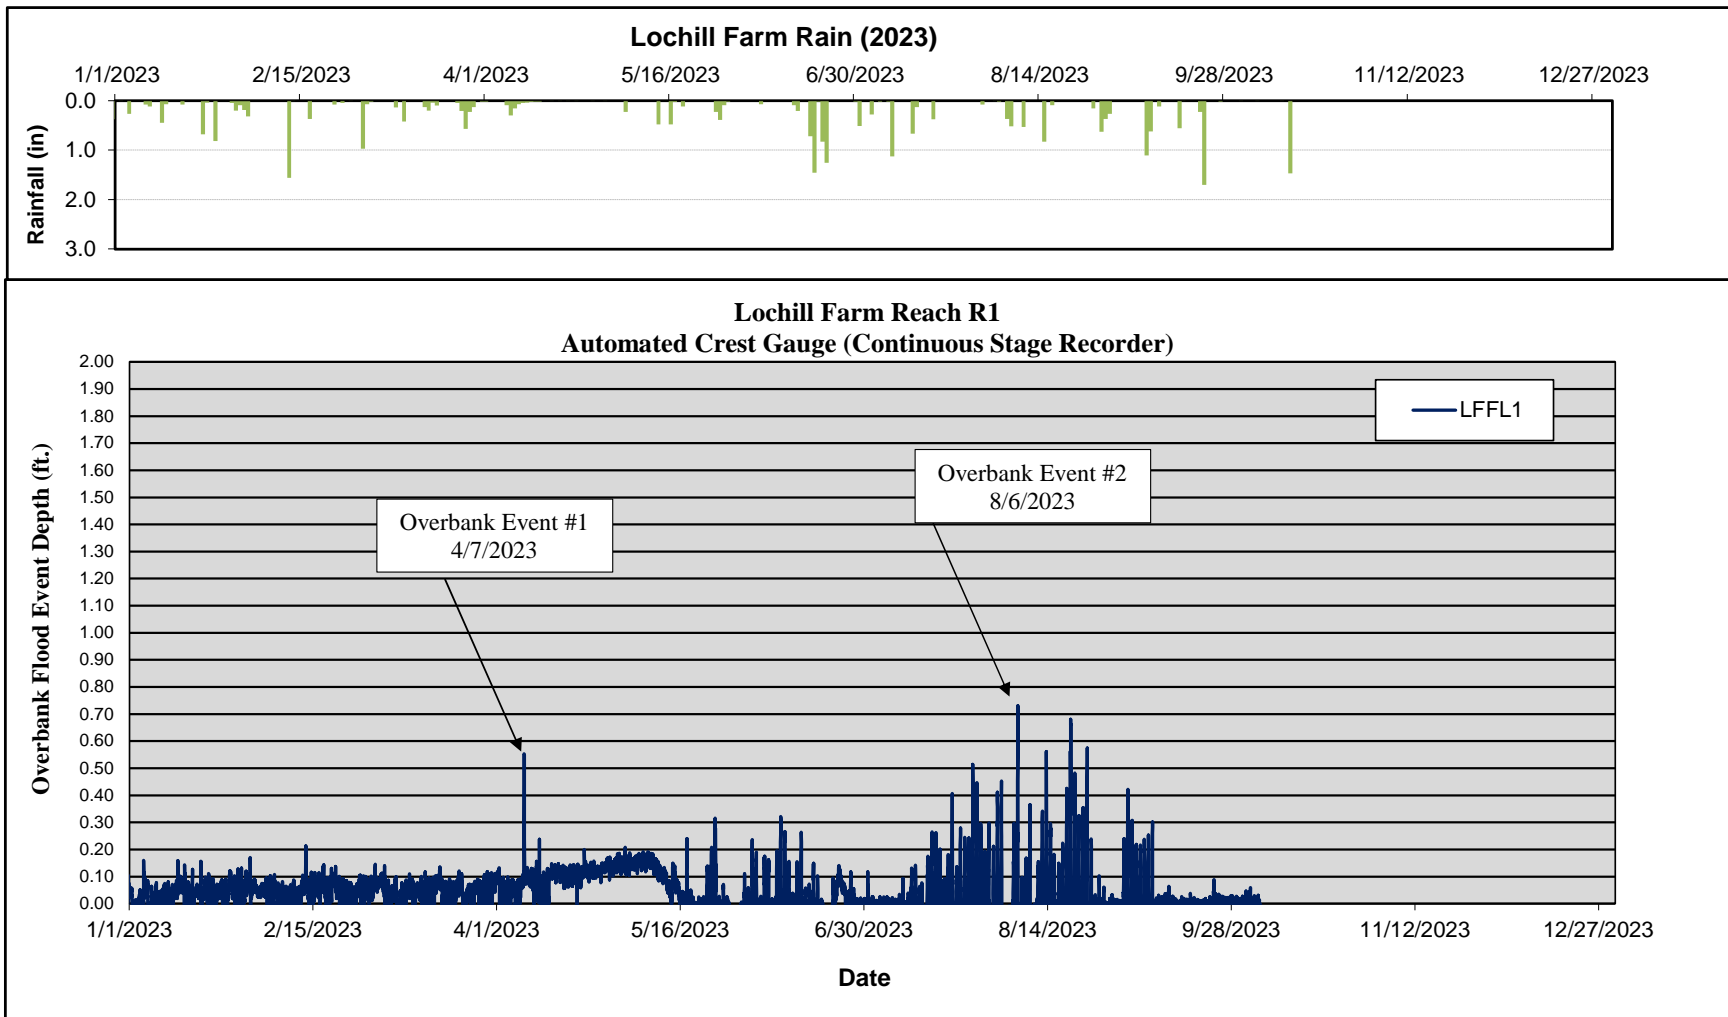
Figure 5. Automated Crest Gauge (Continuous Stage Recorder) Graph

Only the largest overbank event is called out here and in the report. However, several smaller overbank events also appear to have occurred as shown in the graph above.
