# **Logan Creek Stream Restoration Project Year 1 Monitoring Report**

**Jackson County, North Carolina**

**NCDMS Project ID No. 92515; Contract No. D06046-A**

**Project Info:** Monitoring Year: 1 of 5  
Year of Data Collection: November 2015  
Year of Completed Construction: May 2015  
Submission Date: May 2016

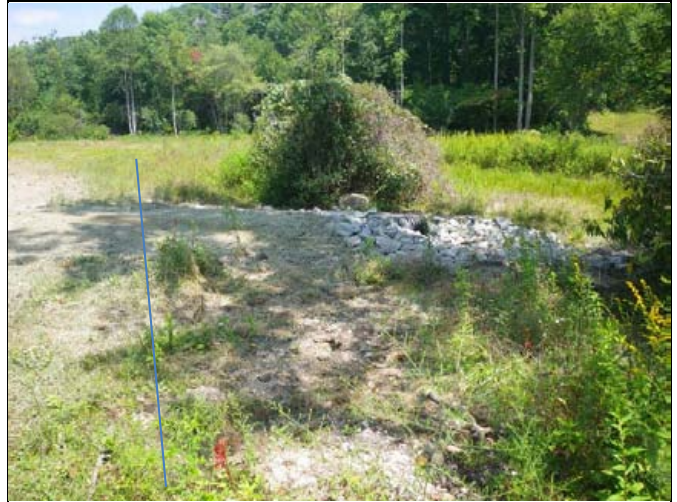
| Table 14. Stream Problem Areas and Photos<br>Logan Creek Stream Restoration Project, Number #92515 | | | |
|--|---|---|---|
| | Station 24+00 | Landowner installed a drainpipe from a new building upslope that crossed the easement line and diverted stormwater from the building site to the floodplain within the easement. This was repaired in November 2016. (EA-2 on CCPV) | 5 to 9 |

Photo 5. Encroachment by landowner who installed a drainpipe to have its outfall within the easement.

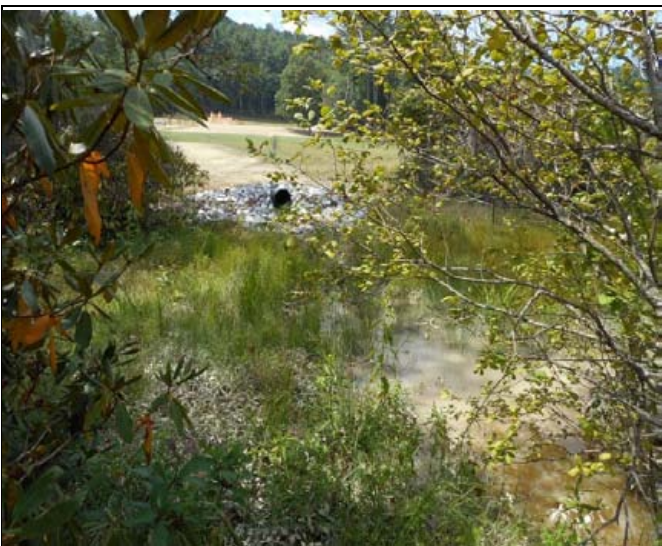
Photo 6. Encroachment by pipe installation, showing opening with standing water and silt on vegetation.

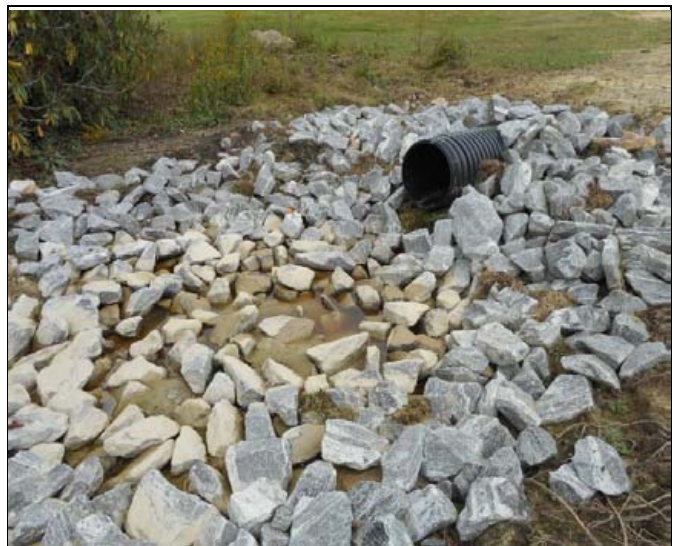
Photo 7. Encroachment by pipe installation showing outlet and riprap apron.

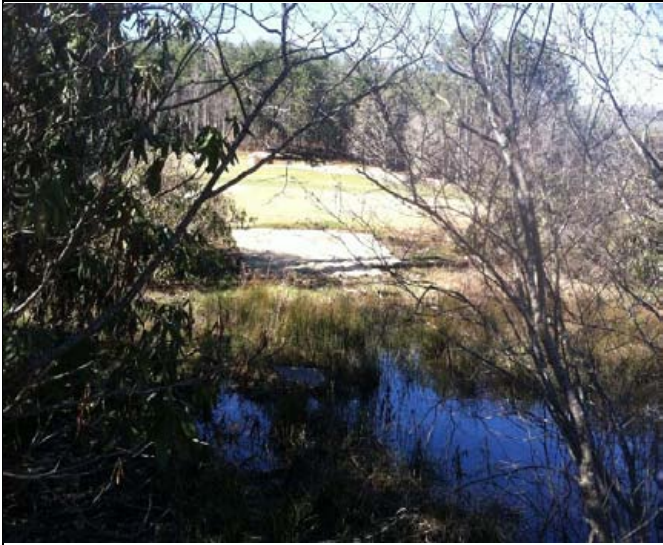
Photo 8. Perspective similar to that of Photo 6 showing the area after the pipe was removed.

(EA-2). We contacted the landowner and DMS to inform them of this easement violation and to request that the pipe outlet be removed from the easement and all impacts to the easement be repaired. The pipe was removed before the end of the year, the affected area regraded, seeded, and erosion control matting installed. While this pipe outlet was installed, excessive stormflow was directed onto the floodplain and caused a small area of instability on the right bank where this flow entered the channel (CPA-2). High flows caused a small area of erosion on the left stream bank at station 2+80 (CPA-1). There apparently was an area of softer soil material incorporated in the bank and eroded during high flows. This happened early in the summer and has been stable in the intervening time. Both CPA-1 and CPA-2 are small and are not continuing to destabilize. We do not plan to repair them at this time but will monitor their condition and take corrective action if needed. The only other area that was considered a Channel Problem Area was a small hole that developed on the floodplain (CPA-3) above some woody debris that was installed in the bank. Standing water on the floodplain drains into the ground in this area and caused this subsidence. We will be filling this hole during 2016. A nature trail exists along the stream beginning at the lower end of Reach 1 and continuing upstream to the trout pond. This trail falls within the easement in many locations but also passes out of the easement in others. This was a pre-existing nature trail and the right to maintain it is allowed in the conservation easement. All issues discussed above reference the CCPV mapping and the Stream Problem Area table included in the e-File data with associated photos.

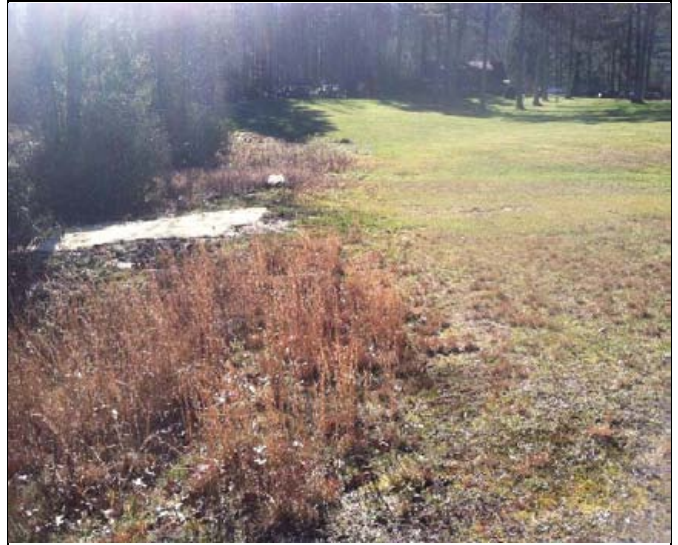
Photo 9. View along the easement line after the pipe was removed. Perspective is similar to Photo 5 but from the opposite direction.
