Logan Creek Stream Restoration Project Year 2 Monitoring Report

NCDMS Project ID No. 92515; Contract No. D06046-A

Project Info: Monitoring Year: 2 of 5
Year of Data Collection: 2016
Year of Completed Construction: May 2015
Submission Date: December 2016

Report Prepared and Submitted by Michael Baker Engineering, Inc.
797 Haywood Road, Suite 201
Asheville, NC 28806

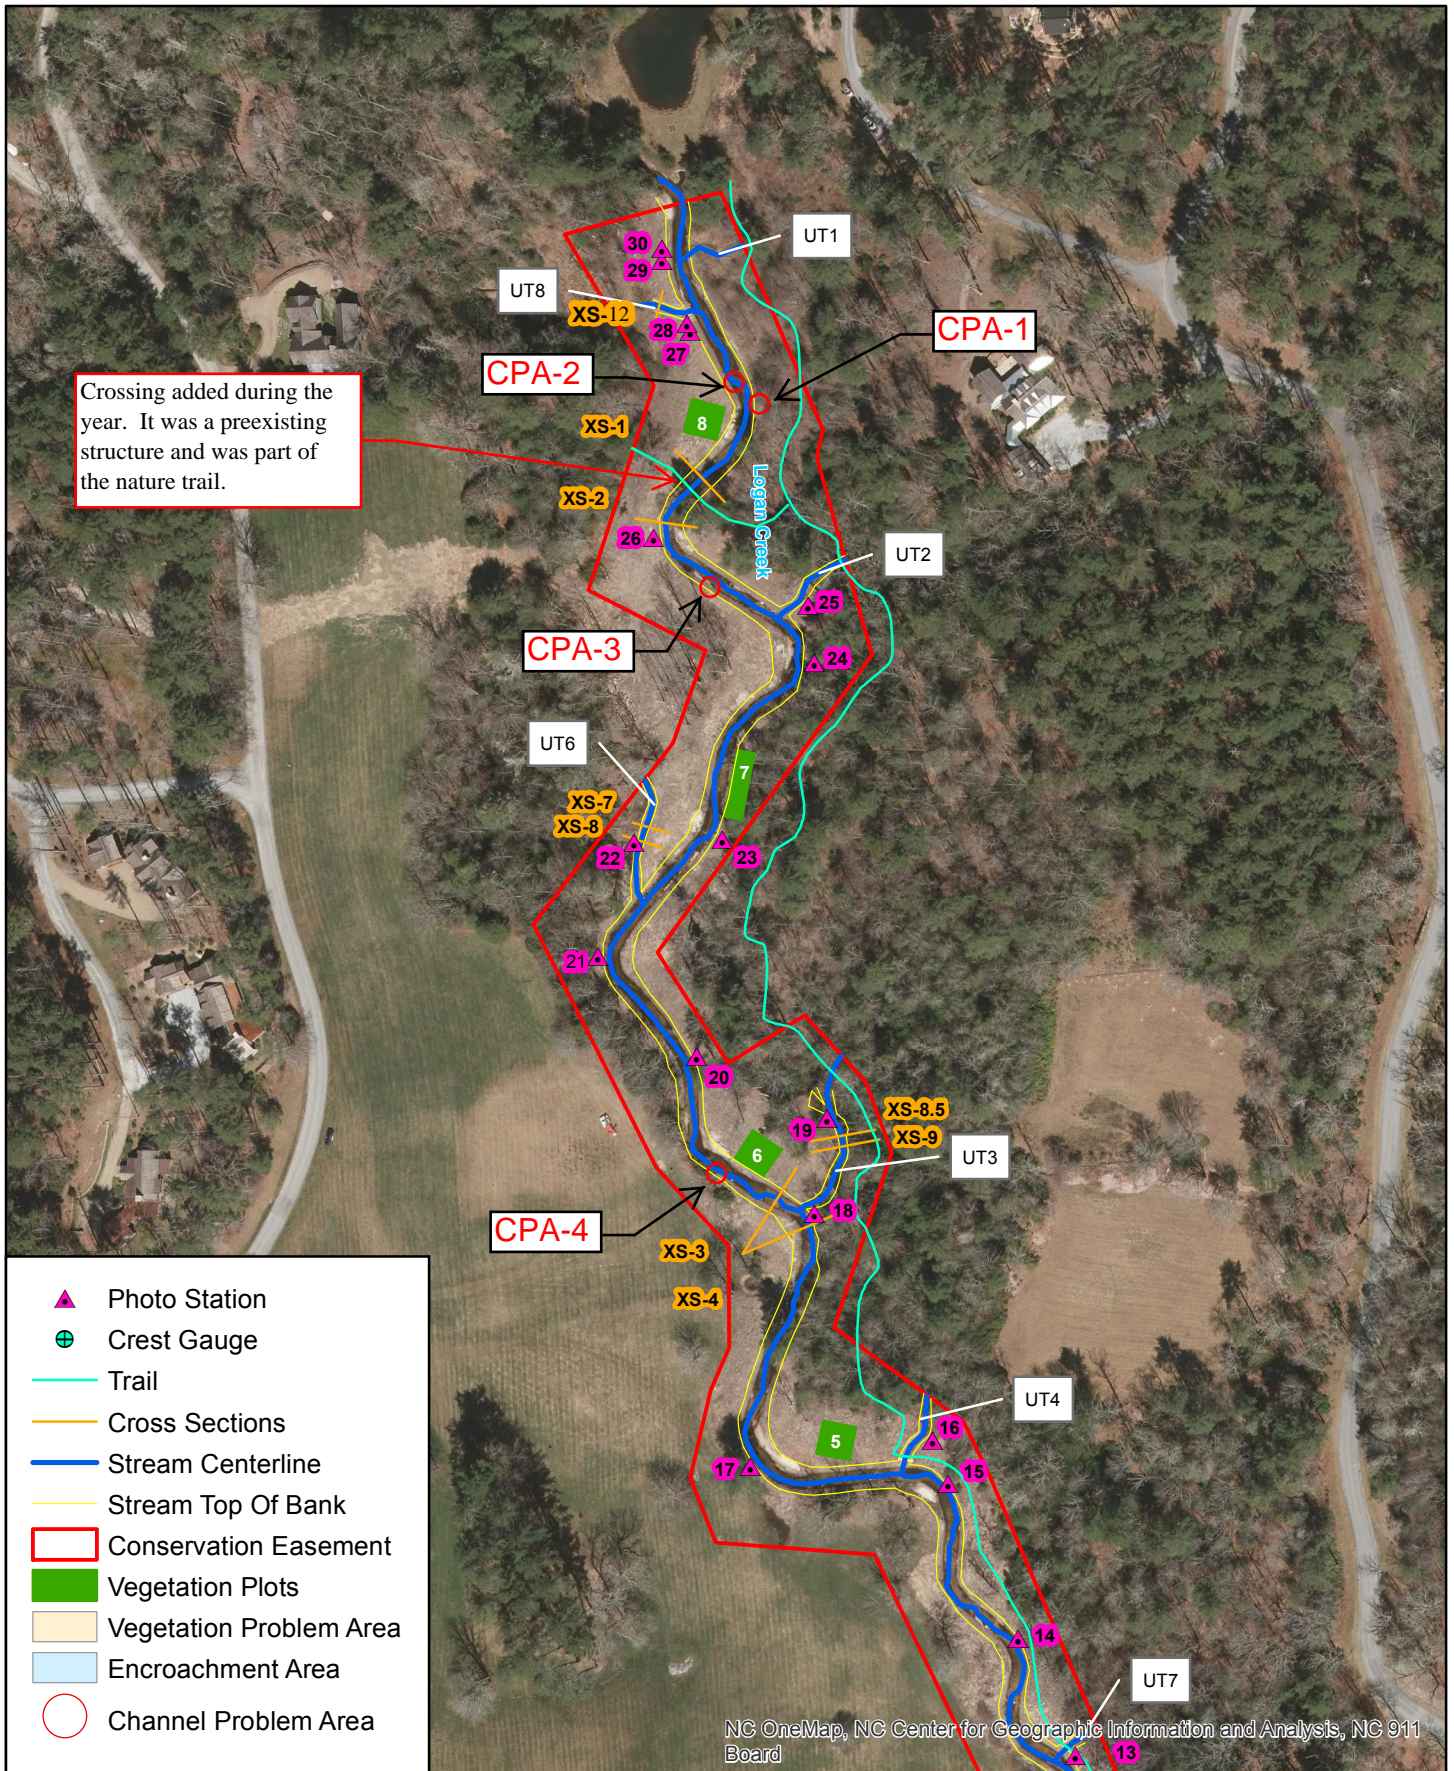
Figure 2
Current Conditions Plan View
Monitoring Year 2
Logan Creek Site

Crossing added during the year. It was a preexisting structure and was part of the nature trail.
