Subject: Response to DMS comments on the Year 3 Monitoring Report Review for the Logan Creek Stream Restoration Project; Savannah River Basin - CU# 03060101; Jackson County, North Carolina; NCDMS Project # 92515; Contract No. D06046-A

Logan Creek Stream Restoration Project Year 3 Monitoring Report

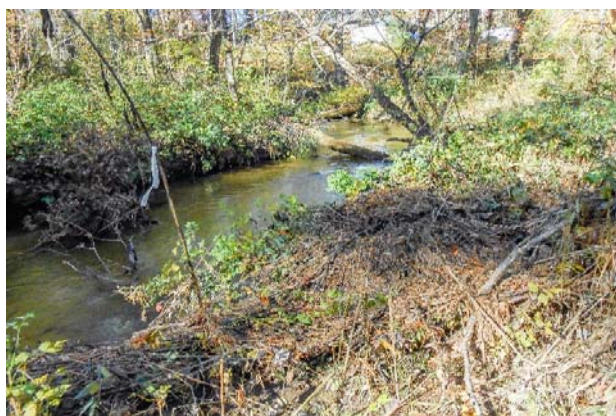
Wrack lines well back from the stream, indicating wide flooding of the floodplain during the storms in October.

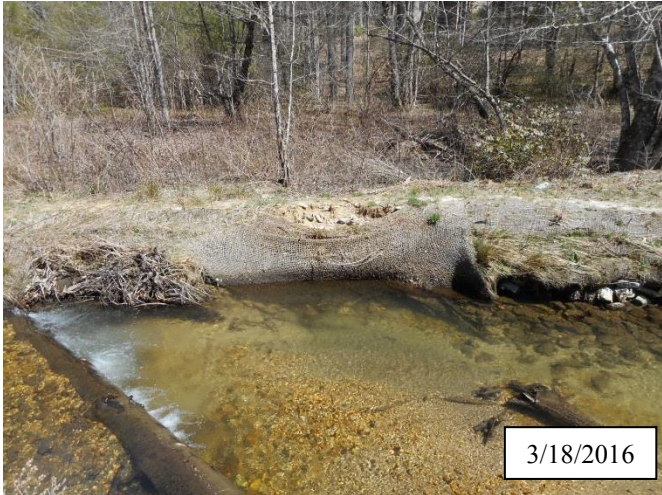
Photo 1. CPA 2-1 – Station 2+10, small area of bank scour caused by flooding of December and January.

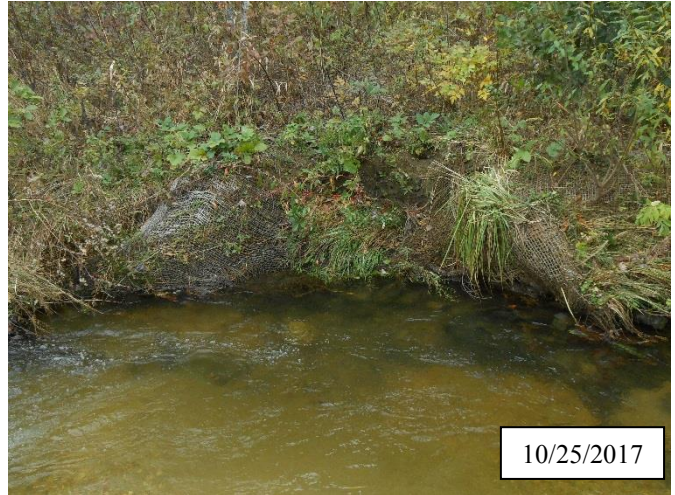
Photo 2. CPA 2-1 – Station 2+10, same area as shown in photo 1 during October 2017 with vegetation stabilizing site. Bank was graded, matting was reinstalled, and live stakes were added during October 2017.

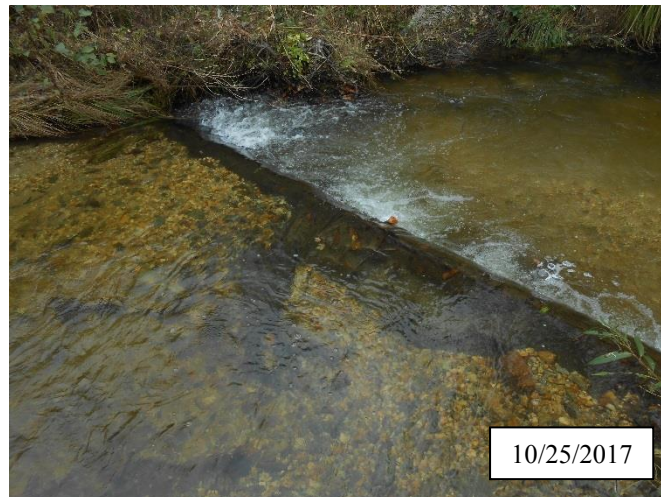
Photo 3. CPA 2-2 – Station 2+00, Piping of log structure after the fabric sealing this structure tore during flooding of December and January.

Photo 4. CPA 2-2 – Station 2+00, Piping structure was repaired in May 2017. Fabric was replaced and substrate was replaced upstream of log structure.

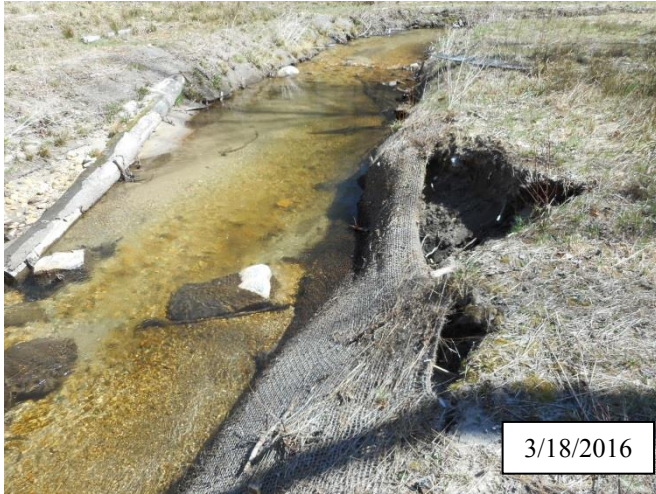
Photo 5. CPA 2-3 – Station 4+60, small area of bank scour caused by flooding of December and January 2016.

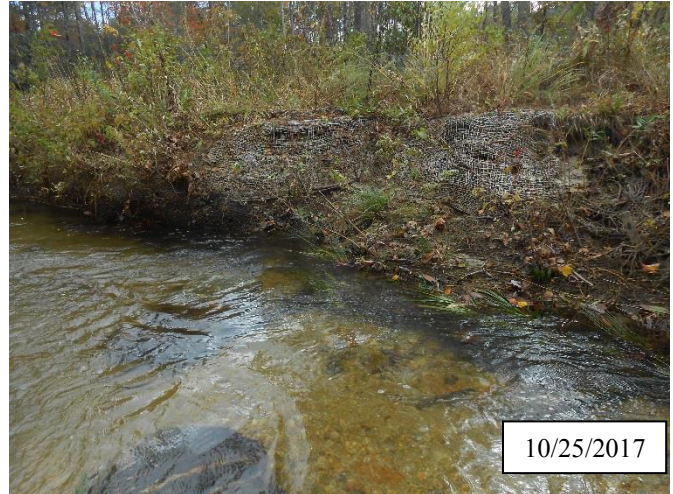
Photo 6. CPA 2-3 – Station 4+60, bank scour area was regraded, matting was reinstalled, and herbaceous vegetation was transplanted in May 2017. Livestakes were installed in October 2017.

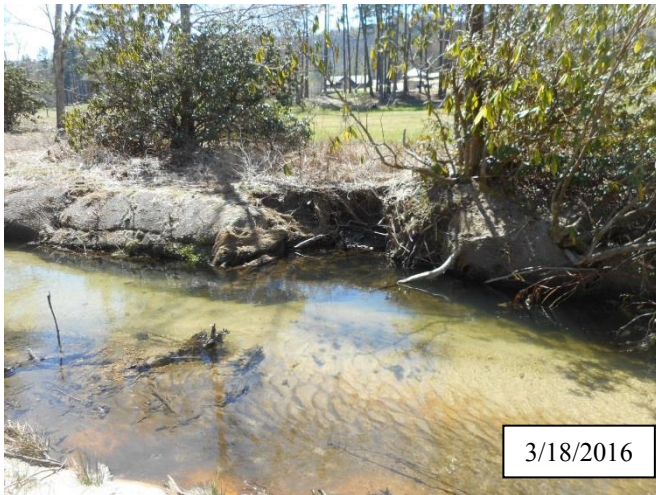
Photo 7. CPA 2-4 – Station 11+70, small area of bank scour caused by flooding of December and January 2016.

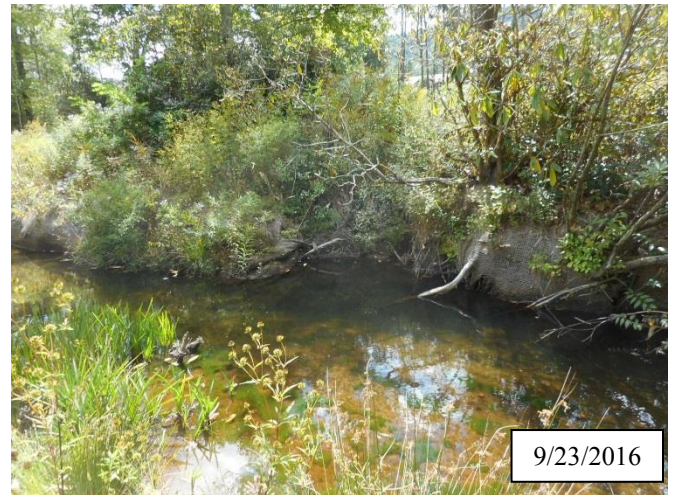
Photo 8. CPA 2-4 – Station 11+70, scour area noted in MY2 has stabilized for the most part. Livestakes were planted in the scour area as well as the bank downstream of the problem area in October 2017.

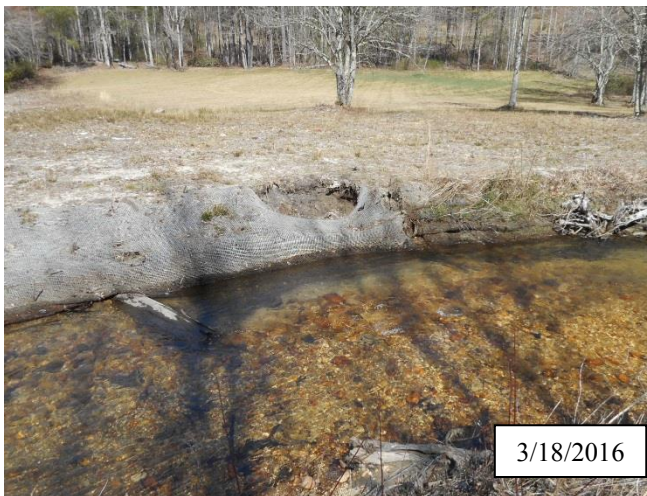
Photo 9. CPA 2-5 – Station 26+60, small area of bank scour caused by flooding of December and January 2016.

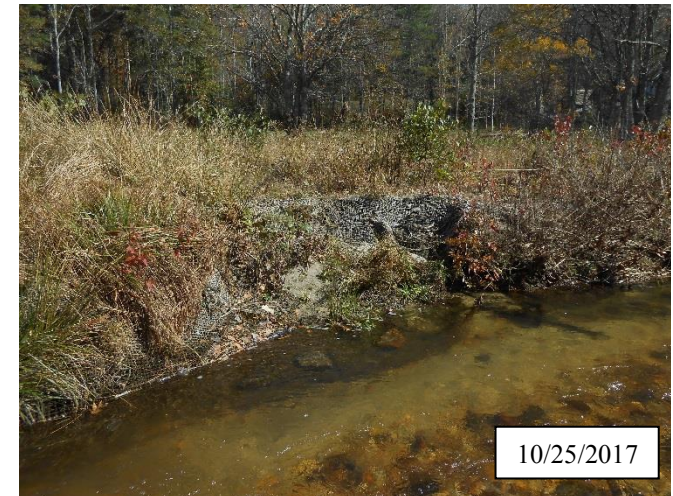
Photo 10. CPA 2-5 – Station 26+60, bank scour area was regraded, matting was reinstalled, and herbaceous vegetation was transplanted in May 2017. Livestakes were installed in October 2017.

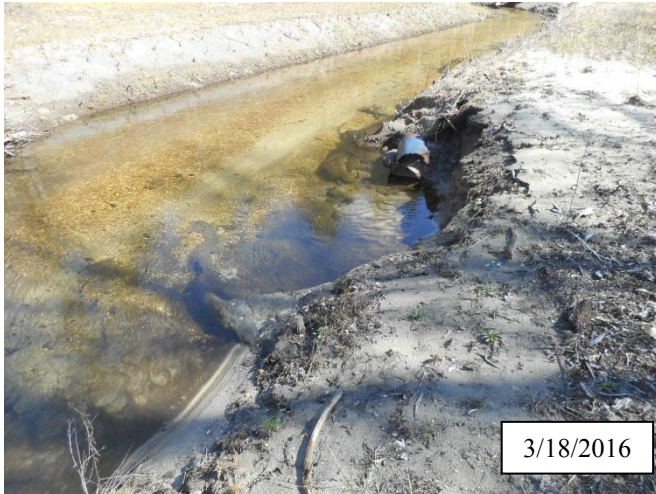
Photo 11. CPA 2-6 – Station 27+00, small area of bank scour caused by flooding of December and January 2016.

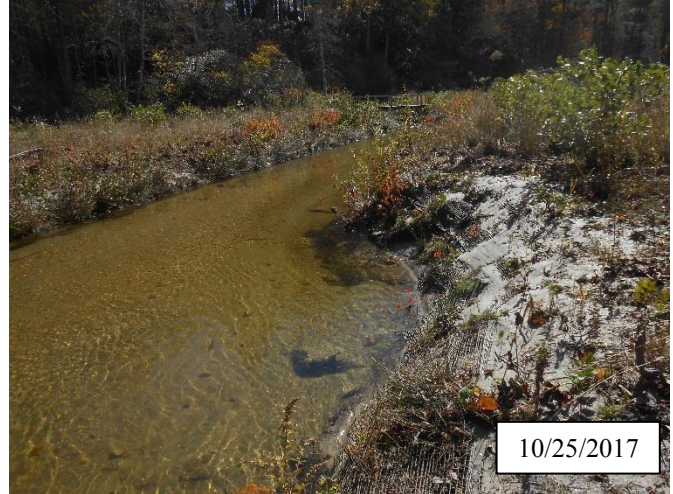
Photo 12. CPA 2-6 – Station 27+00, bank scour area was regraded, matting was reinstalled, and herbaceous vegetation was transplanted in May 2017. Livestakes were installed in October 2017.

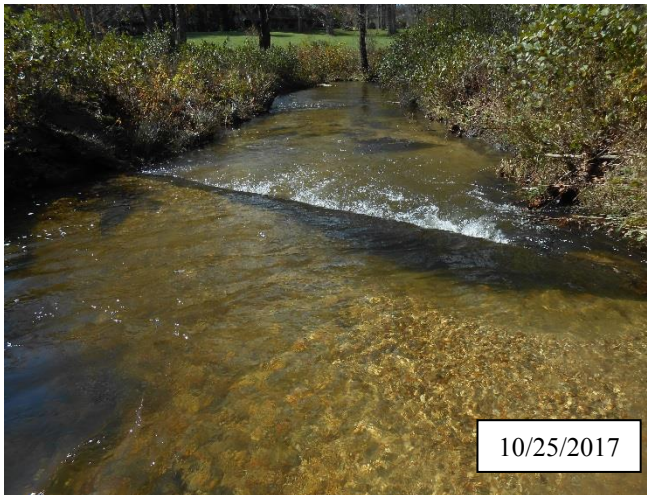
During MY3, three structures (CPA 3-1, 3-3, and 3-5) were noted that were experiencing piping. These structures are all instances of fabric tearing and allowing water and sediment to wash under the log structure over time. These structures will be repaired in 2018.

Photo 13. CPA 3-1 – Station 23+75, piping of log structure after the fabric sealing this structure tore in 2017. This structure will be repaired in 2018.

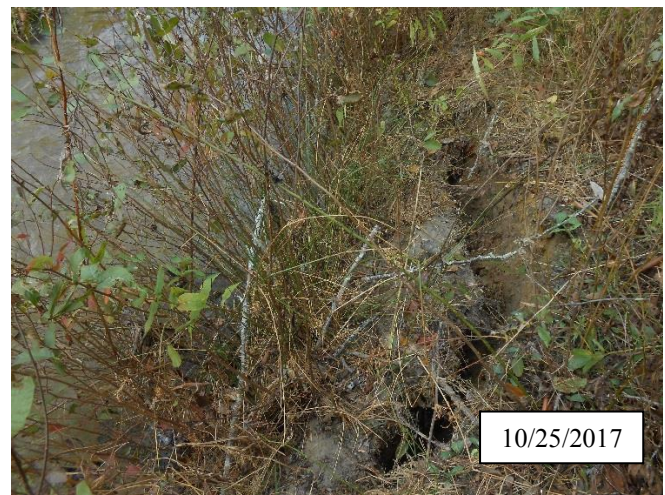
There were also two additional areas of erosion noted in MY3 (labeled CPA 3-2 and CPA 3-4). These areas both have sufficient vegetative cover, and will be monitored in the coming year to see if they stabilize naturally.

Photo 14. CPA 3-2 – Station 21+00, small bank slump area (approx. 6 ft.) along left bank of main stem. Will be monitored to see if the bank stabilizes in MY4

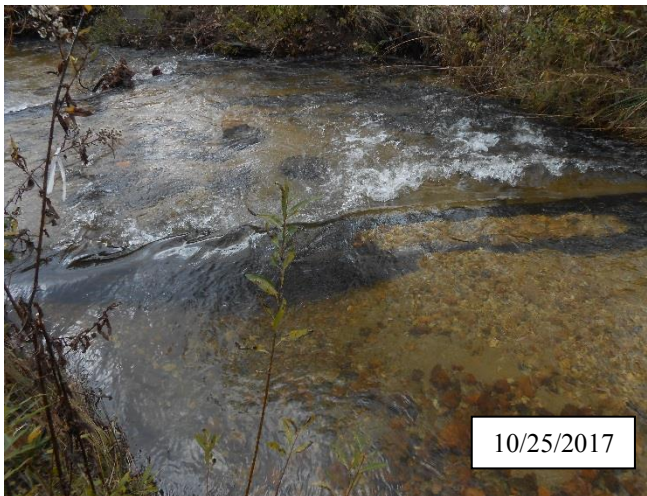
Photo 15. CPA 3-3 – Station 14+75, piping of log structure after the fabric sealing this structure tore in 2017. This structure will be repaired in 2018.

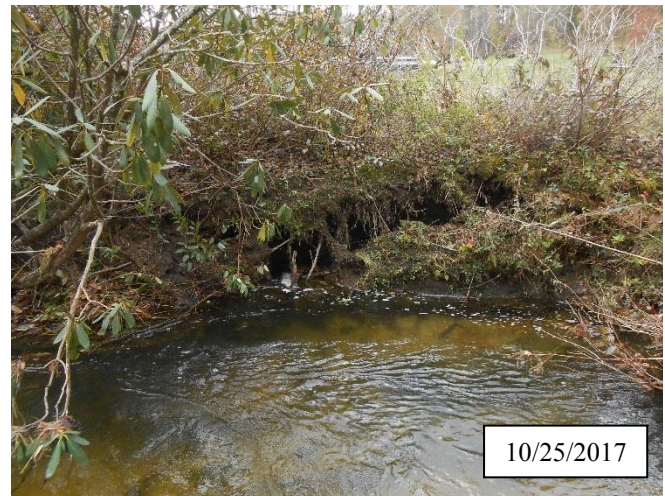
Photo 16. CPA 3-4 – Station 11+50, small bank slump (approx. 8 ft.) along right bank of main stem. Will be monitored to see if the bank stabilizes in MY4

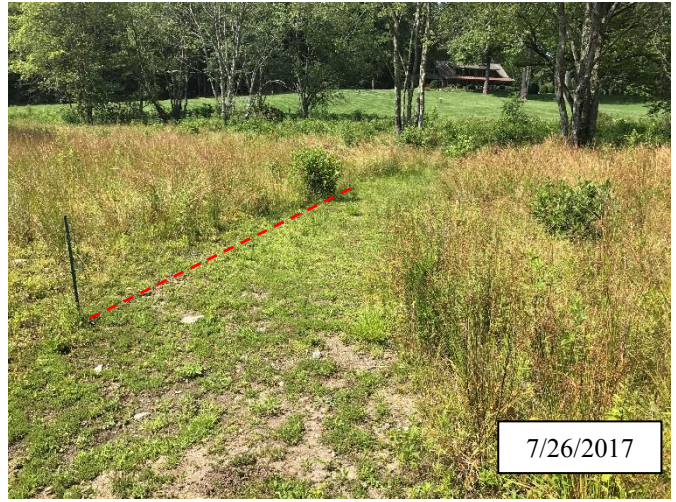
The Encroachment Area (EA-1) that was noted in 2016 is still regularly being mowed through Vegetation Plot 3, although no new trees in the plot have been affected since MY2. The mowed path through the plot is still approximately 10-12 feet wide. This issue will be addressed again with Lonesome Valley maintenance staff. Despite the impacts to the trees in the plot, Veg Plot 3 still meets minimum success criteria for MY3.

Photo 19. EA 2-1 – In July of 2017, the path was still being mowed wide through Veg Plot 3.
