Logan Creek Stream Restoration Project Year 4 Monitoring Report - Final

Jackson County, North Carolina

NCDMS Project ID No. 92515; Contract No. D06046-A

Project Info: Monitoring Year: 4 of 5
Year of Data Collection: 2018
Year of Completed Construction: May 2015
Submission Date: December 2018

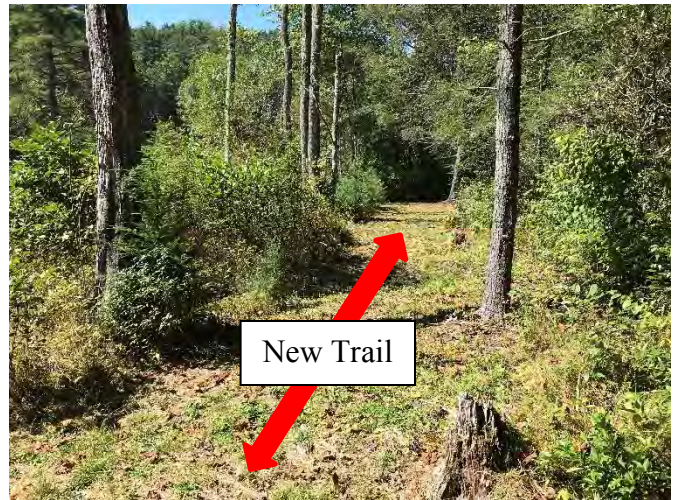
Photo 20. Trail Relocation 2 facing downstream– Trail was relocated away from the stream, bridge will be moved.

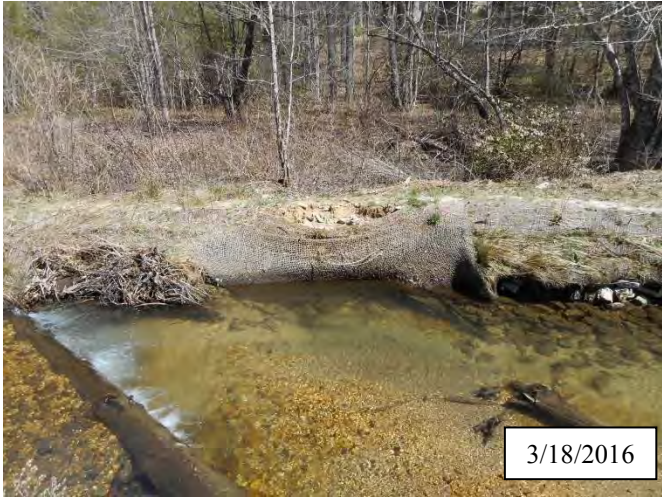
Photo 1. CPA 2-1 – Station 2+10, small area of bank scour caused by flooding of December and January 2016.

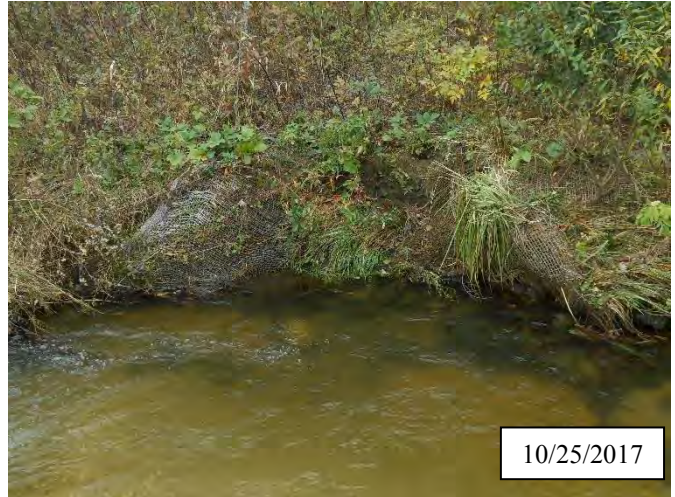
Photo 2. CPA 2-1 – Station 2+10, same area as shown in photo 1 during October 2017 with vegetation stabilizing site. Bank was graded, matting was reinstalled, and live stakes were added during October 2017.

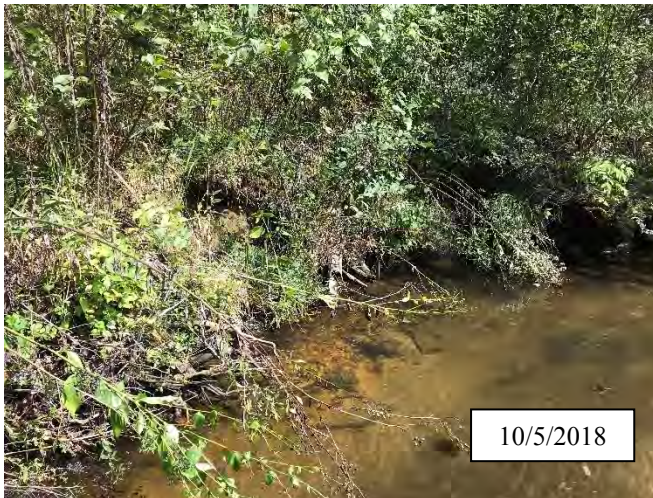
No new erosion areas were noted in MY4. Some of the areas of erosion that were called out in MY3 (CPA 3-2, CPA 2-1, CPA 2-4, CPA 2-5, CPA 2-6) have stabilized and are fully vegetated. The remaining areas of erosion (CPA 3-4, CPA 2-3) have not completely stabilized but have not gotten worse in MY4 and are supporting vegetation. These areas will continue to be monitored in MY5.

Photo 3. CPA 2-1 – Scour area has stabilized and is no longer eroding after repairs were made in 2017.

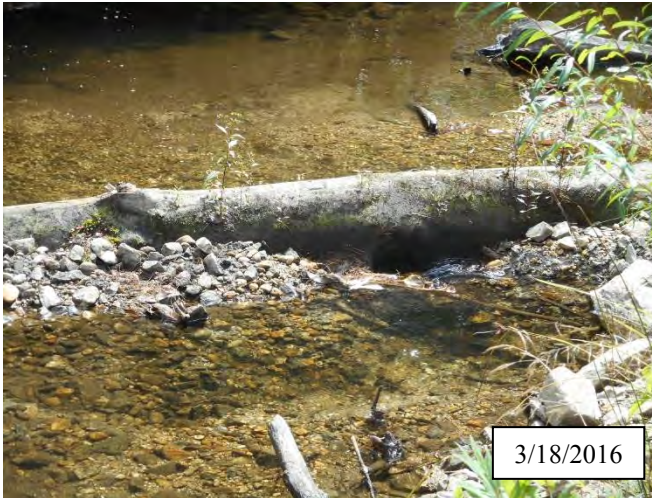
Photo 4. CPA 2-2 – Station 2+00, Piping of log structure after the fabric sealing this structure tore during flooding of December and January 2016.

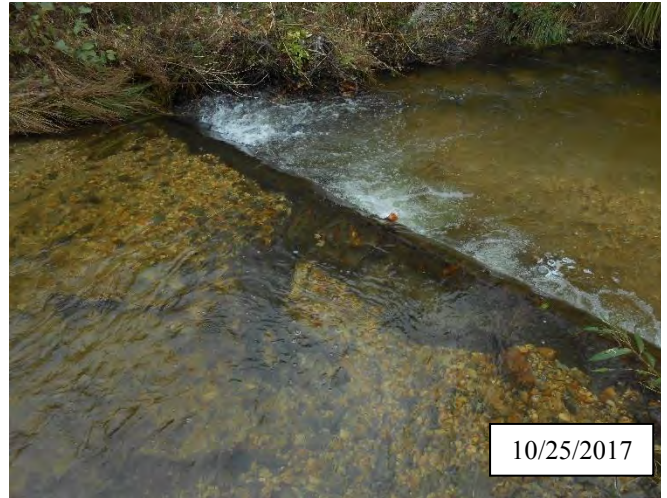
Photo 5. CPA 2-2 – Station 2+00, Piping structure was repaired in May 2017. Fabric was replaced and substrate was replaced upstream of log structure.

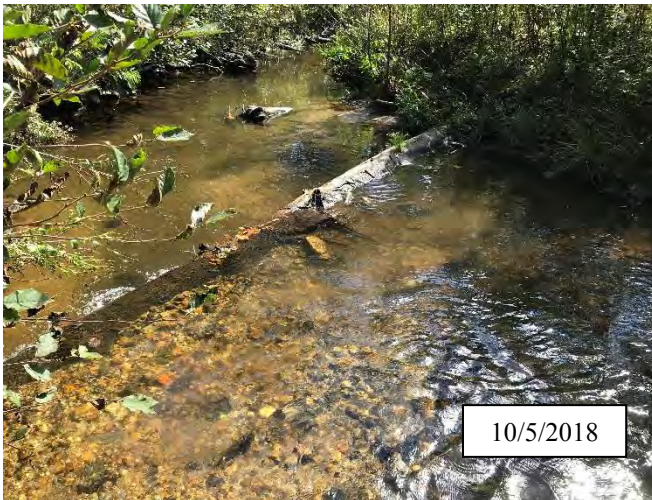
Photo 6. CPA 2-2 – Log structure that was repaired in 2017 has remained stable and is no longer piping.

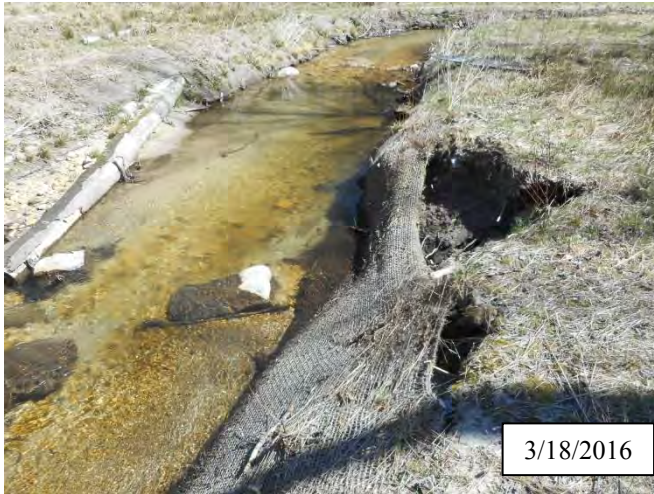
Photo 7. CPA 2-3 – Station 4+60, small area of bank scour caused by flooding of December and January 2016.

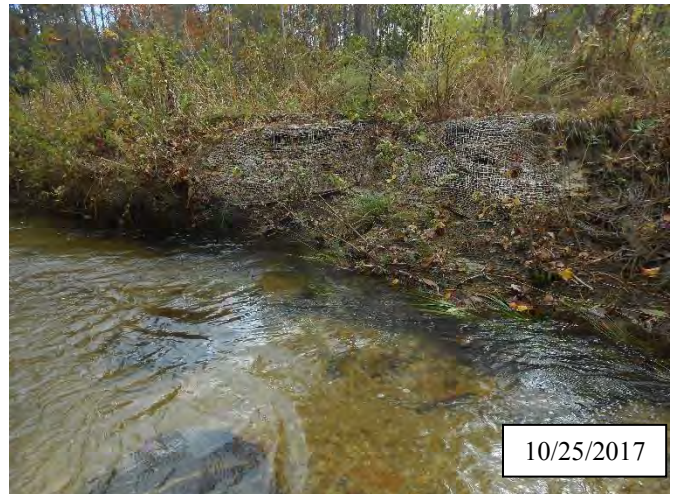
Photo 8. CPA 2-3 – Station 4+60, bank scour area was regraded, matting was reinstalled, and herbaceous vegetation was transplanted in May 2017. Livestakes were installed in October 2017.

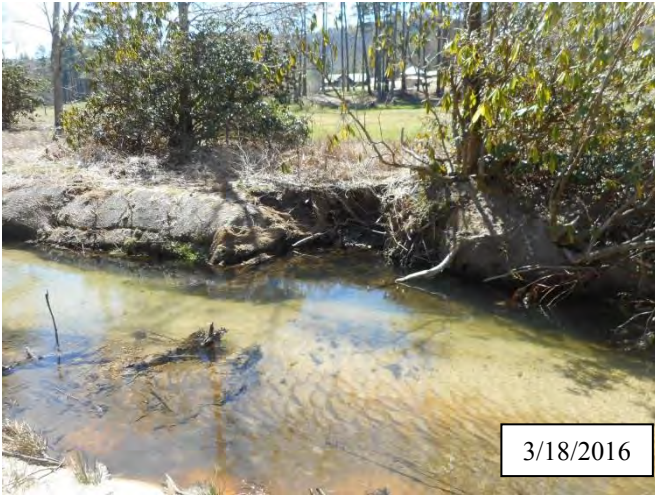
Photo 10. CPA 2-4 – Station 11+70, small area of bank scour caused by flooding of December and January 2016.

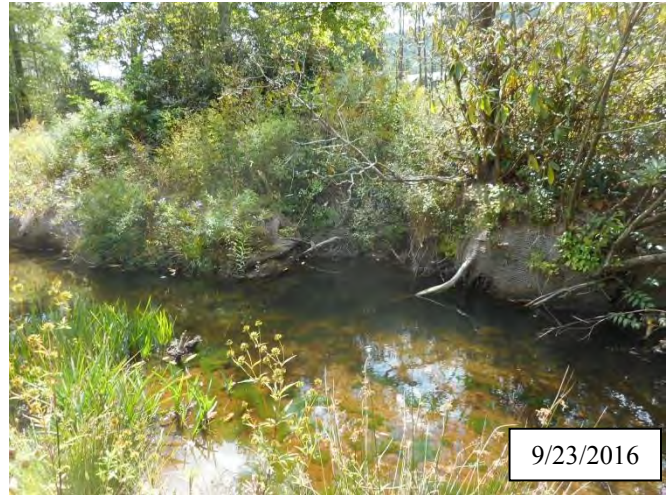
Photo 11. CPA 2-4 – Station 11+70, scour area noted in MY2 has stabilized for the most part. Livestakes were planted in the scour area as well as the bank downstream of the problem area in October 2017.

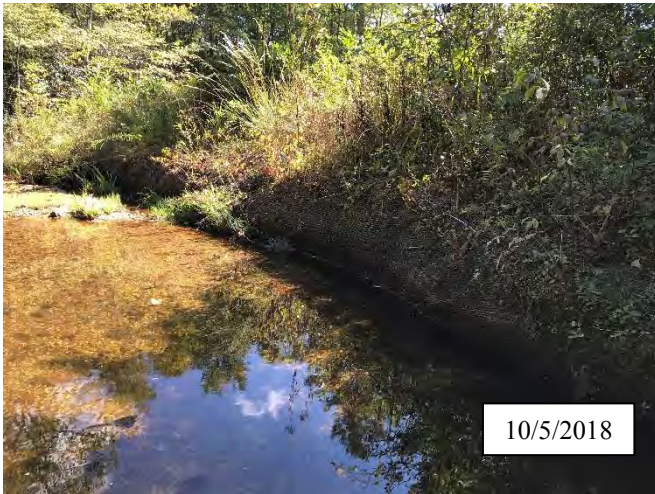
Photo 12. CPA 2-4 – Station 11+70, Bank has vegetated and stabilized in 2018.

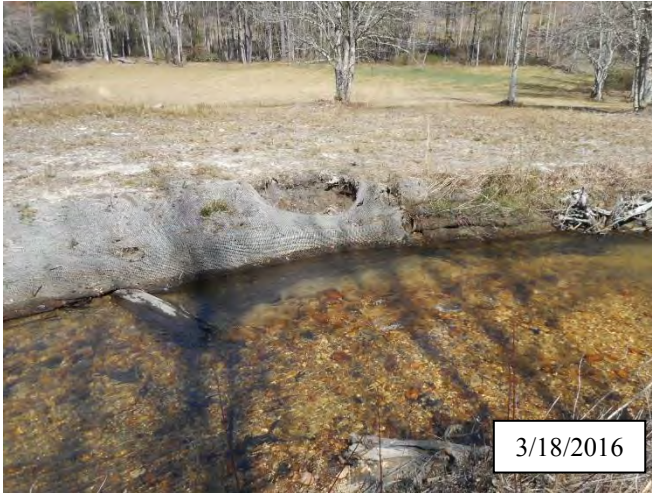
CAP 2-5

Photo 13. CPA 2-5 – Station 26+60, small area of bank scour caused by flooding of December and January 2016.

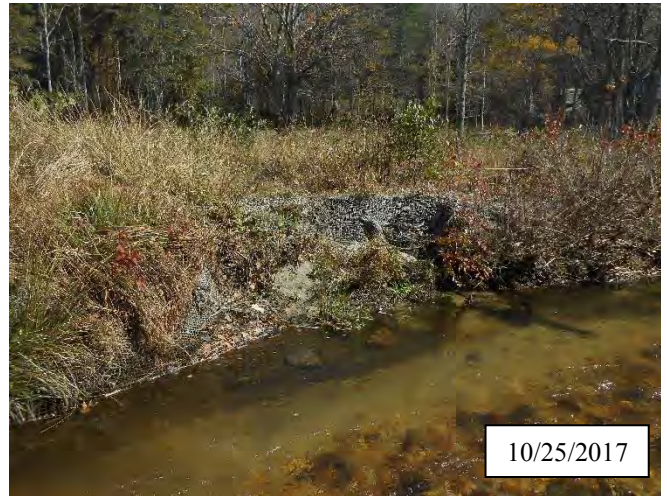
Photo 14. CPA 2-5 – Station 26+60, bank scour area was regraded, matting was reinstalled, and herbaceous vegetation was transplanted in May 2017. Livestakes were installed in October 2017.

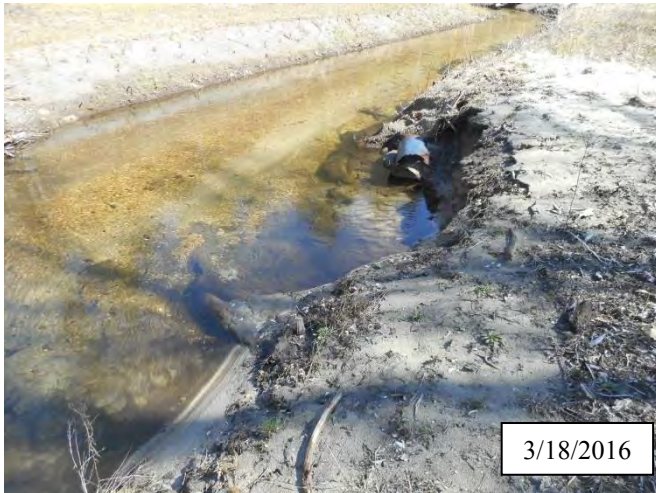
Photo 16. CPA 2-6 – Station 27+00, small area of bank scour caused by flooding of December and January 2016.

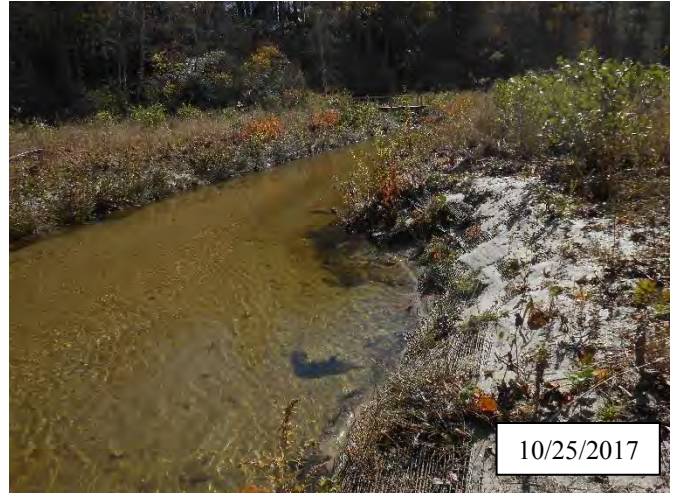
Photo 17. CPA 2-6 – Station 27+00, bank scour area was regraded, matting was reinstalled, and herbaceous vegetation was transplanted in May 2017. Livestakes were installed in October 2017.

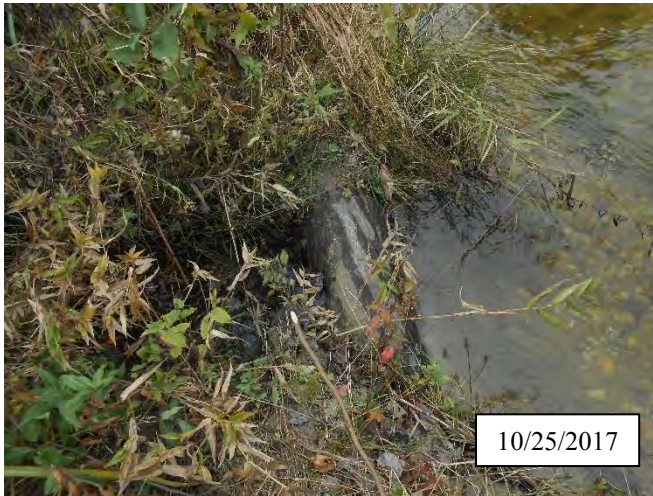
One structure (CPA 3-5) that was experiencing piping in MY3 is still piping in MY4. The other structures that were noted in MY3 have filled in naturally and are no longer piping. Hand repairs will be made to CPA 3-5 during MY5.

* Note: Due to very low water levels some piping is occurring, only one structure may need to be repaired to fix the issue. Most structures in Reach 2 were designed to have water go under them during low water, in order to move sand through the reach.

Photo 27. CPA 3-5 – Station UT8 00+40, piping of log structure on UT-8 near the confluence of UT-8 and Logan Creek. Hand repairs will be made to CPA 3-5 during MY5.

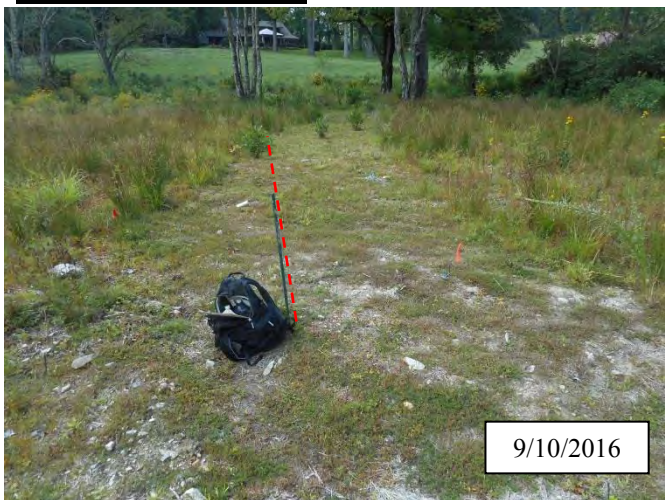
Trail Encroachments

The Encroachment Area (EA-1) that was first noted in 2016 is still regularly being mowed through Vegetation Plot 3 to maintain the nature trail, although no new trees in the plot have been affected since MY2. The mowed path through the plot is still approximately 10-12 feet wide. Despite the impacts to the trees in the plot, Veg Plot 3 still meets minimum success criteria for MY4.

4. Invasive Areas of Concern ⁴	None	1000 SF	Pattern and Color	0	0.00	0.0%
5. Easement Encroachment Areas ³	<p>There was one Encroachment Area (EA-1) noted in 2016 along the nature trail, in the area of stations 23+00 to 28+00. A new maintenance staff person had the nature trail mowed; however, a wider area was mowed than we verbally agreed should be maintained. The width was 10-12 feet wide, while we had agreed to a width of 4-6 feet wide, which approximates the width of the previously existing nature trail. We discussed this with staff at Lonesome Valley and they agreed to address this issue with the trail maintenance staff, and to be sure they know the proper width for future maintenance.</p> <p>During MY3 monitoring, it was noted that the trail through Veg Plot 3 was still being mowed. This issue will be addressed with the trail maintenance staff again.</p>	none	Light Blue	2	0.014	0.11%

Photo 28. EA 2-1 – Maintenance workers mowed the nature trail wider than the 4-6 feet that had been agreed to earlier, near stationing 23+00 to 28+00.

- Executive Summary: In the executive summary, please note the proposed resolution to the mowing encroachment reported (EA-1).
The following statement was added: "Because the vegetation plot meets success criteria we are not asking Lonesome Valley to move the nature trail in this area."
