Subject: Response to DMS comments on the Year 5 Monitoring Report Draft review for the Logan Creek Stream Restoration Project; Savannah River Basin - CU# 03060101; Jackson County, North Carolina; NCDMS Project # 92515; Contract No. D06046-A

**Figure 2 - Overview
 Current Conditions Plan View
 Monitoring Year 5
 Logan Creek Site**

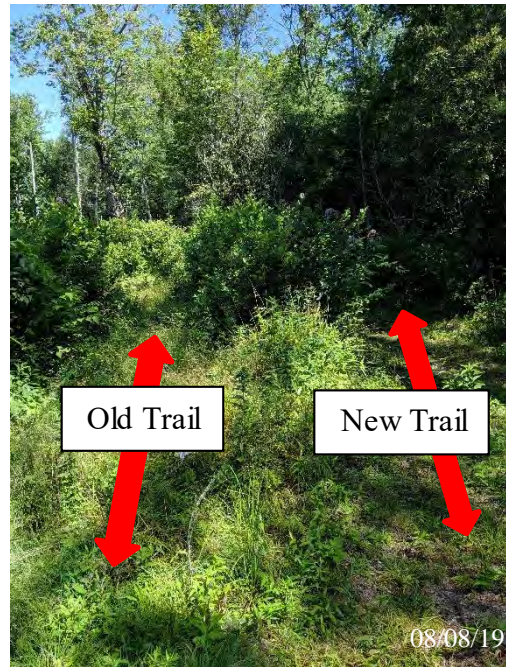
Photo 18. Updated Conditions Trail Relocation 1 facing upstream– Trail was relocated away from stream.

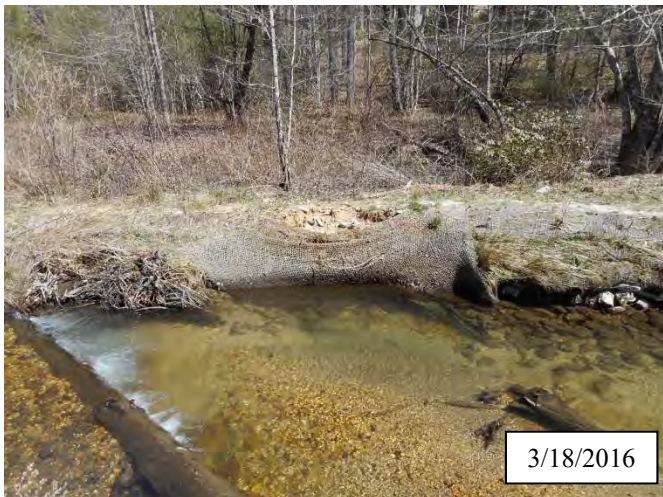
CPA 2-1

Photo 1. CPA 2-1, Station 2+10, small area of bank scour caused by flooding of December and January.

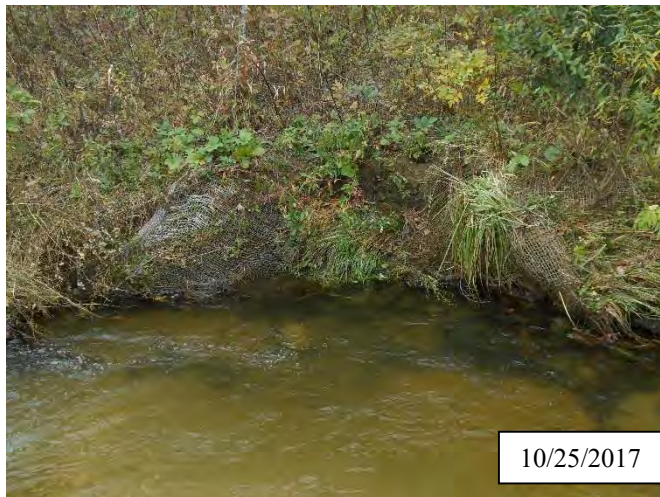
Photo 2. CPA 2-1, Station 2+10, same area as shown in photo 1, with vegetation stabilizing site. Bank was graded, matting was reinstalled, and live stakes were added during October 2017.

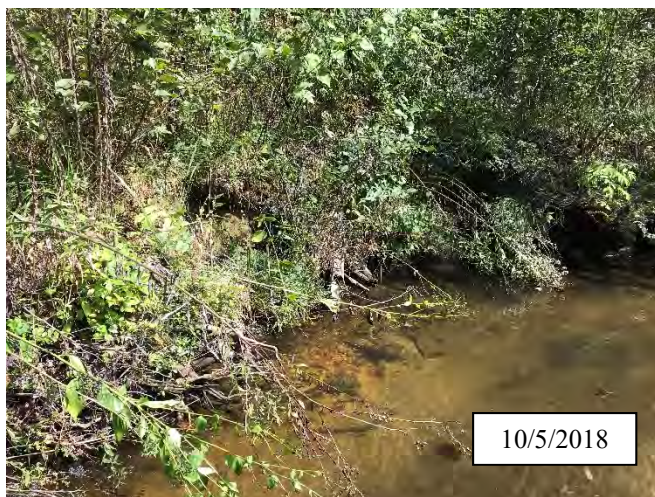
Photo 3. CPA 2-1, Scour area has stabilized and is no longer eroding after repairs were made in 2017.

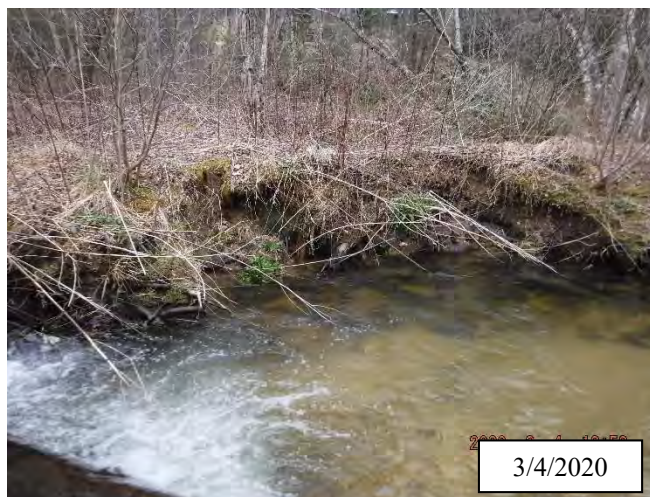
Photo 4. CPA 2-1, Scour area is stable and supporting vegetation, late winter photo (3-2020).

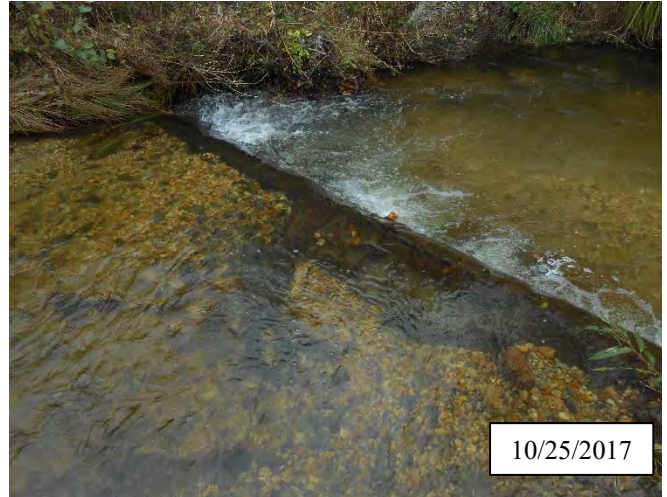
Photo 6. CPA 2-2 – Station 2+00, Piping structure was repaired in May 2017. Fabric was replaced and substrate was replaced upstream of log structure.

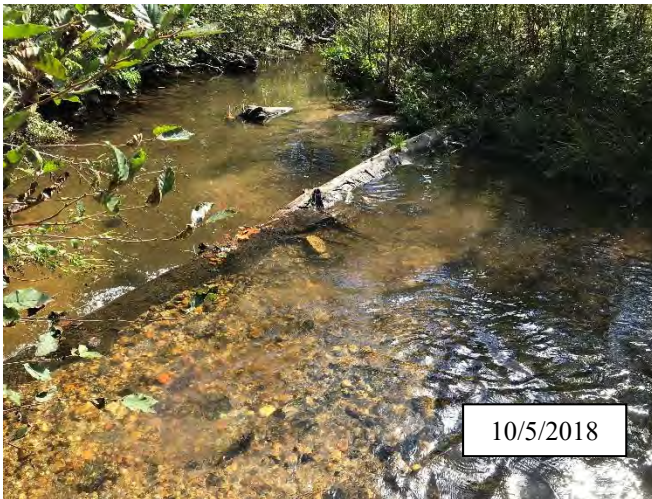
Photo 7. CPA 2-2 – Log structure that was repaired in 2017 has remained stable and is no longer piping.

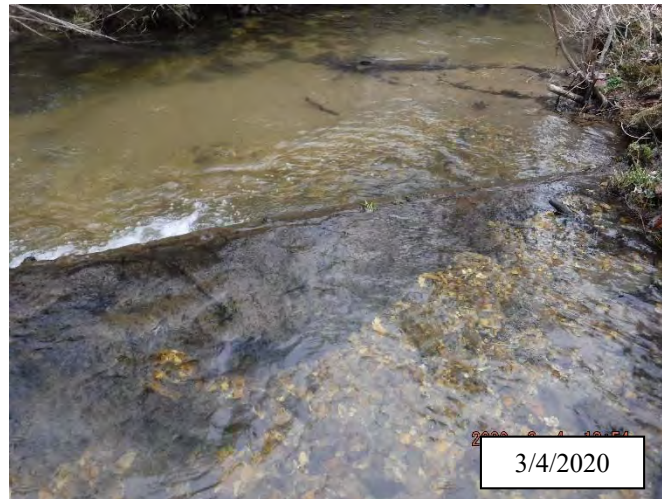
Photo 8. CPA 2-2 – Log structure has remained stable and not piping, late winter photo (3-2020) after multiple high water events.

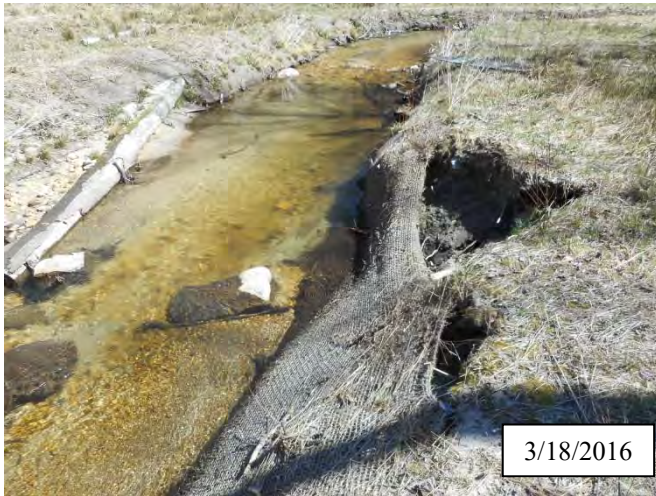
Photo 9. CPA 2-3 – Station 4+60, small area of bank scour caused by flooding of December and January 2016.

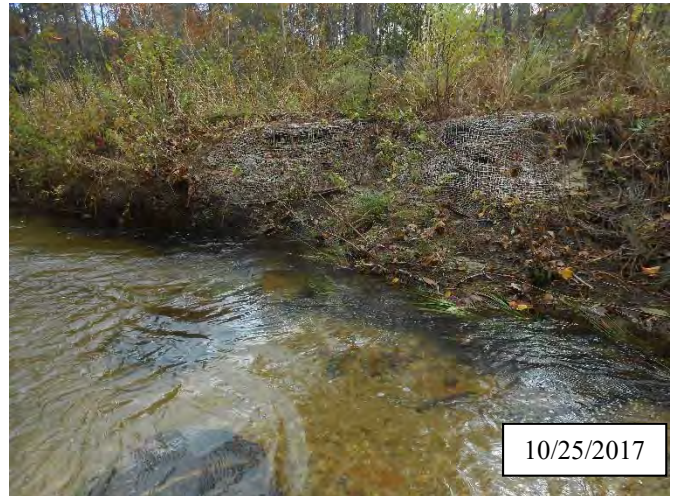
Photo 10. CPA 2-3 – Station 4+60, bank scour area was regraded, matting was reinstalled, and herbaceous vegetation was transplanted in May 2017. Livestakes were installed in October 2017.

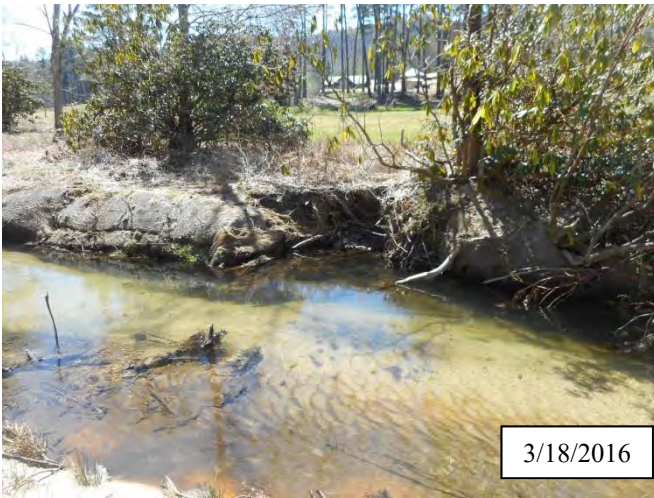
Photo 13. CPA 2-4 – Station 11+70, small area of bank scour caused by flooding of December and January 2016.

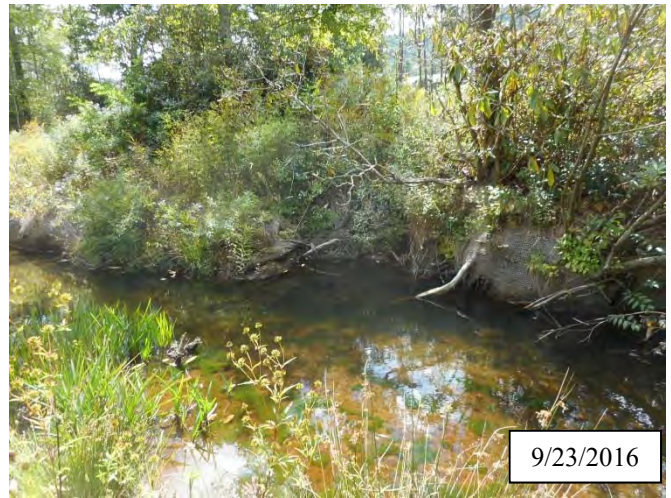
Photo 14. CPA 2-4 – Station 11+70, scour area noted in MY2 has stabilized for the most part. Livestakes were planted in the scour area as well as the bank downstream of the problem area in October 2017.

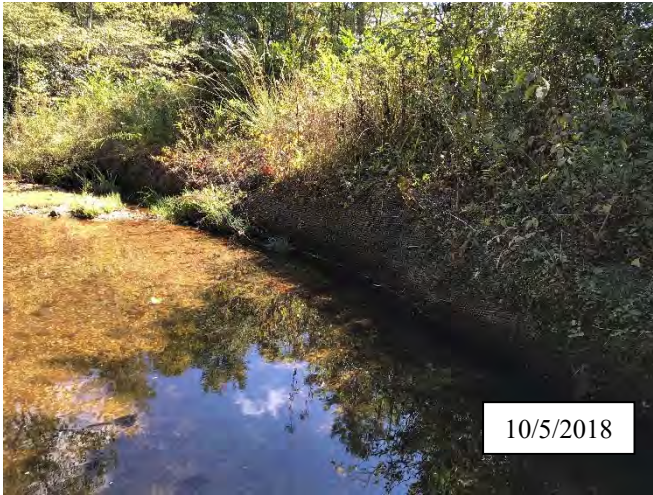
Photo 15. CPA 2-4 – Station 11+70, Bank has vegetated and stabilized in 2018.

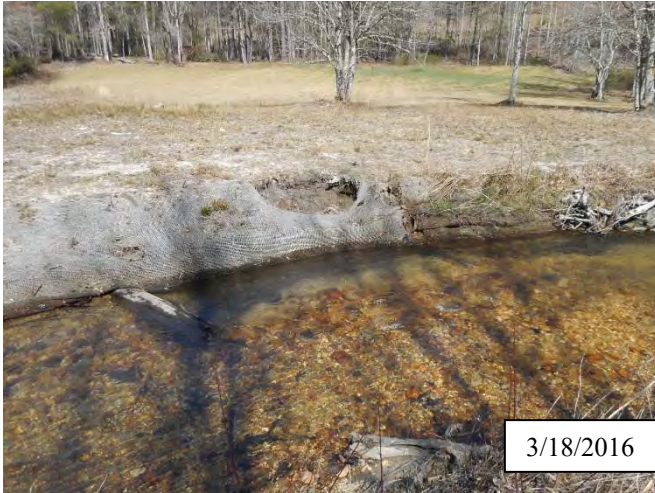
CAP 2-5

Photo 17. CPA 2-5 – Station 26+60, small area of bank scour caused by flooding of December and January 2016.

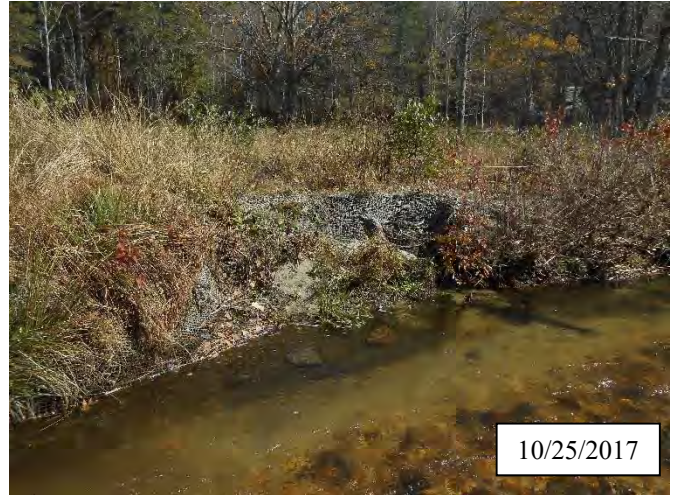
Photo 18. CPA 2-5 – Station 26+60, bank scour area was regraded, matting was reinstalled, and herbaceous vegetation was transplanted in May 2017. Livestakes were installed in October 2017.

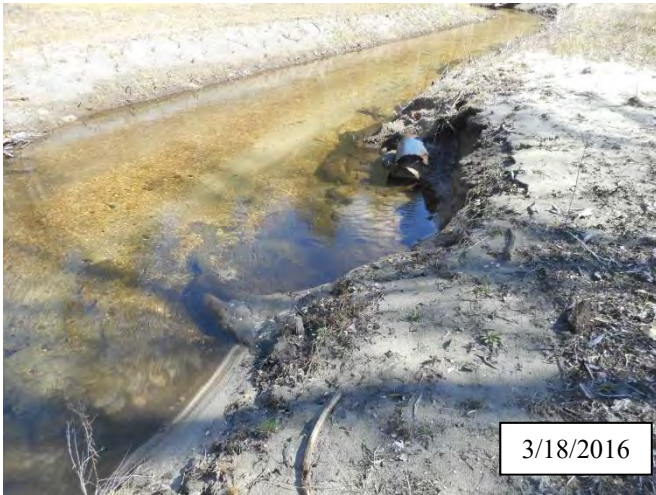
Photo 21. CPA 2-6 – Station 27+00, small area of bank scour caused by flooding of December and January 2016.

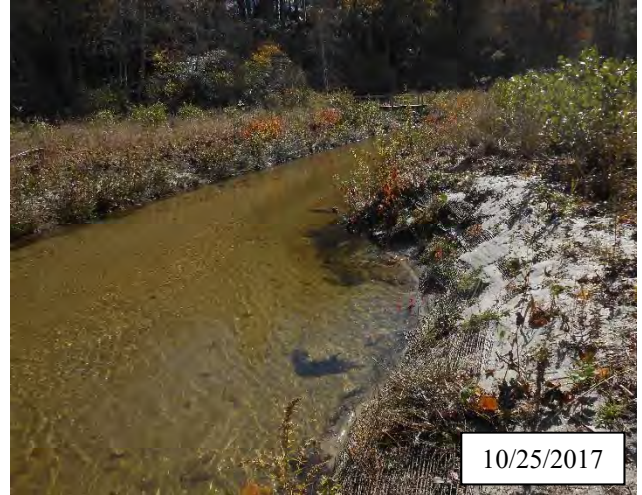
Photo 22. CPA 2-6 – Station 27+00, bank scour area was regraded, matting was reinstalled, and herbaceous vegetation was transplanted in May 2017. Livestakes were installed in October 2017.

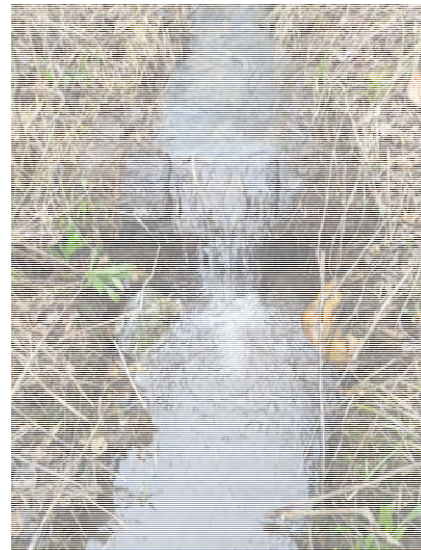
One structure was piping during MY5 monitoring (CPA 3-5). This structure was repaired during February 2020 and is no longer piping. Other structures that were noted as piping in the past have filled in naturally and are no longer piping.

Photo 39. CPA 3-5 – Station UT8 00+40, piping of log structure repaired, in late winter 2020.

CPA 3-5 was repaired during February 2020, and this has been noted in the report in Section 2.2.4 and photos added to Table 12.

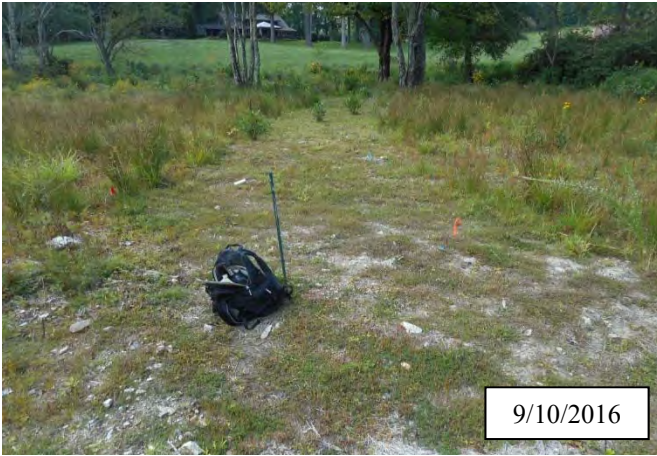
Photo 40. EA 2-1 – Maintenance workers mowed the nature trail wider than had been agreed to earlier, near stationing 23+00 to 28+00.
