MONITORING YEAR 3 ANNUAL REPORT

LONE HICKORY MITIGATION SITE

Yadkin County, NC

DMS Project No. 97135

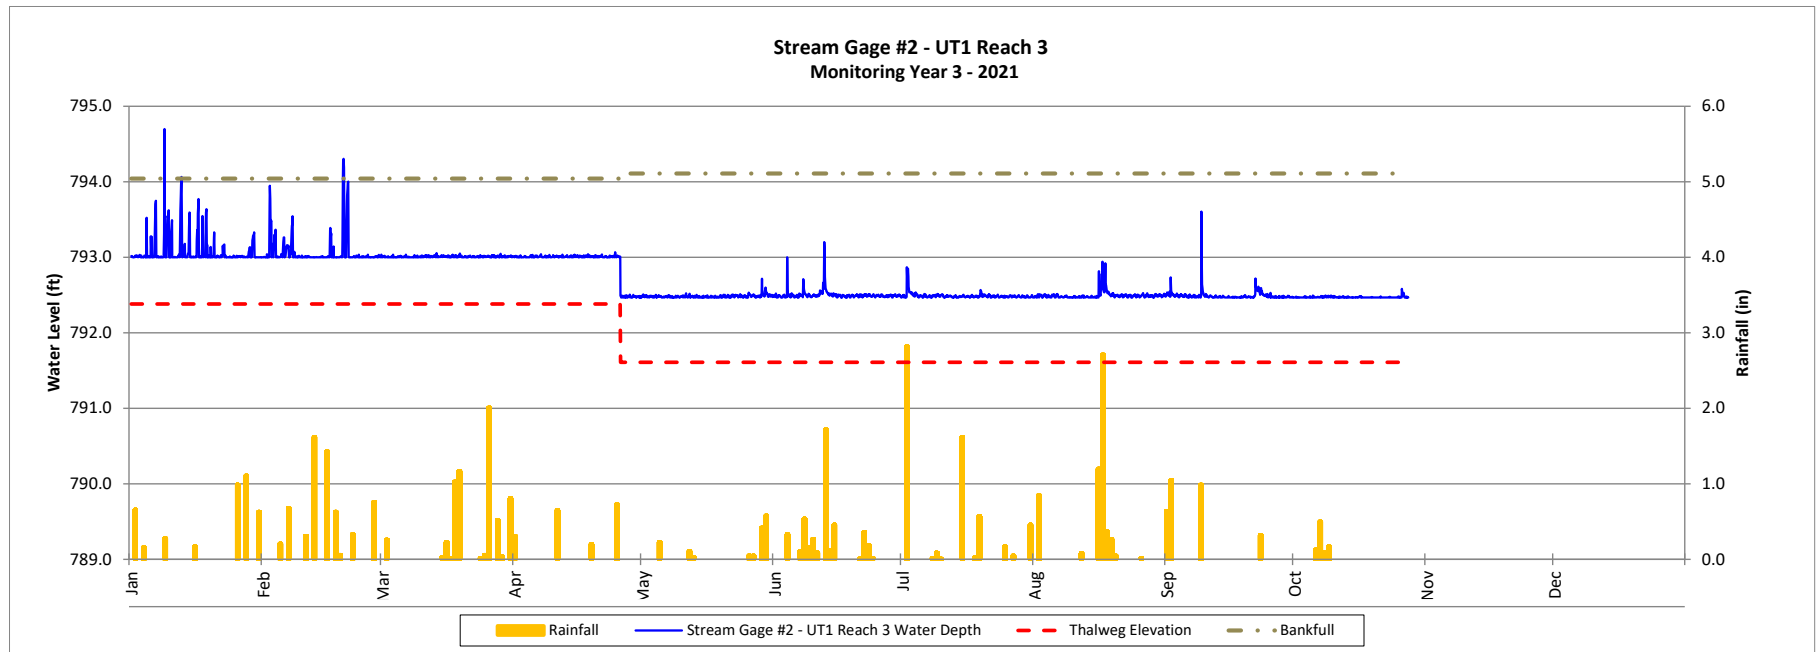
- Stream gage casing was damaged in storm events and properly reinstalled on 4/26/2021
