MONITORING YEAR 4 ANNUAL REPORT

LONE HICKORY MITIGATION SITE

Yadkin County, NC
DEQ Contract No. 6897
DMS Project No. 97135
DWR No. 20161044
USACE Action ID No. SAW-2017-00100
Yadkin River Basin
HUC 03040101

Data Collection Period: February – November 2022
Draft Submission Date: November 30, 2022
Final Submission Date: January 9, 2023

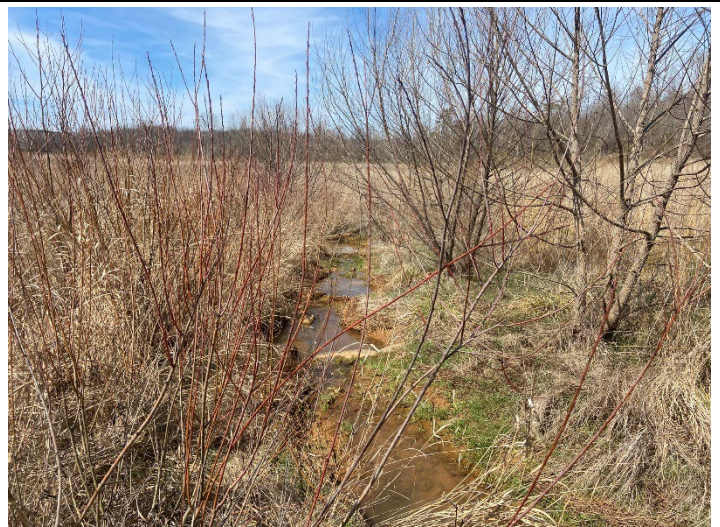
DMS' comment: Stream Photos MY4 (2022) – The March 14, 2022 photos for UT2B indicate that the channel likely has flow more than 11 consecutive days per year. DMS recommends checking the flow gauge before the start on MY5 (2023) to confirm there are no monitoring equipment or calibration issues. A game camera should also be considered on this reach to document the 30 days of consecutive flow.

Wildlands' response: The photo points taken along UT2B on March 14, 2022 showing flow in the upper portions of the channel are consistent with the stream gage plot that documented consecutive flow between March 9, 2022 and March 18, 2022. Wildlands will be sure to check the stream gage to confirm no issues are present before the start of MY5 (2023) and will consider adding a game camera to document consecutive flow as well.

Photo Point 30 – UT2B, view upstream (03/14/2022)

Photo Point 30 – UT2B, view downstream (03/14/2022)

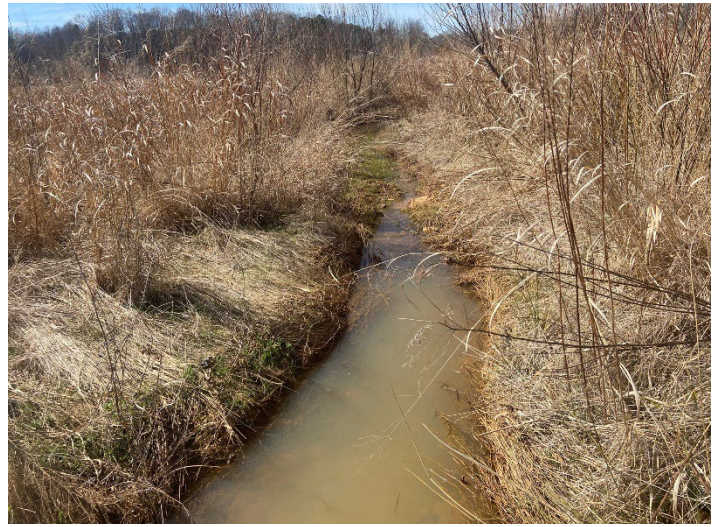
Photo Point 31 – UT2B, view upstream (03/14/2022)

Photo Point 31 – UT2B, view downstream (03/14/2022)

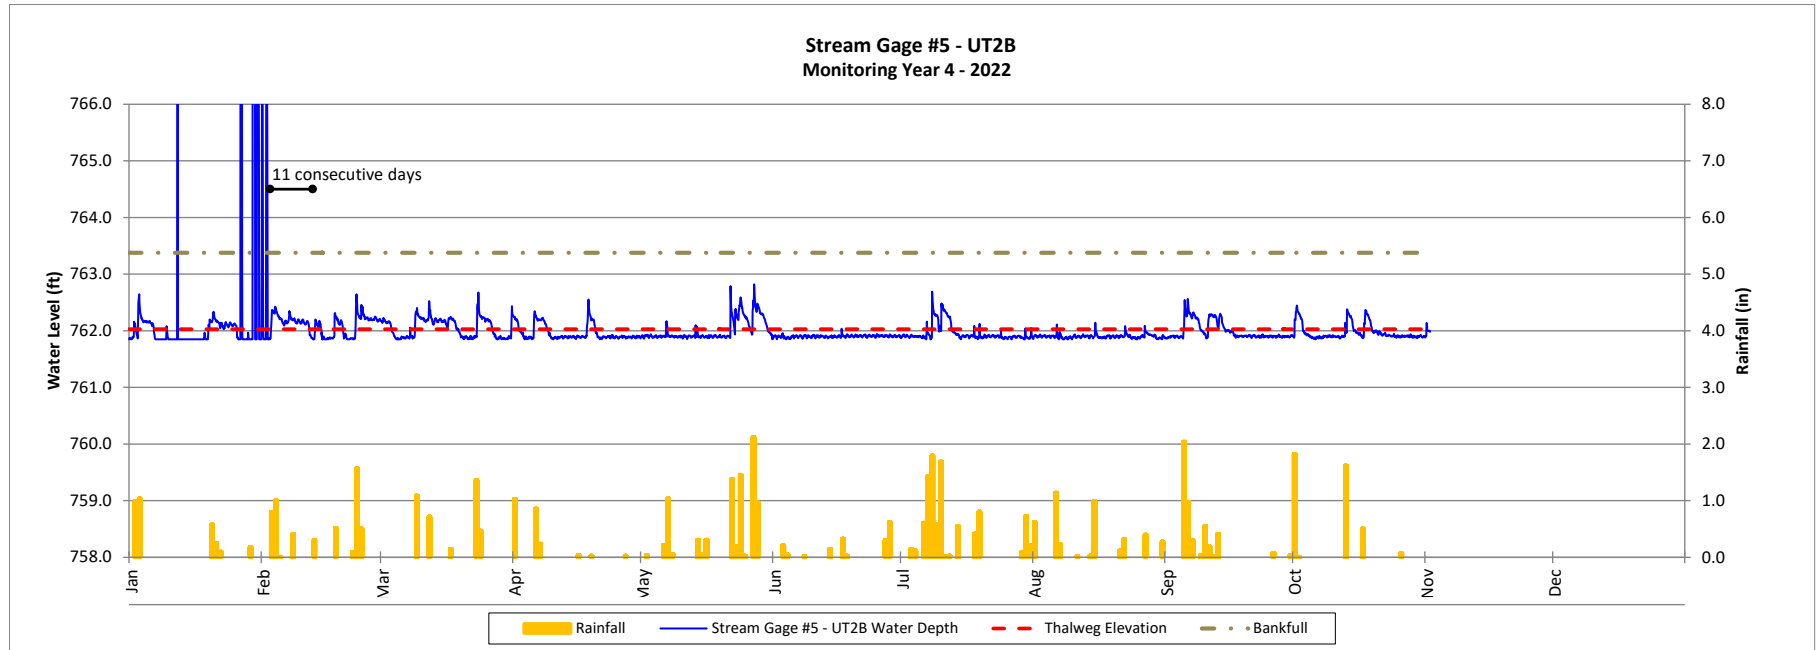
- Spike in pressure due to freezing events on 1/12/2022, 1/27/2022, and 1/29/2022 through 2/2/2022.

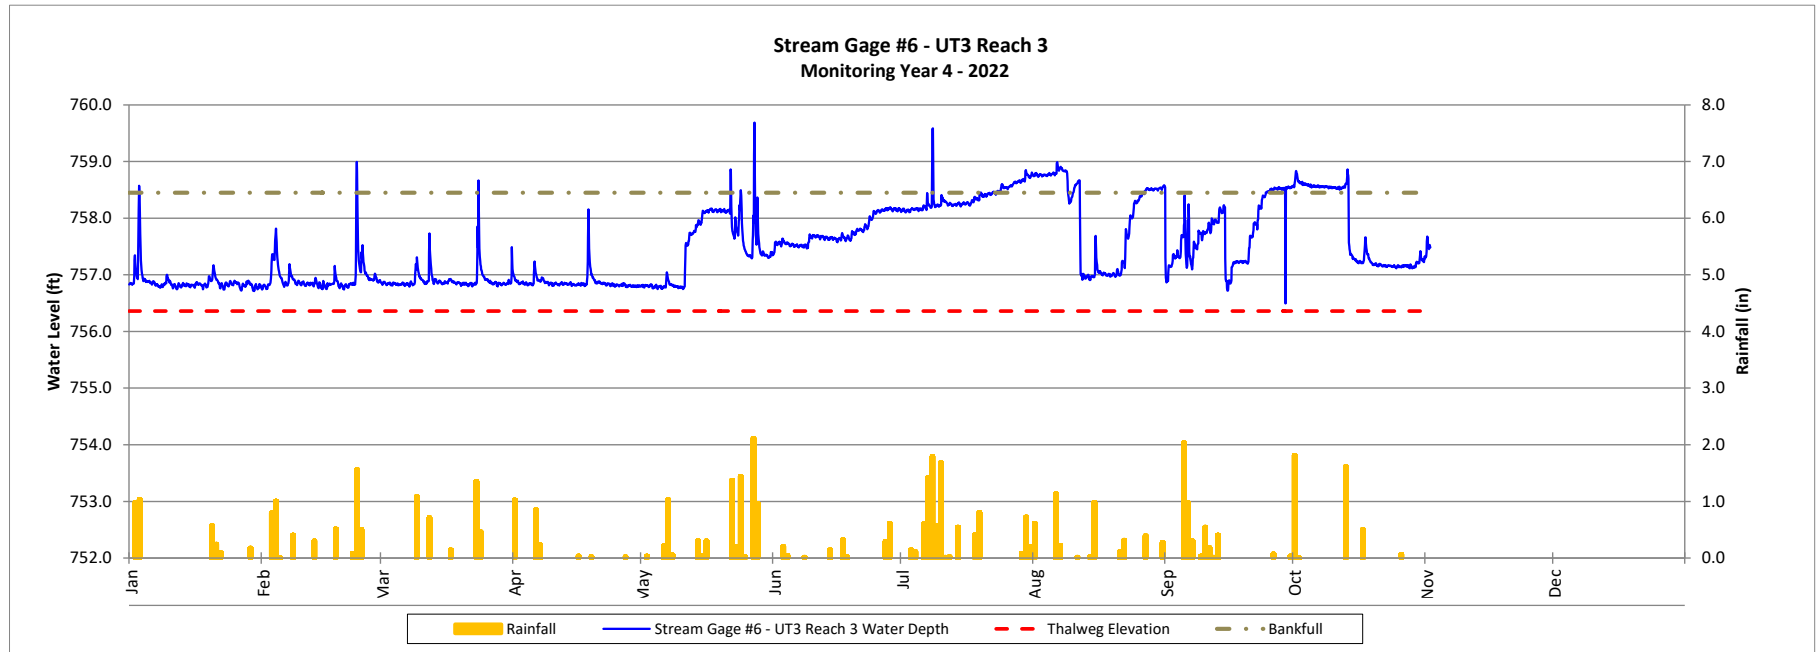
Beaver dams were removed in August 2022 along the very downstream portion of UT3 Reach 3 upstream of its confluence with South Deep Creek. The infrequent inundation caused by the beaver dams at the bottom of the Site has not appeared to have damaged floodplain vegetation or stream stability. Wildlands has contracted with USDA to manage beaver on the Site. Beaver activity will continue to be monitored and managed on the Site through closeout.

- Periods of inundation after 5/11/2022 caused by beaver activity.
