**UT to TAR RIVER (Louisburg)  
FINAL MONITORING REPORT  
YEAR 3  
2008**

EEP Project # 234  
Franklin County, North Carolina

**Monitoring Firm:**

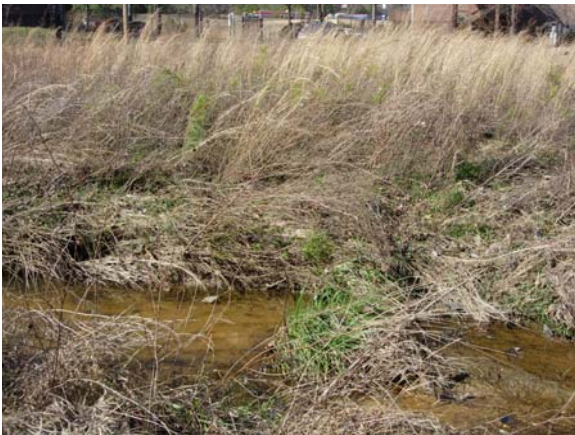
Photo 2. Representative Japanese grass (*Microstegium virmineum*) growth; present below *Andropogon virginicus* (grass) at top of photo (Station No.17+80; view of left bank; 2-20-2008)

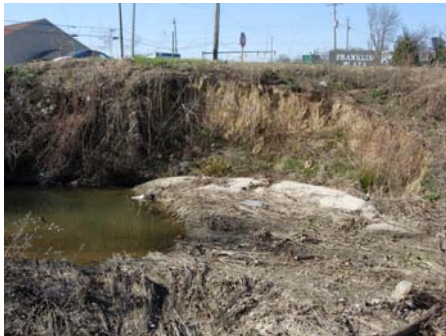
Photo 3: Severe bank failure, aggradation, and bar formation just downstream of culvert at head of restoration reach on (Station No. 10+05; view of left bank facing upstream; 2-20-2008).

UT Tar			
Feature Issue	Station numbers	Suspected Cause	Photo number
Bank Erosion (left bank, severe)	10+08.00	Back eddy from culvert and/or unstable soil characteristics and lack of vegetation.	1, 3
	10+35.75		
Aggradation/Bar Formation	10+08.00	Excess fine sediment deposit from adjacent severe bank erosion and/or other upstream sources.	3
	10+22.45		
Bank Erosion (right bank)	10+27.66	Probably caused by high shear stress along the unprotected bank due to increased flow velocities leaving the culvert during peak flows.	
	10+38.81		
Aggradation	14+33.00	Excess fine sediment deposit from upstream severe bank erosion and/or other upstream sources.	5
	14+72.04		
Rock Sill	16+67.28	Placed too far upstream of the start of the meander to adequately protect the outside of the meander, forming pool in straight section.	
Aggradation	17+15.04	Small central bar; probably deposition resulting from upstream bank erosion and/or other upstream sources.

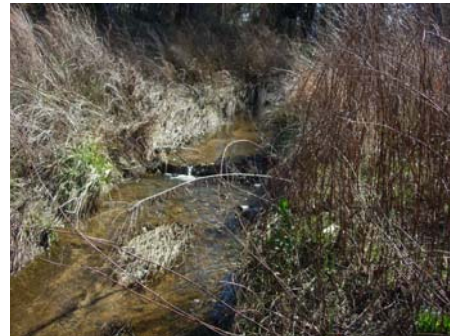
Photo 4: New central bar formation problem area (Station No. 18+65; view upstream; 2-20-2008).

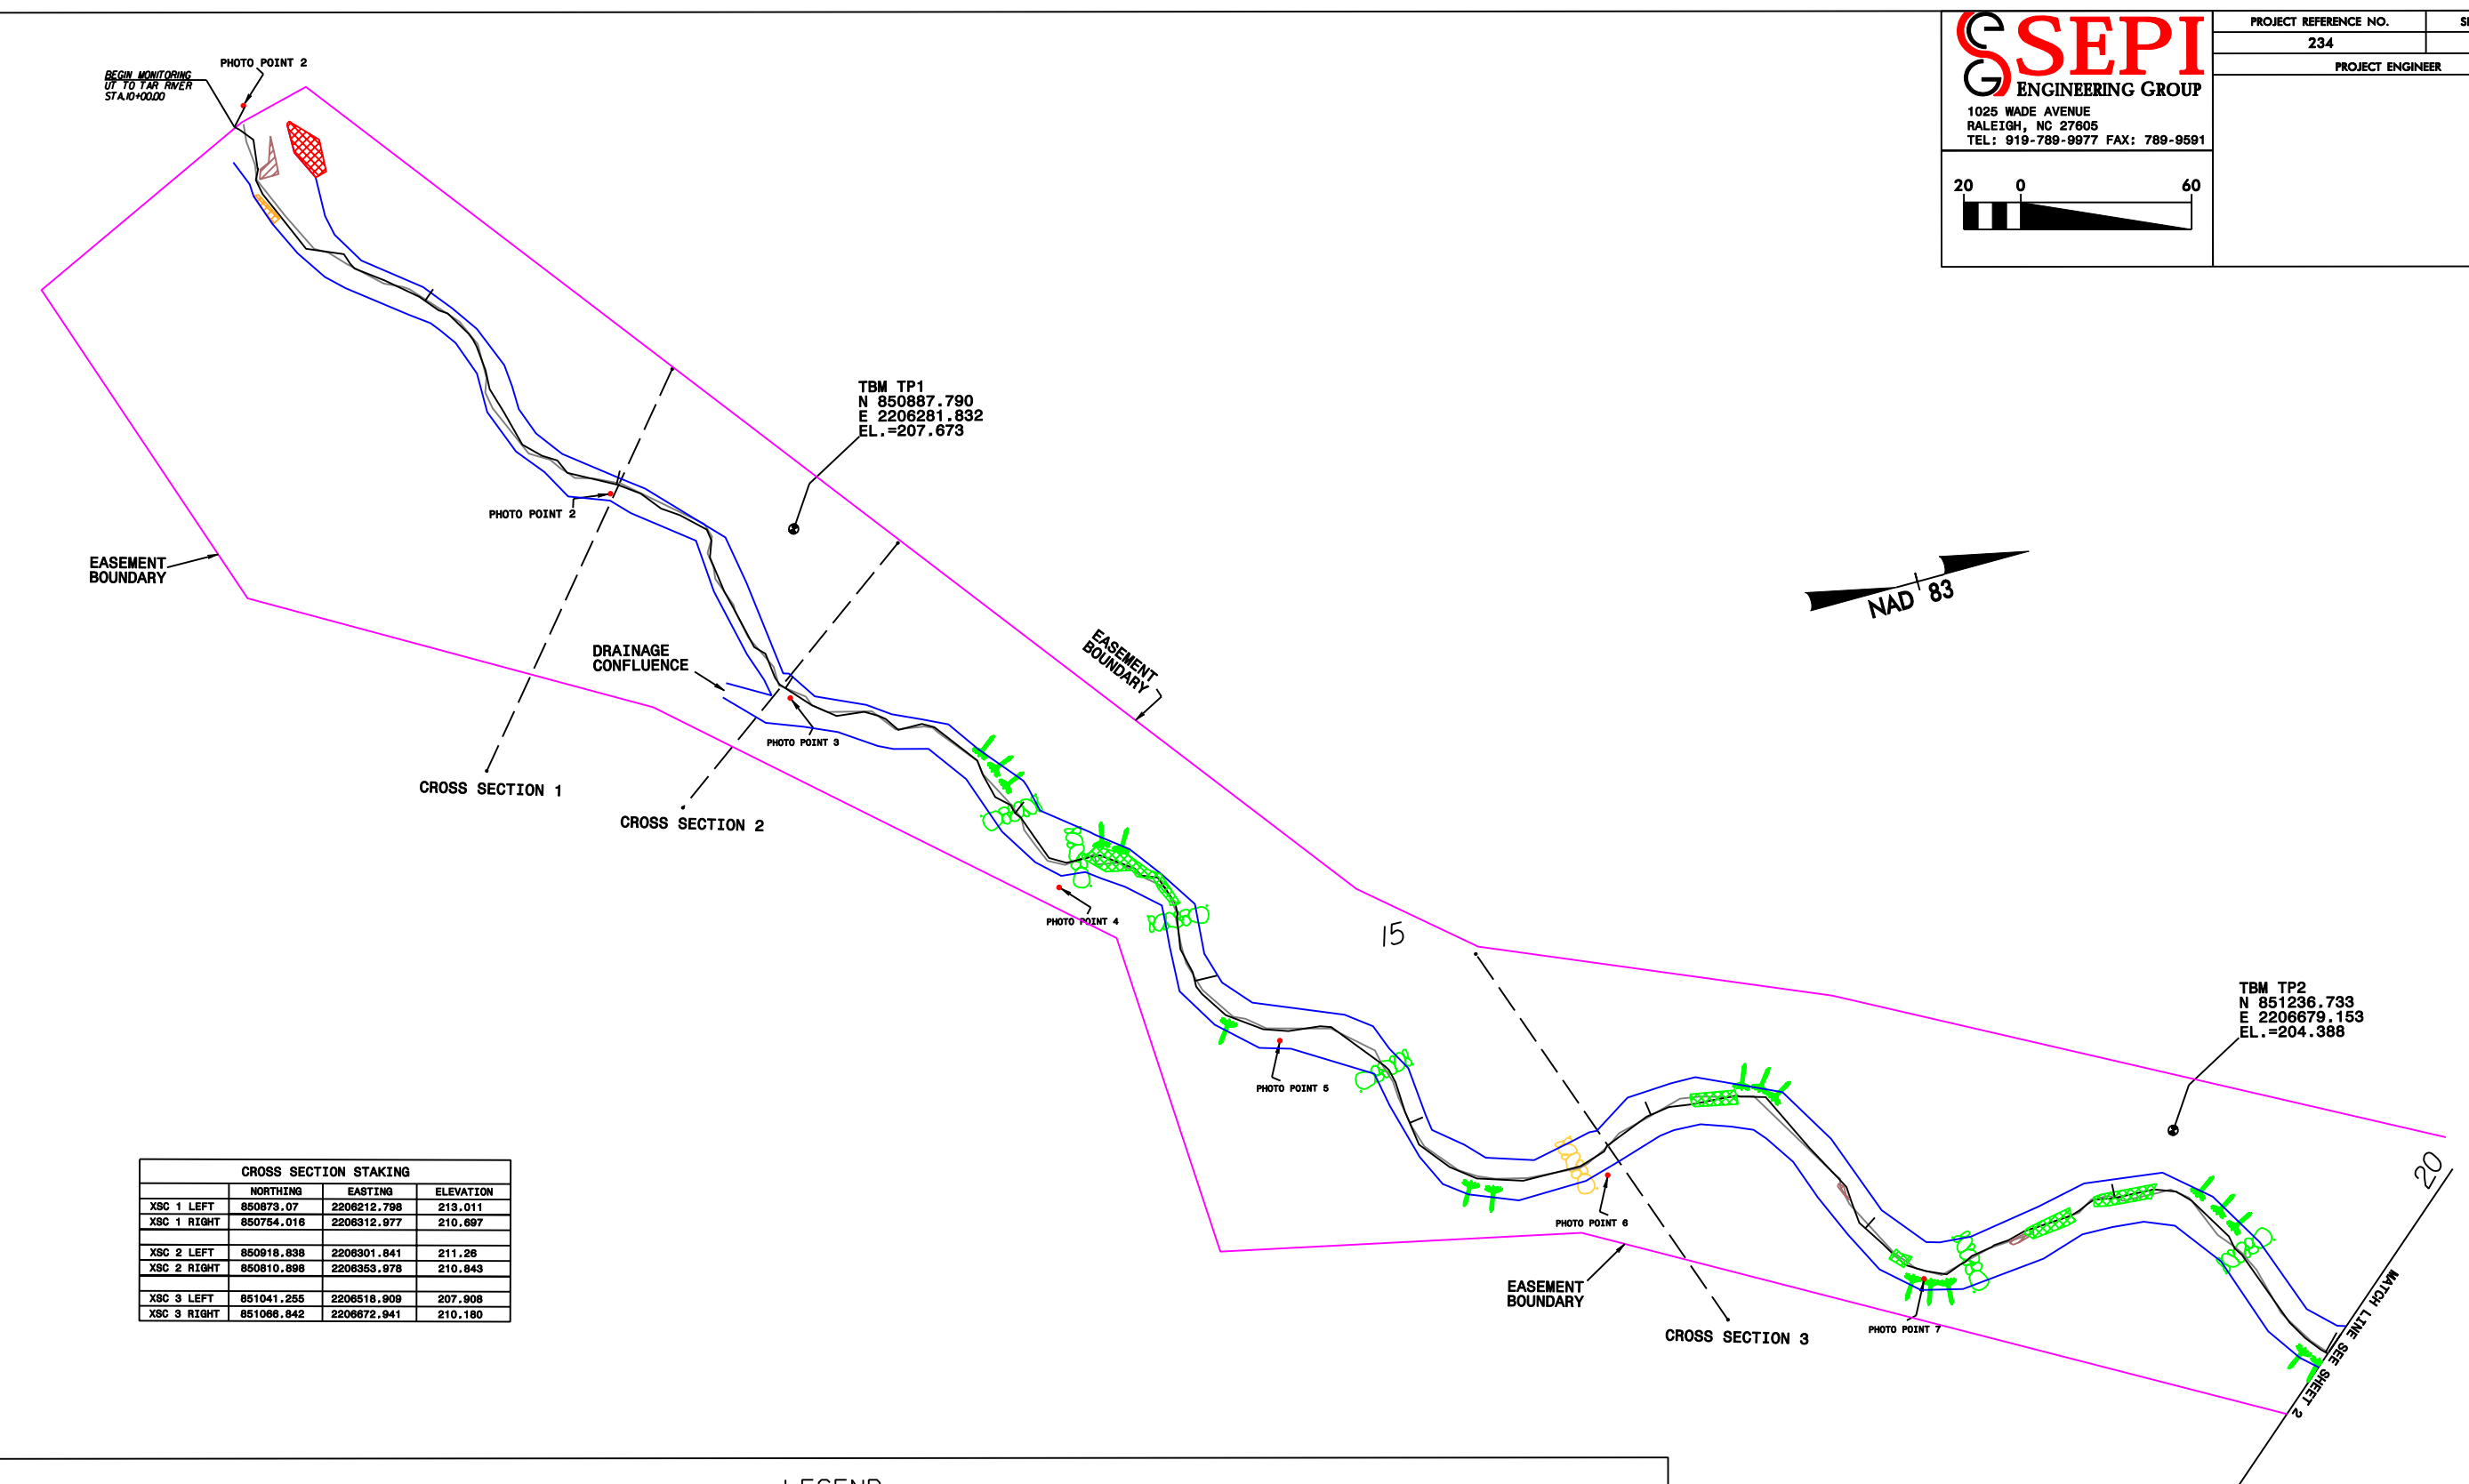
LOCATION: <b>UT TO TAR RIVER</b>	
<b>CURRENT CONDITIONS PLAN VIEW</b>	
<b>STREAM MONITORING - YEAR 3</b>	
PROJ #: <b>234</b>	COUNTY: <b>FRANKLIN</b>
PREPARED BY: <b>IPJ</b>	
CHECKED BY: <b>PDB</b>	DATE: <b>2/10/09</b>

17+31.17		
Bar Formation (Left)	17+81.11	Inadequate bank protection, possibly due to misplacement of bank protection measures and or lack of vegetation/soil instability.	2
	17+88.25		
Aggradation	18+12.97	Excess fine sediment deposits from adjacent/upstream bank erosion and/or other upstream sources.	
	18+19.74		
Aggradation/Central Bar Formation	18+59.14	Excess fine sediment deposit from upstream bank erosion and/or other upstream sources.	4
	18+65.73		
Aggradation	18+65.18	Channel possibly over-sinuuous or bankfull dimensions incorrect.	4
	18+82.68		
Aggradation	18+92.07	Excess fine sediment deposits from adjacent/upstream bank erosion and/or other upstream sources.	
	19+14.43		
Central Bar Formation	21+88.96	Lack of bank protection between rootwad and rock structure.	
	22+01.96		
Bar Formation (Left)	22+82.62	Matting undercutting due to lack of bank protection early in meander and lack of vegetation.

22+87.61		
Bank Erosion (left bank)	23+60.83	Lack of bank protection along outside of meander bend. Structure directly upstream should be a cross vane.	
	23+68.09		
Rock Sill	23+95.66	Inadequate structure to protect banks directly downstream from increased discharge from tributary. Should be cross vane.	
Bank Erosion (left bank, severe)	24+00.07	Back eddy downstream of rock structure and/or lack of protective vegetation/soil stability characteristics.	
	24+25.64		
Bank Erosion (right bank)	23+95.44	Back eddy downstream of rock structure and/or lack of protective vegetation/soil stability characteristics.	
	24+16.53		
Aggradation/Bar Formation	24+02.63	Excess fine sediment deposits from adjacent/upstream bank erosion and/or other upstream sources.	
Bank Erosion (right bank)	24+21.20	Lack of bank protection.	
	24+82.02		
Rock Sill	24+98.36	Angle/placement possibly causing severe bank erosion directly upstream.

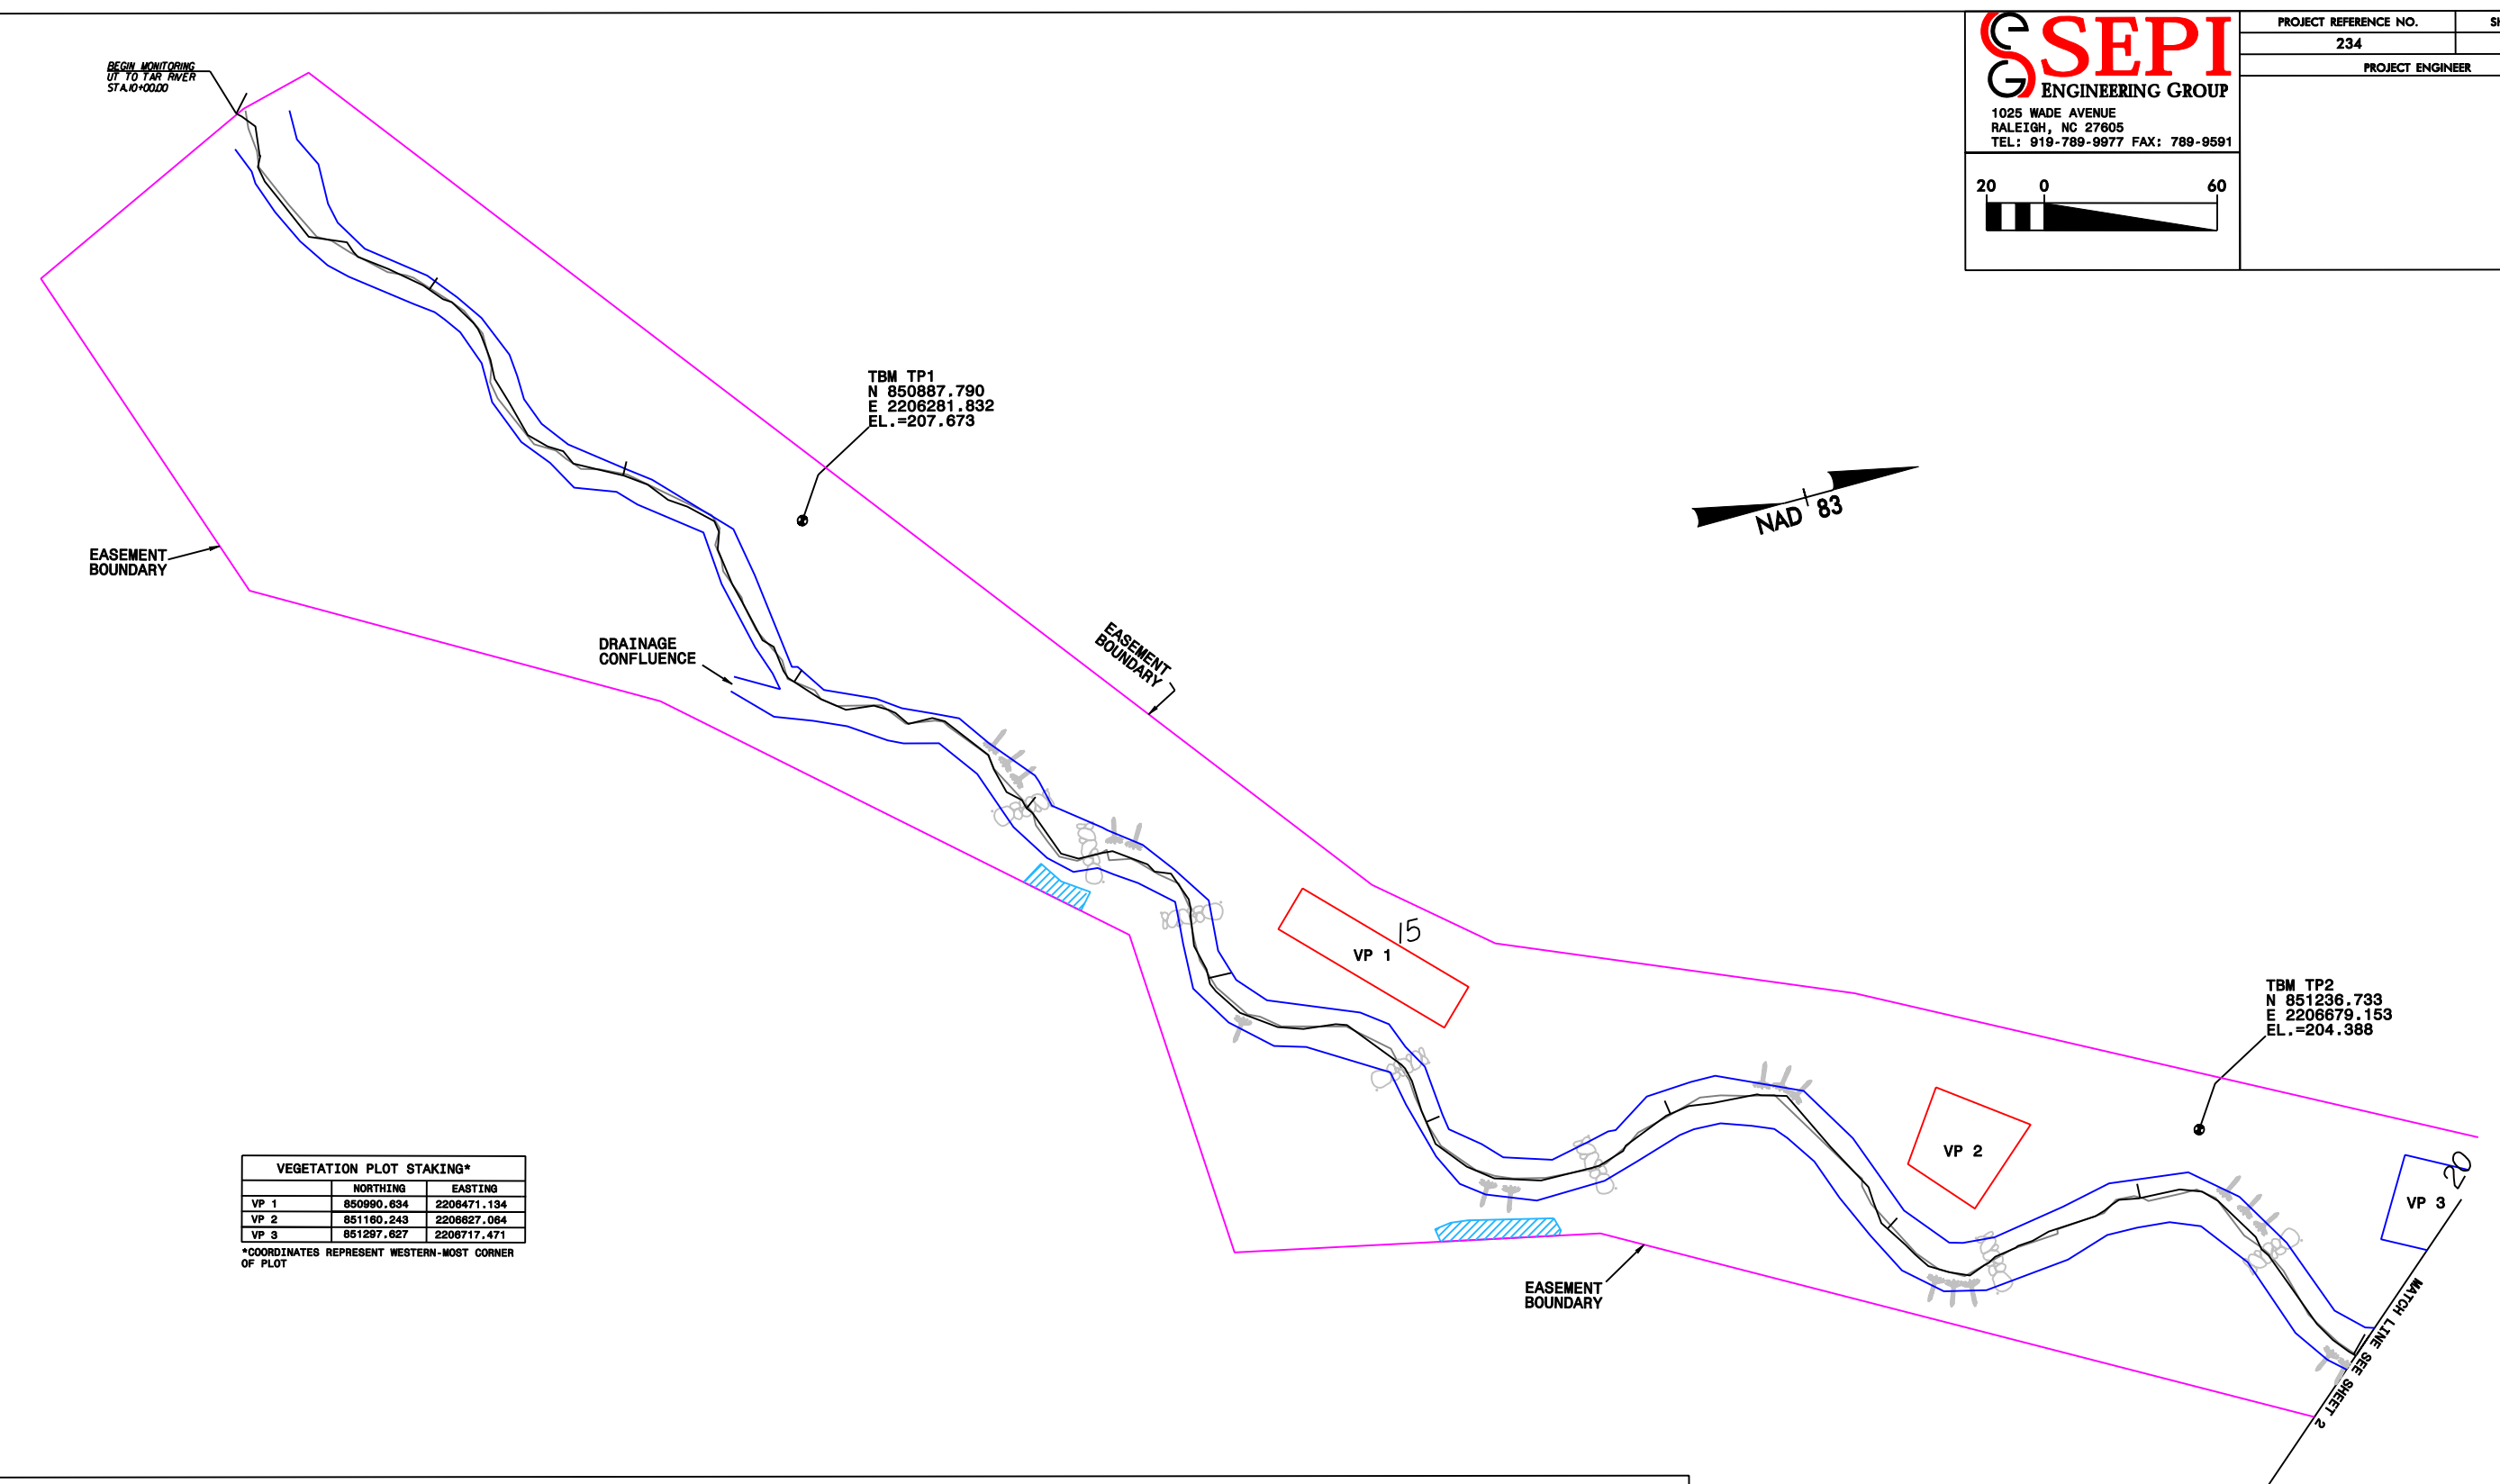
LOCATION:	UT TO TAR RIVER	
	CURRENT CONDITIONS PLAN VIEW	
	VEGETATION ASSESSMENT - YEAR 3	
PROJ #:	234	COUNTY: FRANKLIN
PREPARED BY:	IPJ	
CHECKED BY:	PDB	DATE: 2/10/09

<b>Feature/Issue</b>	<b>Station # / Range</b>	<b>Probable Cause</b>	<b>Photo #</b>
Bare Floodplain (Right Bank)	14+19 to 14+26	Lack of vegetative cover; weak soil characteristics on terrace.	
Bare Floodplain (Right Bank)	16+21 to 16+50	Lack of vegetative cover; weak soil characteristics on terrace.	1
Microstegium virmenium (Left Bank)	24+55 to 26+40	Invasive vegetative opportunism	2
Microstegium virmenium (Right Bank)	24+35 to 27+16	Invasive vegetative opportunism	
Microstegium virmenium (Left Bank)	26+80 to 29+51	Invasive vegetative opportunism	
Microstegium virmenium (Right Bank)	27+12 to 29+51	Invasive vegetative opportunism
