**UT to TAR RIVER (Louisburg)
FINAL MONITORING REPORT
YEAR 4 OF 5
2009**

EEP Project # 234
Franklin County, North Carolina

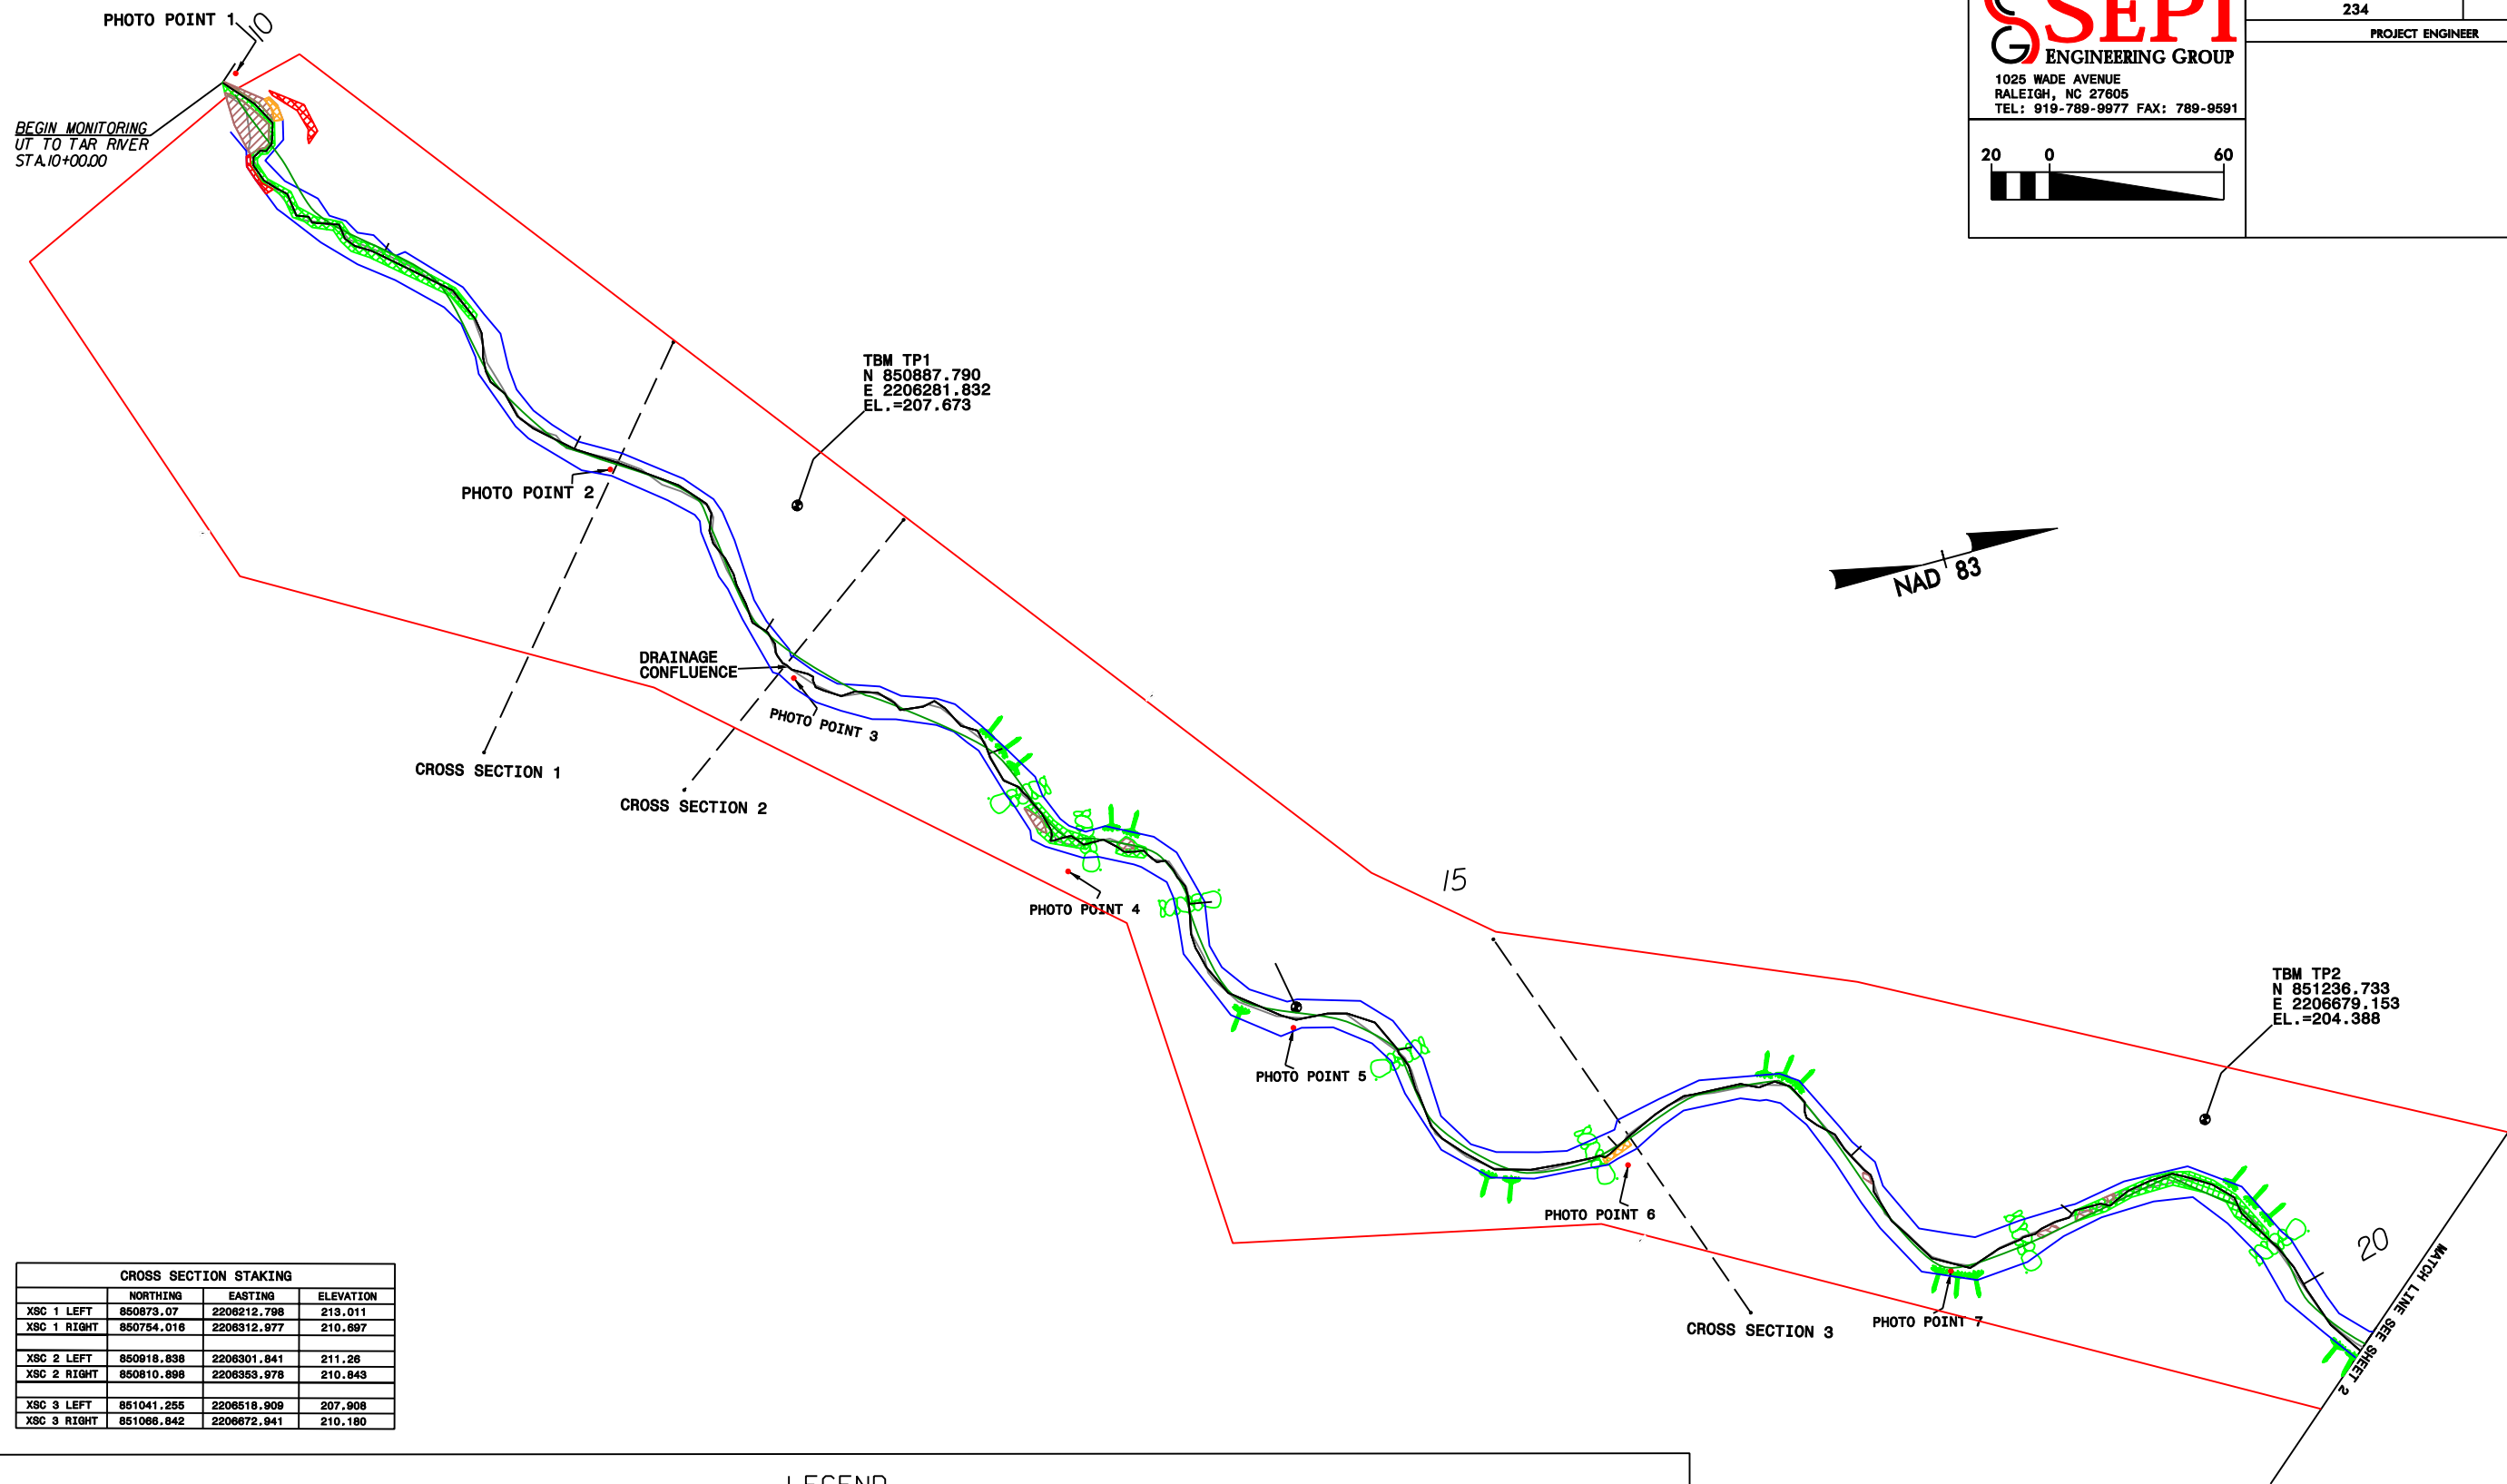
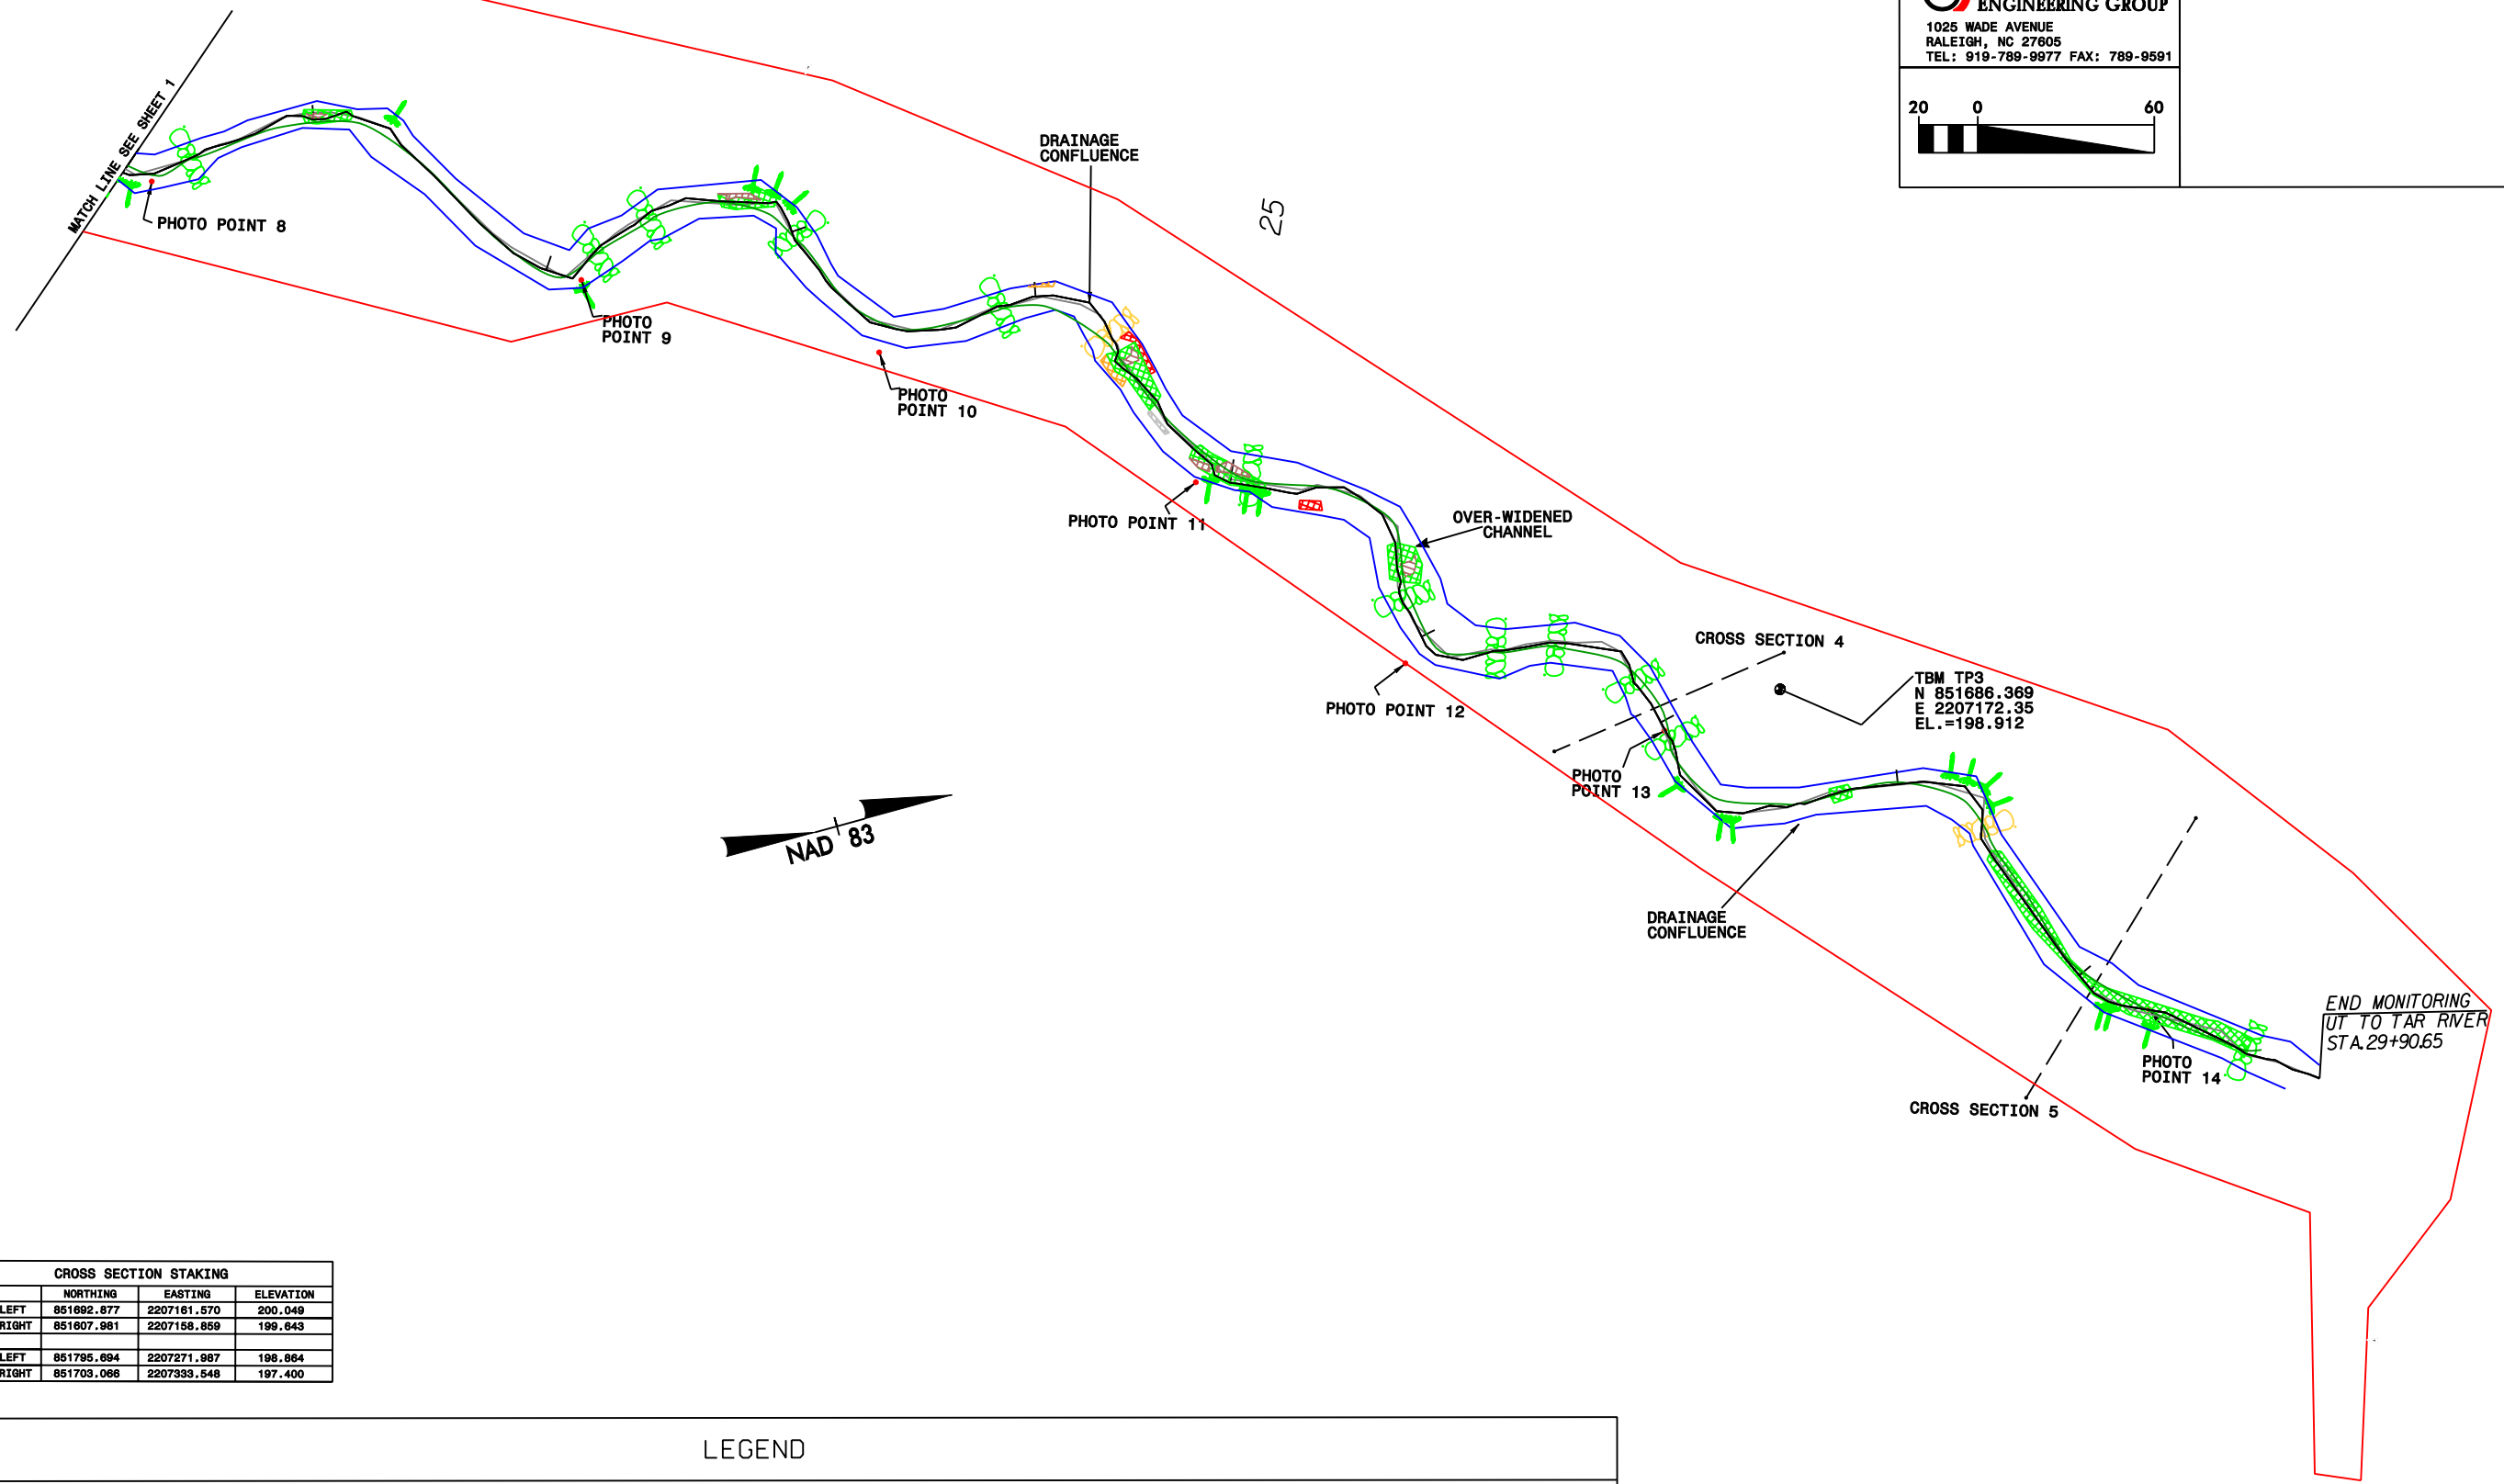
Most of the UT to Tar River project reach appears to have remained stable through Monitoring Year 4. Overall, only 2% of banks were noted to have bank erosion in 2009. However, there were two bank erosion areas of severe concern and some sand/gravel aggradation that is worth noting. The most severe section of erosion is located at the upstream end of the reach, on the left bank, where the terrace has experienced mass wasting just downstream of the culvert outlet. This terrace erosion is encroaching on Burnette Road. Also there is a section of severe erosion on the right bank just downstream of here (Station 10+38). In addition, it was found that the culvert outlet pool, that used to exist as the first channel unit along the profile below the culvert at the upstream end of the reach, is completely filled in with sediment and now exists as riffle habitat. This high sediment load is apparent downstream for approximately 140 linear feet. Also there is a section of severe erosion of the left bank, erosion of the right bank, and excess sedimentation just downstream of the confluence with the stormwater tributary that drains the adjacent shopping

center. The tributary confluence is located at Station 24+19 along the thalweg. This tributary probably has very flashy flows during storm events due to the high percentage of impervious area within its watershed, and is presumably the main agent contributing to the problems just downstream. The sedimentation and severe erosion areas have been noted as concerns since 2007. It is recommended that these sections be reviewed to determine if repair work is necessary. The sediment contributing to these areas probably came from a combination of an upstream source and the severe bank erosion along the project. It appears that the stream pattern remained consistent between the monitoring years. The profile appears to have remained as stable as can be expected for a sand bed stream, with the exception of some apparent aggradation within the first 100 feet of channel and the complete filling in of the culvert outlet pool at the head of the reach, turning it into a riffle (see longitudinal profile overlay). The overall dimension of the stream appears to have remained consistent, with the exception of an apparent decrease in bankfull width and bankfull area at cross sections 1 and 2. However, this observation is not alarming because the annual cross section overlay figures show that there was significant deposition on the bankfull bench, creating levees, but the channel bottom was consistent with previous monitoring years. This deposition also serves as evidence that an over-bankfull flow occurred during Monitoring Year 4, depositing sediment along the edge of the floodplain (i.e. top of bank). This deposition is apparent and was verified in the field. The structures appear to be in good physical condition.

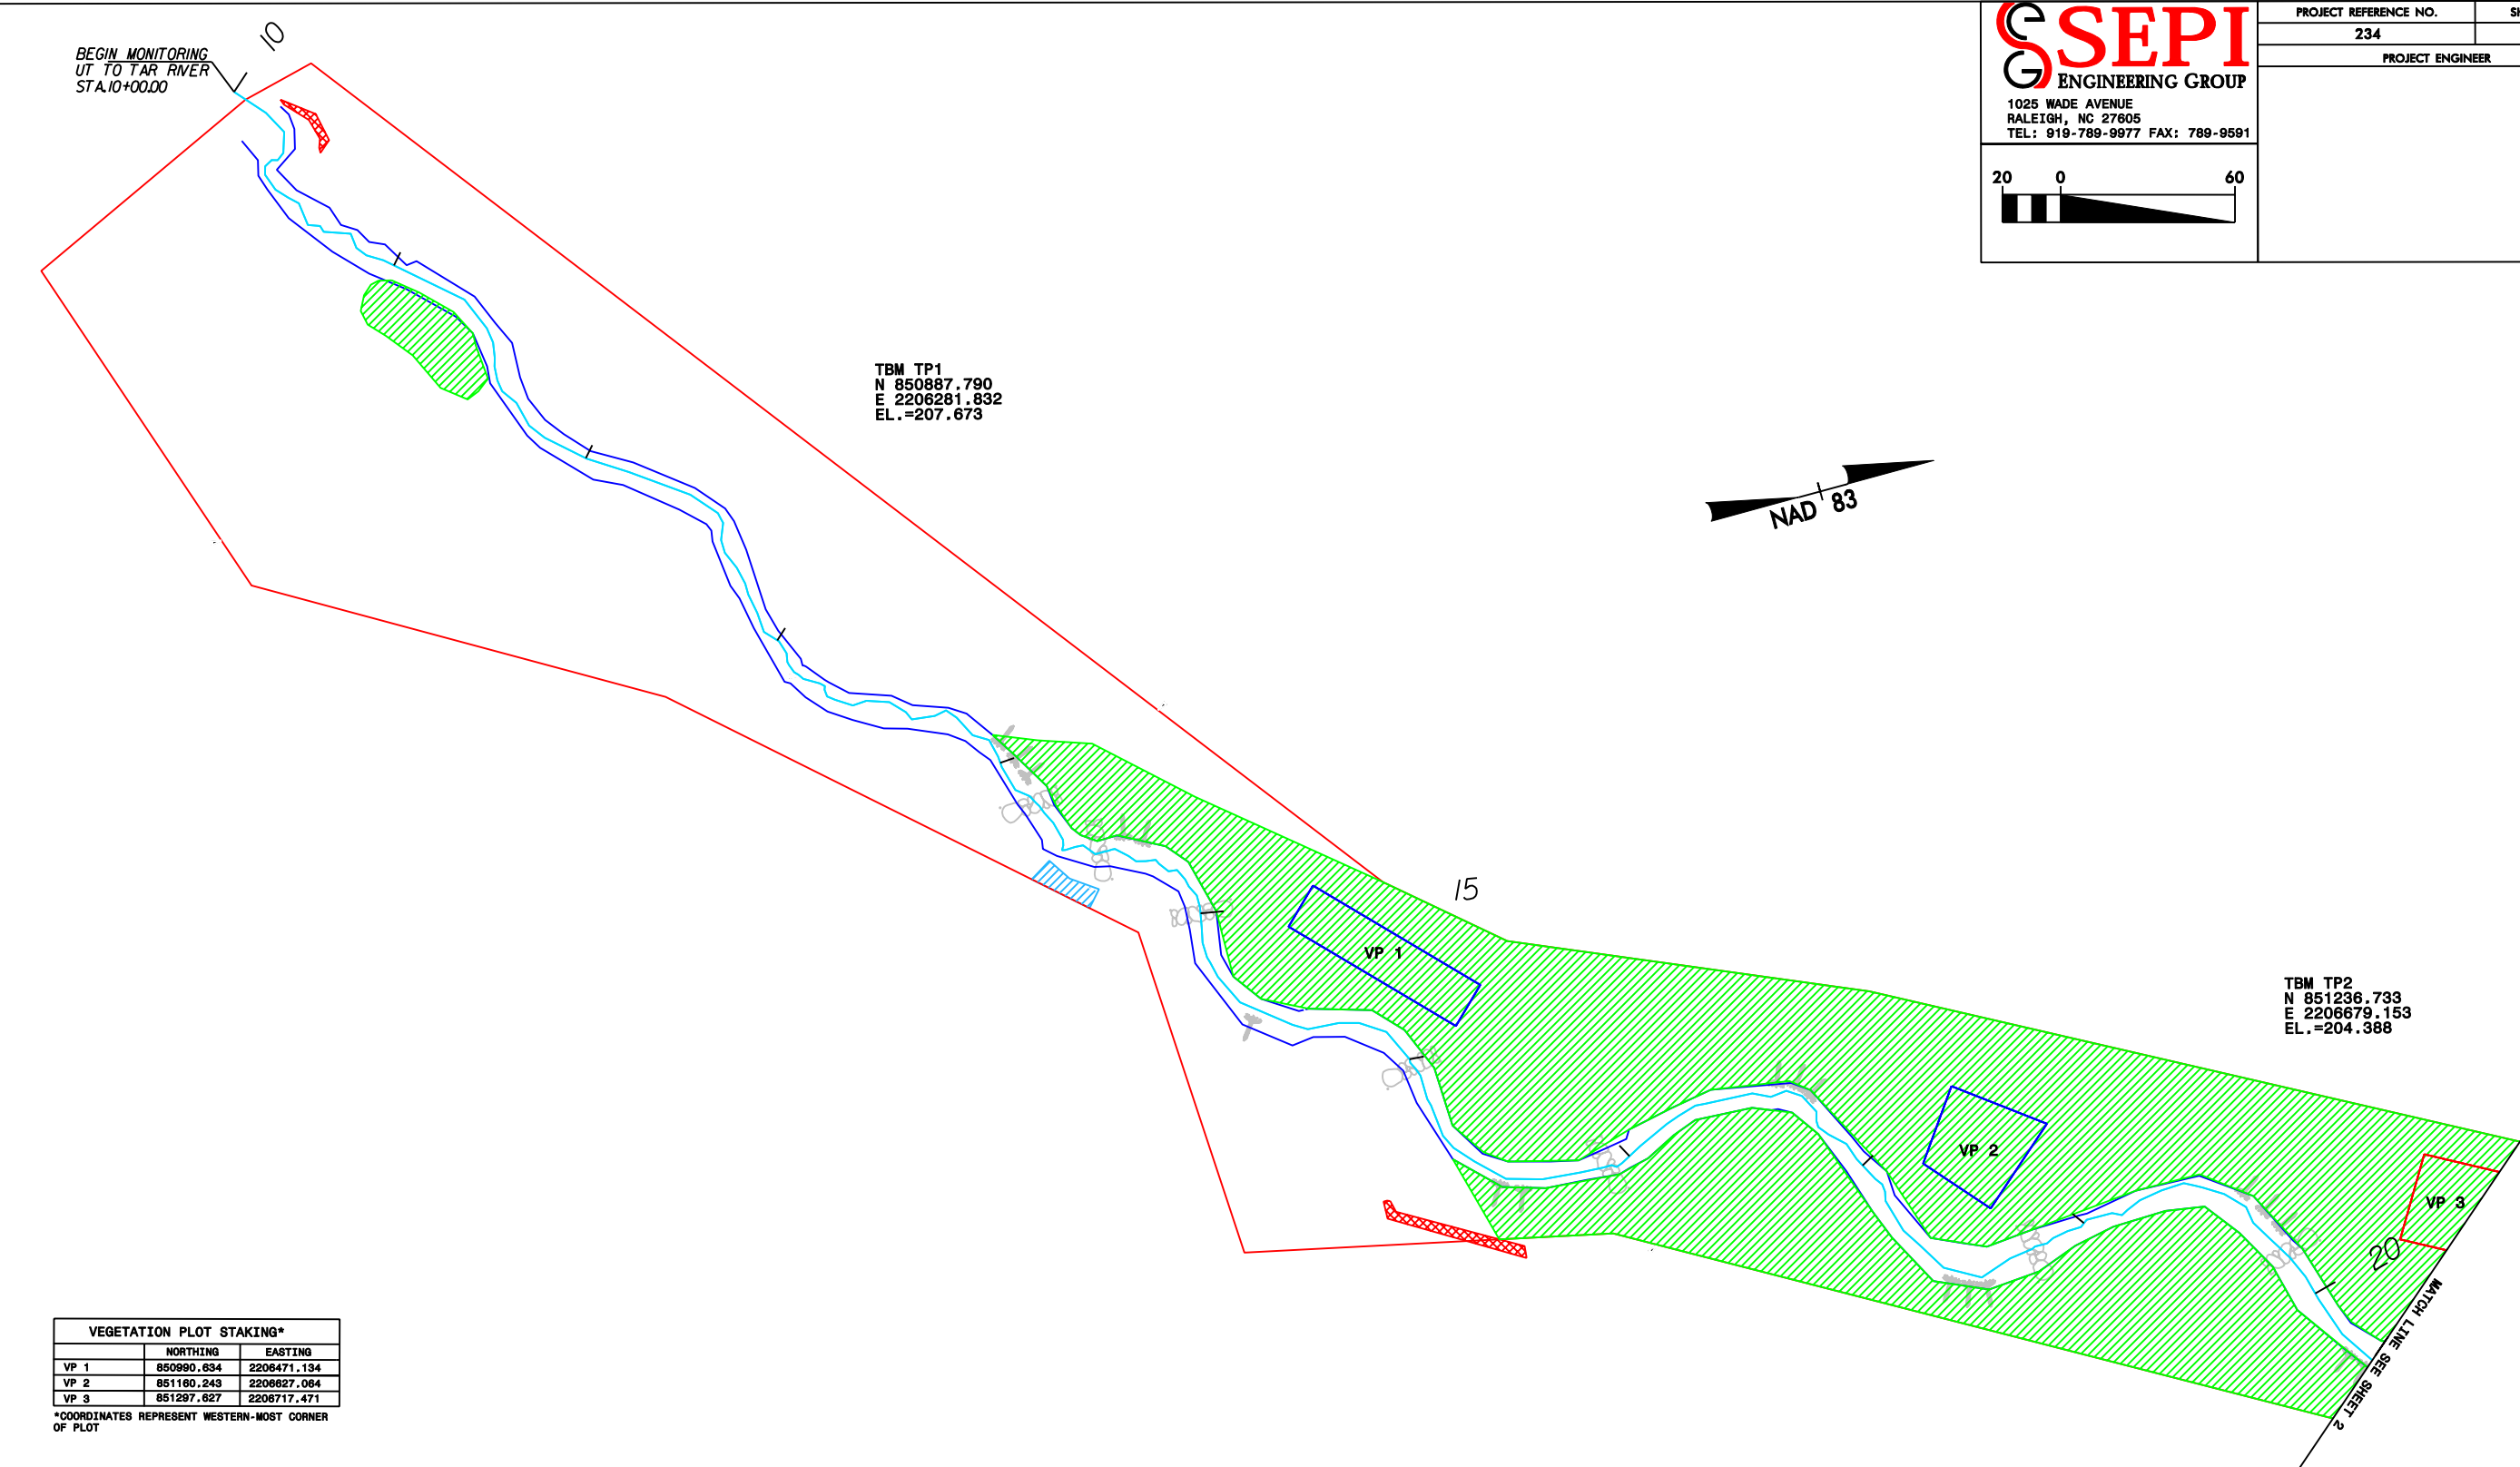
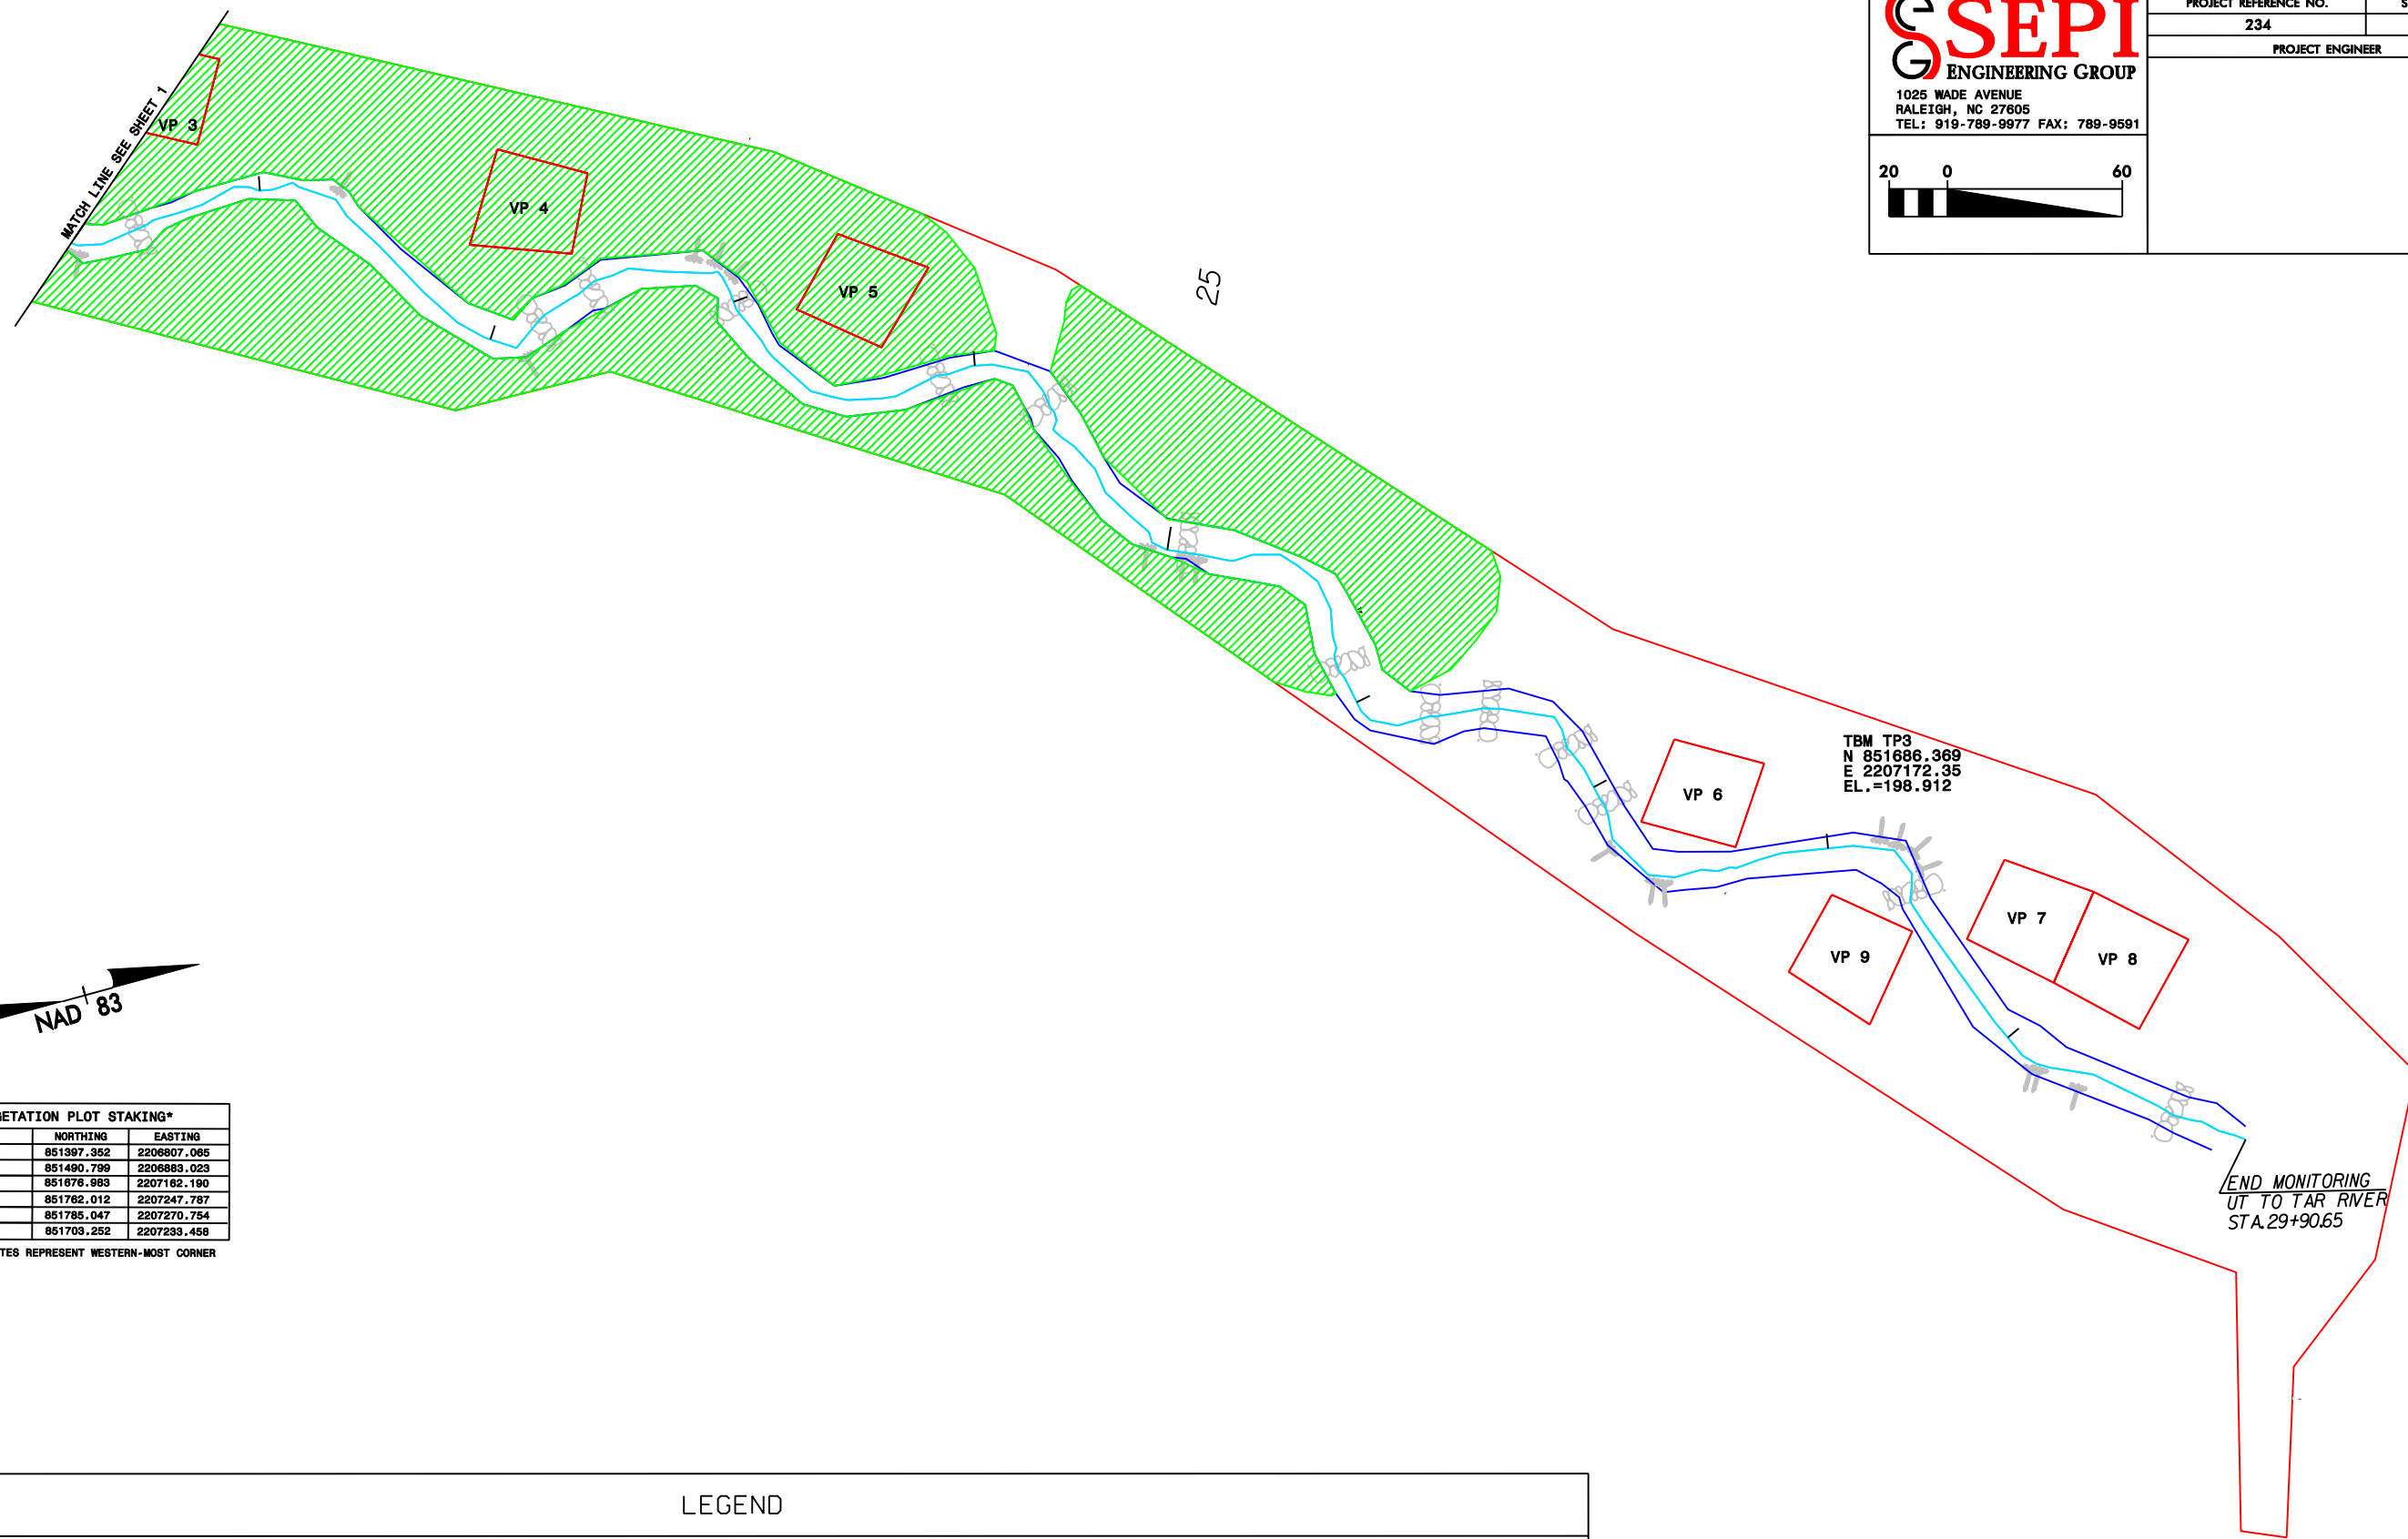
There are two areas of bare/eroding terrace along the right side (facing downstream) of the project. The first area (Station 14+45) is starting to heal, and vegetation is starting to cover the bare soil. The second area (Station 16+40) exhibited significant erosion of the terrace and appears to be moving toward instability as opposed to healing. Dense loblolly pine (*Pinus taeda*) thickets that are growing in the project corridor are a concern because they are suppressing the growth of more ideal late successional species along the middle sections of the project (see Appendix B Vegetation Problem Area Plan Views). The planted stem densities for all the Vegetation Plots (VP), except VP 1 and 2, were below the Monitoring Year 5 goal of 260 stems/acre. Planted stem density across all vegetation plots in Monitoring Year 4 was 120 stems per acre. It should be noted that there were several species for which 'volunteer' individuals were noted in all vegetation plots. With the inclusion of these 'volunteers,' all of the vegetation plots exceed the Monitoring Year 5 stem density goal. Noted volunteer species include: *Alnus serrulata* (VP 6), *Baccharis halimifolia* (VP 1-9), *Betula nigra* (VP 2, 7), *Cephalanthus occidentalis* (VP 6), *Fraxinus pennsylvanica* (VP 4-9), *Liquidambar styraciflua* (VP 1,2,6-9), *Liriodendron tulipifera* (VP 6), *Myrica cerifera* (VP 9), *Platanus occidentalis* (VP 7,8), *Pinus taeda* (VP 1-8), *Quercus phellos* (VP 6), *Quercus pagoda* (VP 3,5), *Quercus spp.* (VP 1-3), *Prunus caroliniana* (VP 1, 2, 6), *Prunus serotina* (VP 1,2, 4), and *Ulmus rubra* (VP 1).
